Final report RL 2015:06e

**Accident on Lake Vättern on 14 June 2014
involving the aircraft N5411Z of the model
Cessna-TU206G.**

File no. L-72/14

07/05/2015

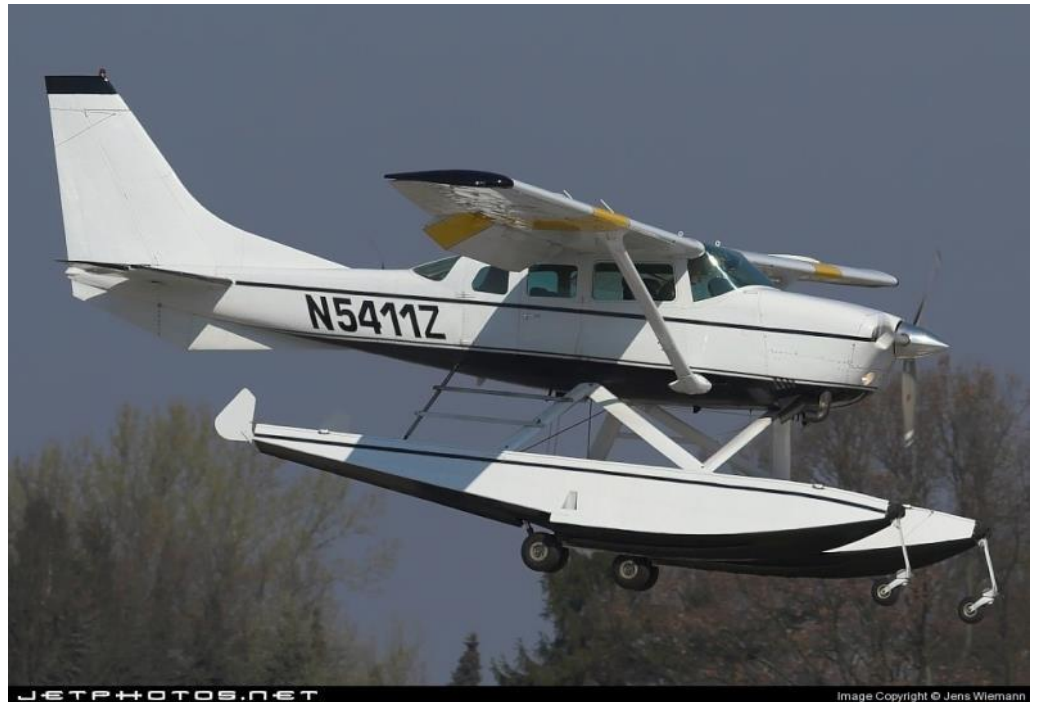
Figure 1. The aircraft in question. Photo: Jens Wiemann.

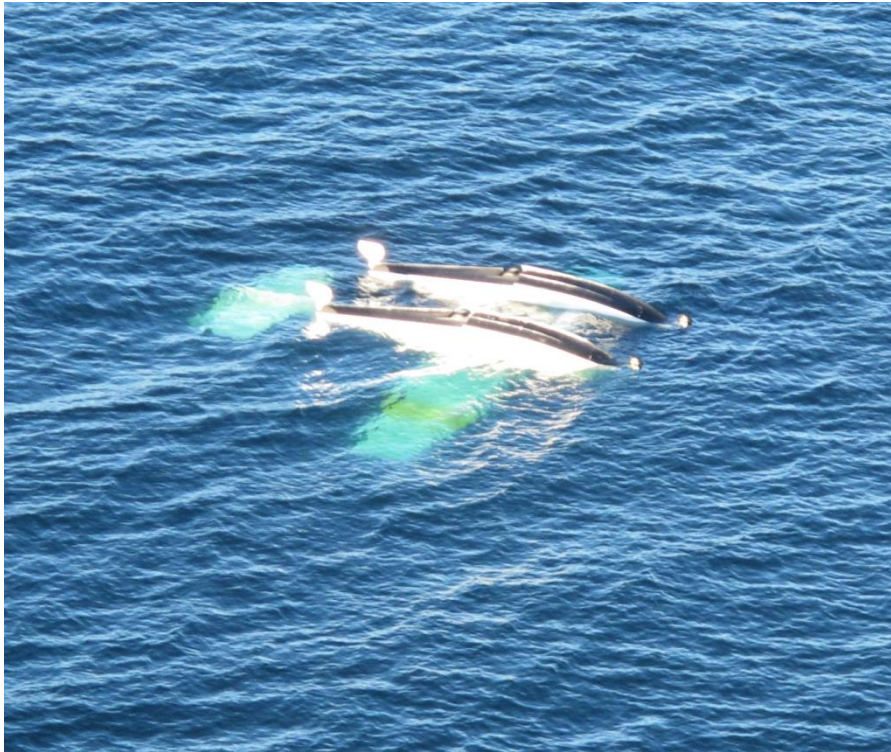
A private individual called 112 at 20.16 hrs and stated that from his home in Gränna he saw an object that was floating on the surface of the water between Gränna and Visingsö. SOS Alarm put the call through to JRCC. The object had drifted from the north and was at the time in the vicinity of the ferry line between Gränna and Visingsö. The rescue helicopter, which at the time was searching outside the northern tip of Visingsö, was redirected to the specified location and found the aircraft in position 58 02N 014 25E (see Appendix 1 figure B2). The aircraft was floating upside down, and only parts of the floats with respective water rudders were visible above the surface of the water, see Figure 2. The rescue helicopter's rescue swimmer dived down and checked the cabin but no person was discovered. At a later stage, the cabin was also checked by a rescue swimmer from the rescue services. Neither on that occasion was any person discovered in or near the aircraft.

Figure 2. The aircraft was found floating upside down. Photo: Swedish Maritime Administration, Lifeguard 901.

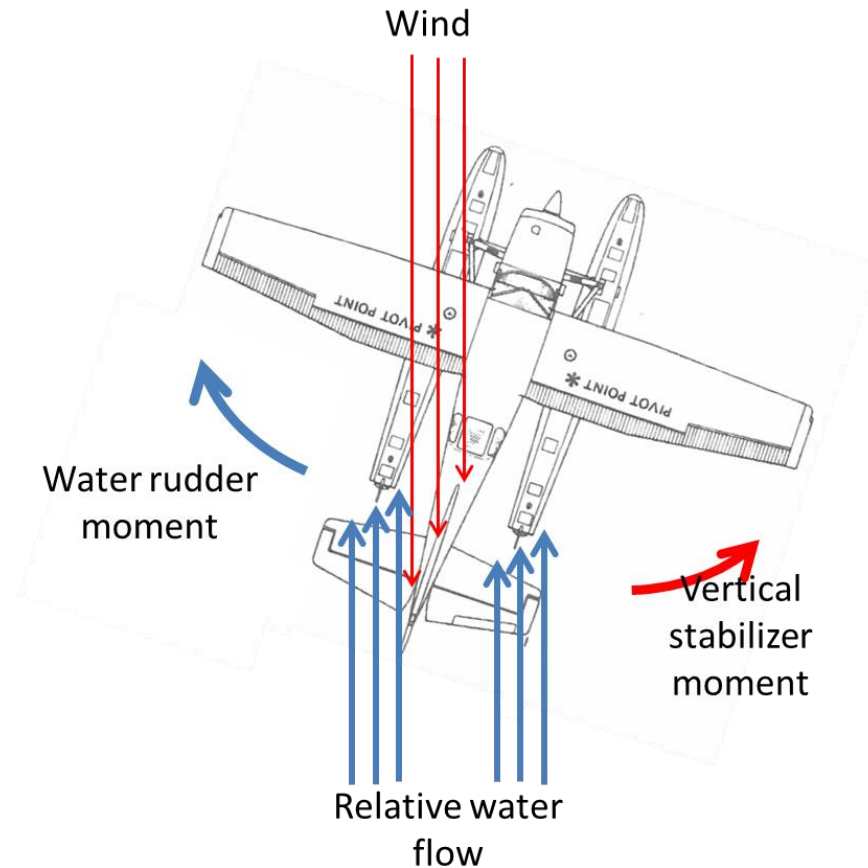
When a float-equipped aircraft floats in the water with the engine shut off and with the water rudders lowered, two counteracting moments arise in the yaw plane. The wind that hits the aircraft's vertical stabilizer wants to turn the aircraft's nose into the wind. The wind will drive the aircraft backwards through the water. The water current over the floats then hits the water rudders, which want to turn the aircraft's nose from the wind (see Figure 3).

Figure. 3. Moments acting on the aircraft.

Which of these two moments will be the greatest depends on the wind speed and the speed through the water. Since water has a density that is about 1000 times greater than air, it will suffice with a speed through the water much lower than the wind speed for the moment from the water rudders to be greater than the vertical stabilizer's moment. Rough estimates performed by SHK show that at a wind of 15 knots, it will suffice with a speed of about 2 knots through the water for the moments to balance.

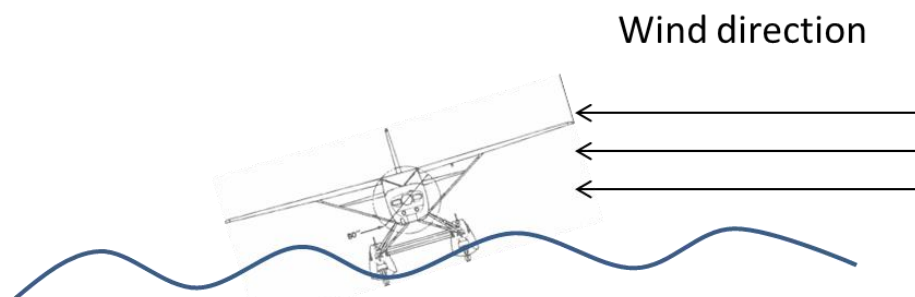
When the aircraft was lying completely sideways and was rolling in the waves, the wind gained an angle of attack against the wing that created a lifting force, which together with the dynamics of the waves caused the aircraft to capsize (see Figure 4).

Figure. 4. The wind's action on the aircraft.

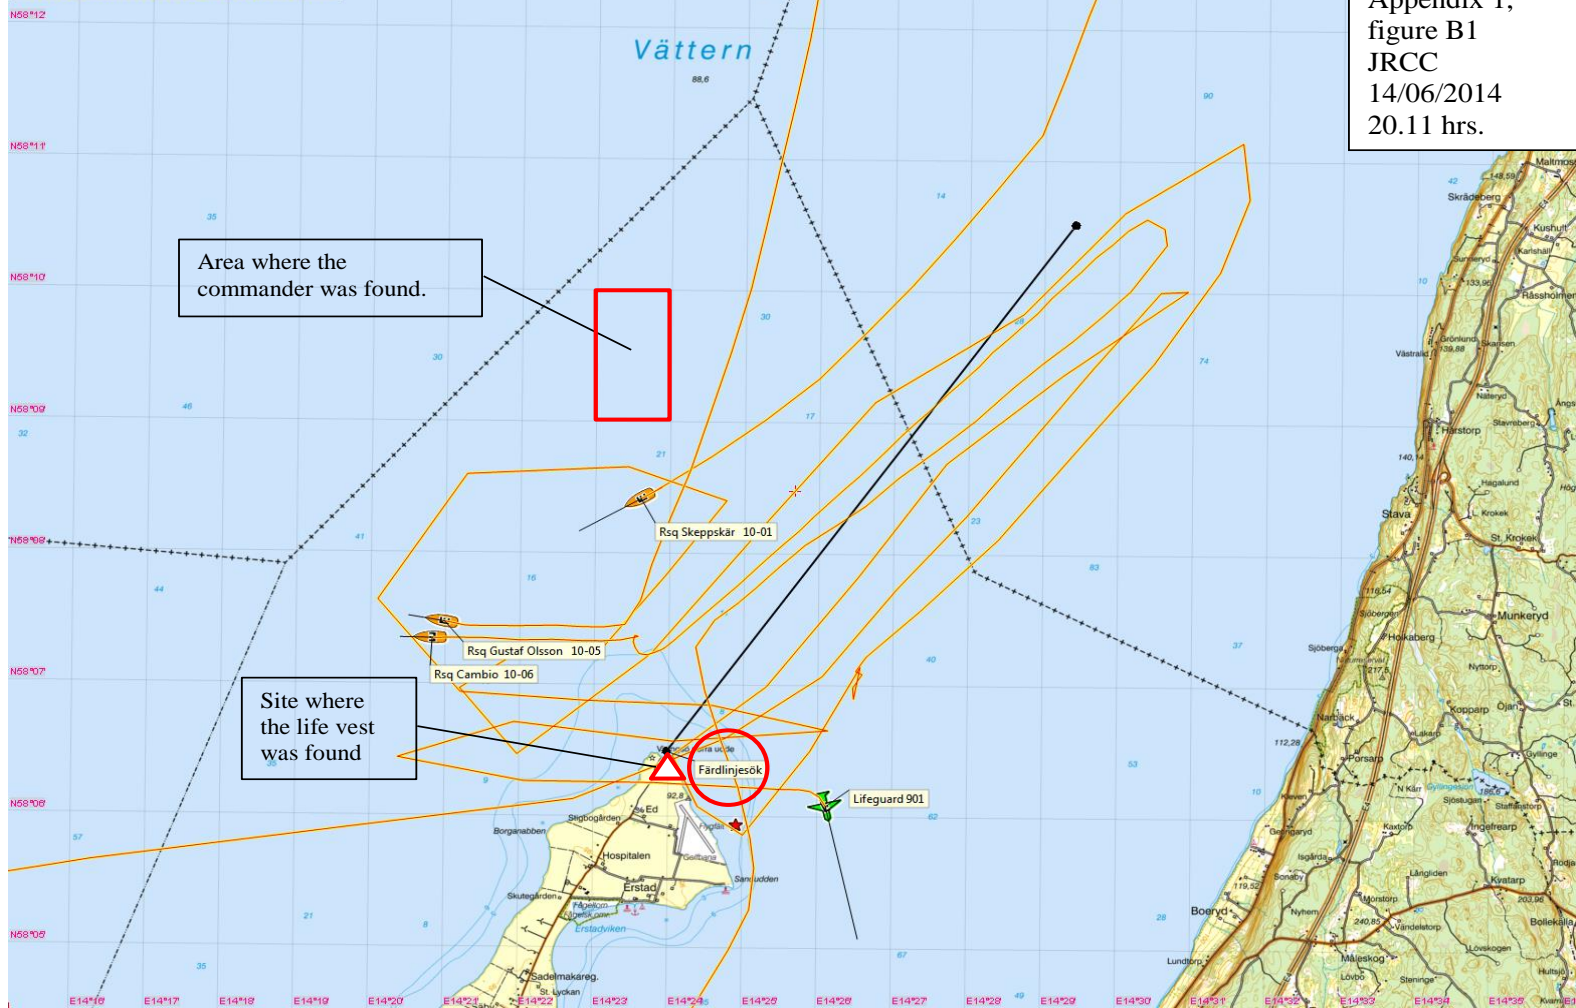
Appendix 1,
figure B1
JRCC
14/06/2014
20.11 hrs.

commander of the aircraft was found floating and deceased in his inflated life vest. The commander was taken on board the steamer and was subsequently retrieved by the Swedish Sea Rescue Society's rescue boat RESCUE CAMBIO for onward transportation to the harbour in Gränna. According to the crew of TRAFIK, the deceased person was found about three nautical miles, approximately 5.5 km, north of Visingsö at position 58 09N 014 23E (see Appendix 1 figure B1).

Area where the commander was found.

Site where the life vest was found

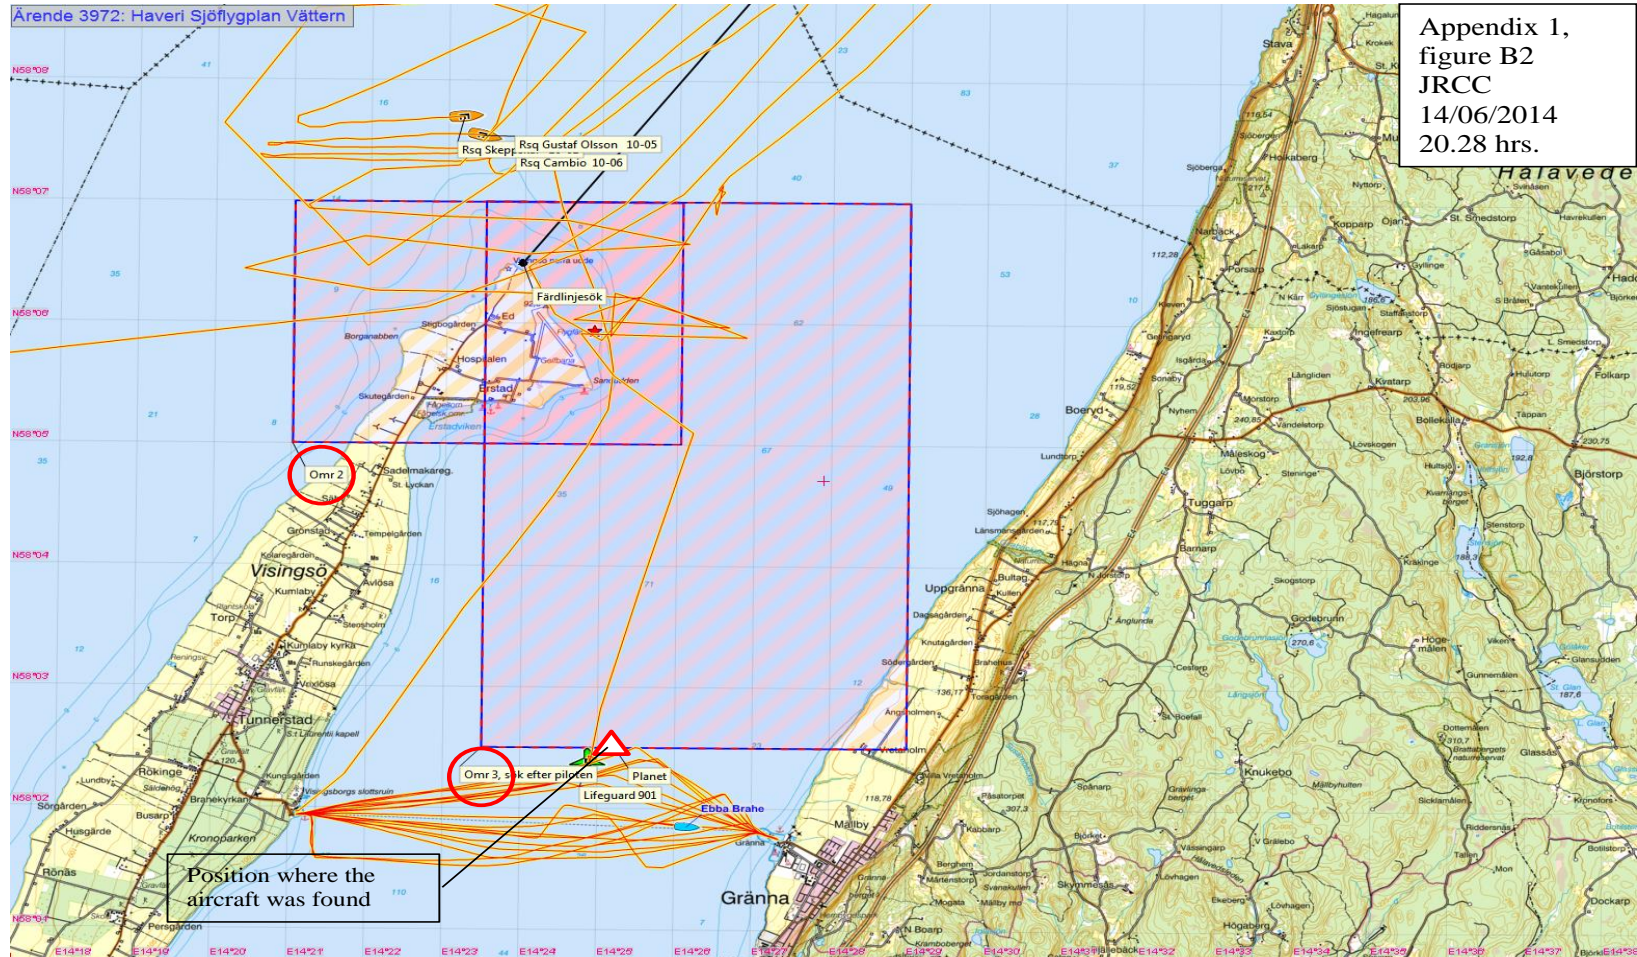
Appendix 1,
figure B2
JRCC
14/06/2014
20.28 hrs.

After the aircraft had been found, JRCC gave a new third search area (see Appendix 1, figure B2). The area was determined in light of the site where the aircraft was found and was limited to the south by the aircraft's discovery site and in the north by the area outside the northern tip of Visingsö. Shortly thereafter, the search area was moved to a new fourth area (see Appendix 1 figure B3), which was limited by

Position where the
aircraft was found
