- Final Report -

AAIS Case N°: AIFN/0011/2014

Runway Confusion

Operator: Badr Airlines
Type: Ilyushin IL-76TD
Registration: ST-BDN
Place of Occurrence: Sharjah International Airport
State of Occurrence: United Arab Emirates
Date of Occurrence: 29 June 2014

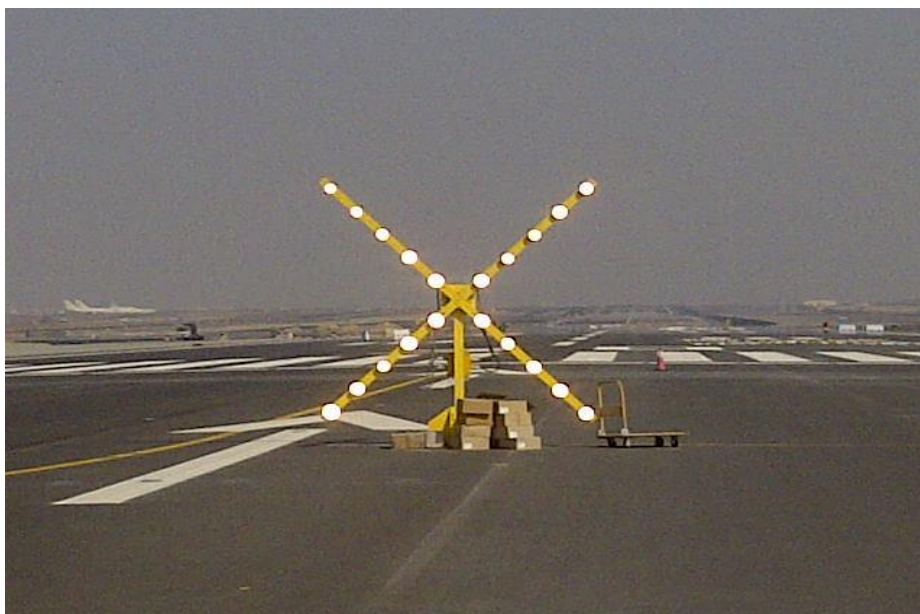
Figure 1. Lit cross mark positioned before the new runway threshold marks

Resulting from the risk assessment plan, white crosses were painted on the surface of the new runway, and one lighted cross sign was positioned several meters before the threshold (figure 1).

In his explanation of the confusion, the captain stated that the cross mark on the runway was not clear to him, and that the sunlight reflection had caused him to become confused.

The CVR revealed that the captain became fixated on the right (northern) runway, which he used to land on, and, up to his perception, there were no other clues that the runway was not operational. The light cross sign and white cross marks were not observed by him. Page 10-8 of the Jeppesen Airway Manual supported the confusion by showing the future appearance of several Bravo intersections with the new runway; showing the under-construction runway more noticeably by a solid black line in comparison to the fainter depiction in gray of the active runway 30; and by showing the designation of the active runway 30 as taxiway Bravo. The caution mentioned below the chart was not sufficient to alert the crew to the fact that the chart depicted a future configuration which would be effective at a later date.

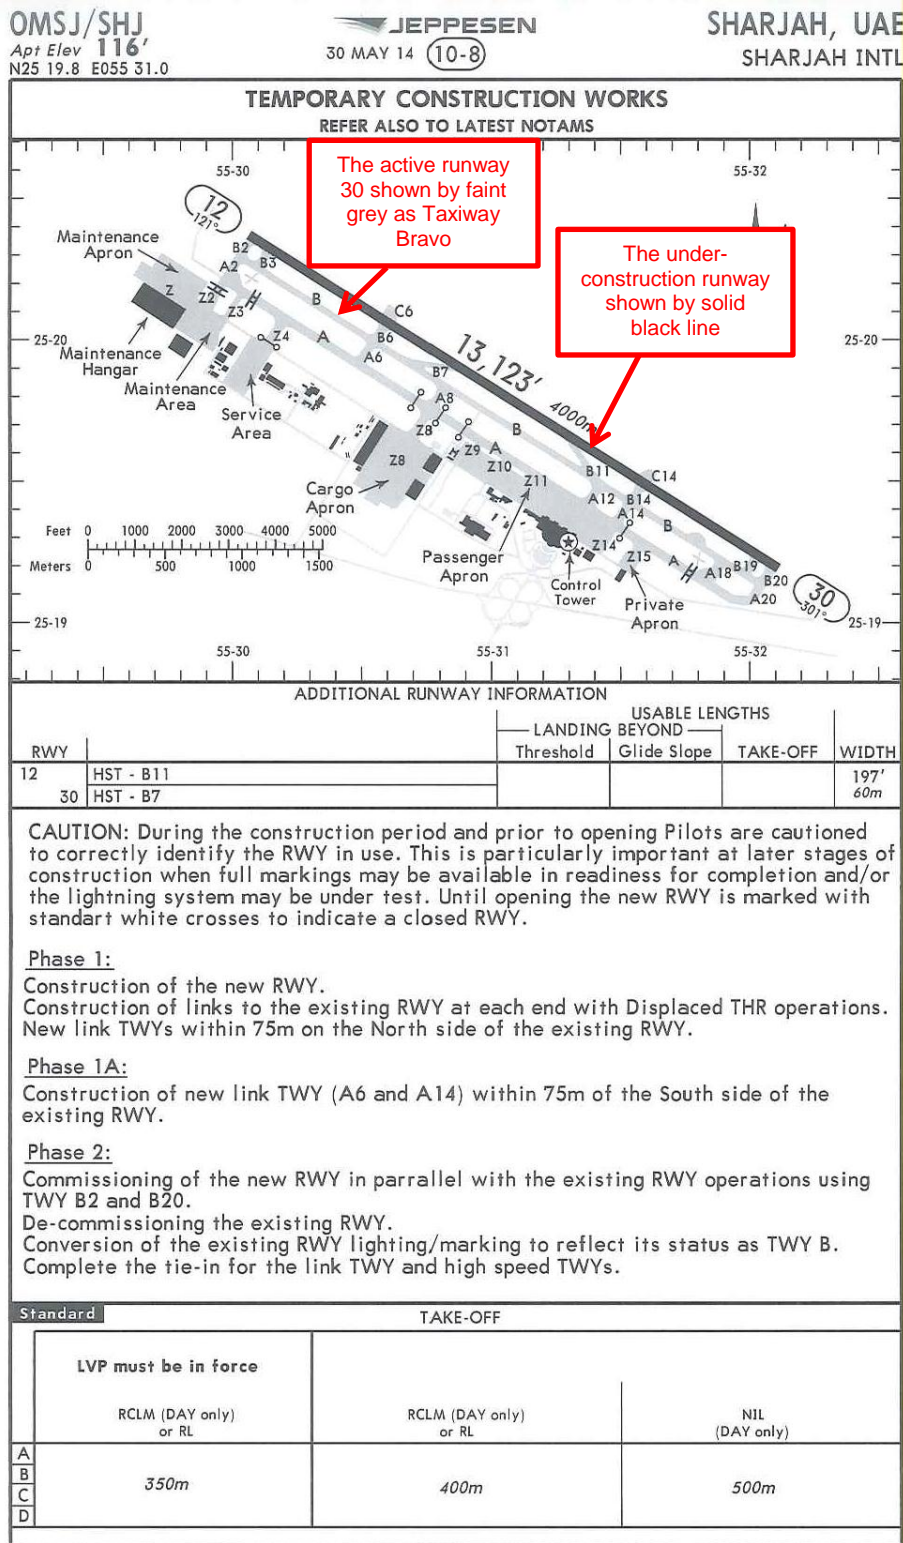
Figure 2a. Jeppesen temporary revision

¹ Runway 30L as perceived by the crew and the dispatcher after reviewing the temporary revision of the Jeppesen (page 108- Temporary Construction Works).

- (m) Page 10-8 was inserted in the Jeppesen Airway Manual when there was no need for it, since it reflected a future change.
- (n) Inadequate independence was afforded to the position of safety within the management structure of the ATS Provider organization.

- 3.3.1 The inability of the flight crew to identify the correct landing surface.
- 3.3.2 The crew had followed an airport chart in the Jeppesen Airway Manual that was not yet effective on the date of the Incident.
- 3.3.3 The insufficient CRM among the flight crewmembers.
- 3.3.4 The inadequate dispatch briefing which did not provide sufficient information and draw attention on page 10-8 of the Jeppesen Airway Manual.
- 3.3.5 The confusing Aeronautical Information Circular (AIC) statement and Jeppesen Airway Manual runway information page 10-8, which improperly depicted a chart that reflected the future situation rather than the existing situation.

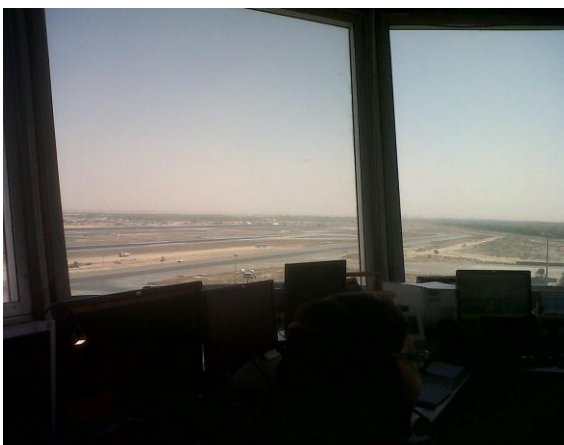
Figure 3. The ATCO position looking towards 30

- (a) The view of the active runway 30 thresholds and approaches was good. The Tower observation windows contain a large pillar which somewhat obstructed the ATCO's view, but the ATCO's view was not overly restricted.

From the Tower controllers' perspective, it should not have been excessively difficult to assess that an aircraft was approaching the incorrect runway, although this cannot be stated definitively since the Investigation did not have the opportunity to observe an aircraft approaching to runway 30. The difficulty in assessing the approach of an aircraft relates to the oblique angle of view, and the fact that the approaches are only 250 meters apart (figure 3).

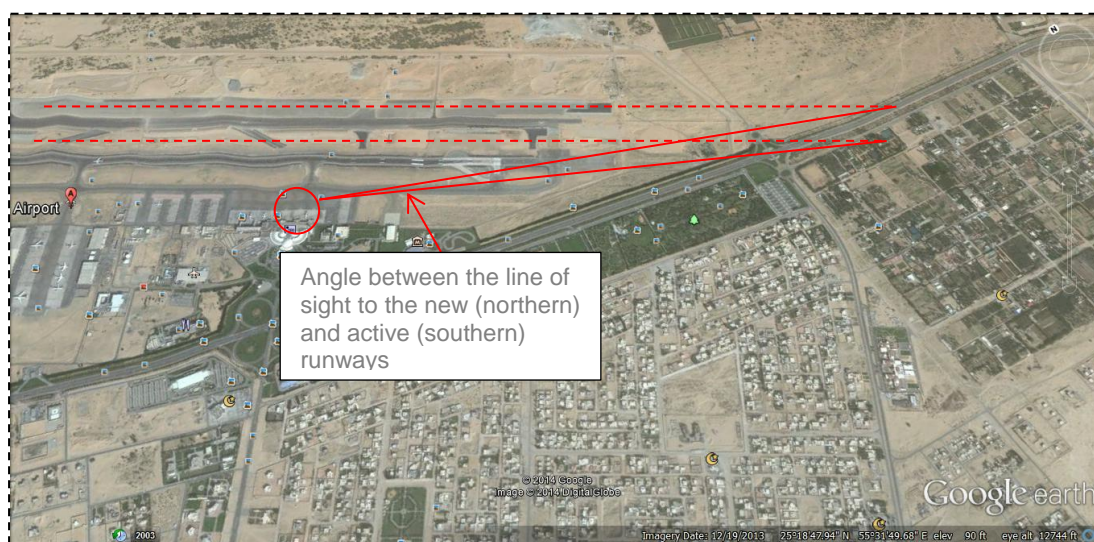
Figure 6. Line of sight from the Tower to the two runways

The Investigation believes that the subsequent incident, which occurred on 10 July 2014, indicates that a Tower controller can discover an approach to the incorrect runway, provided that the controller has been previously alerted that the aircraft is carrying out a visual approach, even if the line of sight to the runways forms a small acute angle (figure 6).

During the final approach of BDR7625, and at the moment the Aircraft appeared in his line of sight, the Controller was on the telephone coordinating the departure of two aircraft with Dubai Departure.

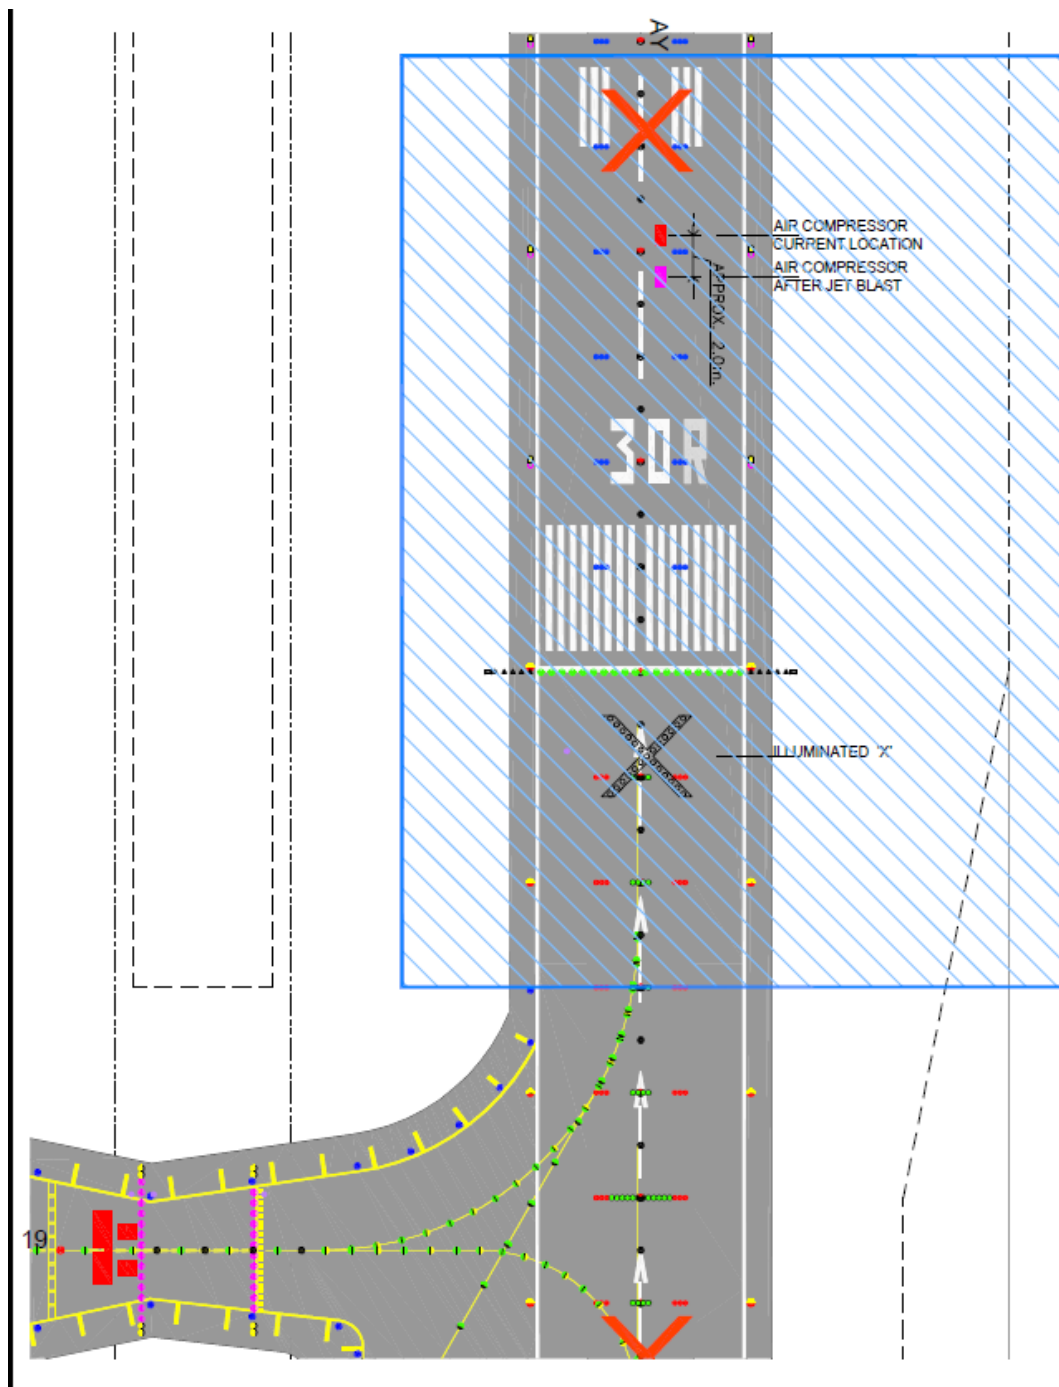
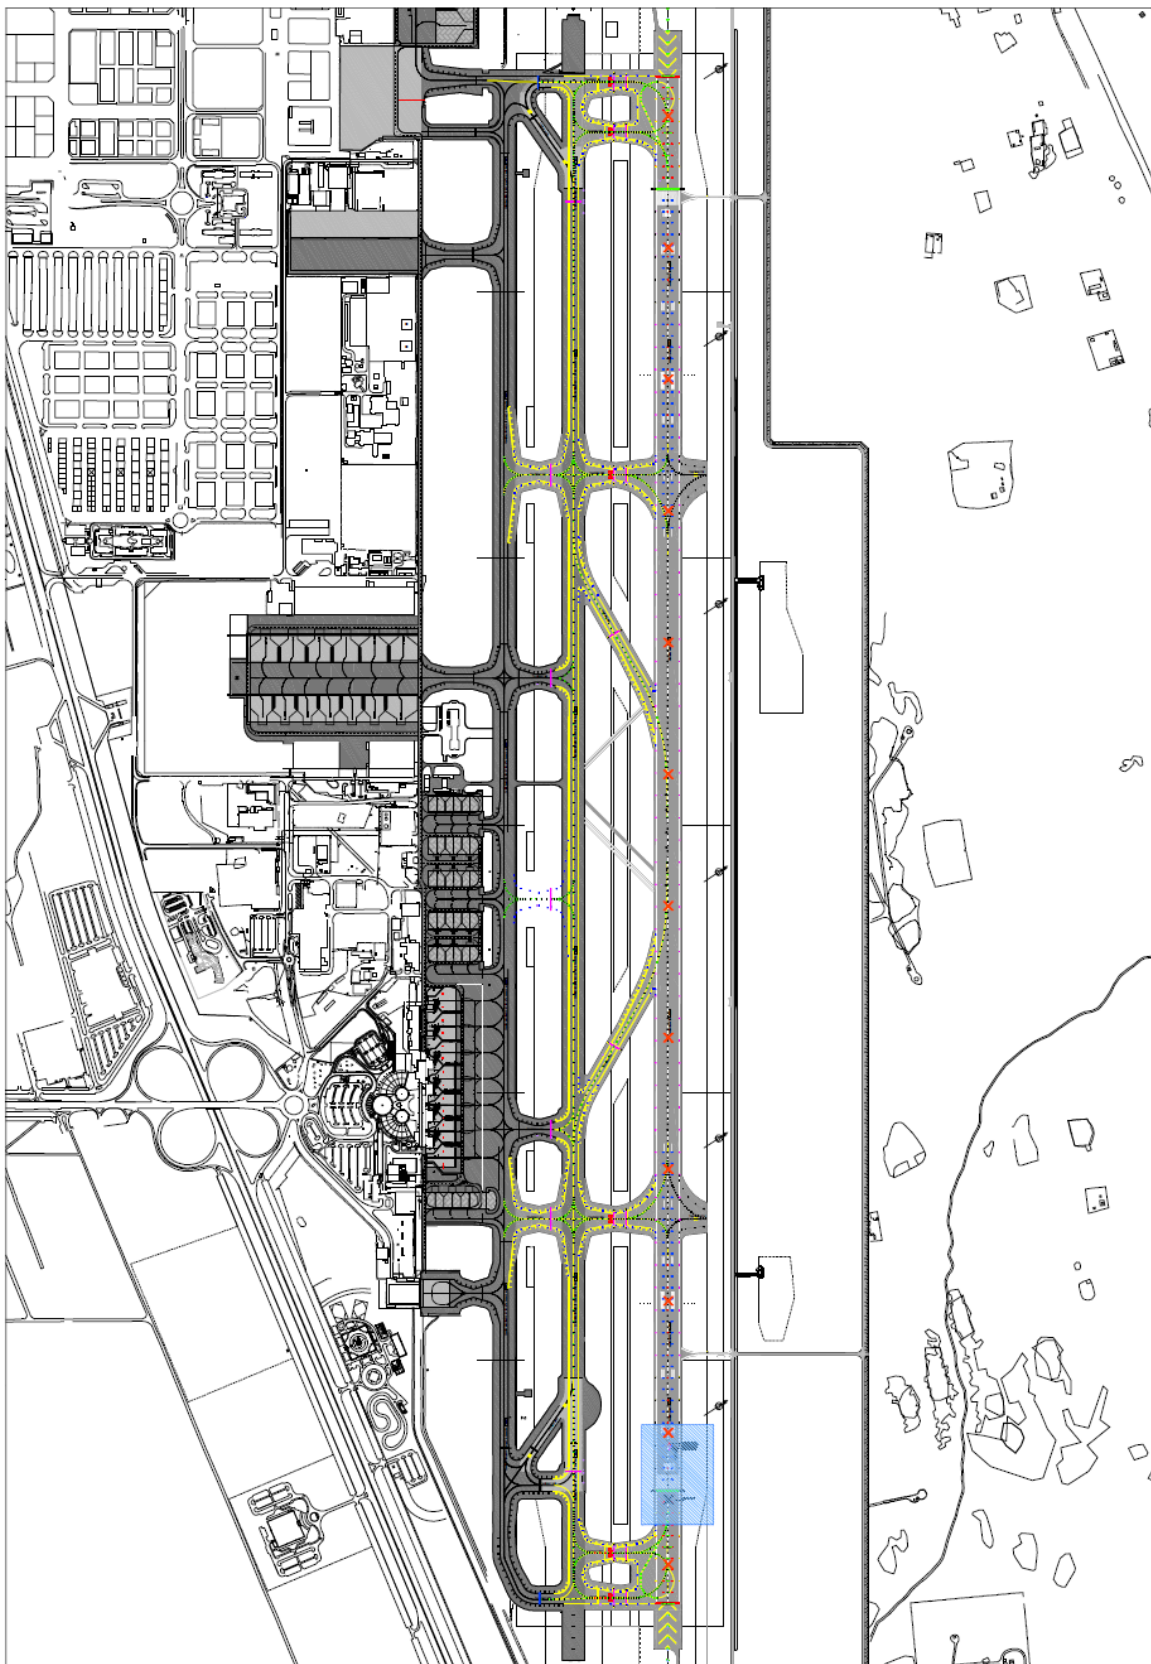
Appendix A. A layout showing the location of the construction equipment

The Aircraft continued losing height after the 'go-around' was initiated until it was approximately 0.3 NM from the threshold and at a height above ground level (AGL) of approximately 50 ft. The jetblast from the engines caused a construction compressor weighing approximately one ton to move.
