AIRCRAFT INCIDENT REPORT AND EXECUTIVE SUMMARY

Reference:	CA18/3/2/1066	
Aircraft Registration	ZS-NMO	Date of Incident	18 July 2014		Time of Incident	0400Z
Type of Aircraft	Bombardier Q400		Type of Operation		Commercial (Part 121)	
Pilot-in-command Licence Type		ATPL	Age	43	Licence Valid	Yes
Pilot-in-command Flying Experience		Total Flying Hours	3280.6		Hours on Type	2120.0
Last point of departure		Cape Town International Airport (FACT) Western Cape. Province				
Next point of intended landing		Braam Fischer Aerodrome (FABL) Bloemfontein. Free State. Province				
Location of the incident site with reference to easily defined geographical points (GPS readings if possible)						
Runway 01 at Cape Town International Airport (FACT) GPS Coordinates S33° 59'15.85" E018' 36,32.01" elevation						
Meteorological Information		Surface wind,320° at 10kt ,Visibility 6000 with light rain				
Number of people on board	2+2 + 19	No. of people injured	0	No. of people killed	0

AIRCRAFT INCIDENT REPORT

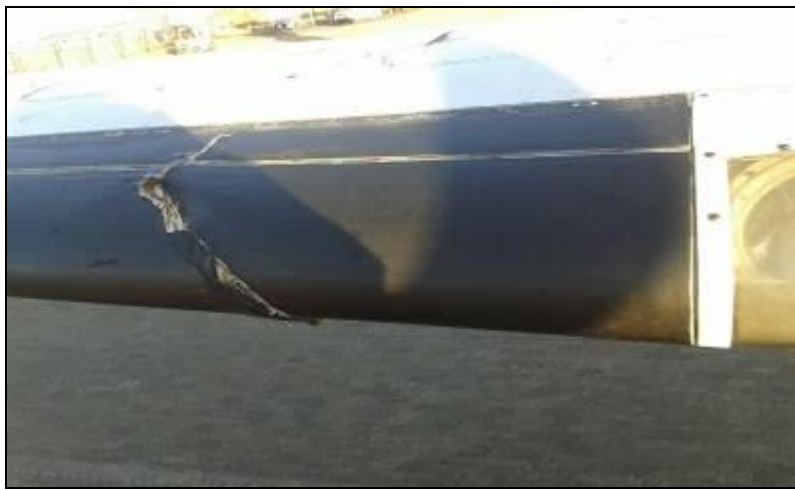
- 1.1.4 It was noted after landing at Bloemfontein that the cowling that separated from the inboard side of number 2 engine, struck the leading edge section, outboard of no 2 engine, causing substantial damage to the leading edge and outer de-icing boot during the in-flight incident. No injuries were sustained.

- 1.3.1 The aircraft sustained damage to the last cowling section and the leading edge de-icing boot outboard of No2 engine.

Figure 1: Shows R/H leading edge & de-icer boot damaged

1.12.1 The right hand engine cowling situated at the left hand side of the engine, became dislodged from the left-hand side of the engine during the take-off sequence and impacted the right hand leading edge and de-icer rubber boot just outboard of right hand engine, causing substantial damage to the leading edge.

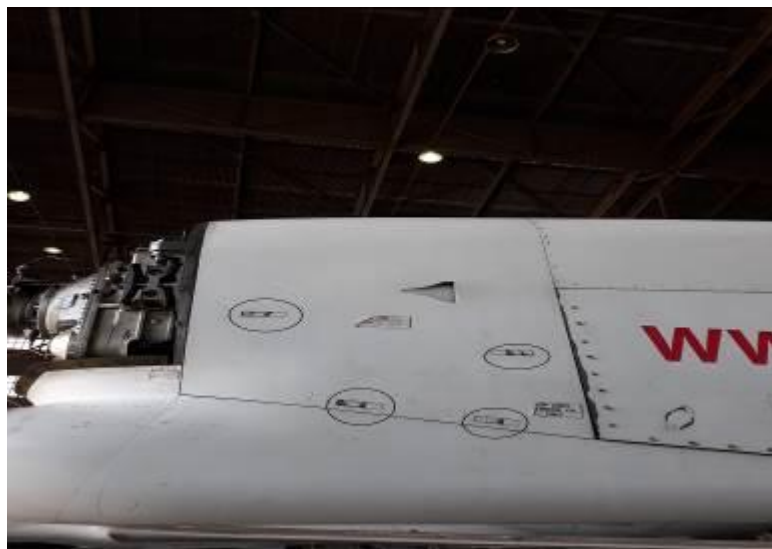
Figure 2: shows No 2 engine cowling position on a DHC-8-402

- 3.1.11 The right hand engine inboard cowling was not properly latched and locked, the work was performed by assistant
- 3.1.12 The right hand engine left side cowling separated from the engine during the take-off run at FACT due to not being properly latched and locked.

- 3.2.1 Right hand engine inboard cowling was not properly latched and locked during pre-flight inspection resulting in the separated from the aircraft during take-off.

- 4.1 It is recommended that the Director of Civil Aviation through regular and ad-hoc oversight, review that maintenance on aircraft is not performed by unqualified personnel at AMOs. This incident occurred as a result of maintenance on the aircraft being performed by an assistant who is not qualified to perform any work on the aircraft.

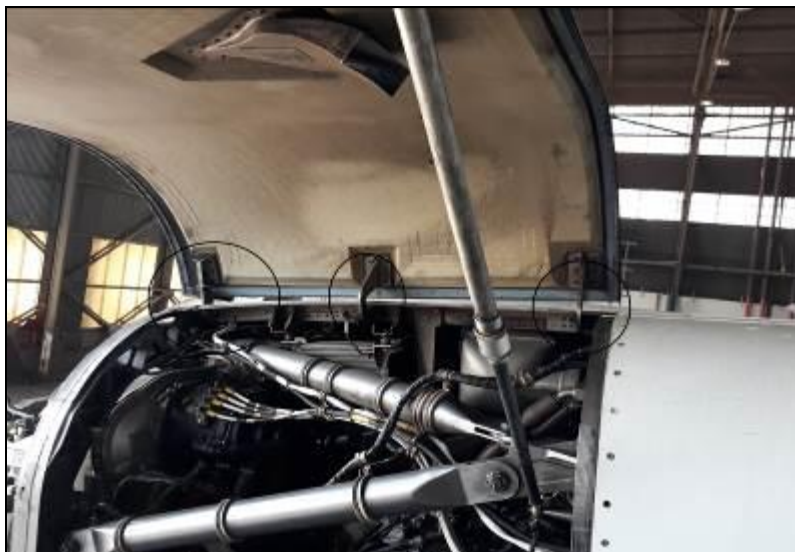
- 1.1.5 The cowling was located at approximately 660 metres from threshold of Runway 01 at FACT by the (ARFF) Cape Town Fire Department. The cowling was inspected and it was established that the two lower latches were unlatched and the two side latches were in the closed and latched position.

Figure 3: Shows position of the engine cowl on a DHC-8-402

1.12.2 The cowling was located by the Aerodrome Rescue & Fire Fighting (ARFF) personnel, approximately 660m from threshold of Runway 01 in the field at FACT. The cowling two lower latches were found unlatched and the two side latches in the closed and latched position.
