**AIRCRAFT ACCIDENT REPORT AND EXECUTIVE SUMMARY**

Reference:	CA18/2/3/9349	
<b>Aircraft Registration</b>	ZU-FBL	<b>Date of Accident</b>	11 August 2014		<b>Time of Accident</b>	0700Z	
<b>Type of Aircraft</b>	RAVEN (Aeroplane)		<b>Type of Operation</b>	Private			
<b>Pilot-in-command Licence Type</b>		NPL	<b>Age</b>	57	<b>Licence Valid</b>	Yes	
<b>Pilot-in-command Flying Experience</b>		Total Flying Hours	128,79		Hours on Type	128.79	
<b>Last point of departure</b>		Saldanha Aerodrome (FASD), Western Cape					
<b>Next point of intended landing</b>		Private airstrip on a private farm (New Plaasmol) at Hopefield, Western Cape					
<b>Location of the accident site with reference to easily defined geographical points (GPS readings if possible)</b>							
Hopefield on a private farm (New Plaasmol) airstrip							
<b>Meteorological Information</b>		Wind direction 20°, wind speed: 11 kts; air temperature: 18 °C; visibility: Good Cloud base: 5000 ft, cloud coverage: 3/8

<b>AIRCRAFT ACCIDENT REPORT</b>
---------------------------------

**Name of Owner** : Rogers C F  
**Name of Operator** : Rogers C F  
**Manufacturer** : BABST C F  
**Model** : RAVEN  
**Nationality** : South African  
**

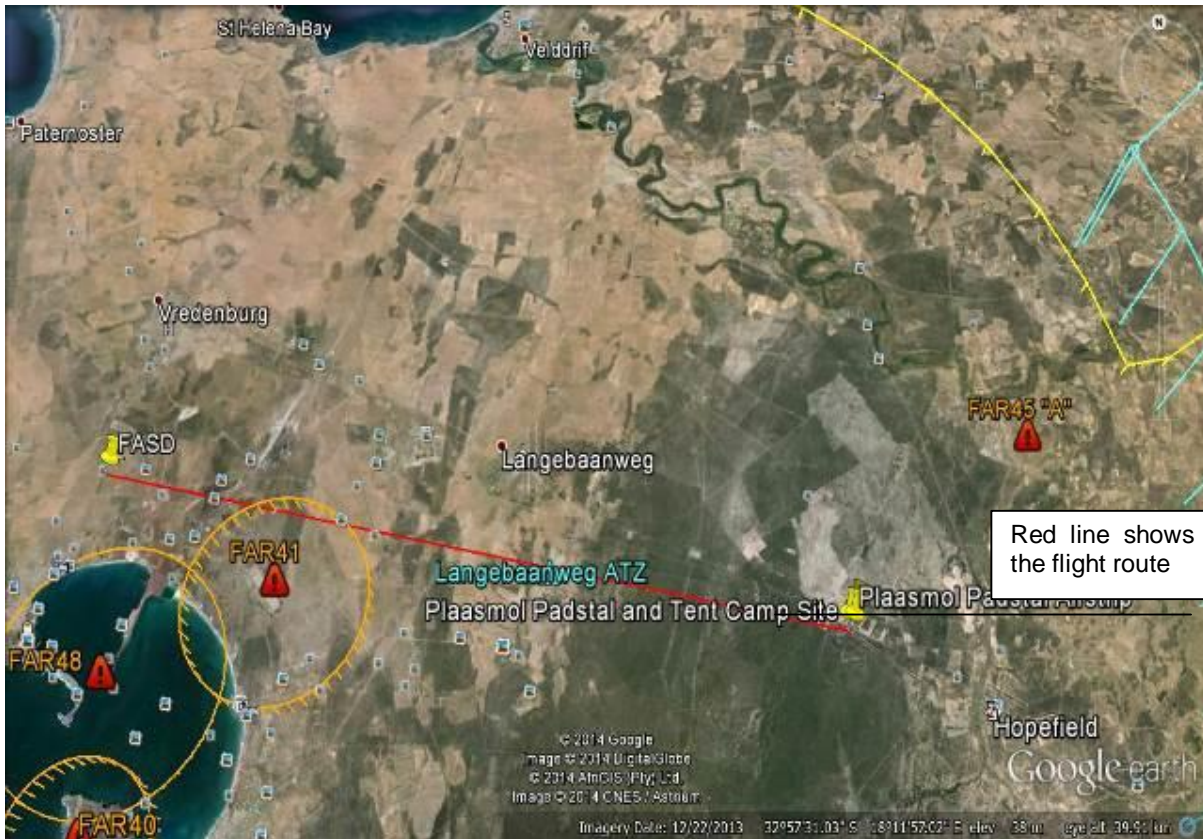
**Figure 1:** Aircraft flight route prior to accident

1.1.1 The aircraft was on approach for landing at the farm on a private airstrip (Runway 15). The pilot first conducted a runway inspection. The pilot stated that during the second approach for runway inspection, while flying approximately 50 ft above ground level (AGL), the aircraft experienced turbulence and lost height. Both the left main landing gear and the left wing of the aircraft clipped some treetops 300 m before the threshold. During contact with the trees the aircraft turned 270 degrees anticlockwise and the pilot lost control.

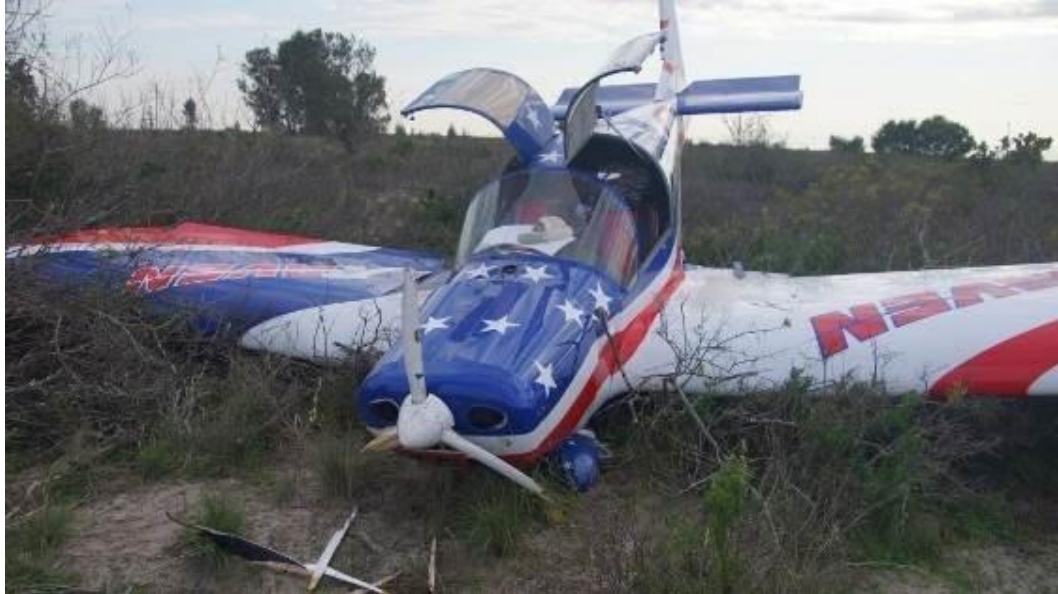
**Figure 2:** The aircraft as it came to rest

1.1.2 The aircraft impacted the ground on bushy terrain and came to stop 34 m left of the runway. The aircraft sustained substantial damage to the undercarriage, wings and propeller. The accident occurred in daylight conditions on a private airstrip with GPS readings S 33° 02' 08.27", E 18° 17' 42.04" at an elevation of 330 ft.

1.3.1 The aircraft sustained substantial damage to the undercarriage, wings and propeller.

*Figure 2 shows the aircraft damage as it came to a stop after the accident.*

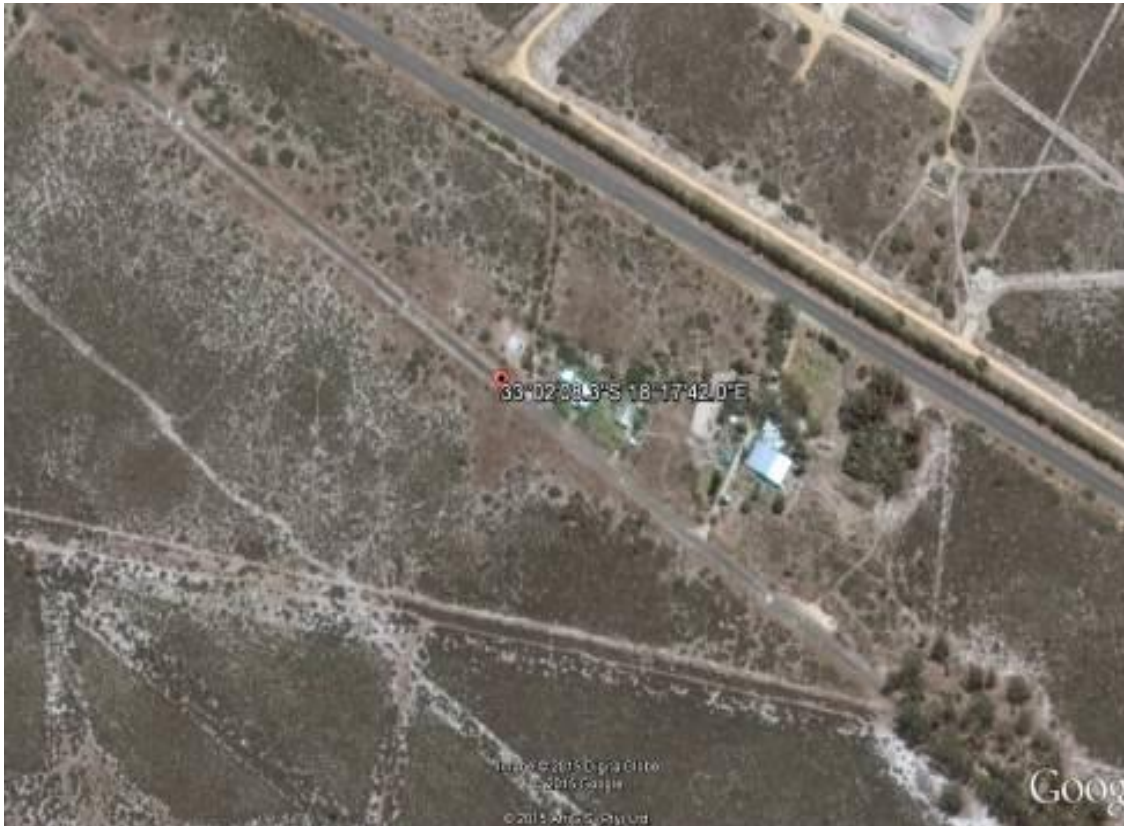
**Figure 3:** The accident site

1.12.1 The aircraft accident occurred on a bushy area on a private farm New Paasmol near Hopefield. The runway is surrounded by trees, which can cause aerodynamic changes.

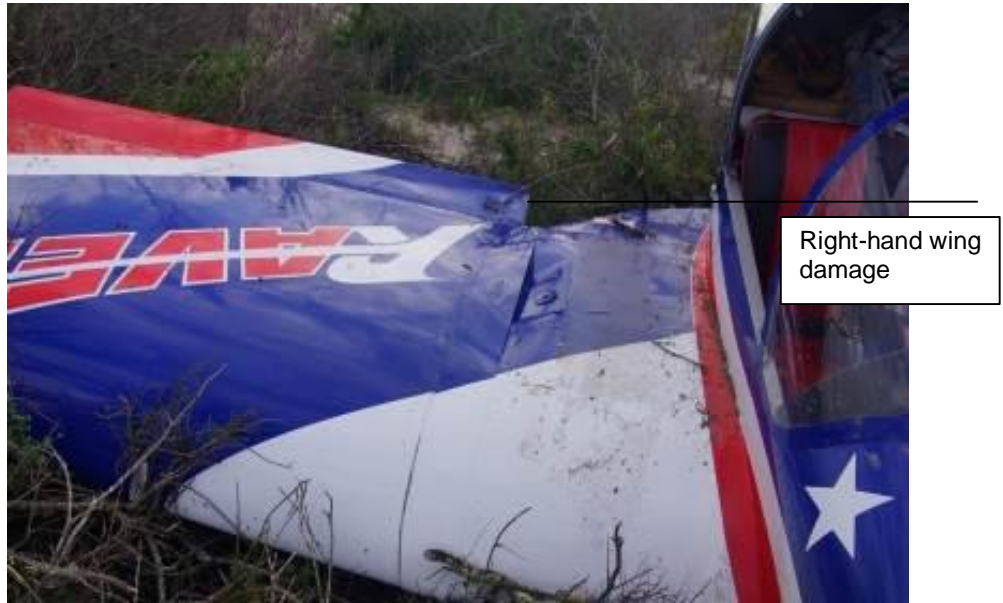
**Figure 4:** Damage to the right wing

1.12.2 The pilot stated that during pullout the aircraft experienced turbulence and lost height, and subsequently veered towards the left and clipped the treetops with both the left main landing gear and the left wing. The aircraft turned 270 degrees anticlockwise, the pilot lost control and the aircraft impacted with the bushy terrain and came to halt 34 m to the left edge of the runway.

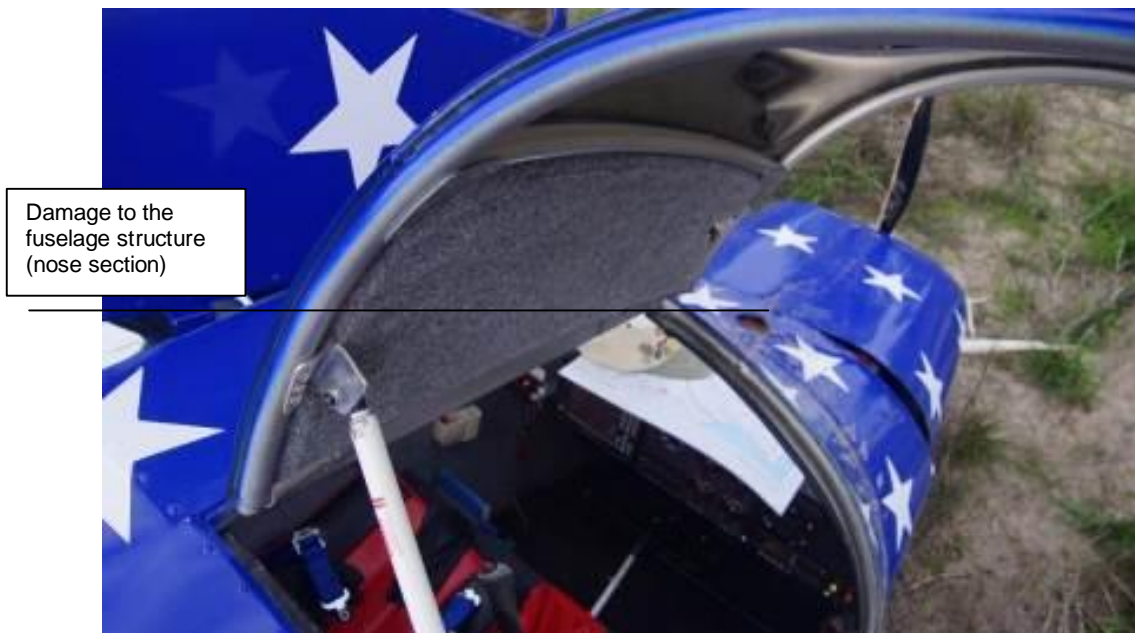
**Figure 5:** Damage to the wooden propeller

1.12.3 The aircraft sustained substantial damage to all landing gear, the propeller, wings and fuselage structure. The damage to the propeller is consistent with the engine producing power during impact. All damage to the aircraft was accounted for as the result of high impact forces.

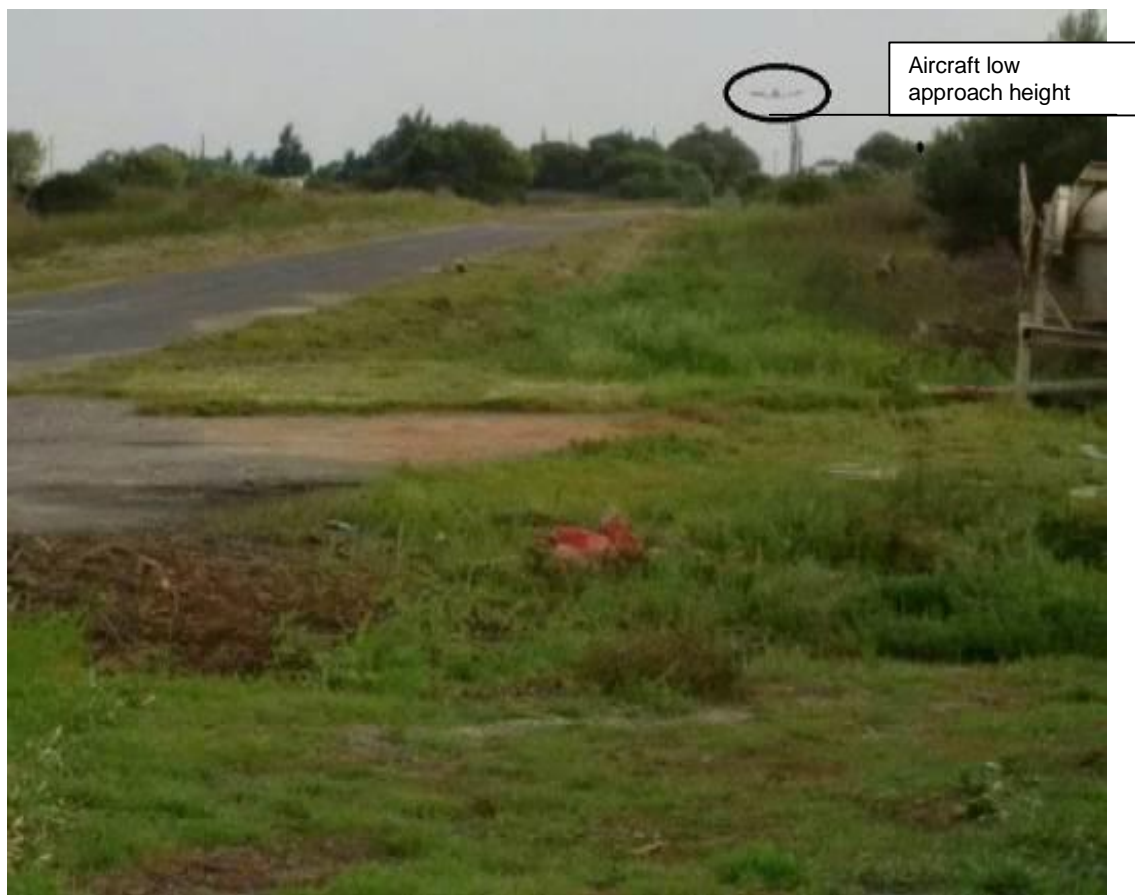
**Figure 6:** Picture 1 of aircraft approach prior to accident

- 1.16.2 The above photos were taken during the second reported runway inspection approach prior to the accident. The aircraft is observed flying at a low height, in close proximity to the ground - lower than the surrounding treetops.
- 1.16.3 The eyewitness who was at the farm when the accident occurred describes the accident as follows.

- 2.5 The pilot stated that he was flying at a height of 50 ft at the time he was conducting the runway inspection. According to the pictures taken then by the witness, the aircraft position, height and configuration were more of a ready-to-land nature. When conducting a runway inspection, pilots should fly on the right-hand side of the runway at a safe height to enable them to assess the field, check for any foreign object or any activities (animals) on the intended landing runway. However, the pilot stated that he was conducting runway inspection.

- 2.6 With the pilot flying at close proximity to the surface below the treetops while conducting a runway inspection, he was risking the chance of losing height, making it difficult to recover the aircraft (if necessary). The airflow will tend to be turbulent due to trees on the side of the runway. The photos show clearly that the aircraft was flying at a height lower than the reported 50 ft, which would not allow the pilot to do a proper inspection either; keeping the aircraft on a straight and level path would be a more pressing concern.

- 4.1 The regulator must edge the flight operators at the unmanned airfield to observe the standard operation procedure for flight safety operations. As evident to the height at which the aircraft was flying during the alleged runway inspection, the pilot could have not been able to see anything on the runway at the time.
