<b>AIRCRAFT ACCIDENT REPORT AND EXECUTIVE SUMMARY</b>
---

Reference:	CA18/2/3/9350	
<b>Aircraft Registration</b>	ZU-UBB	<b>Date of Accident</b>	18 August 2014		<b>Time of Accident</b>	0908Z
<b>Type of Aircraft</b>	Bat Hawk LSA		<b>Type of Operation</b>	Private		
<b>Pilot-in-command Licence Type</b>		Foreign Validation PPL	<b>Age</b>	53	<b>Licence Valid</b>	Yes
<b>Pilot-in-command Flying Experience</b>		Total Flying Hours	165		Hours on Type	9,5
<b>Last point of departure</b>		Private airstrip (Hazyview, Mpumalanga)				
<b>Next point of intended landing</b>		Bathawk city private airstrip (Nelspruit, Mpumalanga)				
<b>Location of the accident site with reference to easily defined geographical points (GPS readings if possible)</b>						
Bathawk city private airstrip in near Nelspruit left of runway 09 (GPS position: 25°24'59" South 030°5' 4'39" East), elevation 2477 feet						
<b>Meteorological Information</b>		Temperature: 24 °C, Dewpoint: 05 °C, Wind: 330° at 7 knots

**Name of Owner** : Van der Ploeg GJ  
**Name of Operator** : Private  
**Manufacturer** : Pappas AJ  
**Model** : Bat Hawk LSA  
**Nationality** : South African  
**Registration Marks** : ZU-UBB  
**Place** : 25°24'5

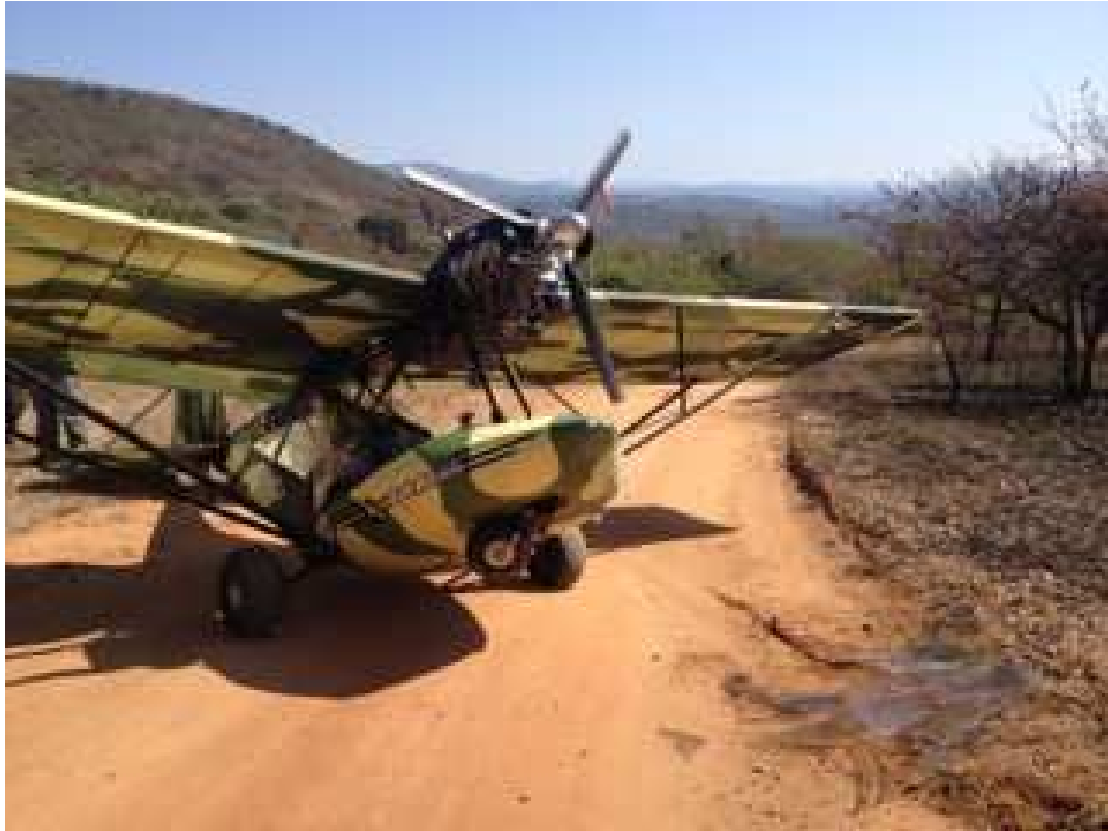
1.3.1 Damage was caused to the nose gear, windscreen and fuselage.

**Figure 2:** Damage sustained by aircraft

1.12.1 The nose gear collapsed towards the fuselage and was indicative of an aircraft that had touched down on its nose wheel at high speed.

- 2.3 The impact damage sustained to the nose gear and windscreen was indicative of a high vertical force applied during the phase. Due to the collapsed gear, maintaining directional control following touchdown would have been difficult. The aircraft subsequently veered to the left of runway 09.

- 3.1.1 The pilot was licensed and qualified for the flight in accordance with existing regulations.
- 3.1.2 No wind shear was forecast for the day.
- 3.1.3 The damage sustained to the nose gear was indicative of a high vertical force.
- 3.1.4 Due to incorrect round-out technique of the pilot, the aircraft touched down on its nose wheel first, resulting in subsequent loss of directional control.
- 3.1.5 The pilot had a foreign validation license.
