<b>AIRCRAFT ACCIDENT REPORT AND EXECUTIVE SUMMARY</b>
---

Reference:	CA18/2/3/9348	
<b>Aircraft Registration</b>	ZS-FPU	<b>Date of Accident</b>	25 August 2014		<b>Time of Accident</b>	0735Z
<b>Type of Aircraft</b>	Cessna 414		<b>Type of Operation</b>		Maintenance Flight Test (Part 43)	
<b>Pilot-in-command Licence Type</b>		Commercial	<b>Age</b>	26	<b>Licence Valid</b>	Yes
<b>Pilot-in-command Flying Experience</b>		Total Flying Hours	542.8		Hours on Type	248.1
<b>Last point of departure</b>		East London Aerodrome(FAEL): Eastern Cape				
<b>Next point of intended landing</b>		East London Aerodrome(FAEL): Eastern Cape				
<b>Location of the accident site with reference to easily defined geographical points (GPS readings if possible)</b>						
Runway 06 at FAEL GPS S33°02.05' E027°49.20' elevation 435 feet AMSL						
<b>Meteorological Information</b>		Wind: 300°/ 08kts; Visibility: >10km; Temperature: 18°C				
<b>Number of people on board</b>	2+0	<b>No. of people injured</b>	0	<b>No. of people killed</b>	0

**Name of Owner** : Blucrane Air  
**Name of Operator** : Blucrane Air  
**Manufacturer** : Cessna aircraft company  
**Model** : Cessna 414A  
**Nationality** : South African  
**

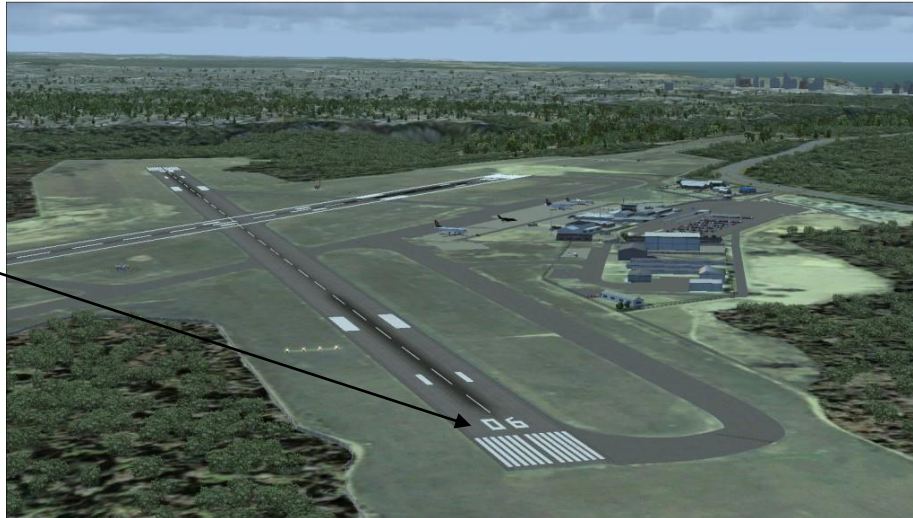
Figure 1: East London airport Runway 06 as found on the internet

1.1.2 The pilot landed the aircraft with the two wheels extended. Once slowed down the left wing made contact with the runway. The aircraft veered off the runway to the left because the pilot could not maintain directional control. The aircraft came to a stop on the grass left of Runway06 near intersection 06/24 and 11/29.

The point where the aircraft came to a stop

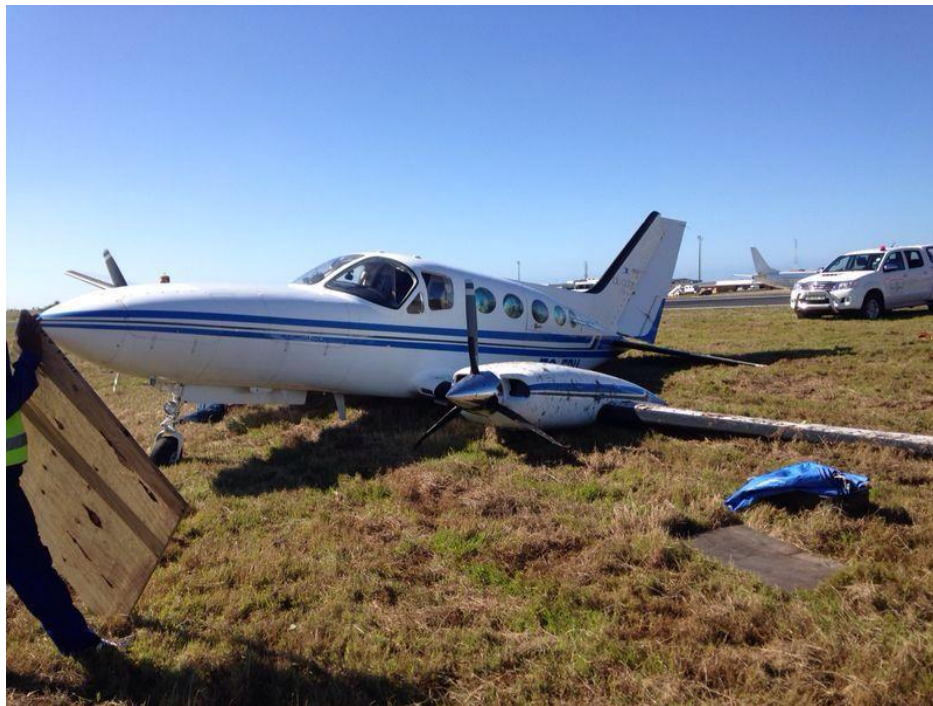
**Figure 2:** The aircraft as found at the accident site

1.3.1 The aircraft sustained substantial damage.

1.12.4 During inspection by the pilot after disembarking the aircraft, it was found that the aircraft sustained damage to the left wing, left propeller, and the underbelly.

1.15.1 The accident was considered to be survivable, the aircraft was intact and the damage was limited to the left wing, left propeller and the underbelly.

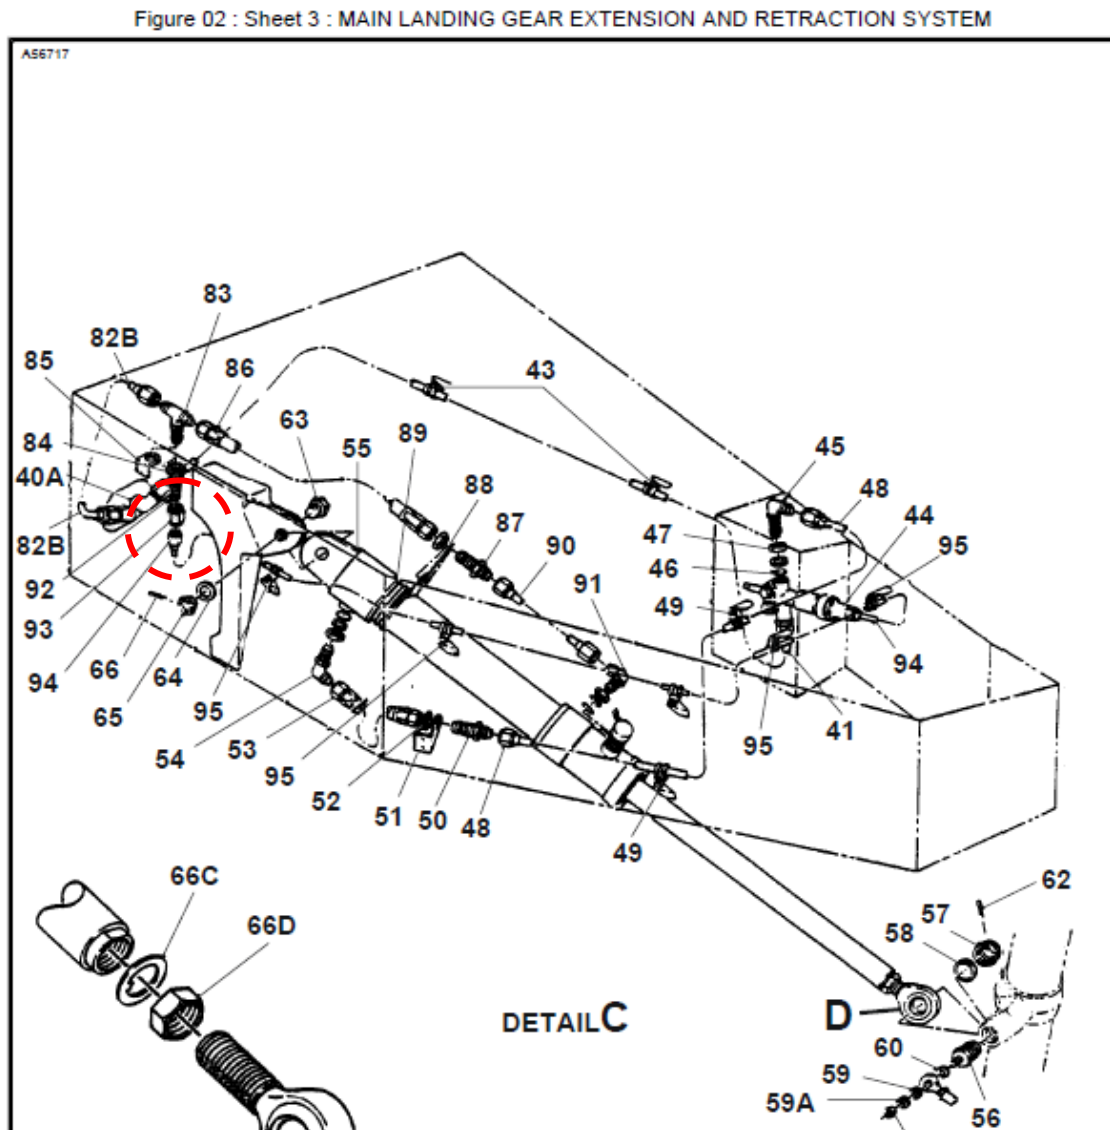
Figure 4 Parts catalogue

1.12.5 Post-accident investigation revealed that the rigid pipe separated from the main landing gear up-lock, which caused the hydraulic fluid to leak again. All other serviceable hardware was found in place and correctly fitted. The supporting sleeve at the attachment to the up-lock cylinder was cracked. As shown in figure 4 and 5 part 94A

2.2.2 Investigation revealed that the rigid pipe in the left main wheel well separated from the main landing gear up-lock cylinder and caused the hydraulic fluid to leak. This resulted in the left main gear not extending. All other components were found in place and correctly fitted, but the supporting sleeve at the attachment to the up-lock cylinder was found to be cracked.

- 3.1.5 The left main gear failed to extend even after the emergency gear down system was deployed.
- 3.1.6 The left main gear did not extend due to the rigid pipe in the left main wheel well separating from the main landing gear uplock cylinder and causing the hydraulic fluid to leak again.
