<b>AIRCRAFT ACCIDENT REPORT AND EXECUTIVE SUMMARY</b>
---

Reference:	CA18/2/3/9356	
<b>Aircraft registration</b>	ZS-ION	<b>Date of accident</b>	12 September 2014		<b>Time of accident</b>	07:10Z
<b>Type of aircraft</b>	Cessna Agwagon A188B		<b>Type of operation</b>	Agriculture Restricted Part 137		
<b>Pilot-in-command licence type</b>	Commercial (CPL)	<b>Age</b>	21	<b>Licence valid</b>	Yes	
<b>Pilot-in-command flying experience</b>	Total flying hours	438.9		Hours on type	149.6	
<b>Last point of departure</b>	Private airstrip near the Waterkloof farm in Heidelberg area, Western Cape Province. GPS Coordinates: S34°17.686' E20° 42.319'					
<b>Next point of intended landing</b>	Private airstrip near Waterkloof farm in the Heidelberg area					
<b>Location of the accident site with reference to easily defined geographical points (GPS readings if possible)</b>						
Open gravel field at the Waterkloof farm, between Heidelberg and Witsand in the Western Cape Province. GPS coordinates : S34°17.686' E20° 42.319' elevation 1843 feet

<b>Probable cause</b>						
The aircraft collided with electrical wires during the agriculture crop spraying operation.						
SRP date	08 August 2017		Release d

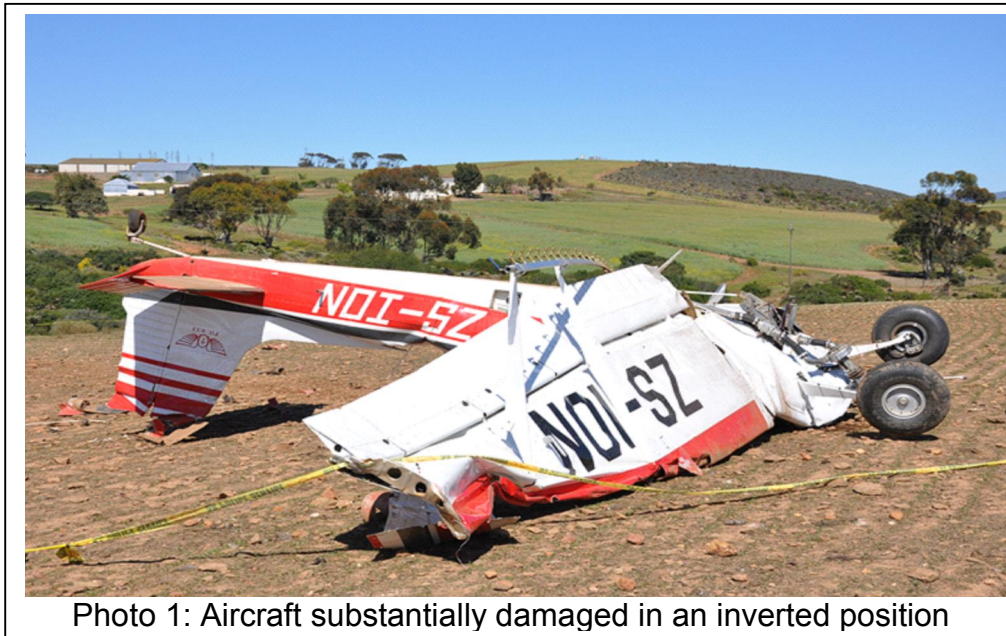
- 1.3.1 The aircraft was destroyed during the impact sequence.

Photo 1: Aircraft substantially damaged in an inverted position

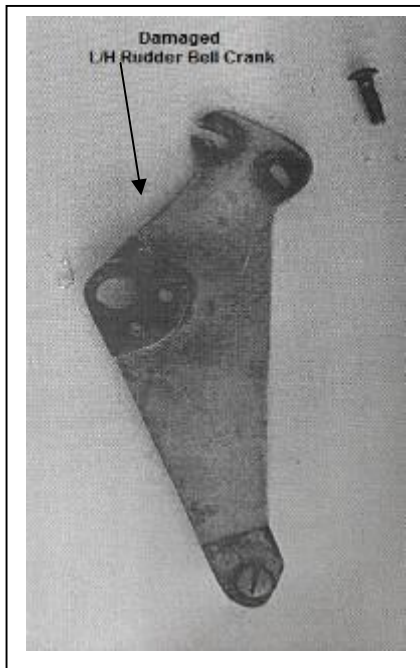
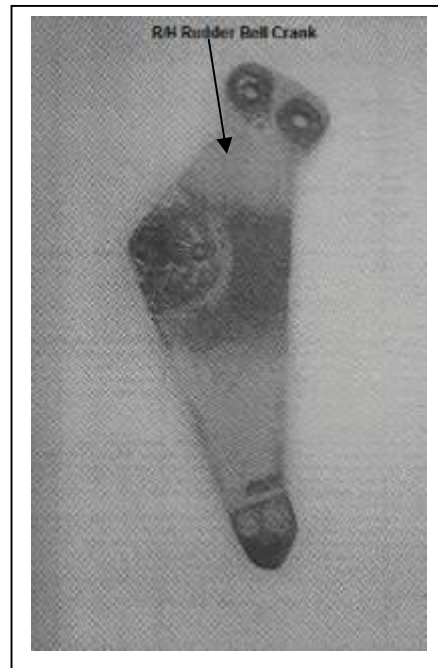
- The pilot responsible for the incident visited Master Tech carrying aft bulkhead rudder bell cranks Part No: 0712309-16AGW. He indicated that the parts were removed from the aircraft. He requested that Master Tech should carry out repairs on the bell cranks for him.

Figure 2 & 3 Damaged bell cranks which were removed from the aircraft

- Master Tech technical personnel's response to the pilot was that the bell cranks had been removed from the aircraft primary flight control system. There was no repair scheme for the bell cranks. The pilot then requested that Master Tech supply him with two new or serviceable bell cranks. The pilot was informed to consult with another AMO which specialised in sheet metal work with the aim to have the bell cranks manufactured. The pilot gave Master Tech permission to go ahead to manufacture the two bell cranks. The pilot signed a job card (no. 23) on 09 September 2014 requesting that Master Tech expedite the work. The aircraft ZS-ION was grounded due to the unserviceable bell cranks.
- While the pilot was still with them, they asked him to explain what had happened to the bell cranks. He informed them that the rudder system had failed, which resulted

- 3.1.13 The aircraft ZS-ION was allegedly involved in an incident in which the rudder control system experienced a defect on 5 September 2014. It was determined that the aft bulkhead rudder bell cranks had failed, resulting in the aircraft becoming unserviceable.

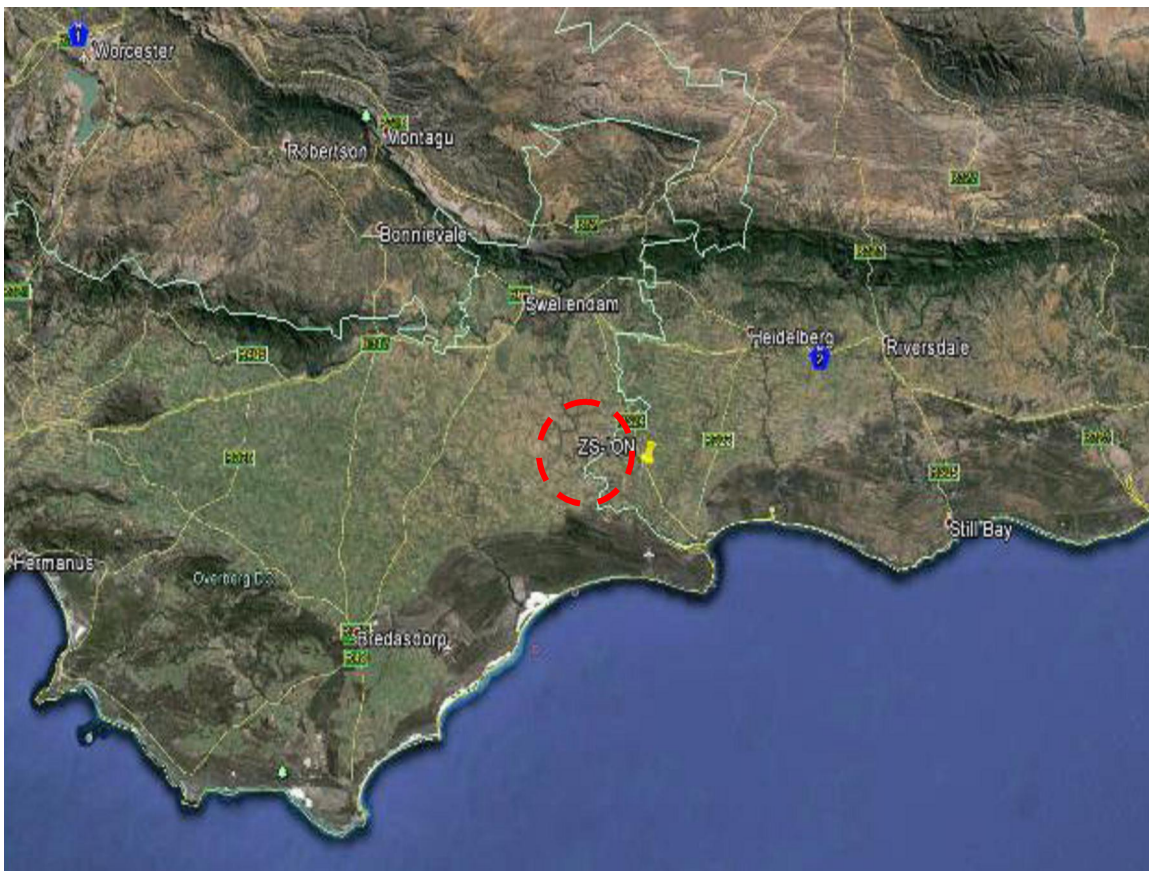
1.10.1 The accident occurred at a location outside the boundaries of an aerodrome. The accident site was an open gravel field at the Waterkloof farm, south west of Heidelberg in the Western Cape. The GPS coordinates of the accident site were S34°17.686' E20°42.319' elevation 1843 feet.

Figure 6 Showing the accident site

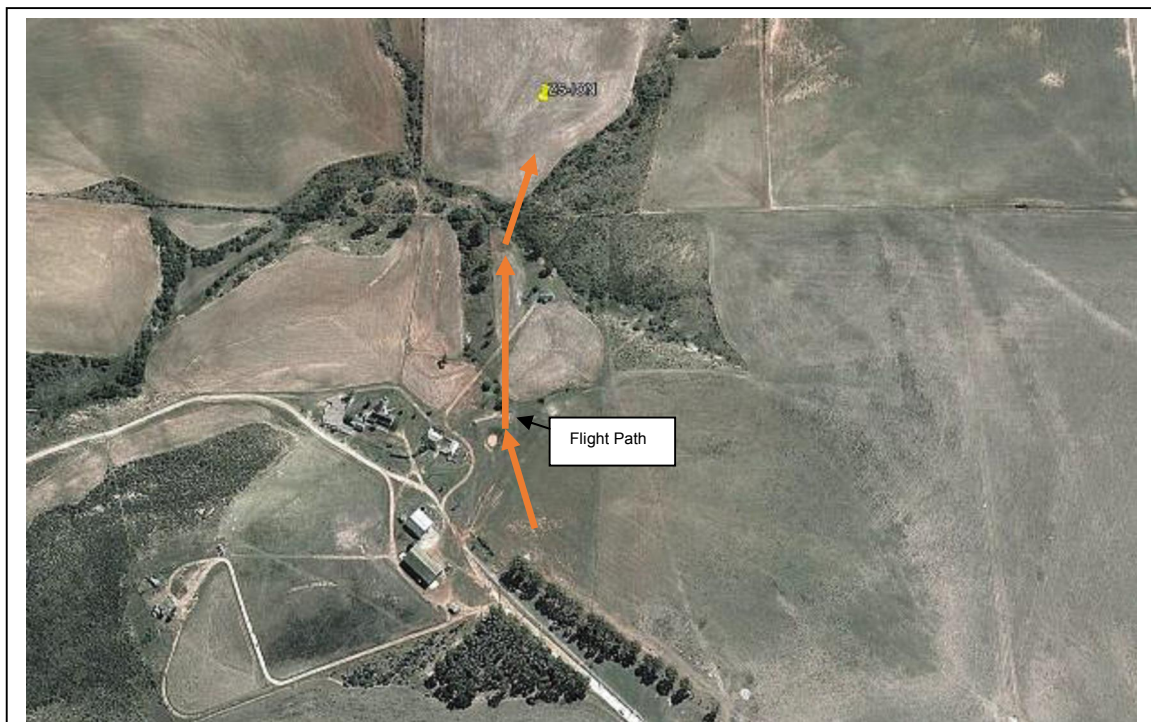
1.12.2 According to the witnesses, they heard a “*loud bang sound*” and saw the accident happen. See below the route which aircraft flew prior to the collision with the electrical wires.

Figure 9 Showing the flight path

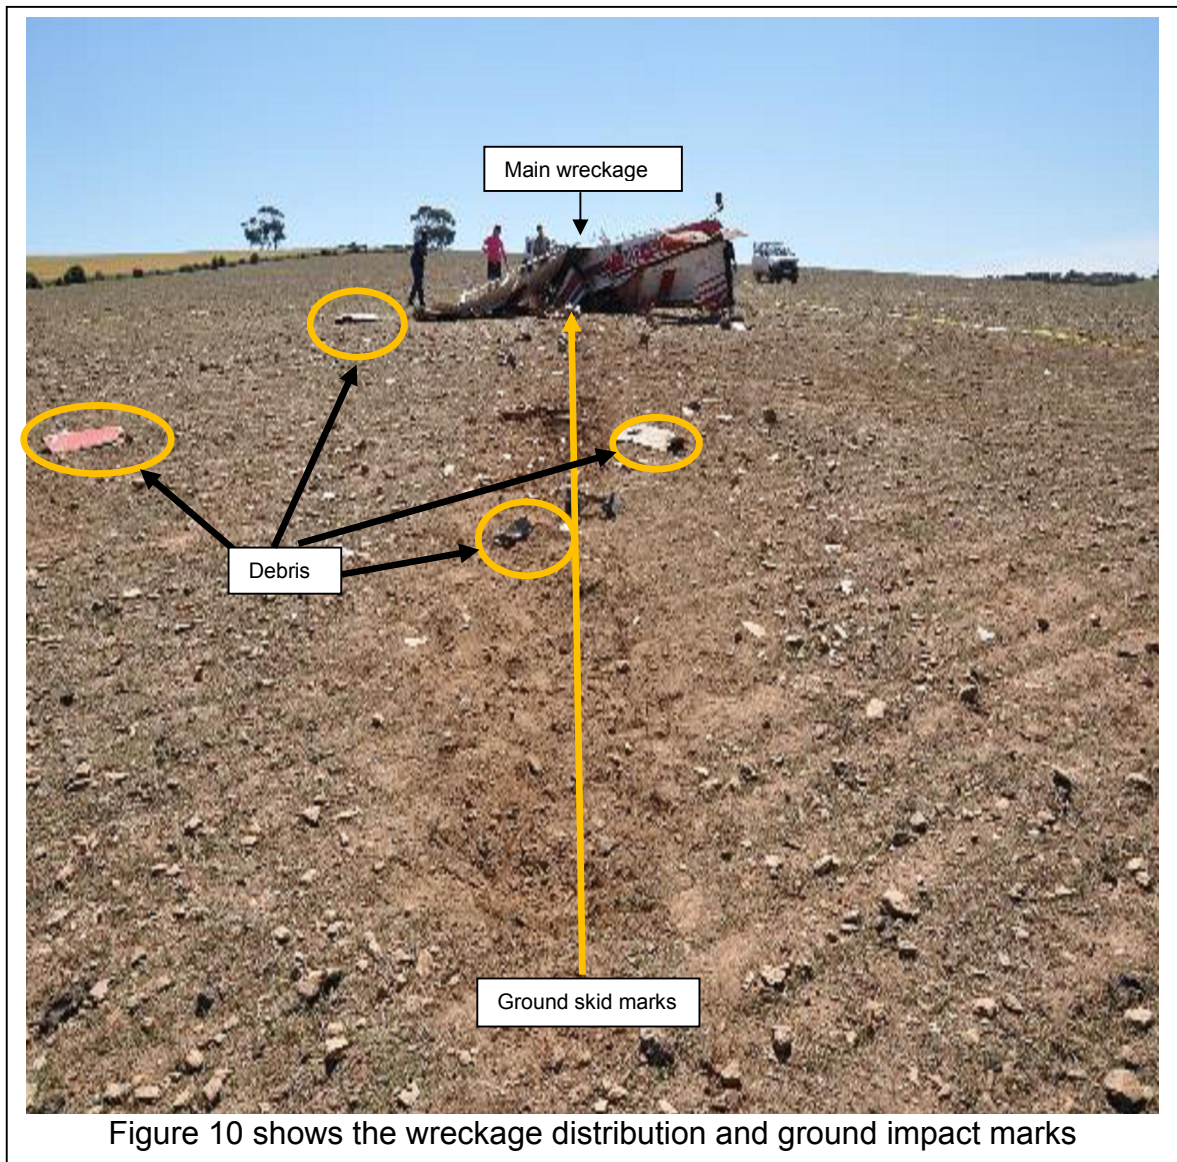
Figure 10 shows the wreckage distribution and ground impact marks

1.12.4 During the on-site investigation it was determined that the aircraft hit the lower high-tension wire. The main wreckage was found at position approximately 200 m – 300 m from the Electrical Wires. The ground marks show that the wreckage skidded for at least approximately 30 m before it came to a complete stop. Small pieces of debris were found scattered along the ground impact path.

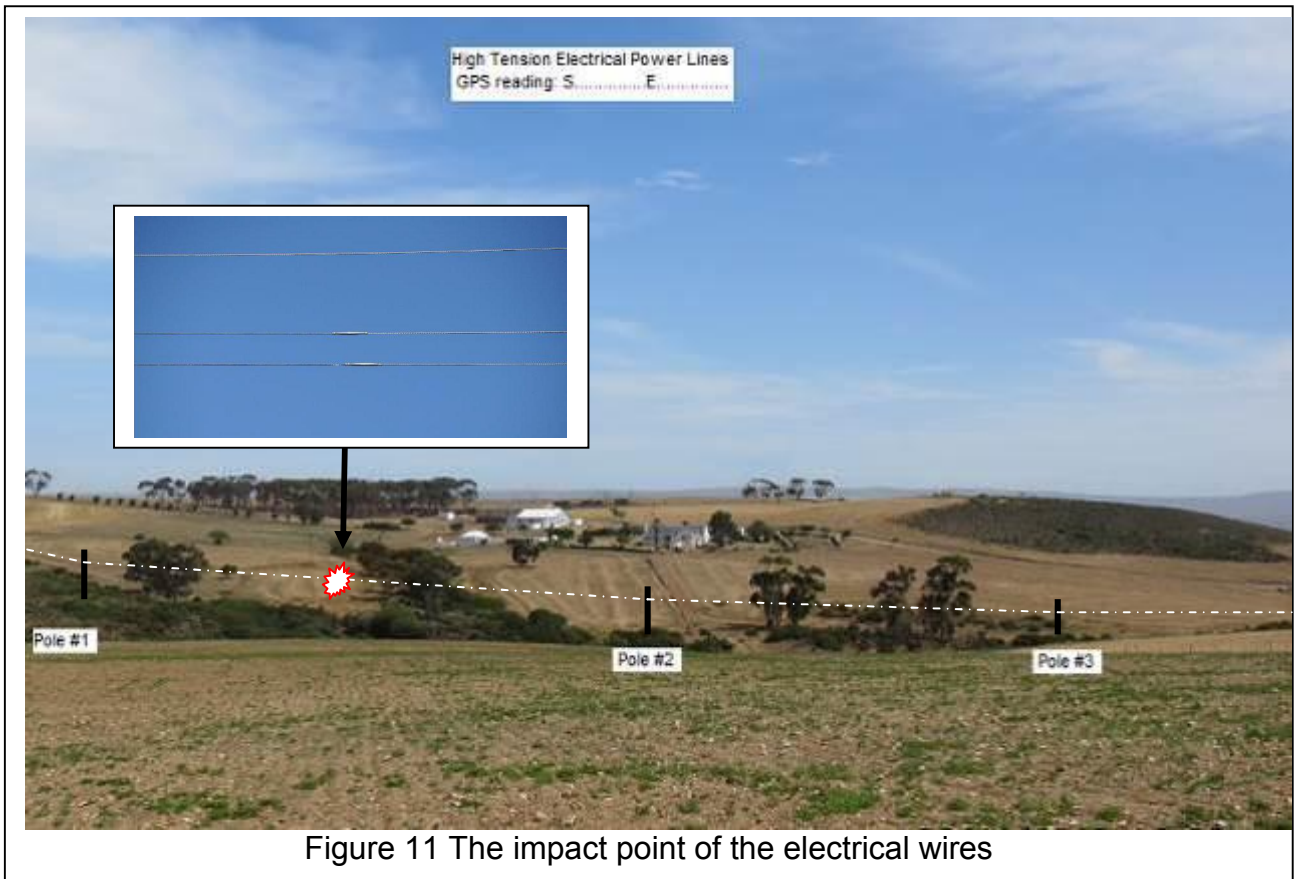
1.12.5 An on-site investigation showed that the aircraft left wing tip collided with the lower wire of the power line. During the impact sequence the wing tip separated from the wing. The wing tip was found on the ground not far from the power line.

Figure 11 The impact point of the electrical wires

- 2.10 The wreckage was examined during the investigation. Evidence was found of impact damage caused to the left wing leading edge by the collision with the electrical wires. The wing cut through two of the electrical wires. It is believed that the left wing inadvertently collided with the electrical wires when the training pilot attempted a right bank pull-up manoeuvre at the end of the canola field. It is a fact that the training pilot was already aware of the power line, as he had flown the aircraft several times during the operation at Waterkloof Farm. It is just unfortunate that he found himself in a very hazardous situation, flying low in what is defined as an agricultural confined space leading him straight to the electrical wires.

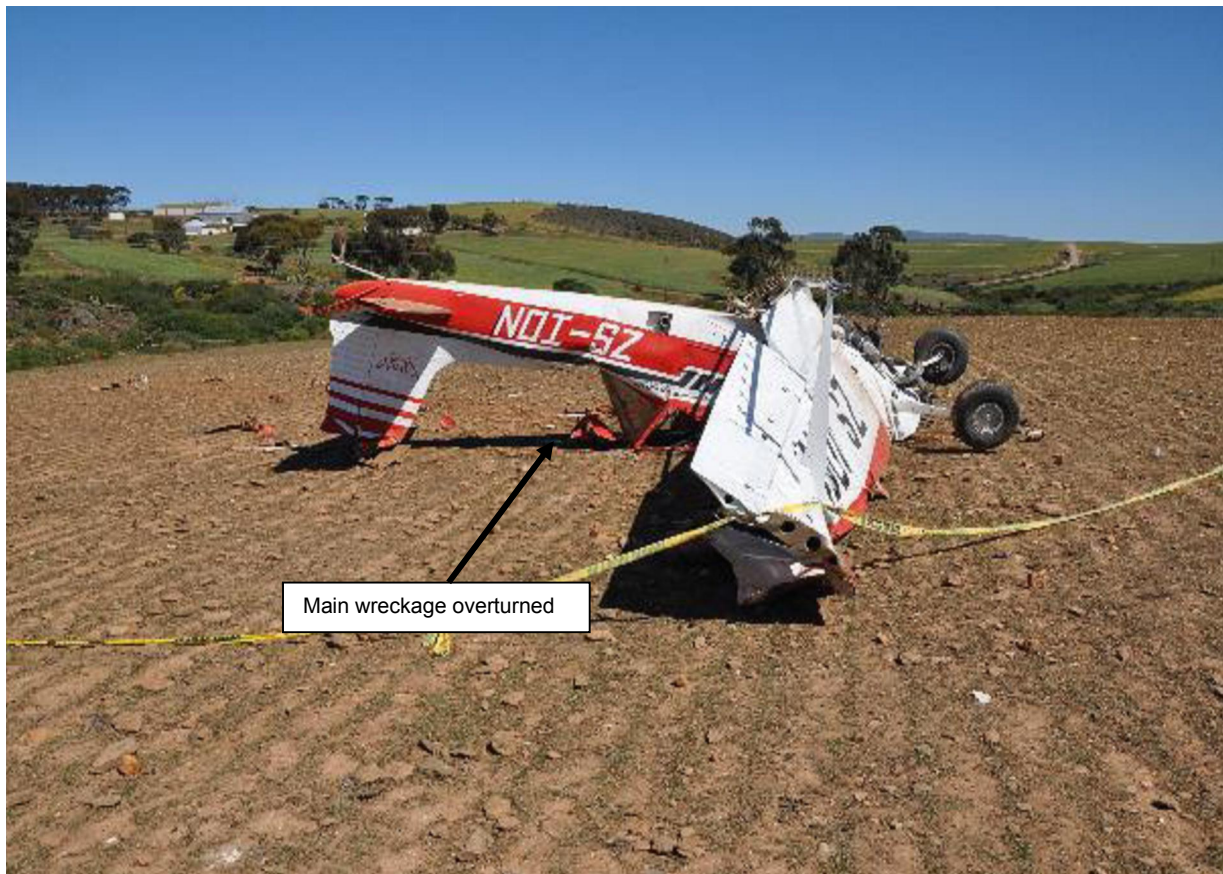
1.12.6 The evidence shows that after the aircraft collided with the electrical wires, the aircraft turned over, and as can be seen on the pictures above and below, the aircraft then impacted the ground in that overturned attitude with the canopy skidding on the ground.

Figure 12 Showing the main wreckage at the rest position

**Note:** During the ground impact sequence, the pilot sustained traumatic head injuries as evidenced by the overturned aircraft skidding on the ground.

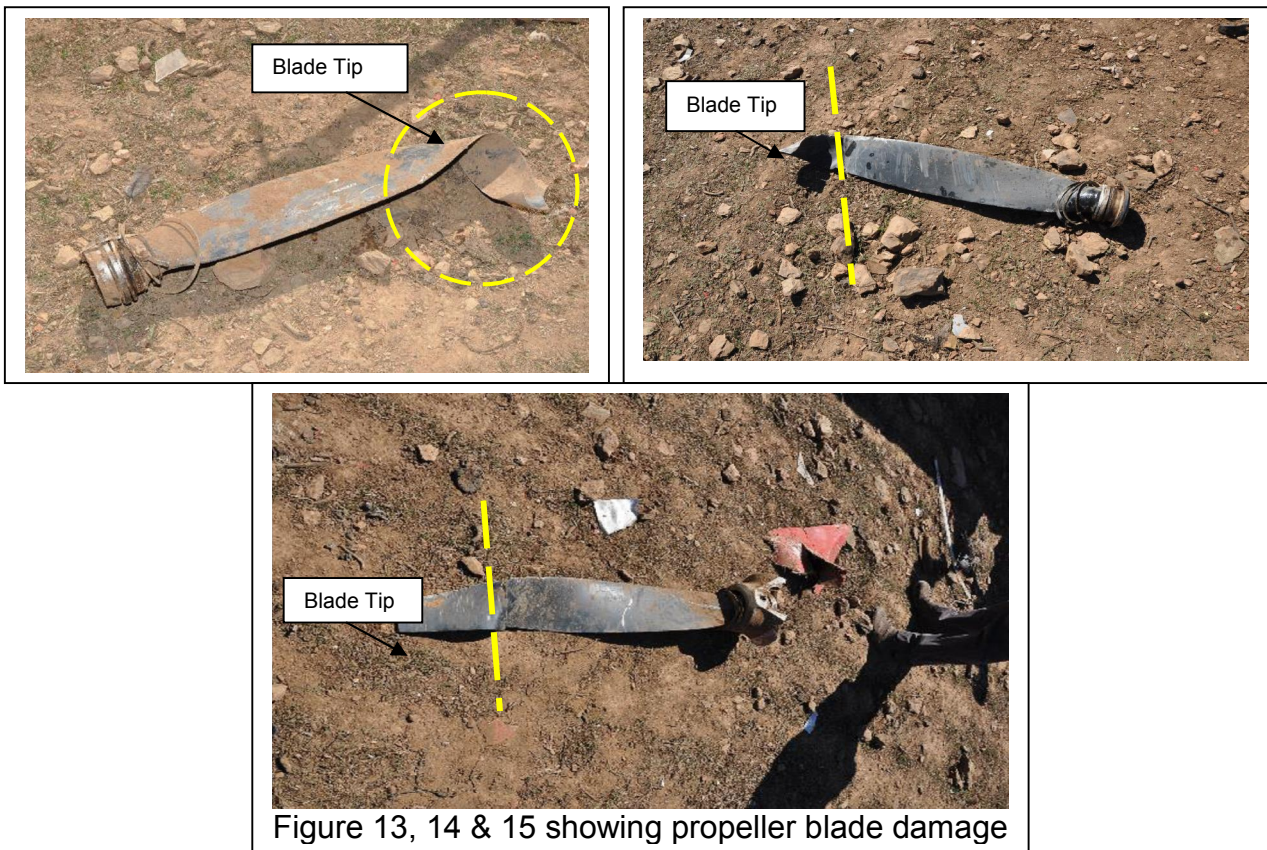
1.12.7 The propeller was found destroyed as a result of damage sustained during the ground impact. The damage caused to propeller blades was assessed and indicated that forces induced by the rotation of the two blades in the propeller separating from the engine.

- (i) Blade #1 was found a short distance away on the right side of the tail section of the aircraft. Damage was caused to the blade tip. It appears that the blade tip broke off when the blade struck the ground while in high mechanical rotation (RPM), hence the indicated failure mode. Thereafter the blade dislodged from the propeller hub assembly and separated from the aircraft.

- (ii) Blade #2 was found close to the main wreckage, under the overturned right wing. The blade tip sustained what is believed to be a hard prop strike with the ground during the ground impact sequence. The damage caused to the propeller blade tip indicated high mechanical rotation (RPM), hence the failure mode. It appears as though this blade impacted the ground shortly after the first blade.

- (iii) Blade #3 was found a bit further away from the main wreckage. The blade tip sustained the same damage as blade #2. The blade tip also broke off in very high rotation (RPM).

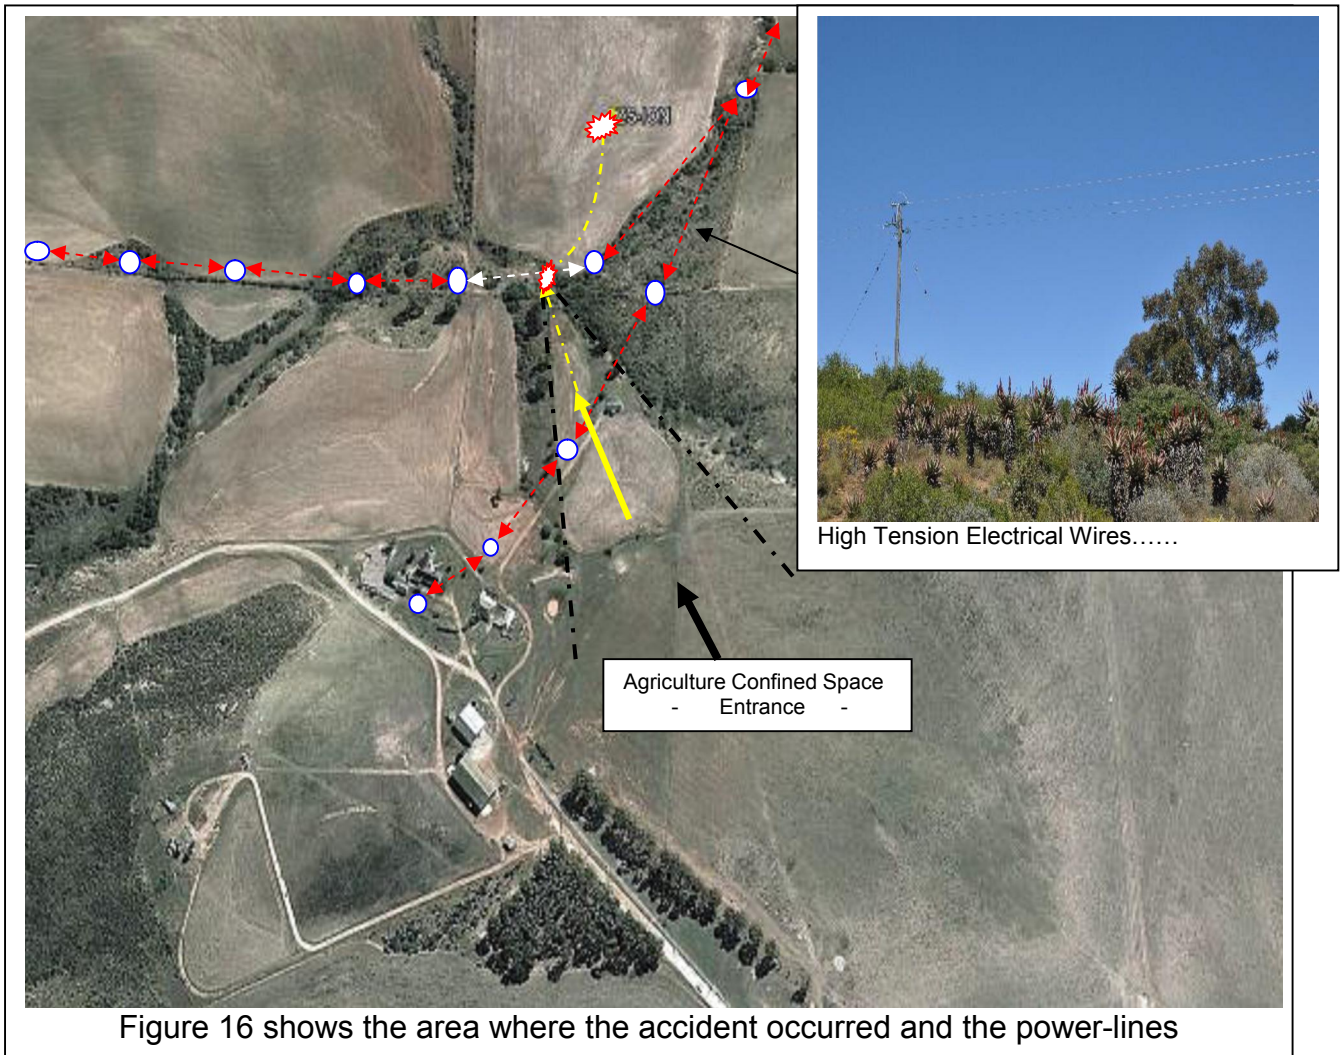
1.16.5 A survey of the last field sprayed was done during the investigation. Due to the following hazardous condition identified, the survey showed that the pilot may have found himself in an agricultural confined space:

- (i) High-tension electrical Wires found on the flight path, in front and aft of the spray field. In order to spray the field, the pilot had two options to approach the field: by flying either over or under the Electrical Wires. Witnesses stated that they heard a loud noise of the aircraft flying very low over their house in the direction of the spray field heading toward the Electrical Wires. It is unlikely that he would have attempted to fly under the Electrical Wires.
- (ii) There were big trees lined up on the left and right edges of the spray field. The observation was that the spray field had a conical shape with the trees on the sides. The smaller, narrow side created a tunnel shape leading to the Electrical Wires the aircraft collided with.
- (iii) Gradient (up and down slopes) of the terrain around the spray field may have influenced the pilot to make an accurate judgement
