**FINAL ACCIDENT REPORT OF
ADVANCE AVIATION COMPANY, LTD'S
EUROCOPTER EC 130 B4, HS- CCN
NEAR PUTAO (NAUNG MOON)
(27- 09- 2014)**

1. Registered owner and operator : Advance Aviation Company Ltd.
2. Aircraft type : Helicopter, Eurocopter EC 130 B4
3. Nationality : Thailand
4. Registration : HS- CCN
5. Place of accident : Near Putao (Nanug Moon)
Latitude N 27° 34' 37.80"
Longitude E 98° 1' 42.42"
6. Date& Time : 27 September 2014 at 14:40 Local time
(+6:30 UTC)
7. Type of operation : Search and Rescue
8. Phase of operation : En-route

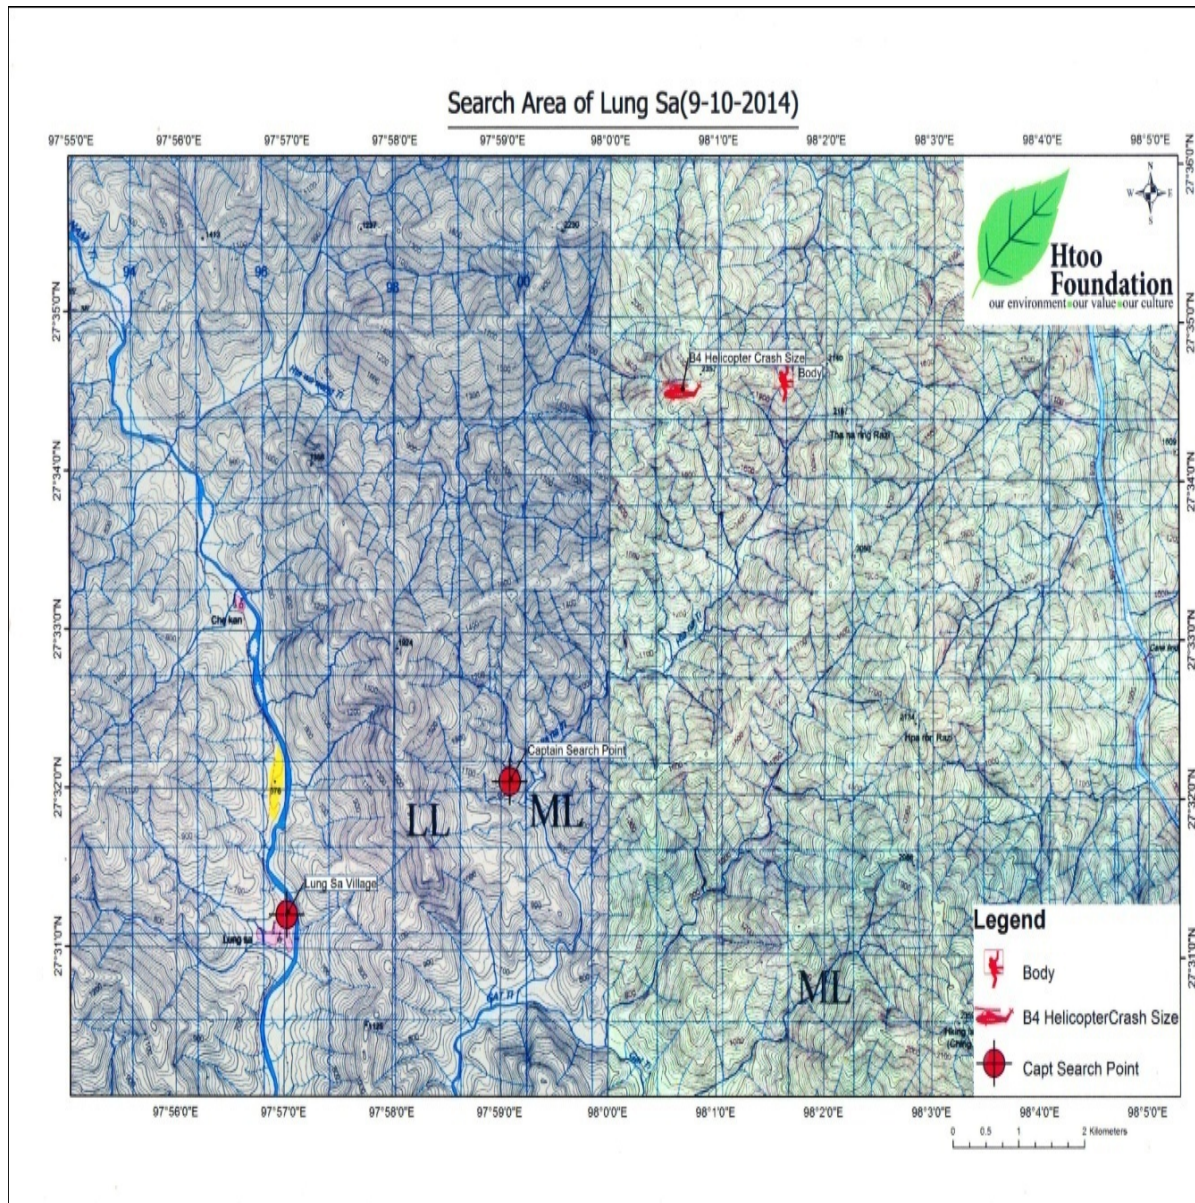
Figure 3: Crash site and other Location

On 7 October 2014, the passenger who was survived arrived at Lan Sar village and contacted to Htoo foundation. Although search operation was started urgently, the Pilot could rescued but the Navigator was found expired.

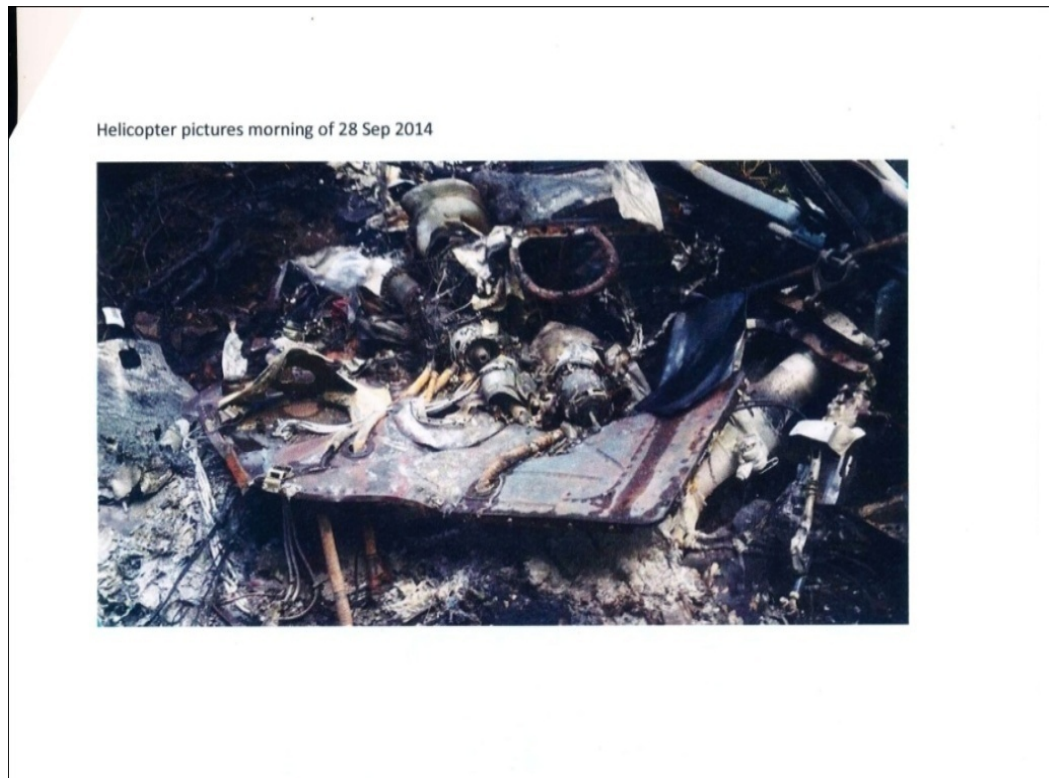
Figure: (4) Damage to aircraft

Helicopter main rotor blades stroked to mountain (about 6400. fts) and fall down on the trees. It touched the ground tail first then nose followed and after that engine sudden stoppage. Electric spark came out and burned with fuel. Helicopter was fire post accident and destroyed. The location of crash site was 12-13 NM, north- east of Naung Moon (27° 34' 37.80" N, 98° 1' 42.42" E)

At that moment, Main rotor blades hit to the trees and helicopter slid tail down through the mountain tree branches then nose followed. Helicopter engine was sudden stopped.

As soon as all the persons evacuated, helicopter started burning with electrical spark and fuel. Then helicopter was destroyed post fire.

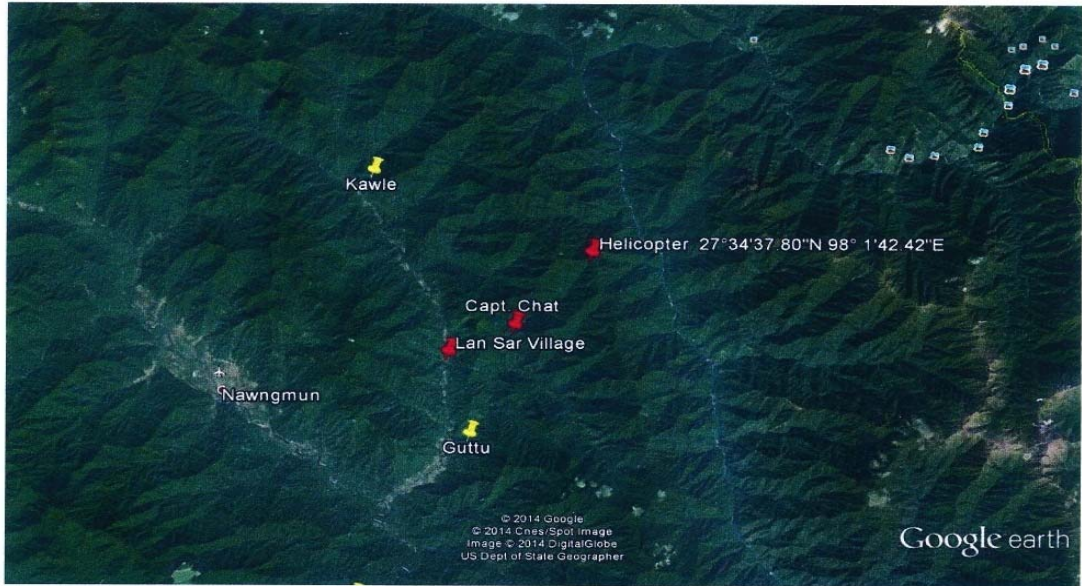
Figure 5: Wreckage site map

The coordinates of accident site one Latitude N 27° 34' 37.8", Longitude E.98° 1' 42.42".
