**FINAL REPORT No.4-02/7-14(6-2015)**

**LOSS OF SEPARATION BETWEEN THE AIRCRAFT Bombardier DH8D, flight  
BTI34H and ATR-72-500, flight FCM-72TX, ON November 15, 2014**

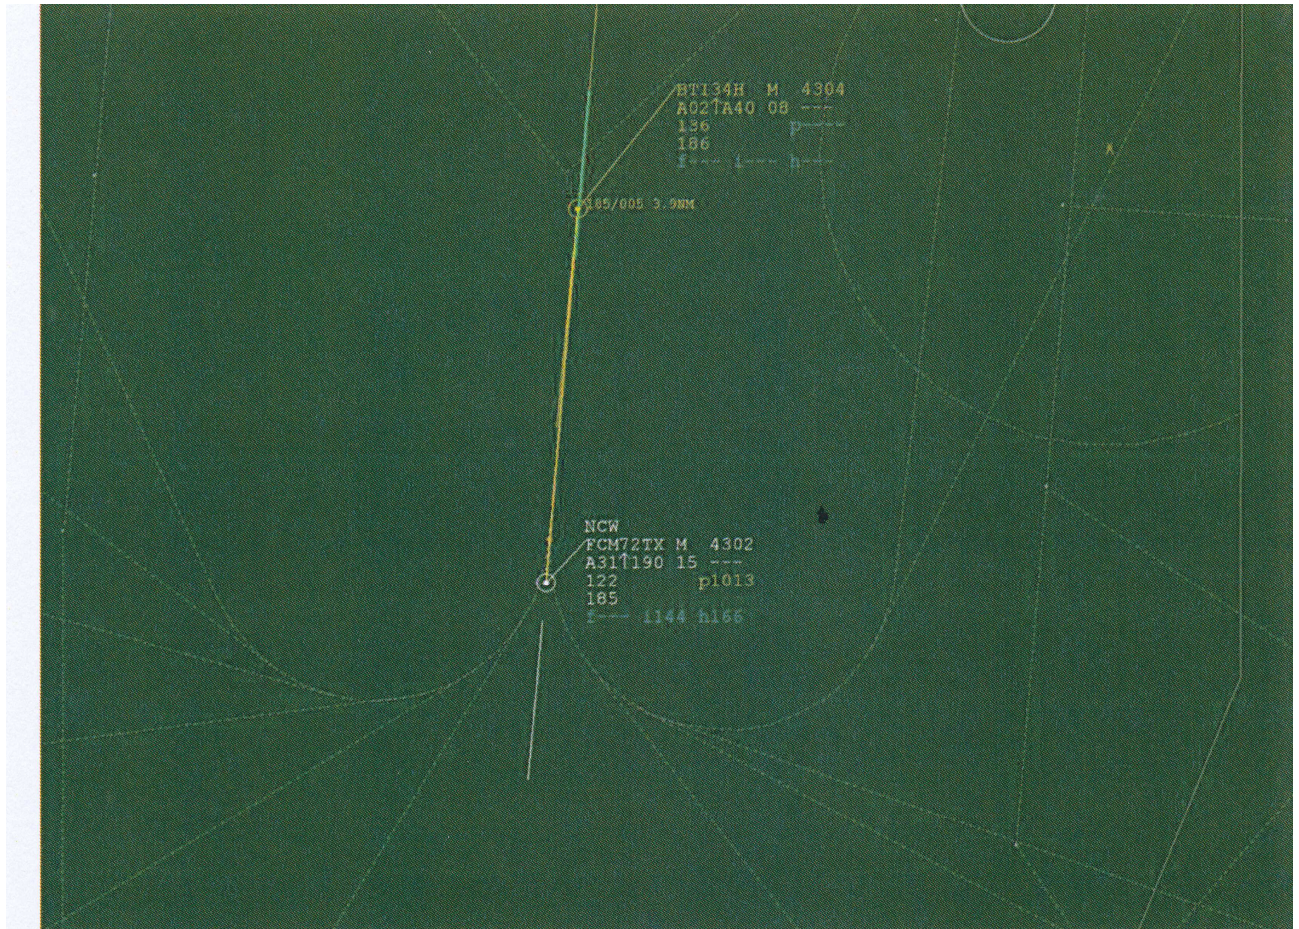
### Traffic situation at 12:08:36 UTC

At **12:08:29** FCM72TX was at altitude 2900FT by climbing FL-190,with rate of climb 1500FT/MIN. ground speed 123KT on true track 187 degrees.

BTI-34H departed from RWY18 on “ERIVA 4E” departure. Altitude 100FT by climbing 4000FT, ground speed 126KT on true track 187 degrees. Distance between traffic 4NM.

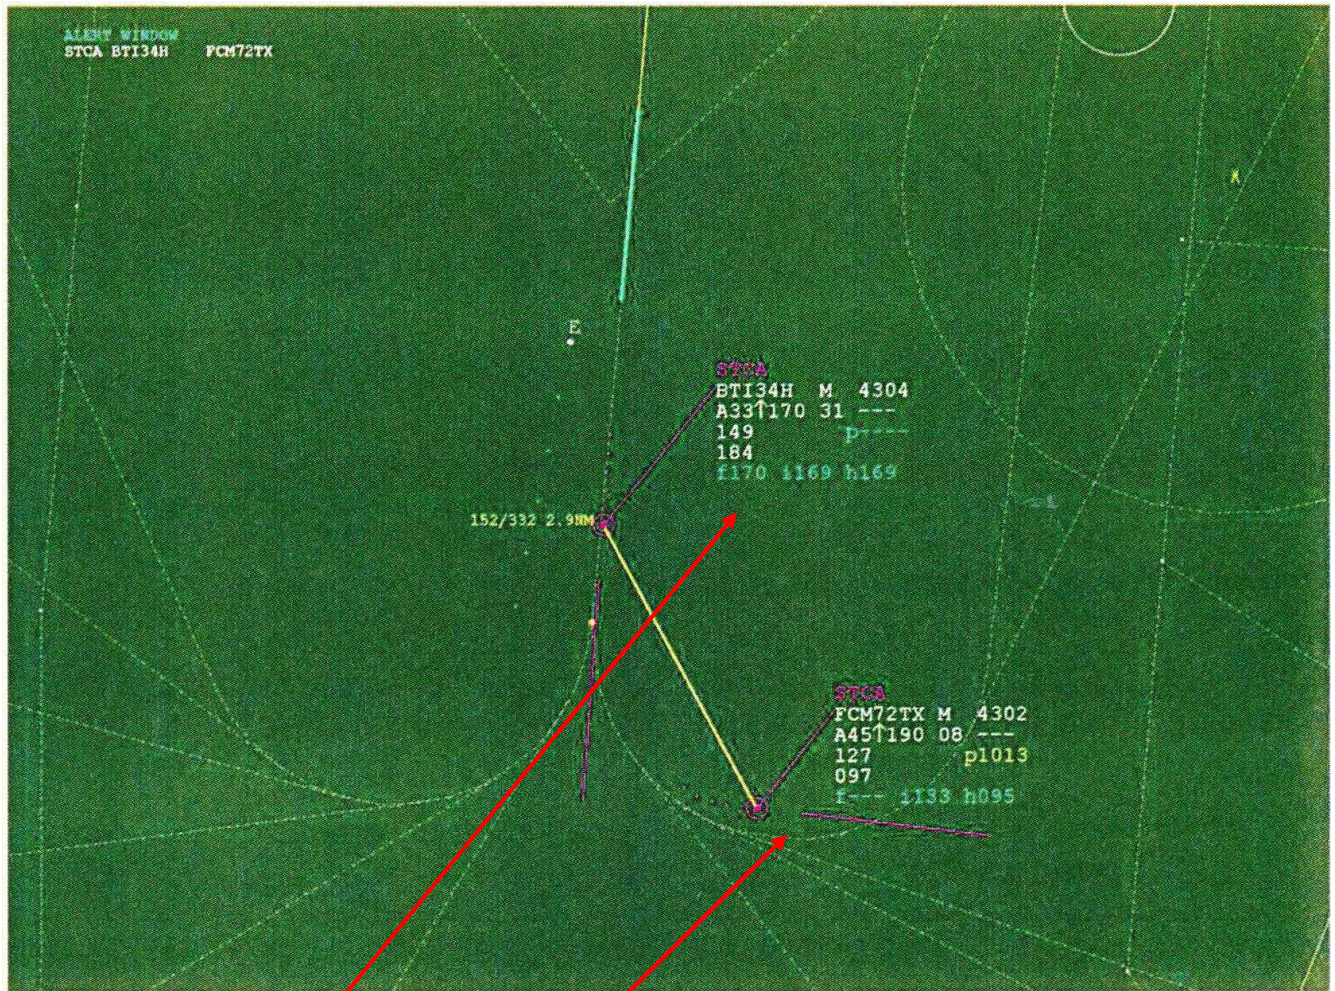
**Traffic situation at 12:09:42 UTC**

According to radar data at **12:09:42 UTC** STCA signal triggered warning about potentially dangerous situation. **FCM72TX** was at altitude **4500FT** climbing to flight level **190** with climb rate **800 FT/min**.

**BTI-34H** was at altitude **3300FT** climbing to flight level **170** with climb rate **3100 FT/min**. Horizontal distance between aircraft was **2.9NM**, vertical interval **1200FT**.

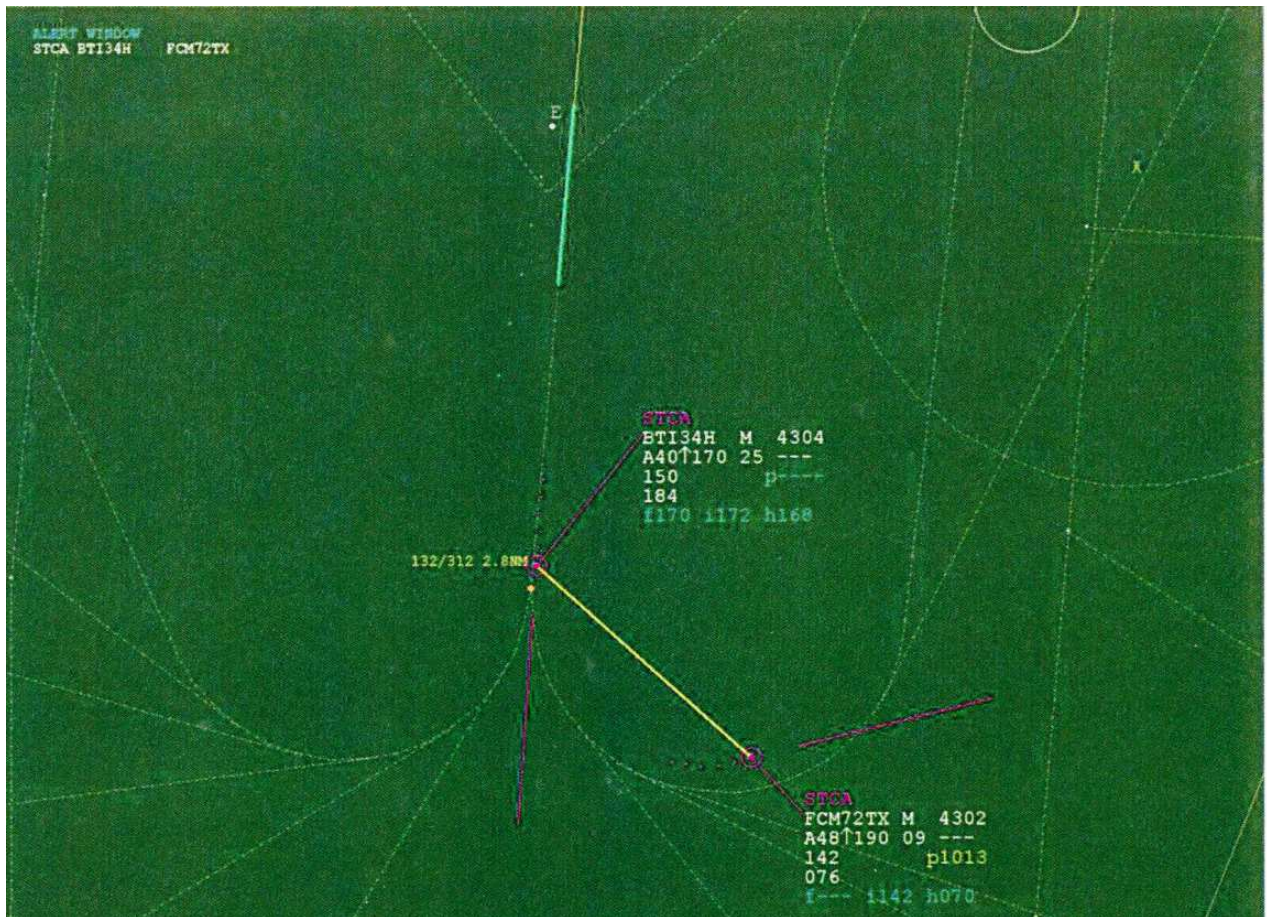
**Traffic situation at 12:09:58 UTC**

At **12:10:09** FCM72TX was at altitude **5100FT** by climbing FL-190 turning left, with rate of climb 1400FT/MIN. Ground speed 144KT on true track 056 degrees.

BTI-34H was at altitude **4400FT**, ground speed 156KT on true track 184 degrees. Distance between traffic **2.7NM**. Vertical interval between aircraft was **700FT**.
