Final report RL 2016:07e

Serious incident during approach to Visby Airport on 30 November 2014 involving the aircraft SE-MDB of model ATR-72-212A, operated by Braathens Regional AB.

File no. L-148/14

19-10-2016

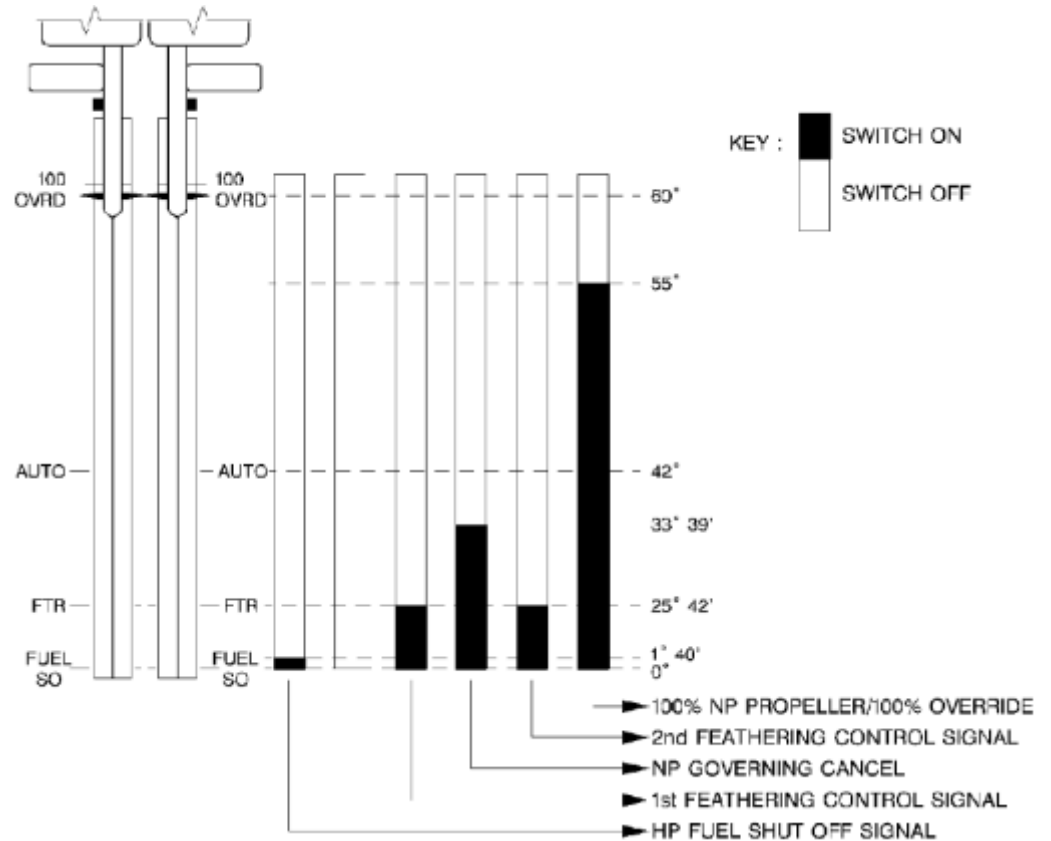
Figure 2. The propeller controls.

Initially, the right engine's propeller control could not be moved into the shut-off position, which was likely caused by the trigger unintentionally being in its upper position as the control reached the feather position.

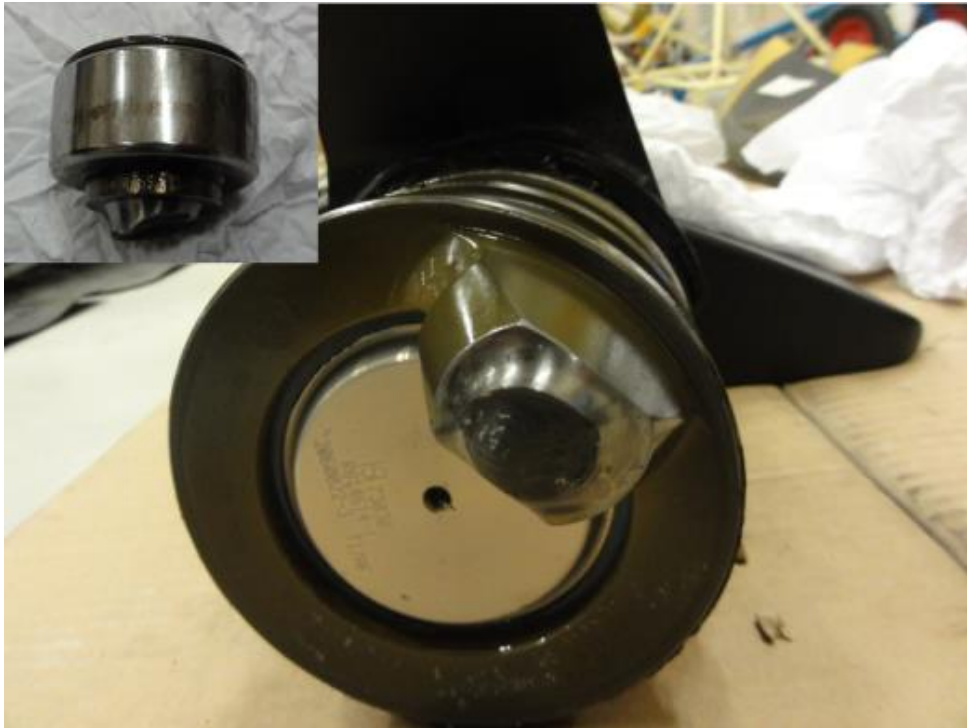
- The eccentric trunnion pin on blade no. 2 was ruptured (see figure 3).
- The front actuator plate was severely bent on all six positions (see figure 4).
- The engine mounts had received damage from contact with metal.
- The engine's compressor housing was cracked along half of its circumference.
- The shaft of the AC generator was ruptured.

Figure 3. The ruptured eccentric trunnion pin.

The broken trunnion pin showed signs of multiple bilateral overloads.

The fracture surface of the ruptured blade trunnion pin reveals that there have been multiple instances of overload, in both directions, prior to the final rupture.

Consistent with the propeller type certificate holder's likely cause theory, an improved ball bearing separator has been designed which is being introduced to the propellers currently in operation and has been incorporated in new production propellers.

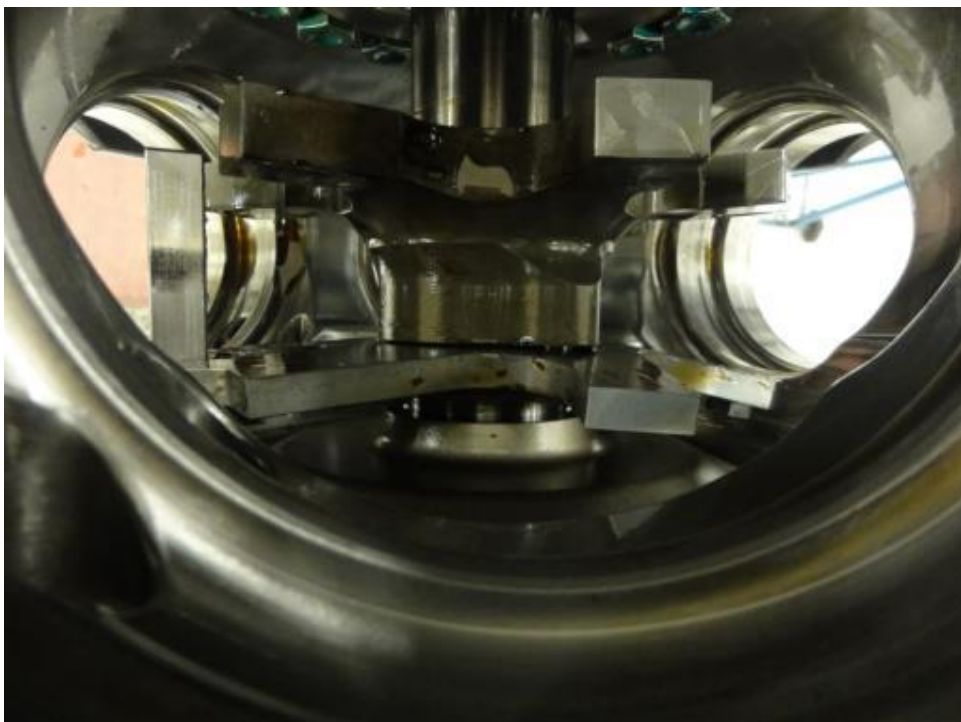
Figure 4. The bent actuator plate at the bottom of the picture is the front plate.

The damage to the actuator plates also shows evidence of multiple instances of overload.

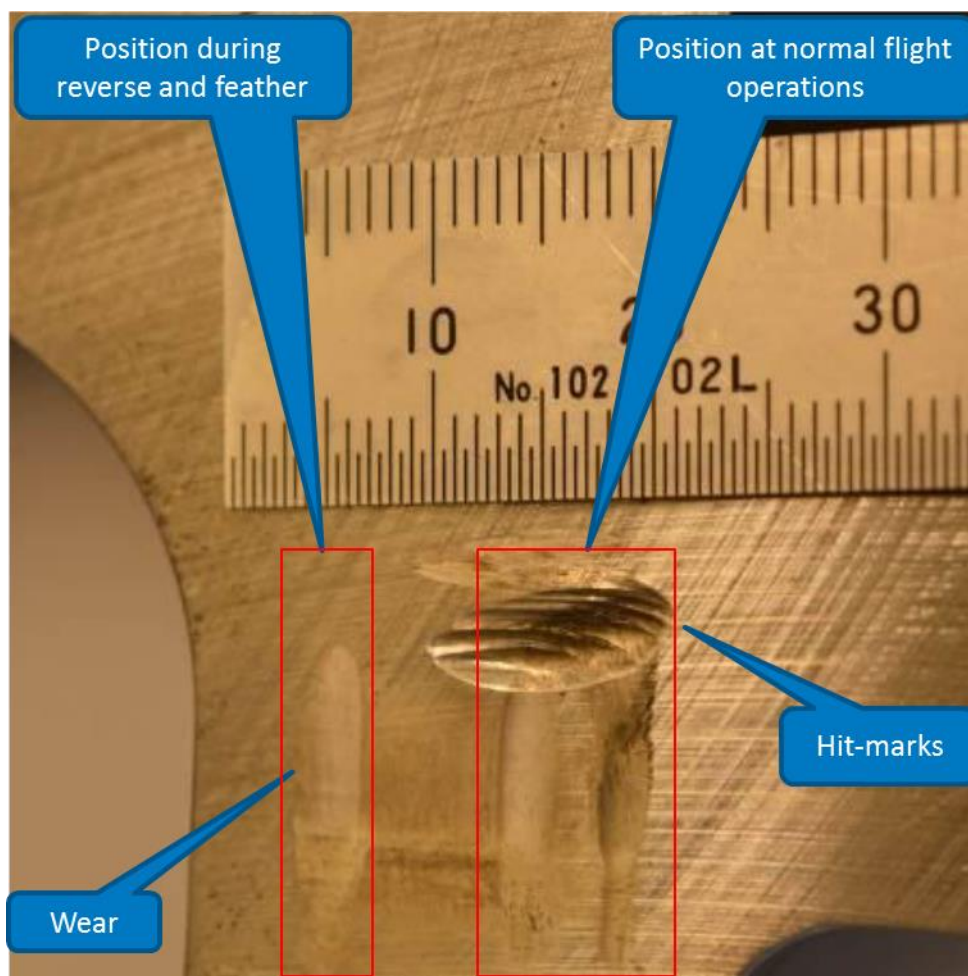
There are two types of damage (see figure 5). One is gentle wear, without deformation of the material, which has occurred over time. The other is a plastic deformation caused by impact or indentations.

Figure 5. The image shows the two types of surface damage and the contact point when reversing and in normal operation, respectively, on one of the protuberances on the front actuator plate.

In figure 5, indentations from the support plate on the trunnion pin's bearing is visible. These indentations have occurred as a result of the protuberance of the actuator plate being bent. In the area for reversing, there are no signs of contact with the washer, which shows that the protuberance was not bent at the time of the previous landing. The image also shows wear on the front actuator plate, which is evidence that the trunnion pin bearing has had contact with it over time.

The evidence above shows that the non-wear damage took place during the incident flight.

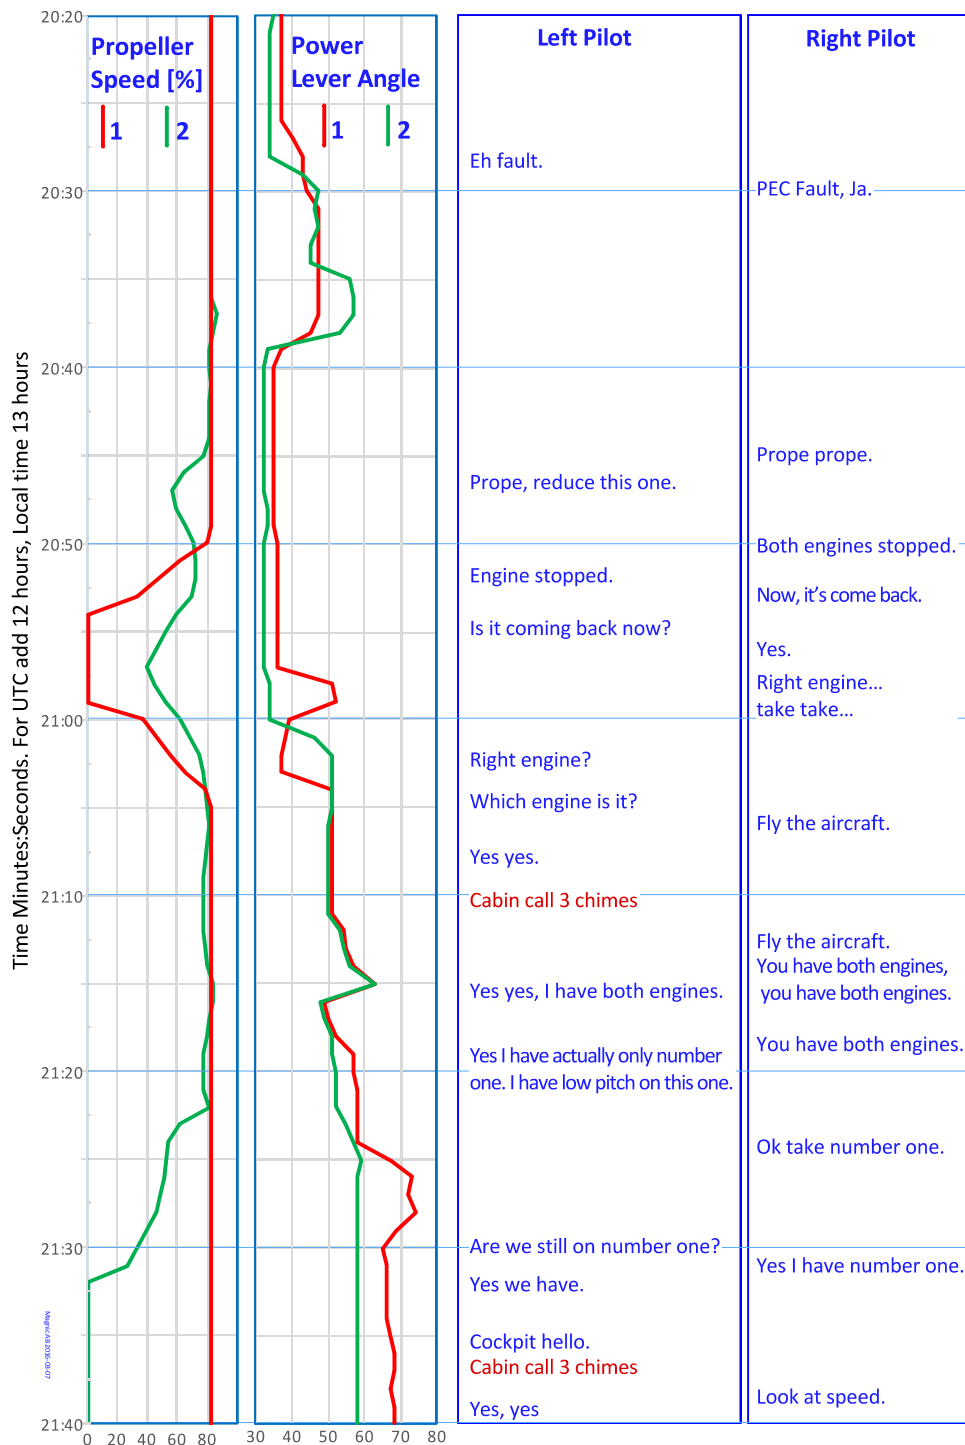
Figure 6. The figure shows a CVR printout combined with the power levers position and propeller RPM. 35 degrees power levers angle corresponds to the flight idle position. The times to the left are given in minutes and seconds. (The transcript above of the communication in cockpit has been translated from Swedish to English.)
