AIRCRAFT ACCIDENT REPORT AND EXECUTIVE SUMMARY

Reference:	CA18/2/3/9381	
Aircraft Registration	ZS-LJT	Date of Accident	9 December 2014		Time of Accident	0655Z
Type of Aircraft	Rockwell S2R-T34		Type of Operation	Agriculture Part 137		
Pilot-in-command Licence Type		CPL	Age	50	Licence Valid	Yes
Pilot-in-command Flying Experience		Total Flying Hours	5 420		Hours on Type	2 002
Last point of departure		Ugie Aerodrome, Eastern Cape Province				
Next point of intended landing		Ugie Aerodrome, Eastern Cape Province				
Location of the accident site with reference to easily defined geographical points (GPS readings if possible)						
PG Bison Plantation, 8.63 nm north-west of Ugie central business district (GPS co-ordinates: S31°06'55" E028°06'21")						
Meteorological Information		Wind: 290° variable, visibility: 10 km sky clear, Temperature: 22°C, Dew point: 13°C				
Number of people on board	1 + 0	No. of people injured	0	No. of people killed	1	
Synopsis

Name of Owner : Natal Aerial Spray (Pty) Ltd
Name of Operator : Natal Aerial Spray (Pty) Ltd
Manufacturer : Rockwell International
Model : S2R-T34
Nationality : South African
Registration Marks : ZS-LJT
Place : Ugie, Eastern Cape Provi

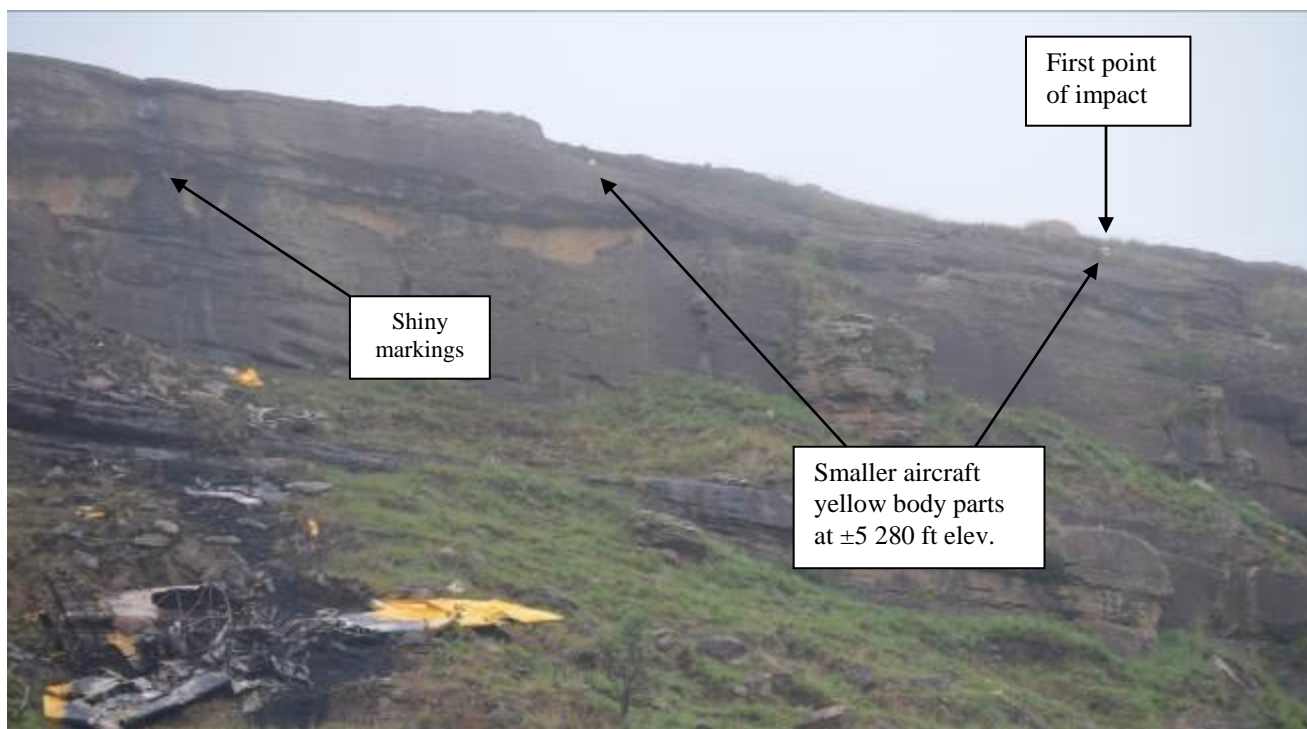
- 1.1.5 On inspection of the accident site, one can see debris on the top of the mountain with yellow markings; the aircraft was yellow in colour. As can be seen in figure 2, the yellow parts are spread over a distance apart. The shiny marking starts from the top to the bottom. It could have been the herbicide that was supposed to be sprayed or the Jet A1 fuel. It is not clear how long the aircraft held on to the cliff but the time was long enough to see that something did leak from the aircraft.

Figure 2: Some aircraft body parts and shiny markings

1.12.2 On the face of the cliff, one can notice dark marks left by JET 1A fuel or the herbicide, which must have been leaking from the aircraft while it was hanging on the cliff. It is not clear how long the aircraft hung on the cliff; it eventually came down, crashing approximately 45ft below the vertical cliff as shown in Figure 2. The aircraft broke in half along the wings' leading edge.

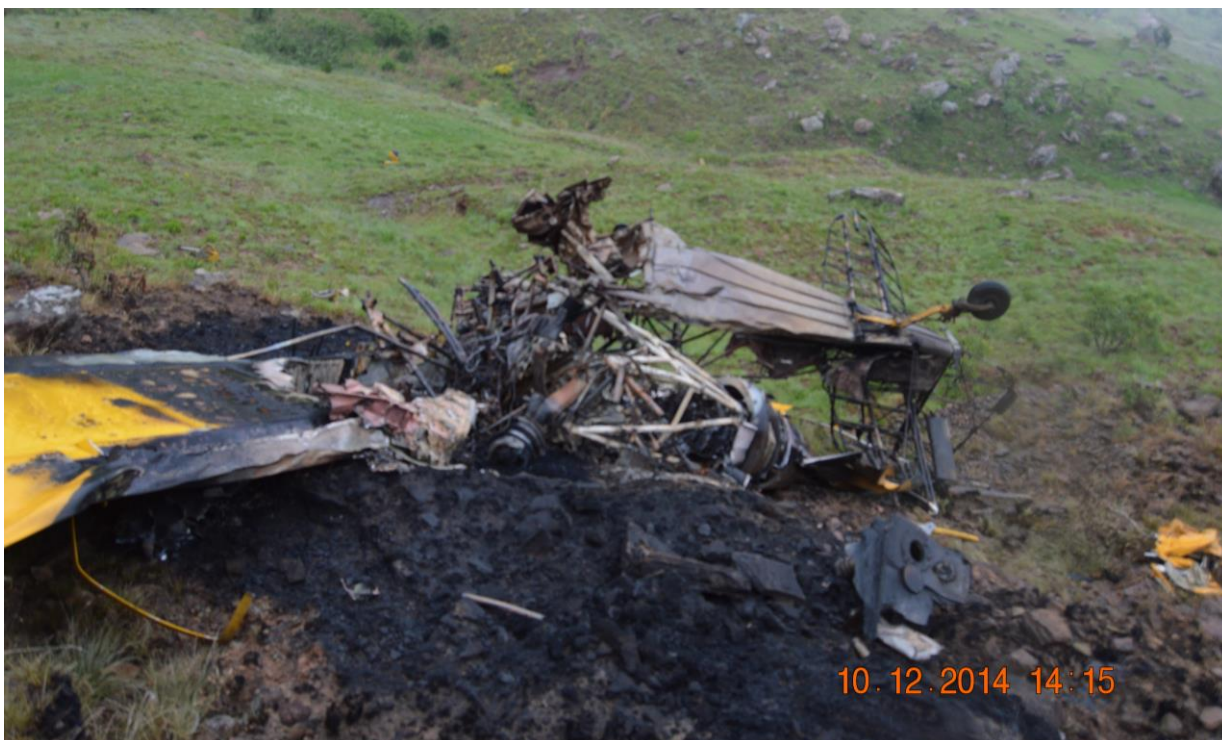
1.3.1 The aircraft was completely destroyed by post-impact fire.

Figure 3: Mangled and burnt ZS-LJT airframe

1.12.3 The aircraft was engulfed by post-impact fire and was completely destroyed. The propeller hub and one of the main landing gears were severed from the aircraft and were found 8 m and 10 m, respectively, from the main wreckage, without any traces of fire. The pilot was not inside when the fire started; he must have been flung out during the accident sequence.

1.14.1 After the aircraft fell off the cliff face and impacted the ground it burst into fire. The pilot was not in the aircraft and was unable to do anything about the raging fire. The aircraft's wingtips were the only parts not consumed by the fire.
