AAIS Case N°: AIFN/0021/2014

Remote Control Circuit Breaker Short Circuit

Aircraft Type: A380-861 / GP7270

Registration: A6-EDD

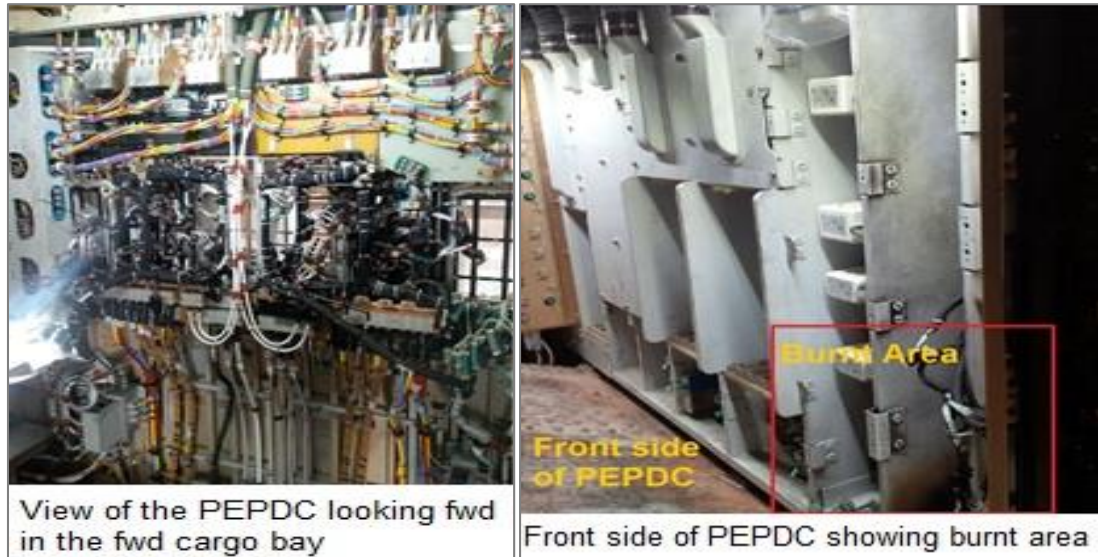
Figure 1. Front and Back view of PEPDC

Several components on the PEPDC adjacent to the burnt RCCB 991JV6 were affected by the electrical short circuit and resulting smoke. Arcing was noted on busbar 100PP. The support structure surrounding the burnt RCCB 991JV6 was damaged by heat created from the short circuit.

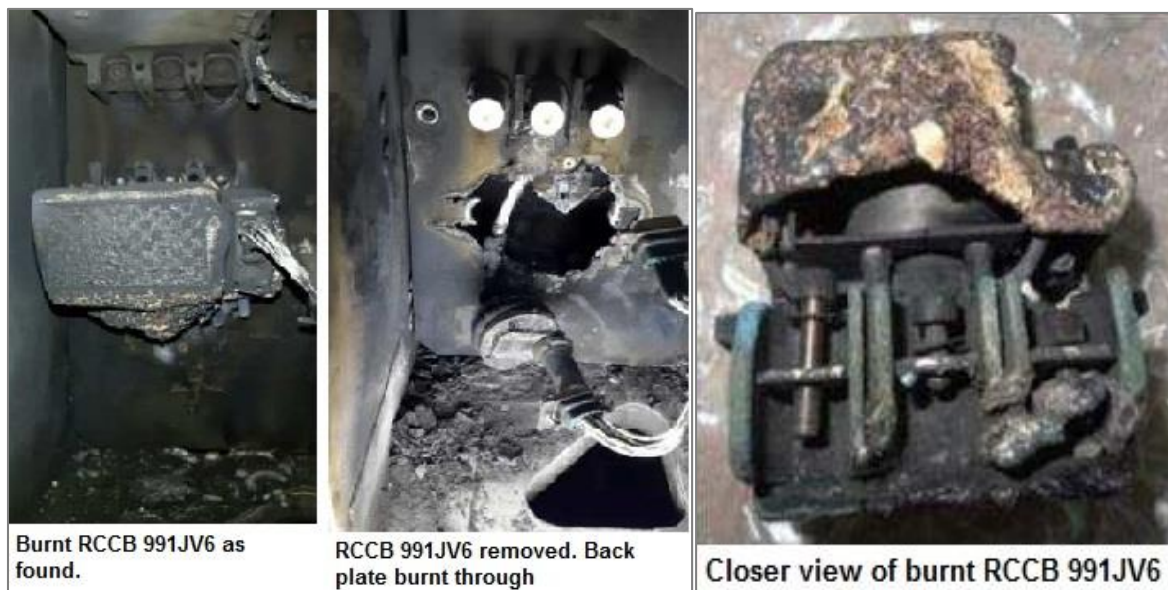
Figure 2. Burnt RCCB 991JV6

The Air Accident Investigation Sector determines that the smoke and melting of the remote control circuit breaker was due to a short circuit of RCCB 991JV6 caused by an unheeded significant buildup of dust and fluid conductor mixture between phases B1 and C1 of RCCB 991JV6.

13. A thick cloud of smoke formed in the avionics compartment and remained for a while.
14. The inspection of the PEPDC front side revealed that the RCCB 991JV6 was burnt, together with the back plate.

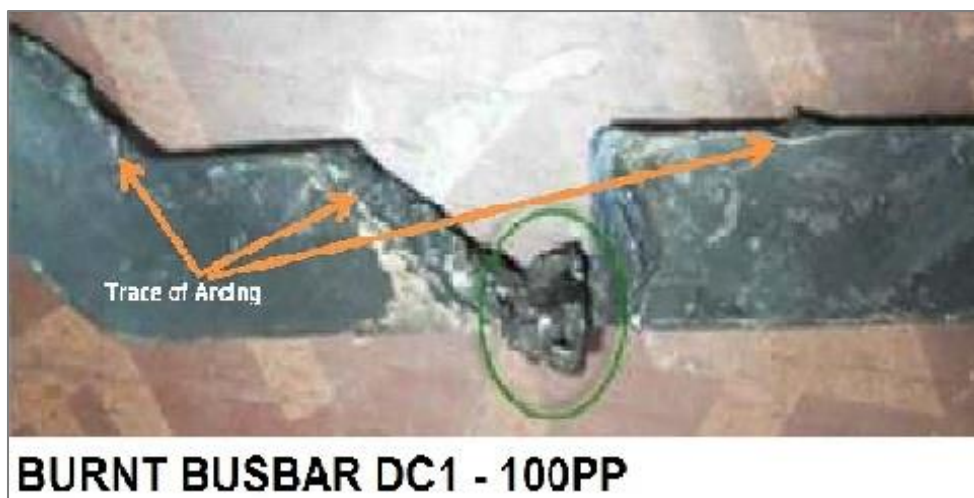
Figure 3. Burnt Busbar 100PP

15. On the aft face of the PEPDC, the busbar 100PP and the current transformers, located on the aft side of the back plate of RCCB 991JV6, were also found burnt.

The Zodiac examination report, stated that “The arcing found on the busbar 100PP [see figure 3] confirmed that the busbar 100PP was in contact with terminal screw phase B of the RCCB. A second short circuit occurred between the RCCB phase B 115VAC and the 28VDC of the busbar 100PP.”

3. It was determined that the first short circuit was due to a mix of fluid and dust that heated and an electrical arc was created between phases B1 & C1 of the RCCB 991JV6.
4. A second short circuit was caused when the 115VAC phase B of RCCB 991JV6 dropped, after it had burnt, and then contacted the 28VDC busbar 100PP causing this to burn also.

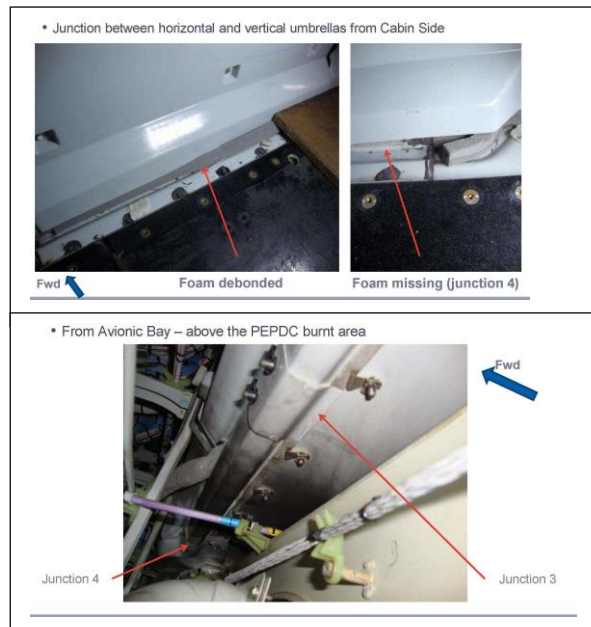
Figure 13. PEPDC protection- Foam condition and stains

1. The PEPDC fluid protection was found to be deteriorated.
2. Foam was found to be debonded and missing at some locations, and in particular at the junction.
3. Fluid stains were found in areas below the umbrella, including stains on the PEPDC.

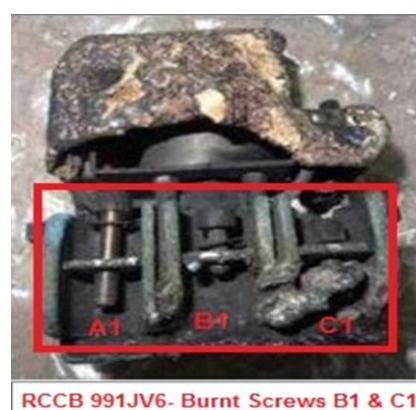
Figure 15. Burnt RCCB

- “The involved RCCB was open at the time of the occurrence and therefore no current was passing to the connector’s outputs.
- As seen in figure 15, it is noted that the middle screw (B1 phase) and the right screw (C1 phase) have lost some material (due to overheat) in the lower part of the screw (thread part).
- If there would have had a torque issue, overheat would have been located at the screw head where the connection takes place and therefore would have some loss of material at this level.”

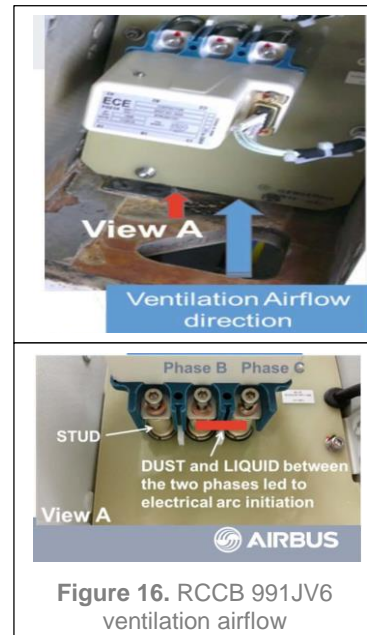
Figure 16. RCCB 991JV6 ventilation airflow

- For the six years the Aircraft was in-service, Airbus commented that RCCB 991JV6 was more prone to accumulate dust than upper contactors as it is located just above the PEPDC ventilation hole.
- Airbus mentioned that the short circuit across the RCCB was most likely generated by the mixture of dust and liquid that created an electrical arc between two phases, B1 and C1, of the RCCB as noted on figure 16.
- The Investigation could not determine the amount of dust that would have accumulated.

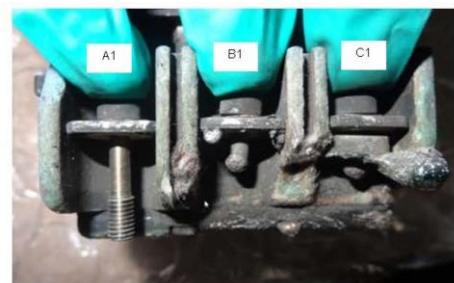
Figure 17. RCCB 991JV6 melted screws B1 and C1

Figure 17 shows the condition of the RCCB screws A1, B1, C1. The screws are electrically powered with 3-phase 115VAC once the ground electrical power is connected to the aircraft electrical system. B1 and C1 screws were melted as noted: B1 screw 10mm and C1 was 12mm. The C1 screw melted material was still attached to the screw. The external chamber separation was missing between B1/C1. Screw A1 was not affected.

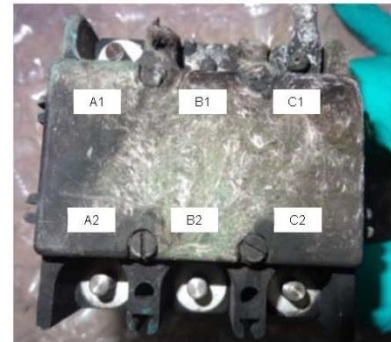
Figure 18. RCCB 991JV6 pins A2, B2, C2.

Figure 18 shows the condition of the screws A2, B2 and C2. As SB No. A380-29-8011 had not been embodied on this Aircraft, the contactor is normally open, and thus, there was no electrical power available at screws A2, B2 and C2. The screws were not affected.

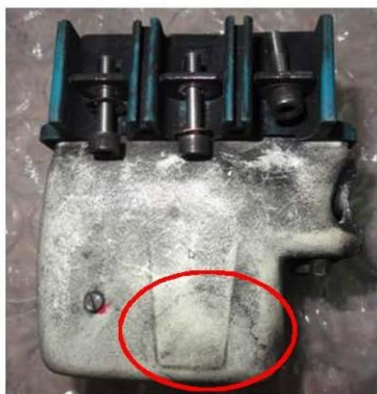
Figure 19. RCCB 991JV6 exterior dried fluid

Figure 19 shows where traces of dried fluid was found on the exterior surface of the RCCB.

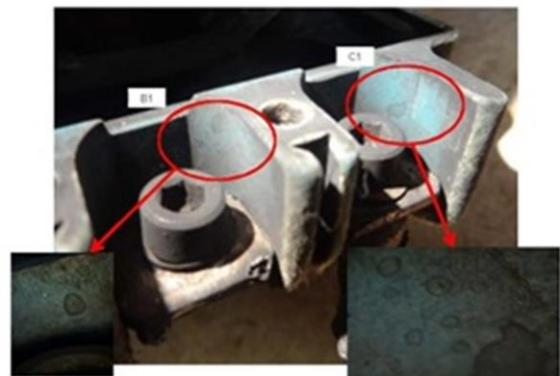
Figure 20. RCCB 991JV6 dried fluid in cavities B1 and C1

Figure 20 shows where traces of dried fluid was found after the soot was cleaned from the cavities of phases B1 and C1.

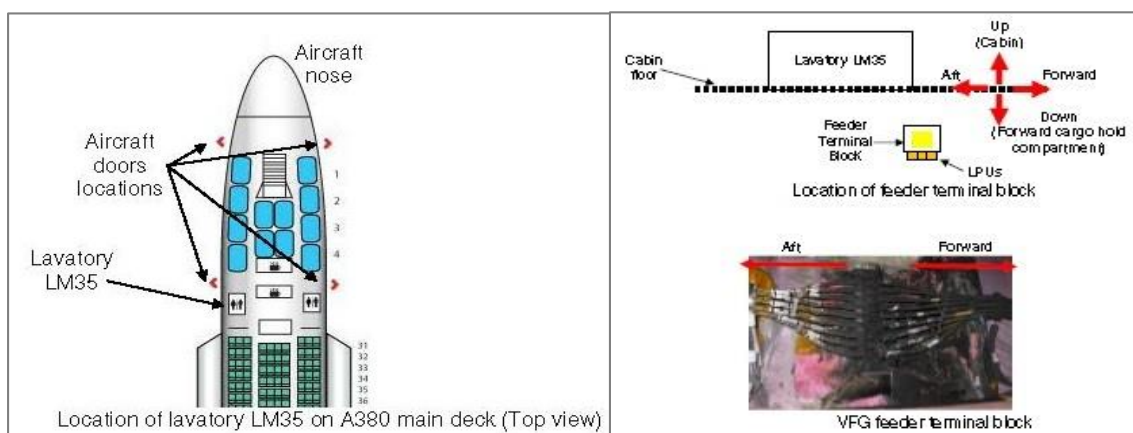
Figure 21. Photos from Singapore Annex 13 report AIB/AAI/CAS.072

The aircraft was inspected after landing in Singapore. Signs of burning was found on the feeder terminal block for the No.1 VFG located in the forward cargo compartment below lavatory LM35, on the feeder cables connected to the feeder terminal block and on the insulation blankets

around the feeder block. The lightning protection units (LPUs) connected to the feeder terminal block showed signs of melting. The inner surface of the cover of the feeder terminal block was partially covered with soot but did not show any sign of heat damage.

A degraded main excitation cable had probably caused an over-voltage across the lightning protection units (LPUs) attached to the feeder terminal block, resulting in a short circuit between the three phase feeder cables and structural grounding. The short circuit caused excessive current to flow through the feeder cables attached to the
