**KOMITE NASIONAL KESELAMATAN TRANSPORTASI  
REPUBLIC OF INDONESIA**

**Aircraft Serious Incident Investigation Report**

**PT. Garuda Indonesia**

**ATR 72-600; PK-GAG**

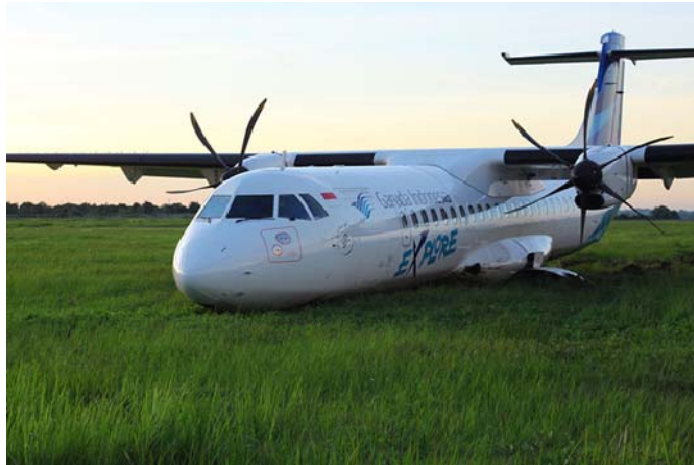
**Figure 3: The final position of the aircraft with the nose and main landing gears trapped on the soft soil**

The aircraft was landed for Lombok International Airport in runway 13, after touchdown the aircraft veered to the right and stop about 390 metres from the last touchdown position and 33 metres from the runway edge (position of the nose wheel). The aircraft trapped on the soft soil.

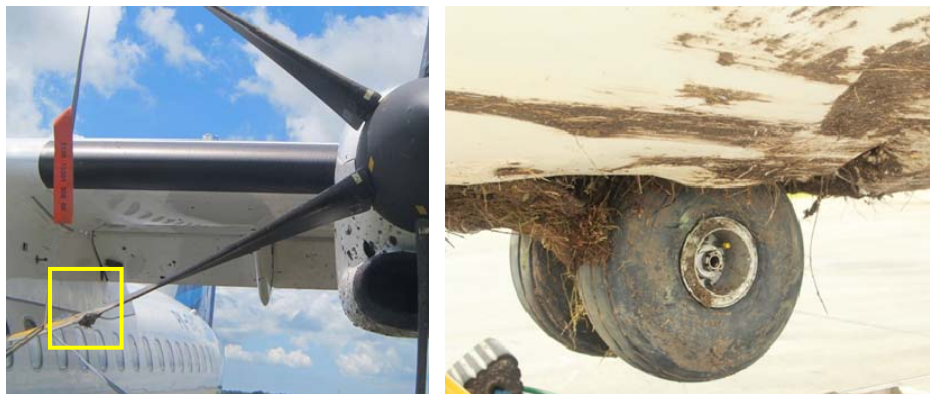
- The nose landing gear collapsed rearward,
- The lower front of fuselage dent,
- Right propeller blade and the tips bent.

**Figure 4: The damage on the propeller and the nose wheel**

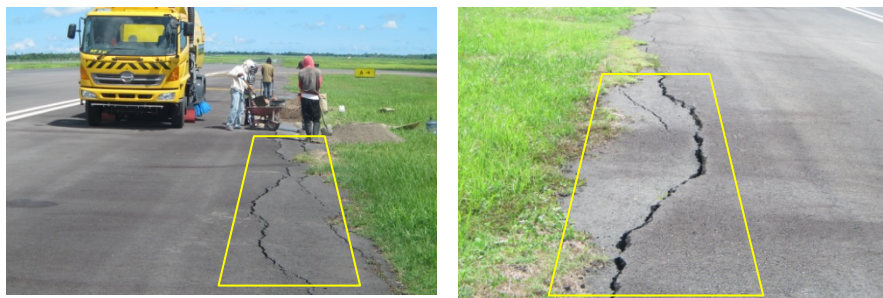
Observation on the area of the runway found at the right runway edge pavement surface crack about 20 cm width, 50 cm depth and about 100 meters length, the operator repaired by filling the broken area with the concrete.

**Figure 5: Crack on the runway edge pavement**

Refer to analysis chapter 2.3 of this report, the KNKT recommends that the airport operator should improve the surfaces runway strip condition to comply with existing regulation.

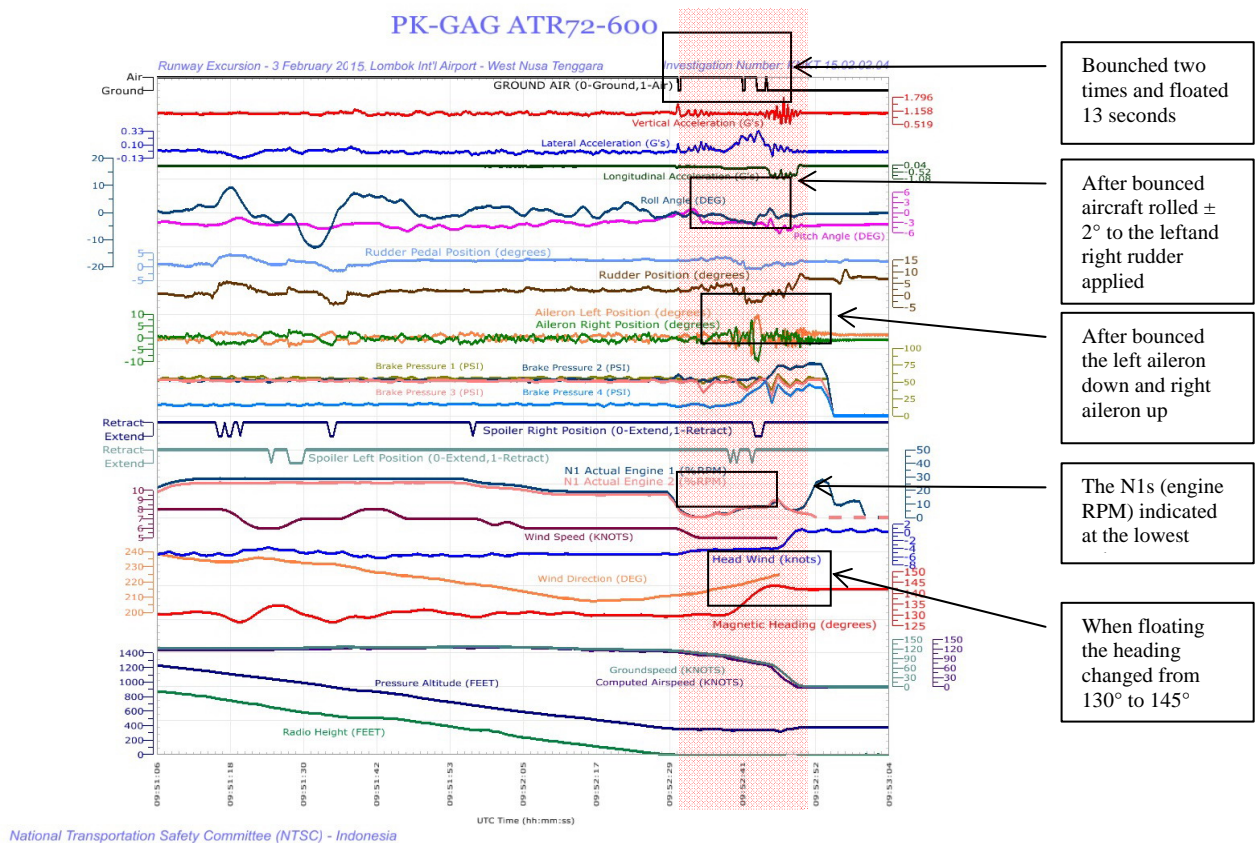
**Figure 6: The graph of several parameters of the DFDR started from 1200 feet on final until the aircraft stop**

- The aircraft bounced two times. The interval between the first and second touchdown was 10 seconds and the third touchdown was 3 seconds later.
- After bounce, aircraft rolled to the left at approximately 2°, right rudder applied and left aileron up. The aircraft heading changed to the right from 130°.
- The aircraft firmly on the ground at speed approximately 80 knots and at approximately 3 seconds after reached heading 145° the FDR recorded the peak of the lateral acceleration, which indicate aircraft initially left the runway pavement.
- The plot of the FDR superimposed to Google Earth indicated that the first touchdown was at 700 meters from the beginning runway 13.

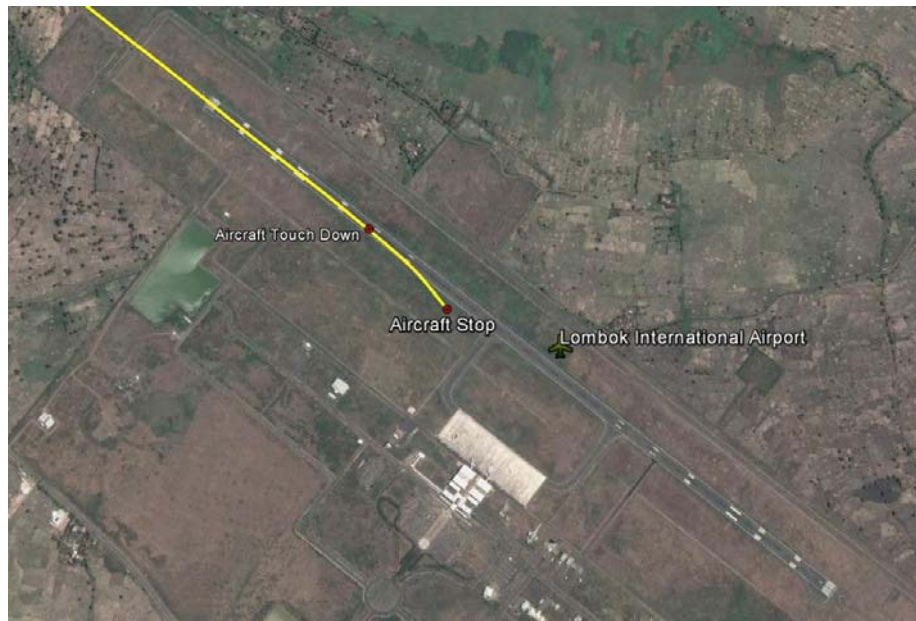
**Figure 7: The aircraft flight path based on data recorded on the DFDR superimposed to Google Earth**

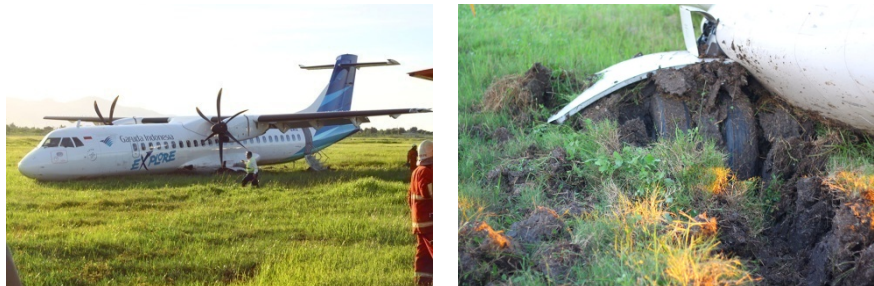
The nose landing gear collapsed rearward and damaging the front lower fuselage, the nose landing gear side broken.

**Figure 8: The nose landing gear collapsed rearward and damaging the front lower fuselage**

10. The main nose landing gear trapped on the runway strip and the nose landing gear collapsed rearward, damaging the front lower fuselage, and the nose landing gear side stay broken.

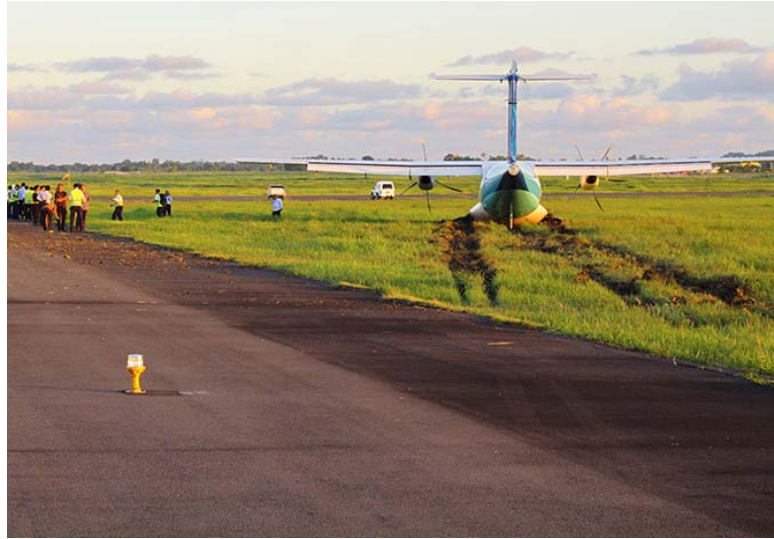
**Figure 9: The last aircraft position**
