**FINAL REPORT OF GROUND COLLISION
OCCURRENCE (GCOL) KOREAN AIR, AIRBUS, A- 330- 200 (HL- 7538) &
BANGKOK AIRWAYS, ATR 72- 212A (HS- PGA) AT YANGON
INTERNATIONAL AIRPORT ON FEBRUARY, the 12th, 2015**

SYNOPSIS

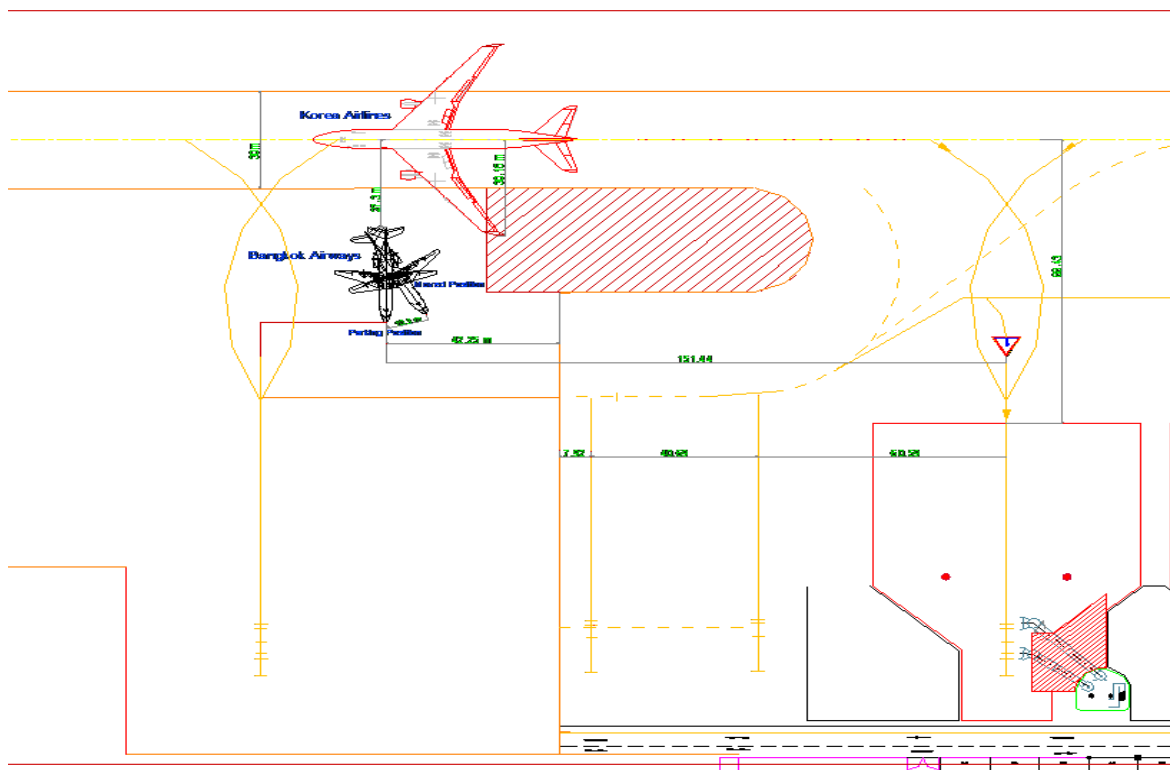
Figure 2 .Aircraft Parking Position

On that day, Bangkok Airways aircraft (HS-PGA) was parked on Apron-A in nose-in position, the empennage of which was 27.3 meters away from the taxiway centerline. No passengers and crew were onboard. (**Figure 2**)

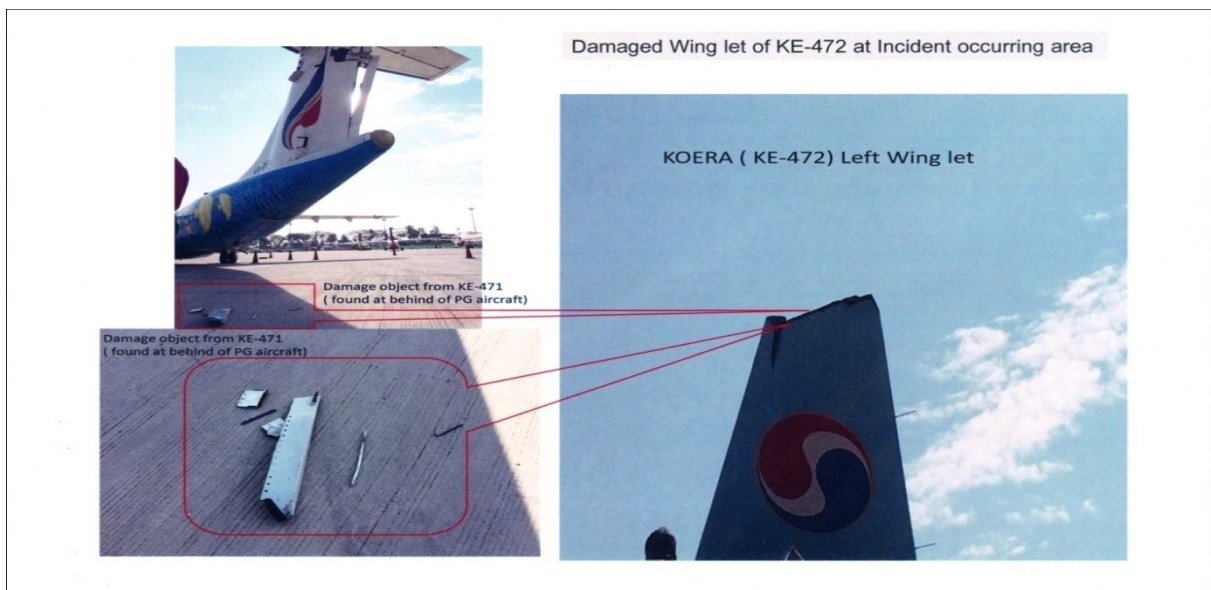
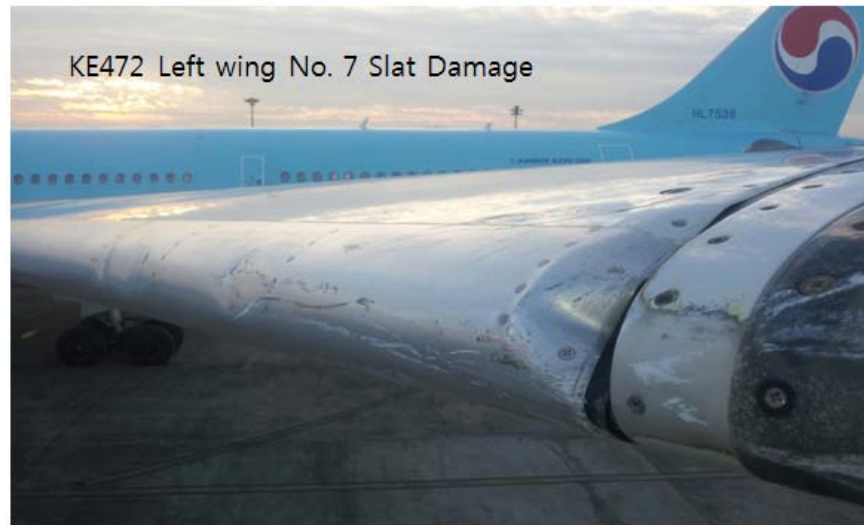
Figure 3: Korean Air (HL- 7538) left winglet and Left wing No.7 slat damage

The aircraft (HL-7538) Left winglet and Left wing No.7 slat were damaged. It suffered minor damages. (**Figure 3**)

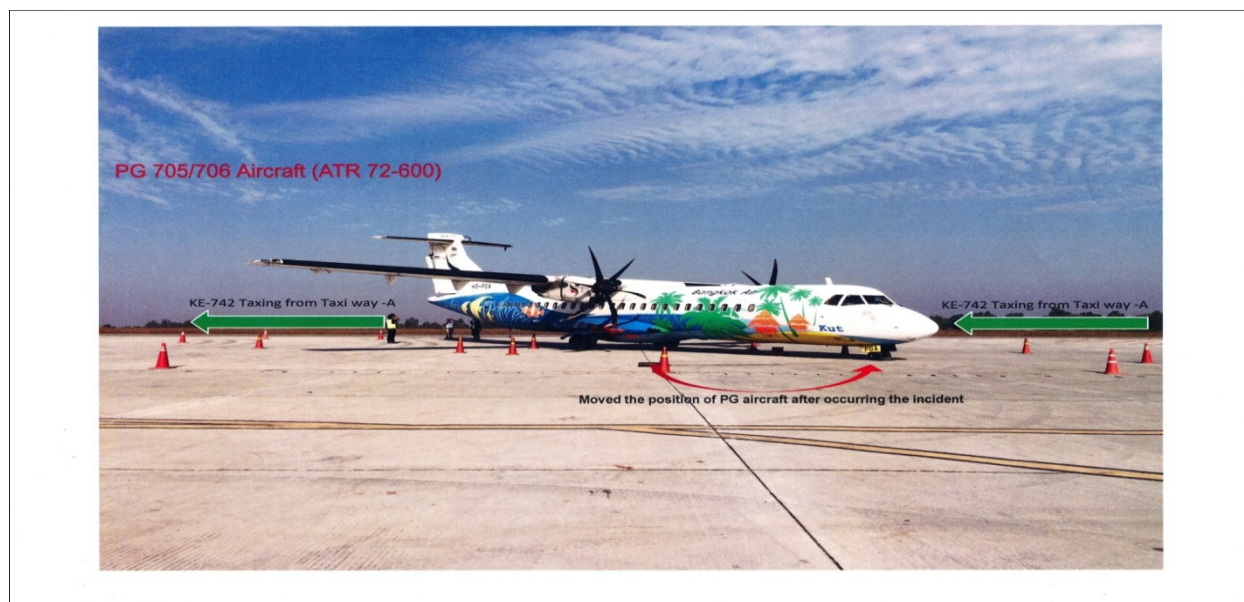
Figure 4. The moved nosewheel position of Bangkok Air before and after being struck.

After it has been struck by the A-330, the aircraft (HS- PGA) nosewheel moved 15 ft to the left (**Figure 4**).The Elevator and vertical stabilizer were damaged and need to be structurally repaired. (**Figure 5**)

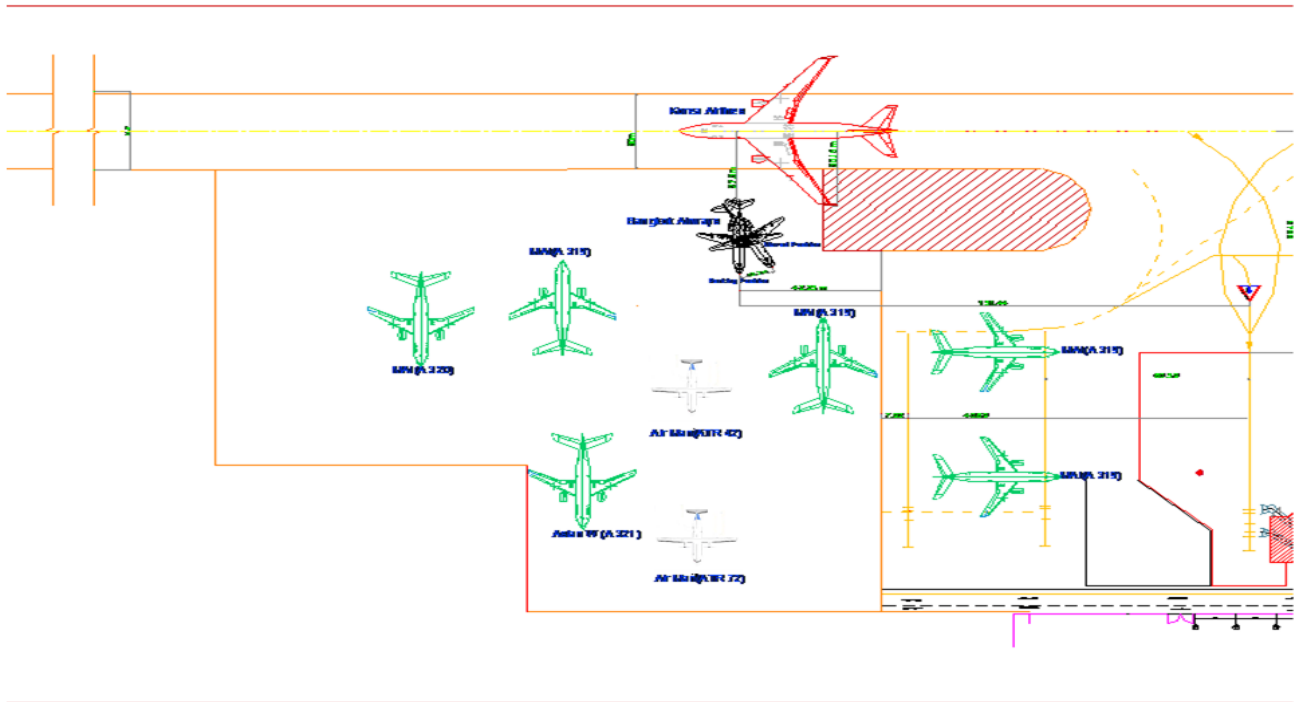
Figure 2 . Aircraft Parking Position

There are eleven aircraft parking stands, five night parking bays on the existing apron and four aircraft parking stands on apron A(New Apron), all together twenty. However, **up to (32)** aircraft had to park on the whole apron, which means that it was congested and not the same as shown in AIP and Jeppsen publication. **Apron A** is a newly constructed area in where some lighting facilities had not been completed yet at the time of occurrence .As a result-the lighting was not able to cover up to the edge of the apron A and dark.

Ground handling team had parked the ATR 72-212 A HS-PGA on zero parking zone which was within the apron-A area (newly constructed apron). There were two other aircrafts around that spot. **However it is not a designated place for aircraft parking and it not specified in AIP.** Taxiway A is 30 meters large. As per Annex .14, YIA Code letter Taxiway minimum separation distance from taxiway center line to object must 47, 5 meters. **However HS-PGA was parked 27, 3 meters from the taxiway center line.**
