AIRCRAFT ACCIDENT REPORT AND EXECUTIVE SUMMARY

Reference:	CA18/2/3/9416		
Aircraft Registration	ZU-EHM	Date of Accident	27 February 2015		Time of Accident	15:30Z		
Type of Aircraft	Windlass Aquilla microlight		Type of Operation		Private (pleasure)			
Pilot-in-command Licence Type		NPL	Age	57	Licence Valid	Yes		
Pilot-in-command Flying Experience		Total Flying Hours	764,28		Hours on Type	341,20		
Last point of departure		Dairy farm private airstrip, Irene, Centurion, Gauteng						
Next point of intended landing		Dairy farm private airstrip, Irene, Centurion, Gauteng						
Location of the accident site with reference to easily defined geographical points (GPS readings if possible)								
On a private farm airstrip with GPS co-ordinates: S25 ° 52' 43.17", E028° 12' 35,74"								
Meteorological Information		Wind direction: 270°; Air temperature: 25 °C; Wind speed: 7 kts; Visibility: Good						
Number of people on board	1+1	No. of people injured	1+0	No. of people killed	0

Name of Owner : VAN DER BYL A R
Name of Operator : VAN DER BYL A R
Manufacturer : Solo Wings CC
Model : Aquilla II
Nationality : South African
Registration Marks : ZU-EHM
Place : Dairy farm private airstrip, Irene,

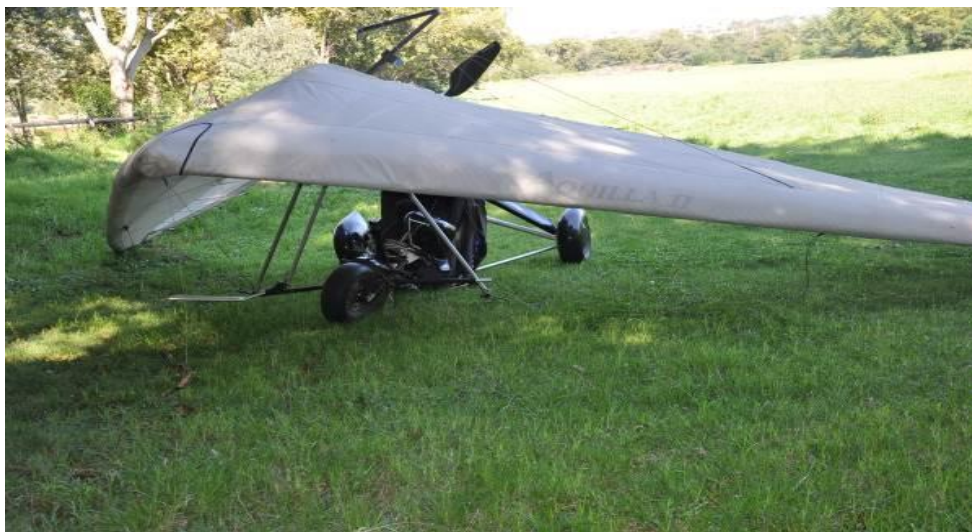
Figure 1: Damage to the aircraft

some tall, thick grass before the prepared landing strip runway. On contact with the grass, the microlight rolled over and came to rest inverted, facing in a northwesterly direction. The microlight sustained substantial damage to the nose gear, airfoil tube, keel tube (bar) and the pylon's extended member.

1.3.1 The aircraft sustained substantial damage.

1.3.2 Figure 1 shows the damage sustained by the microlight during the accident sequence.

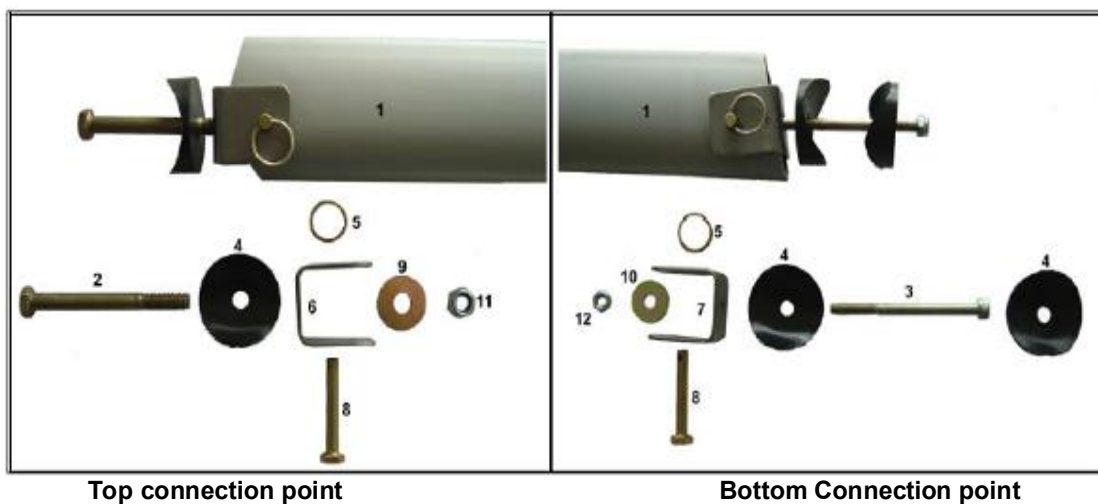
Figure 3: Airfoil connecting points . illustrated parts

This is the front tube with an airfoil shape that forms part of the microlight main structural members (Figure 3). It connects on both the top and the bottom on the U-shaped brackets with safety pins (8) and a safety ring (5). The bottom U-shaped bracket is bolted in place on the front elbow (2). The two saddles are used on the bottom airfoil tube connecting point. The one saddle is used between the U-shaped bracket (7) and the elbow and the other on the end connection before inserting the washers (10) and the nut (12).

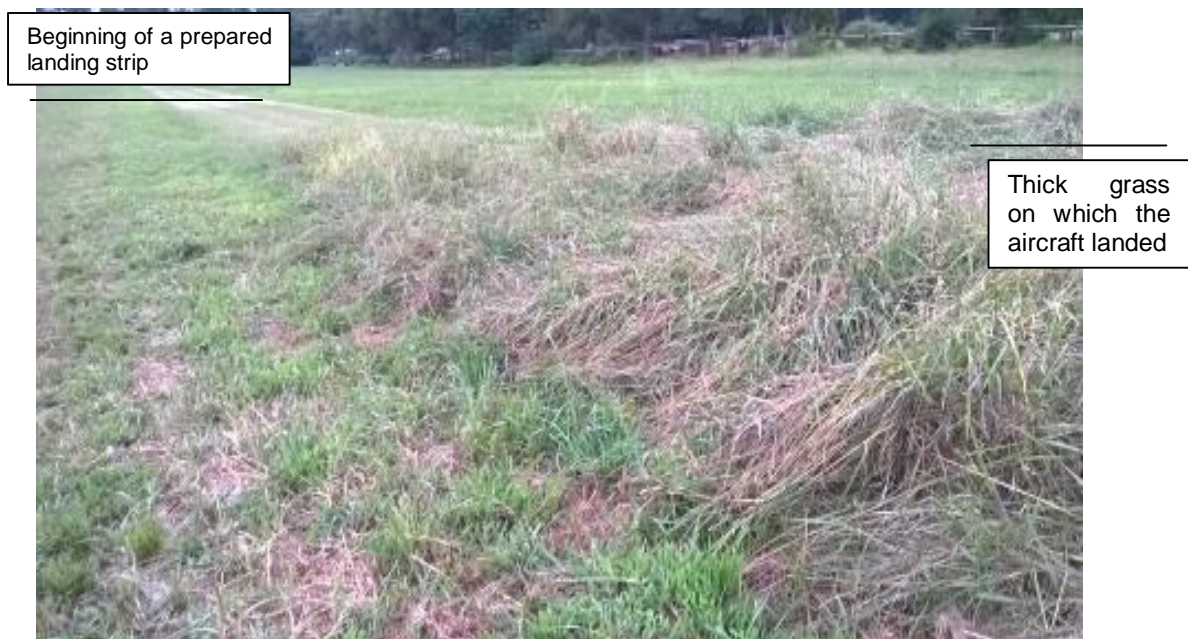
Figure 4: Landing strip

1.12.1 The area at which the aircraft took off in under the air space controlled by the AFB WTKLF. The aircraft accident occurred on the thick grass before the prepared landing strip. The pilot was unable to control the aircraft during landing due to the disconnected tube control noticed during take-off.

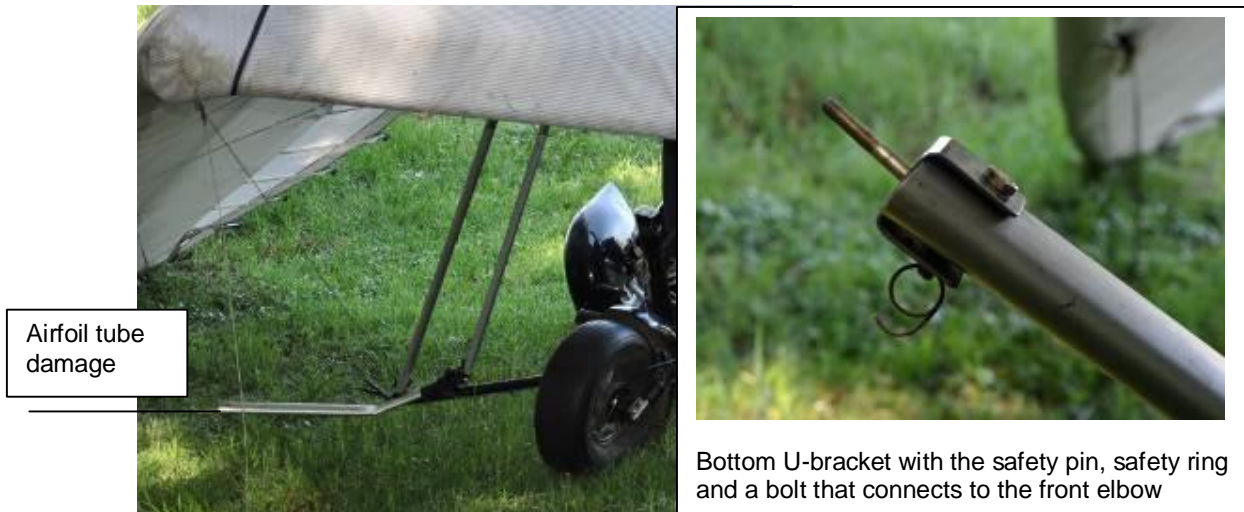
Figure 5: Airfoil with bottom U-bracket

1.12.2 According to the accident site observation, the microlight landed on the nose landing gear first, followed by the airfoil tube digging into the ground, and then rolled over. The airfoil tube was damaged during impact and got bent. The bottom connection of the airfoil tube's U-bracket became disconnected due to a lost nut (Figure 5).

- 2.2 According to the nyloc nut specification, the nut cannot easily get lost if fitted according to specifications. This suggests that the nut might have been tampered with either during or after maintenance. We could not recover the nut during investigation to determine whether it was a reuse or was the correct specification. However, the microlight flew for 9,94 hours after the maintenance over a period of nine months.

- 2.4 If the nut had been fitted as a reuse item during maintenance or between operational activities, the pilot might have anticipated its getting lost over time during operation, due to vibration. The airfoil tube is considered flight-critical because it is considered a balance structural member. However, the pilot stated that he did not bother inspecting the nut for security as it was not part of the standard pre-flight inspection checklist.

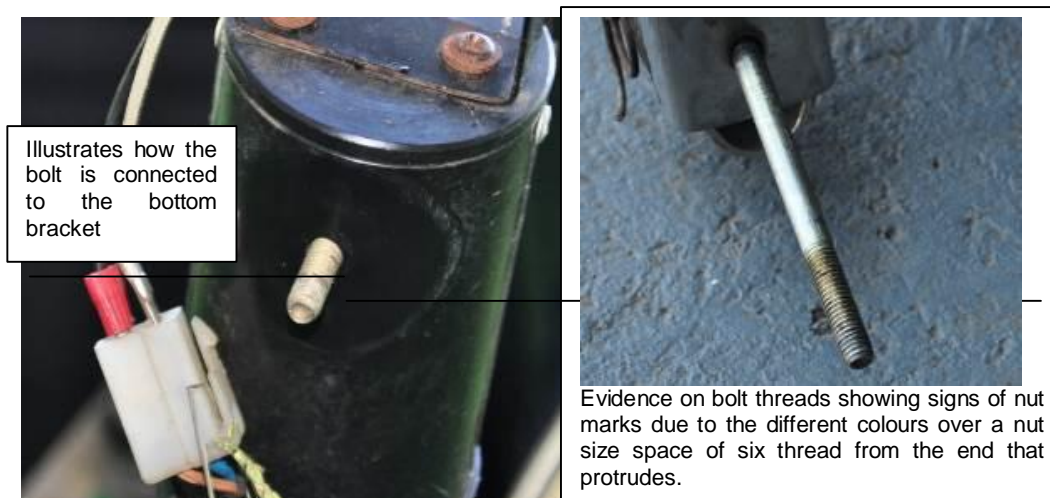
Figure 6: Evidence marks on bottom saddle

1.12.3 The nut and saddles were not found in the accident area. However, there were evidence marks on the front elbow, showing that the saddles had been attached prior to the accident (Figure 6). There was further evidence showing that there had been a nut prior to the accident. The microlight remained with the wheels-up position on the grass. During the rescue, some of the cables were cut for access. The aircraft sustained substantial damage to the airfoil tube, keel bar, nose gear and the cables.

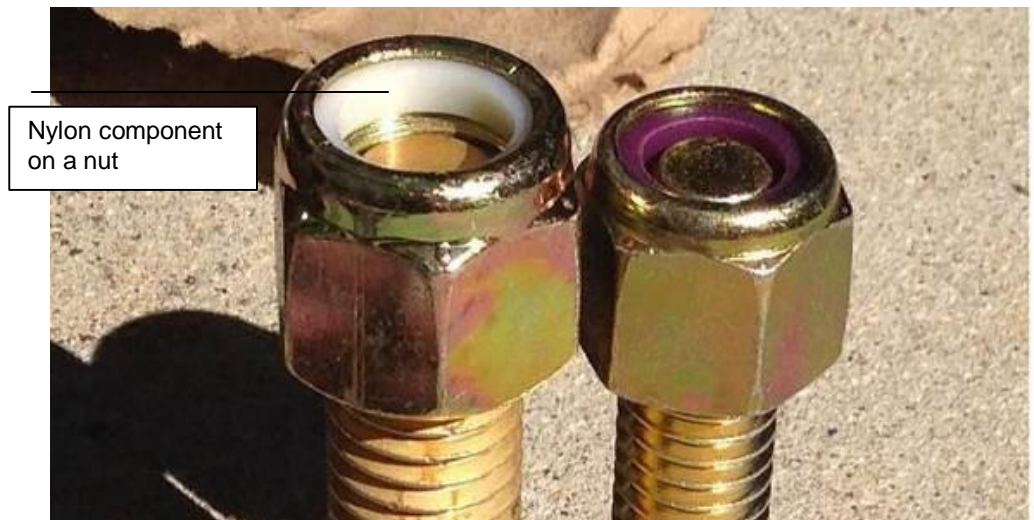
Figure 7: Nylon nut types

A nyloc nut is a fastener that incorporates a nylon component to effectively lock the nut into position on the bolt. The nylon component of the nyloc nut has a smaller inside diameter than the actual nut, thereby locking the nut in place by squeezing the nylon firmly around the bolt when tightened. Unlike a standard locking washer, the nyloc nut prevents the nut from loosening under vibration as the nylon is tightly wedged into the bolt threads and provides resistance to turning once tightened.

Even though the nylon locking nut can be reused in many applications, it is recommended that a fresh locking nut be used on any critical fastener connection. The slightest risk of failure warrants a ban on the reuse of the fastener in all critical applications, such as cylinder head bolts, connecting rod bolts and main bearing cap bolts. Modern nylon formulas permit the nyloc nut to be used in many internal engine applications without concern.
