AAIS Case N°: AIFN/0003/2011

Partial Loss of Right Hand Engine

Thrust Reverser

Operator: Emirates
Make and model: Boeing 777-200
Nationality and registration: UAE, A6-EMH
Place of occurrence: Moscow Domodedovo Airport
State of Occurrence: Russia
Date of Occurrence: 5 March 2011

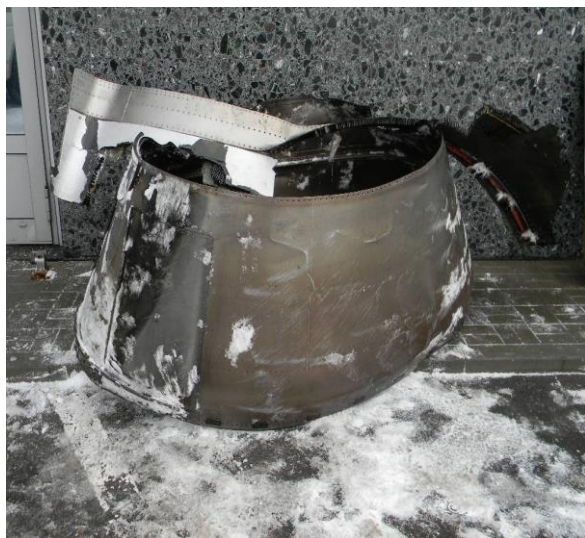
that no debris had been found. However, airport authority inspections later found pieces of the thrust reverser on the runway (see figures 1 and 2 below). The flight crew informed the Operator of the EICAS messages and a decision was made, by the commander, to continue the flight based on the information available to him at the time. On arrival, Dubai ATC reported that small pieces had separated from the Aircraft during landing. The flight crew shut down the right engine immediately after vacating the runway and requested a runway inspection. Following normal passenger disembarkation, the commander was made aware of the missing thrust reverser part (figure 3).

Figure 1. Aft right engine thrust reverser

The Air Accident Investigation Sector determines that the failure of the thrust reverser inner wall was primarily due to residual thermal damage that was not correctly inspected and repaired following previous exposure to high temperatures.

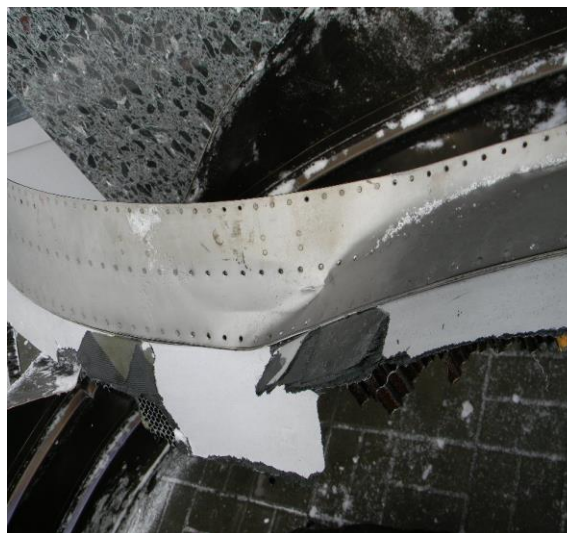
Figure 2. Detail of the aft thrust reverser

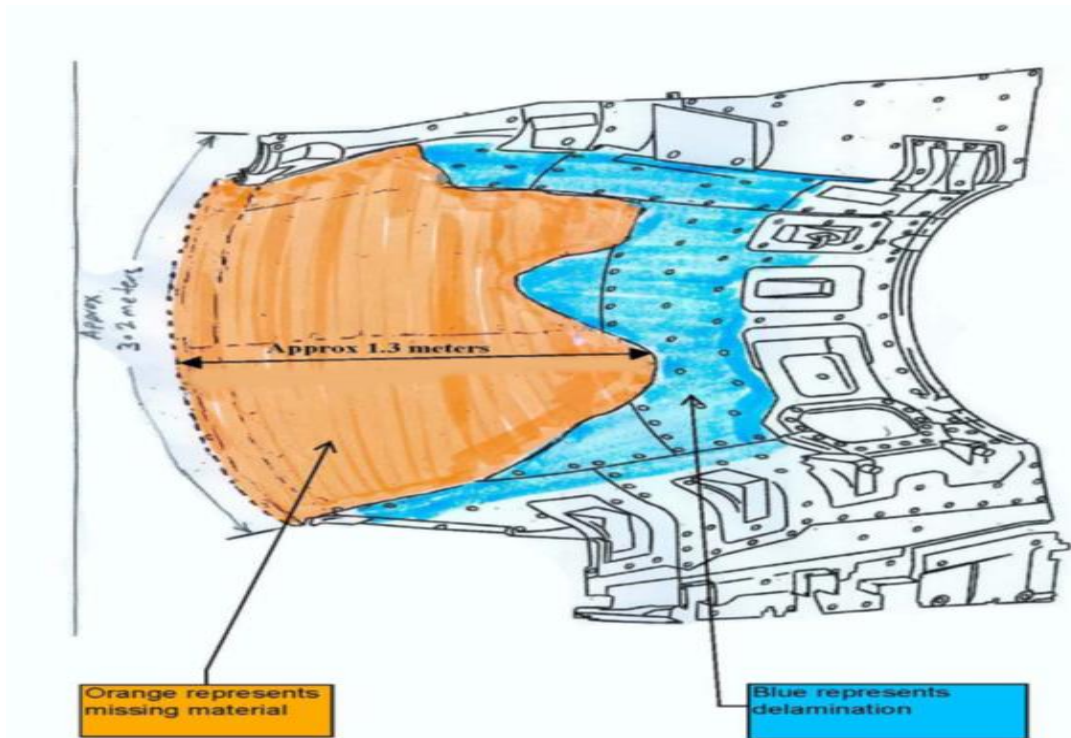
Figure 3. Drawing showing approximate material damage and loss on Left hand reverser's inner of wall of the right hand engine

The B777-200 was powered by two RB 211 Trent 800 engines. Each engine thrust reverser has two inner walls (left and right) that surround the aft part of the engine. These inner walls do not move. Reverse thrust is produced when movable doors, which are located aft of the two inner walls open, diverting fan bypass air forward, assisting the aircraft in reducing its speed. The inner wall (Part Number 315W5101-1) that failed was the left hand inner wall of the No.2 engine.

The failed inner wall was returned to Boeing for forensic laboratory examination, which was performed under the supervision of the NTSB, at the request of the AAIS. The detailed failure analysis revealed that an earlier repair had suffered some degree of adhesion failure between the adhesive film and the earlier repaired core and concluded that the inner wall failed primarily due to residual thermal damage that was not addressed when the panel was initially inspected and repaired. The repair was not effective due to inadequate cleaning of the core prior to repair and failure to expand the repair sufficiently to remove the thermal damage.

Furthermore, the forensic examination revealed that it was possible that the thrust reverser was mis-rigged, resulting in higher-than-normal loads which could have caused the weakened panel to fail.
