<b>AIRCRAFT ACCIDENT REPORT AND EXECUTIVE SUMMARY</b>
---

Reference:	CA18/2/3/9420	
<b>Aircraft registration</b>	ZS-HBV	<b>Date of accident</b>	8 March 2015		<b>Time of accident</b>	1000Z
<b>Type of aircraft</b>	Garlick UH-1H (Helicopter)		<b>Type of operation</b>	Fire fighting		
<b>Pilot-in-command licence type</b>	Commercial		<b>Age</b>	71	<b>Licence valid</b>	Yes
<b>Pilot-in-command flying experience</b>	Total flying hours		10 970.7		Hours on type	227.6
<b>Last point of departure</b>	Newlands Forest Station, Western Cape					
<b>Next point of intended landing</b>	Cape Point National Park, Western Cape					
<b>Location of the accident site with reference to easily defined geographical points (GPS readings if possible)</b>						
Open field in the Cape Point National Park (GPS position: 34°15.771' South 018°25.101' East)						
<b>Meteorological information</b>	Surface wind: ±160°/10kt gusting 20kt, Temperature: 16°C, Visibility: + 10 km					
<b>Number of people on board</b>	1 + 0	<b>No. of people injured</b>	0	<b>No. of people killed</b>	1

<b>Probable cause</b>						
<p>The pilot was unable to regain control of the helicopter following a loss of tail rotor thrust, which was cause

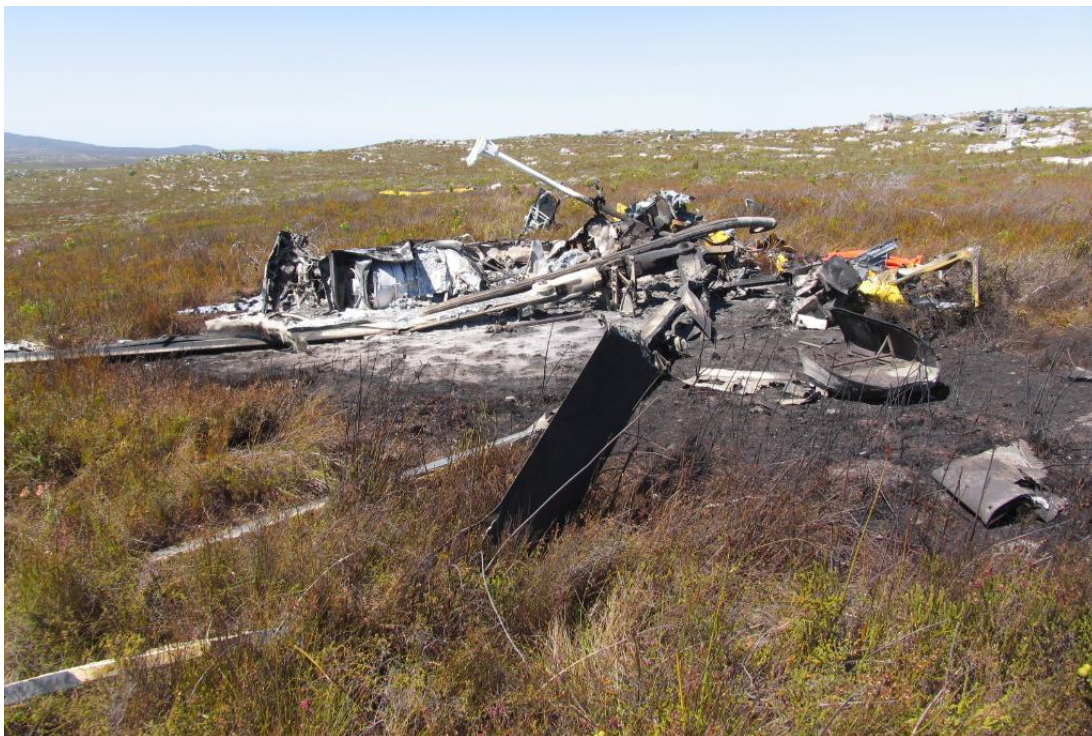
1.3.1 The main wreckage was destroyed during the impact sequence and post-impact fire. The tail boom was severed from the fuselage during ground impact, with the forward as well as the aft section of the tail boom not being exposed to any fire damage.

**Figure 2.** The main wreckage

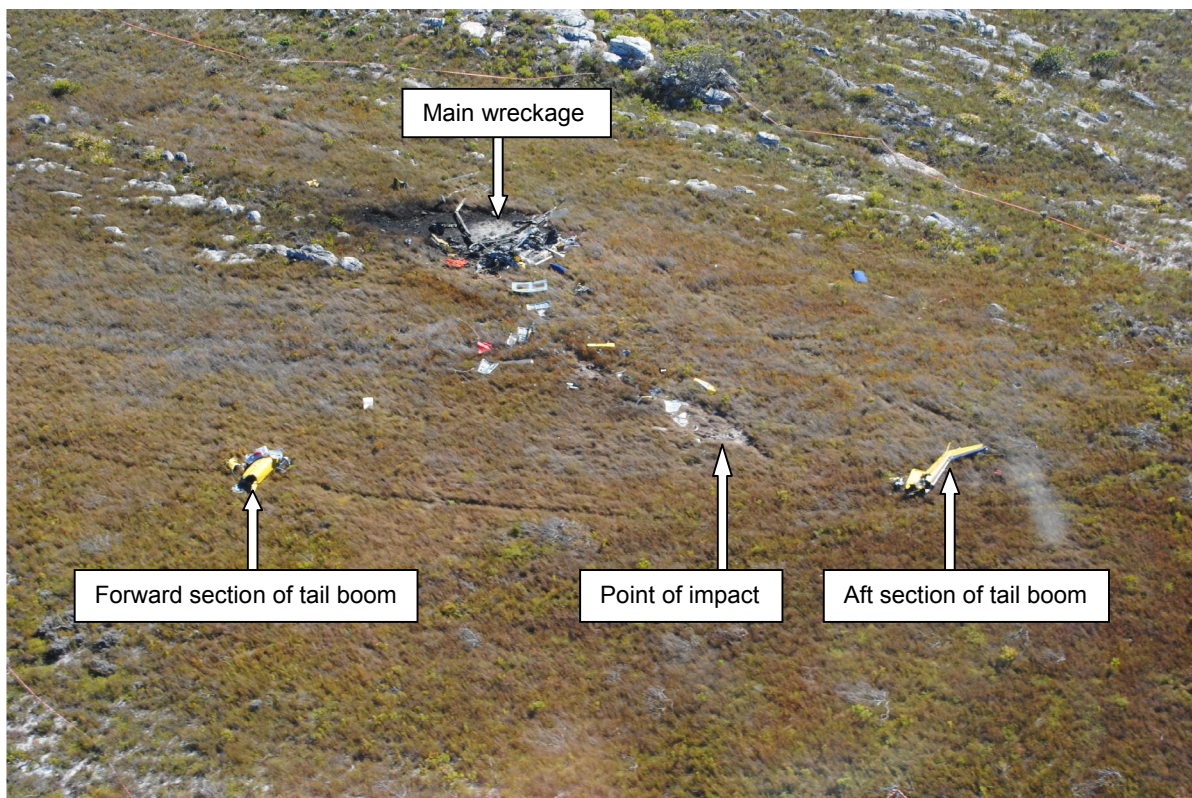
1.12.1 Examination of the accident site and wreckage indicated that the helicopter struck the ground at a high rate of descent and low forward speed in a northerly direction. The tail section was severed by the main rotor blades after the helicopter struck the ground and separated from the main fuselage just aft of where it attached to the fuselage. The tail boom was found in two pieces, with the forward section being located approximately 35 m to the left of the initial point of impact and the aft

section approximately 12 m behind the initial point of impact, as can be seen on the aerial photo in Figure 4. Most major components were located with the main wreckage, which came to rest approximately 30 m forward of the initial point of impact in an inverted attitude. The main wreckage was extensively burned and fragmented into large and small sections, even though approximately twenty Bambi bucket loads of water were dropped on the burning wreckage by one of the helicopters that were dispatched to the fire.

**Figure 4.** Aerial view of the accident site

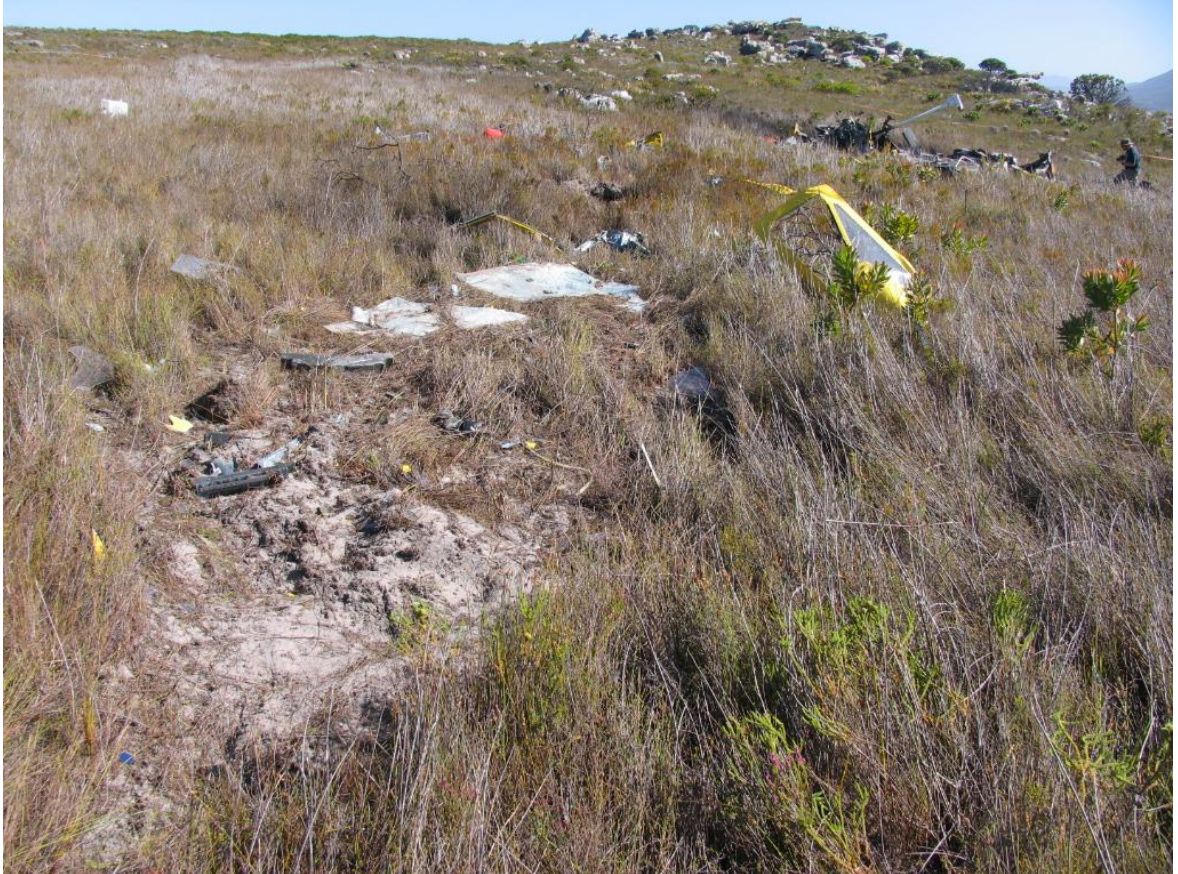
1.12.3 Severe deformation of the main rotor blades was observed, as they had impacted the ground as well as the fuselage during the impact sequence. Several parts/components separated from the main body and were found spread along the

impact line (looking forward from the initial point of impact towards the main wreckage). These included the wind shields, doors, door posts, rudder pedals, battery, fragments of the honeycomb structure from the main rotor blades, positioning mirrors, pieces of the Bambi bucket, parts of the skid gear and both pilot/front seats. The helicopter document folder, as well as two plastic tool boxes, was located in the area of the main wreckage. None of these items sustained any fire damage.

**Figure 5.** View from the initial point of impact in a northerly direction (towards the main wreckage)

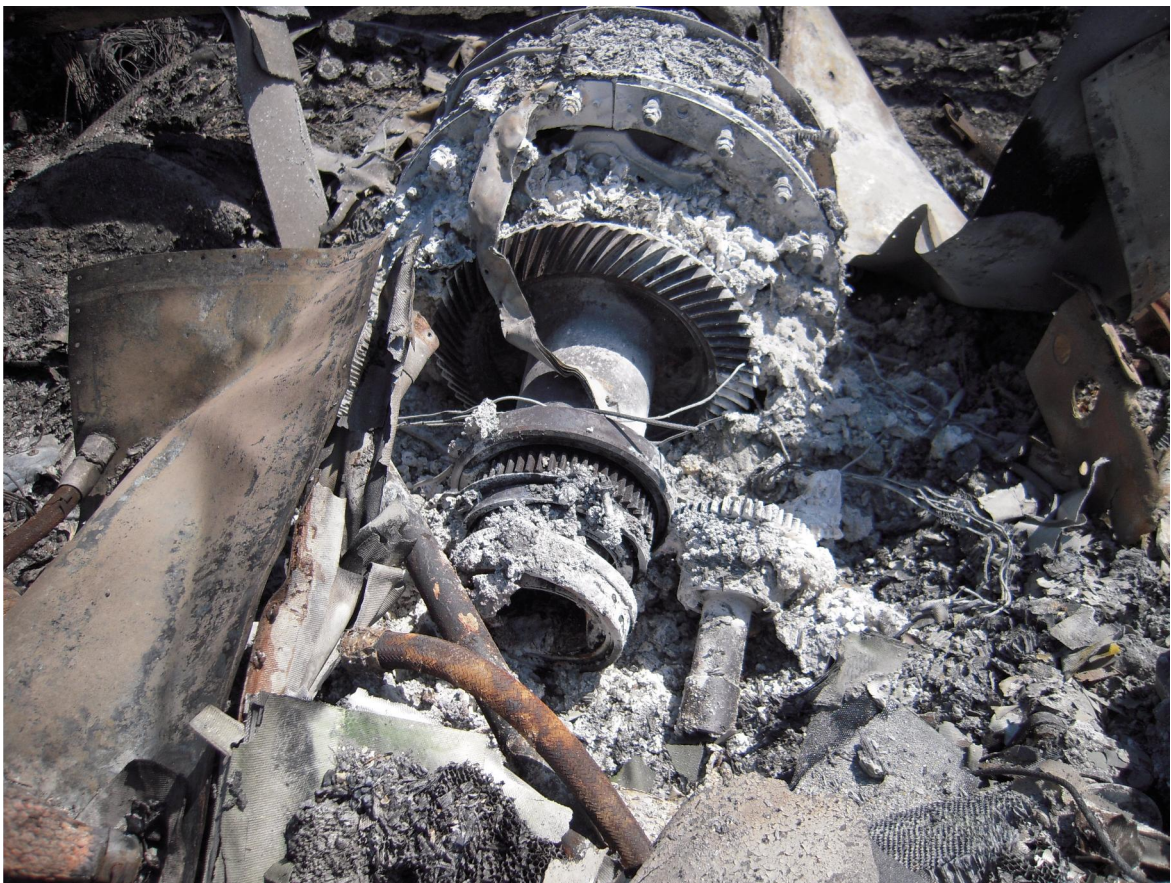
1.12.2 The main transmission, which included the main rotor gearbox, main rotor mast, main rotor assembly, including the head and blades, sustained extensive thermal damage. The flex frames on both ends of the main driveshaft were fractured. The tail boom and related components sustained the least amount of impact damage. The tail rotor blades exhibited minimal damage. One of the tail rotor pitch change links was found to have fractured in overload. The engine sustained extensive thermal damage; however, visual inspection of the turbine blades did not reveal any damage. It was not possible to establish the position of the throttle at the time of the accident.

**Figure 6.** The main rotor gearbox consumed by the post-impact fire

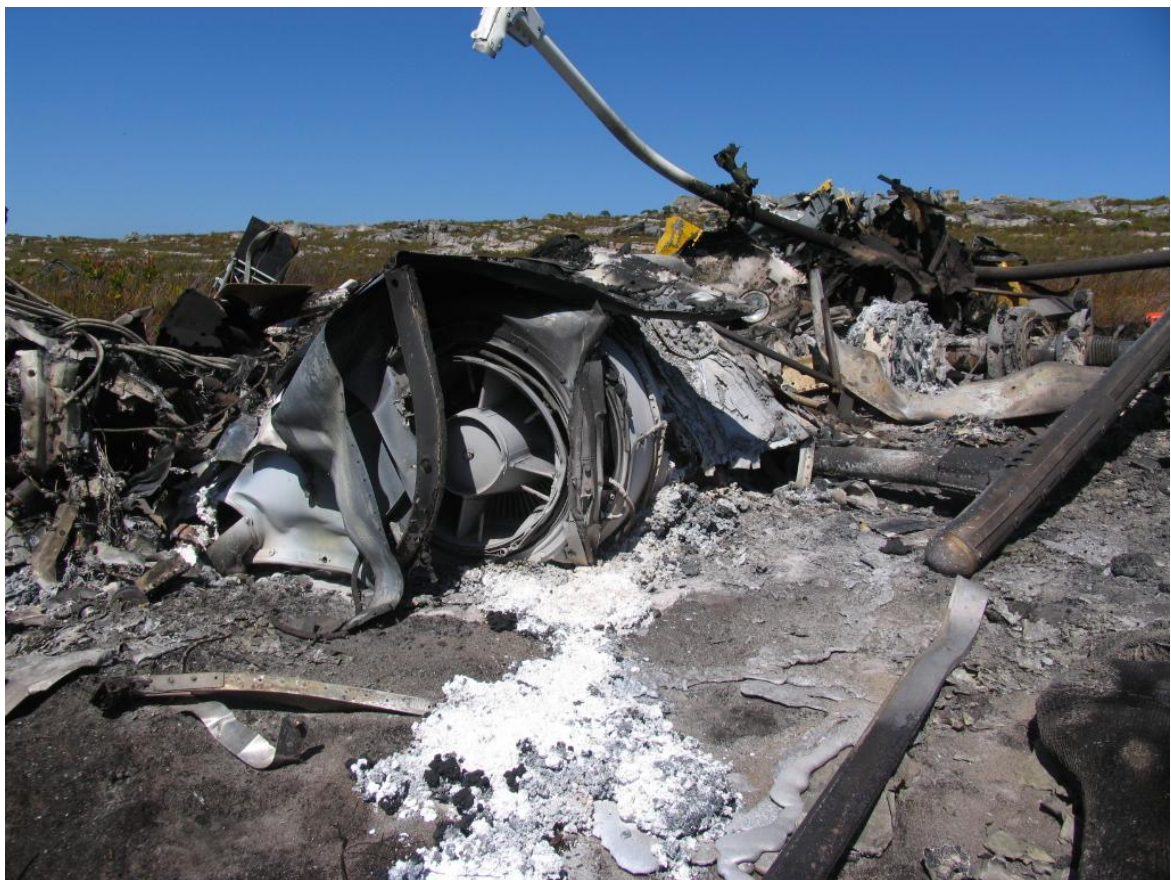
**Figure 7.** Aft section of the engine and main wreckage

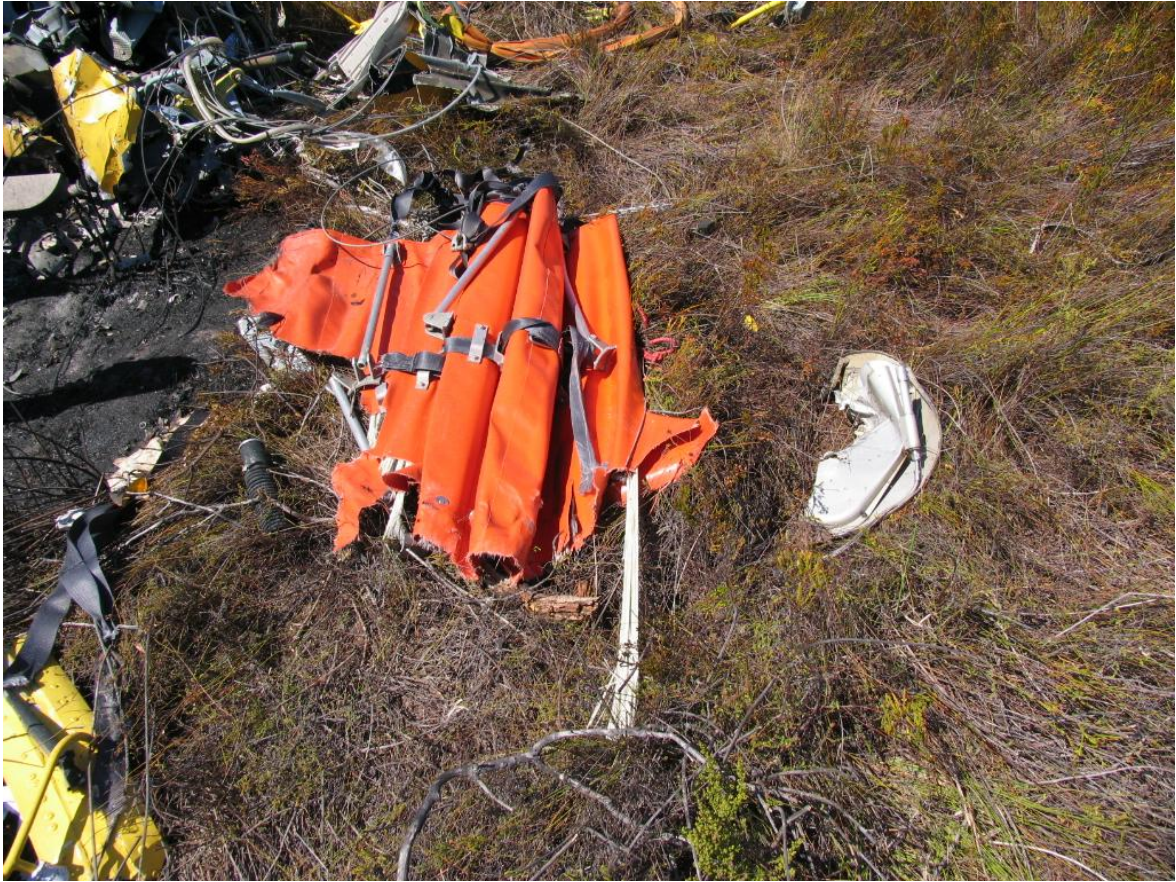
1.12.4 The pilot did not jettison the Bambi bucket; it was found to be still secured to the cargo hook assembly. It displayed evidence of main rotor blade impact, which was consistent with the statements of both pilots flying the other two helicopters, who saw the bucket colliding with the blades prior to the helicopter impacting the ground (see Figure 8).

**Figure 8.** A section of the Bambi bucket that was severed by the main rotor blades

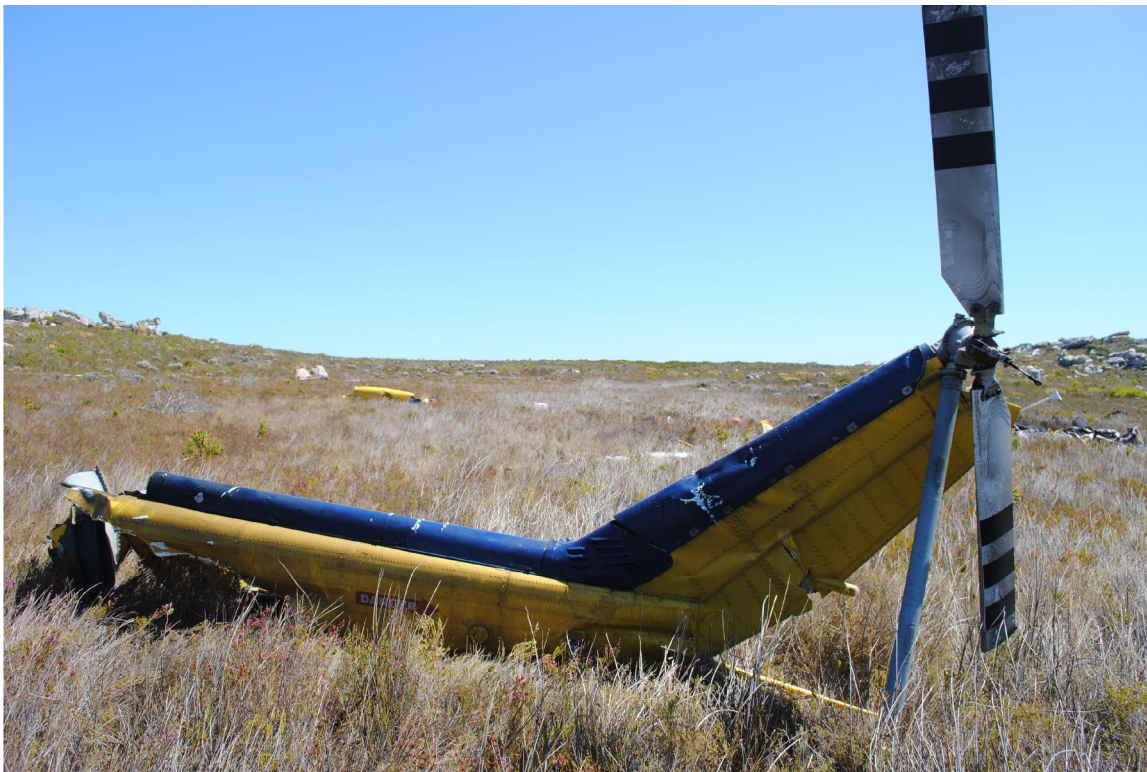
1.12.5 The tail boom was severed by the main rotor blades during the impact sequence. Neither the forward nor the aft section of the tail boom sustained any fire damage. Figures 9 and 10 show the location of main rotor blade contact with the tail boom. The tail rotor drive, which was still attached to the tail boom structure, is also visible. The aft horizontal section of the tail boom displays deformation of the tail driveshaft cowling (three areas) as well as in the area of the 42° intermediate gearbox cowling. Neither of the tail rotor blades (visible in Figure 9) displays rotational or ground impact damage. Blue paint was observed on both tail rotor blades, which is consistent with the blades making contact with the tail boom pylon cover as well as the pylon structure. Both tail rotor pitch change linkages were found to have failed. The aft tail boom section was lifted and placed in an upright position in order to inspect the tail rotor drive train and control system. It was noted that the tail rotor driveshaft located just forward of the 42° intermediate gearbox had fractured and had become displaced at the input coupling to the 42° intermediate gearbox as a

**Figure 9.** Aft tail boom and blades (tail boom was placed in an upright position)

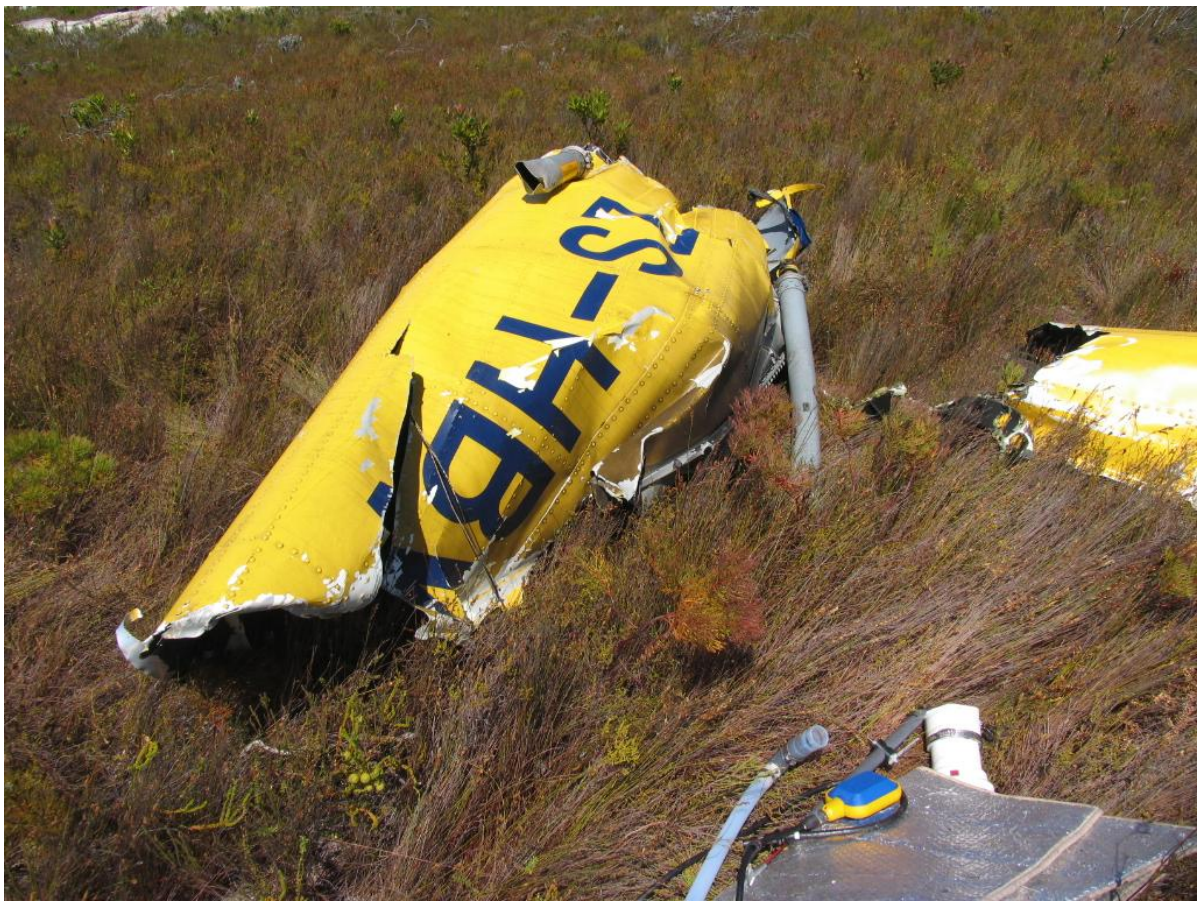
**Figure 10.** The forward tail boom structure that was severed by the main rotor blades

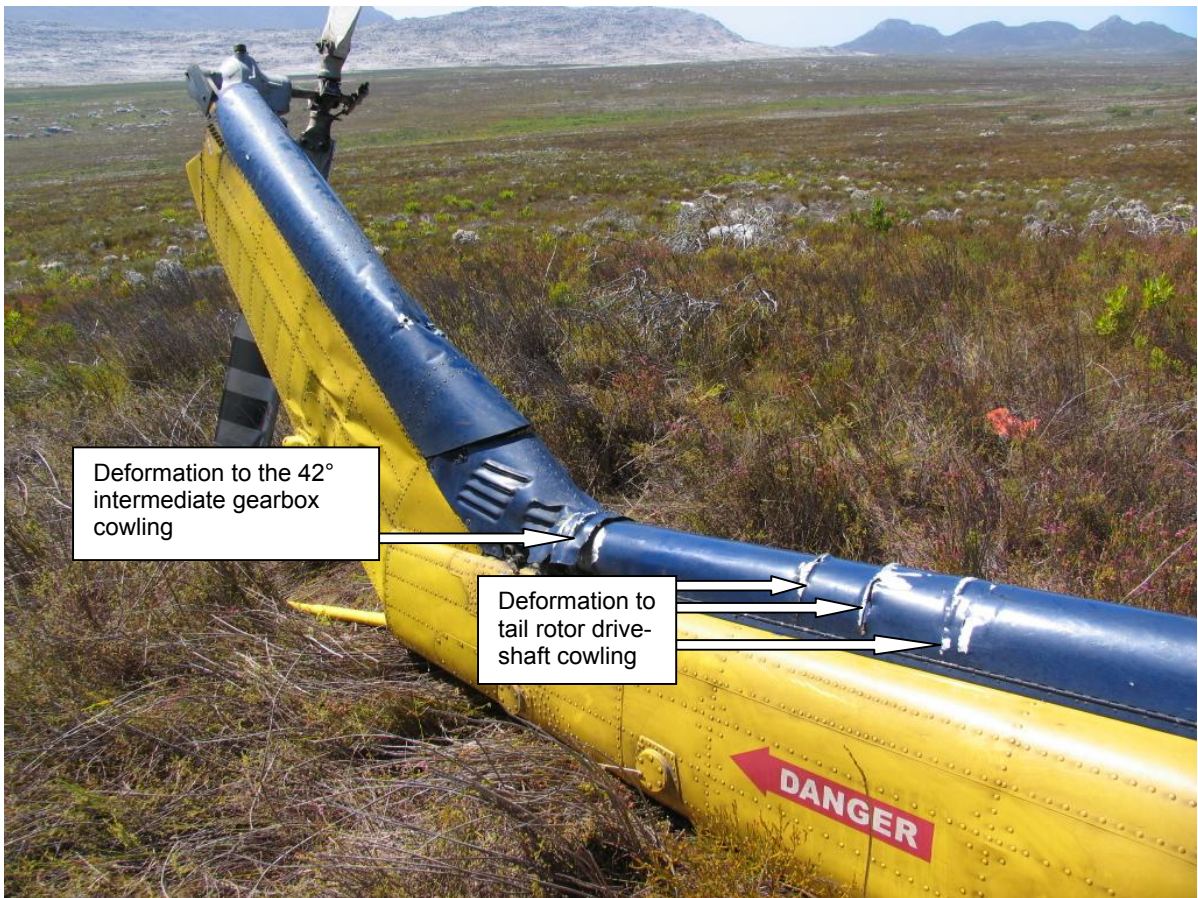
**Figure 11.** The aft tail boom structure with driveshaft cowling deformation visible

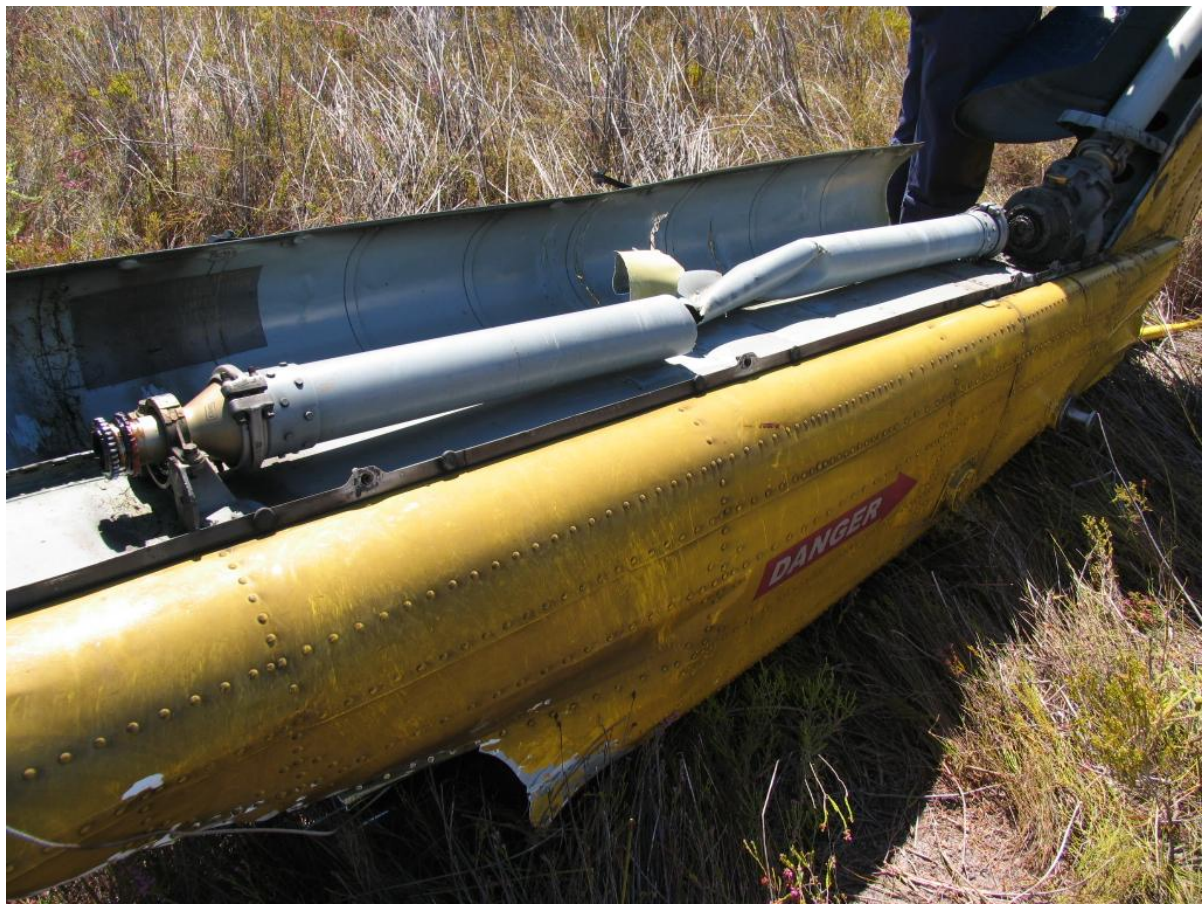
**Figure 12.** Tail rotor driveshaft just forward of the 42° intermediate gearbox fractured in torsional overload

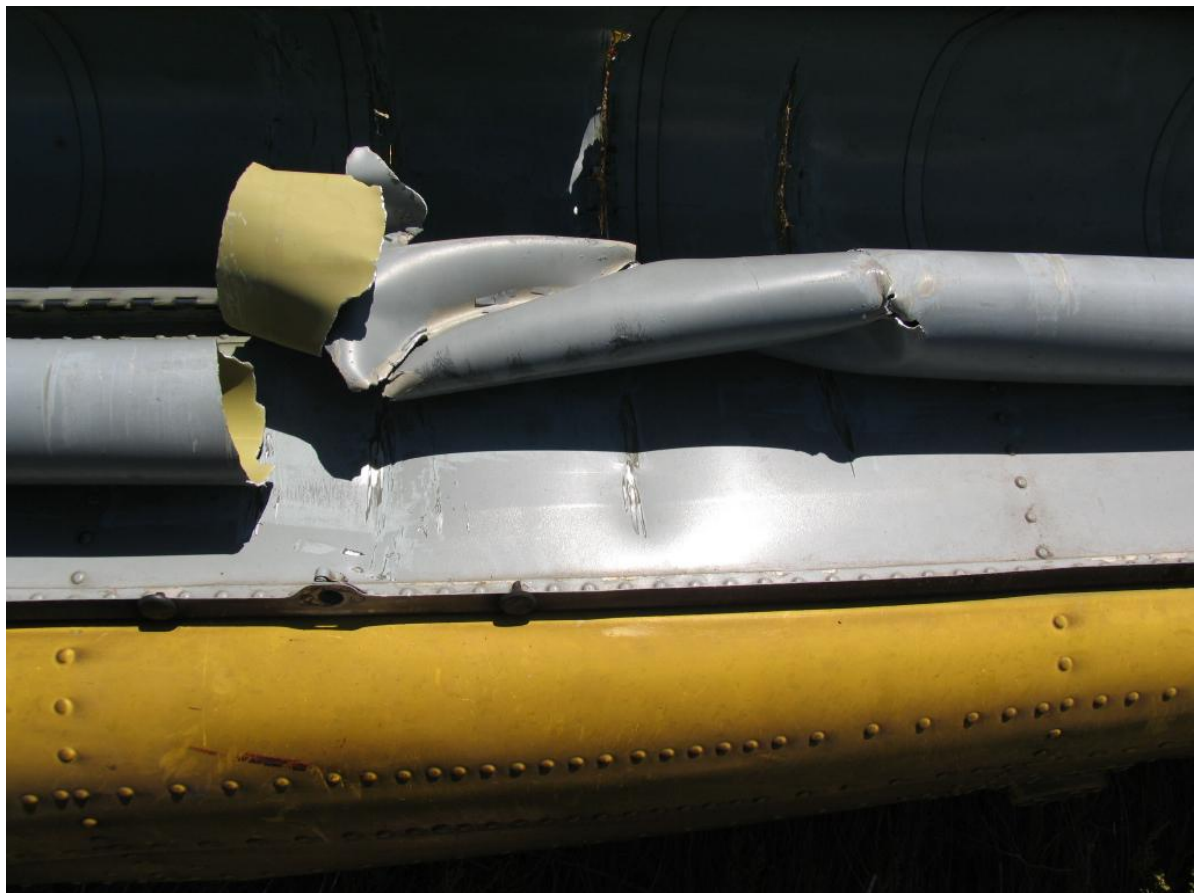
**Figure 13.** A closer view of the failed tail rotor driveshaft

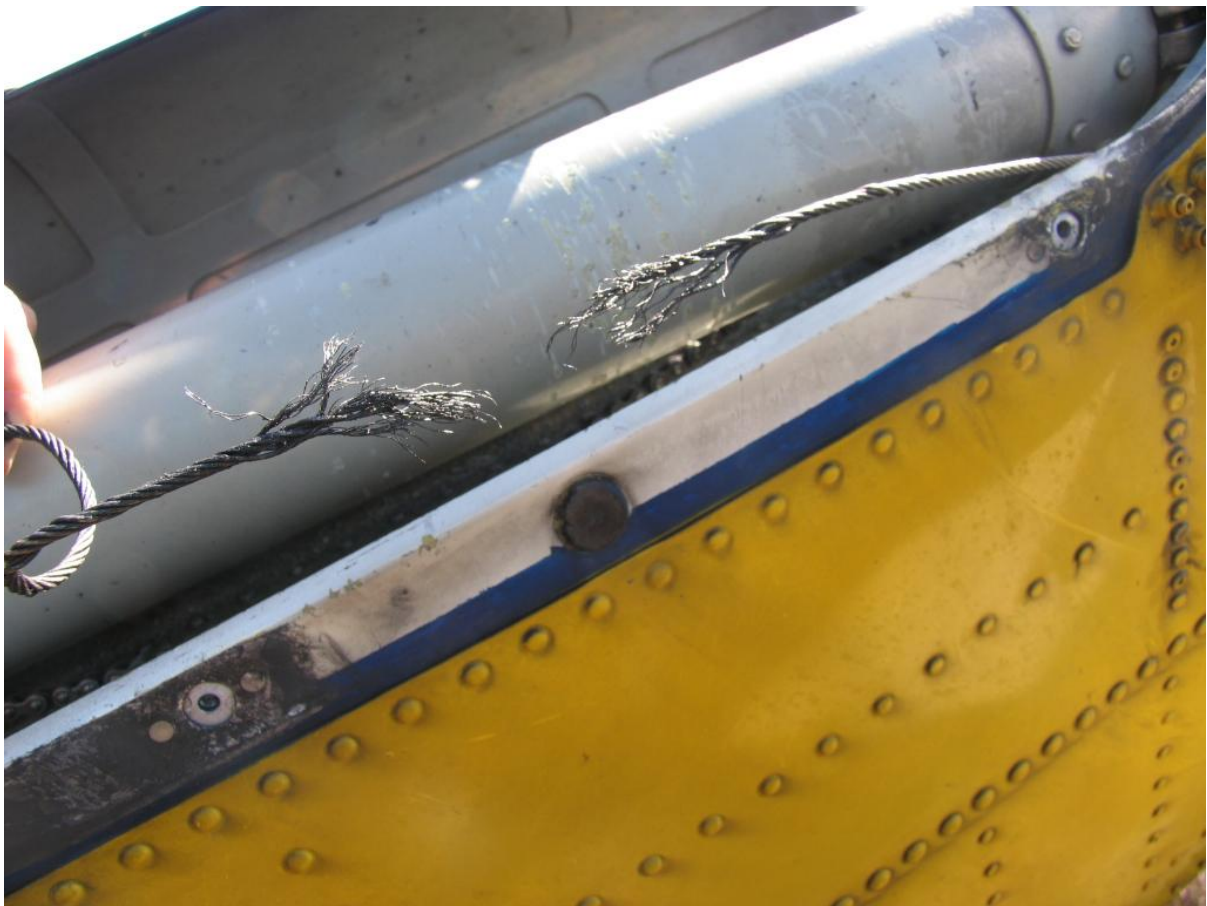
result of the failure of the shaft assembly. It was further noted that the lower tail rotor control cable that connects to the chain assembly, which in turn connects to the tail rotor pitch change mechanism, had failed. The tail rotor driveshaft cowling (pylon) as well as the tail rotor driveshaft in the area where the cable had failed displayed evidence of shaving, to such an extent that the cowling was found to be shaven through at two locations. Neither the 42° intermediate gearbox nor the 90° tail rotor gearbox was damaged in the accident sequence. Both these gearboxes were free to rotate when turned by hand, with no unusual sounds. The magnetic plugs on both these gearboxes were removed during the on-site investigation. Neither of them displayed sediment deposits that could be associated with a chip warning light as was communicated by the pilot. The magnetic plug displayed in Figure 17 was from the 90° tail rotor gearbox. No oil was observed in the sight gauges of either of the two gearboxes, nor was there any evidence that oil had leaked from either of these gearboxes during the accident sequence (see Figure 18 (a) and (b)).

**Figure 14.** Photograph of both ends of the aft tail rotor control cable that was found to have failed

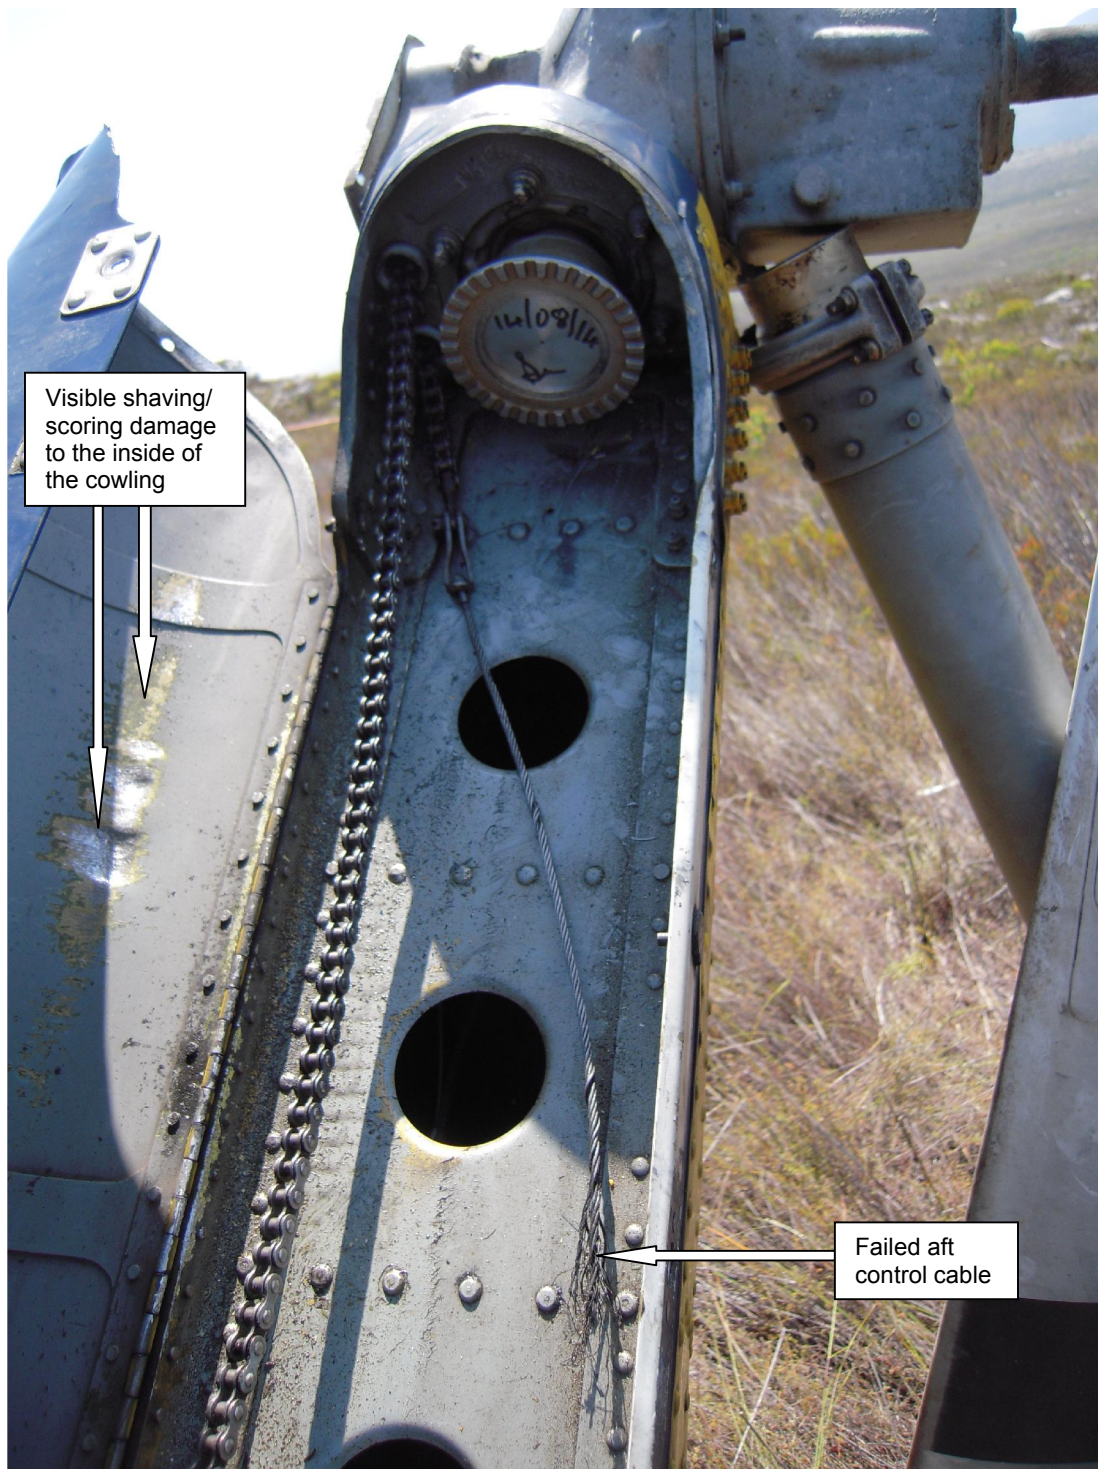
**Figure 16.** One end of the failed tail rotor control cable attached to the chain drive

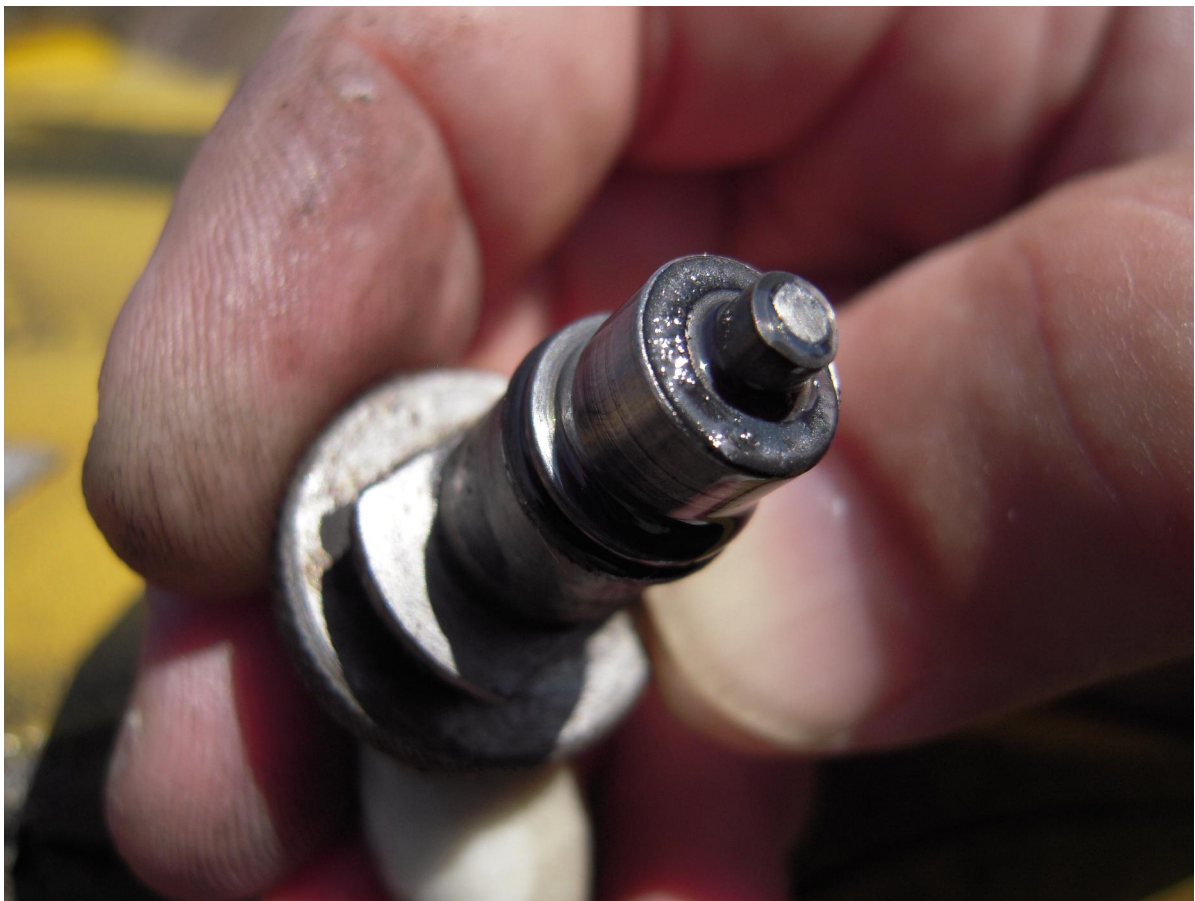
**Figure 17.** Magnetic plug on the 90° tail rotor gearbox removed during the on-site investigation

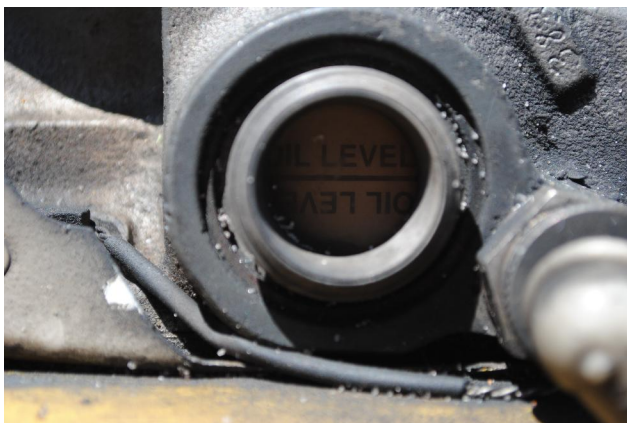
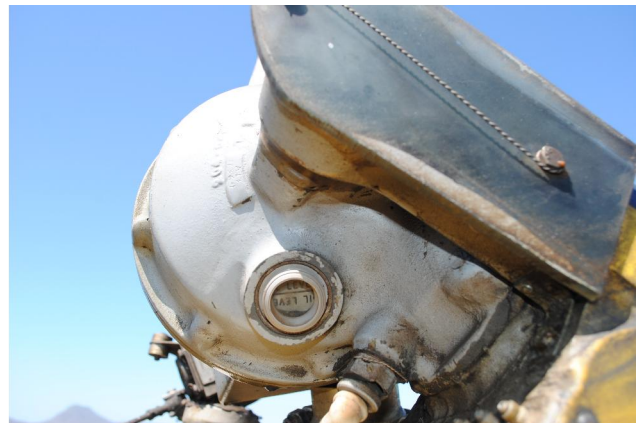
**Figure 18.** Oil sight gauges of the 42° gearbox (a) as well as the 90° tail rotor gearbox (b) with no oil visible in either

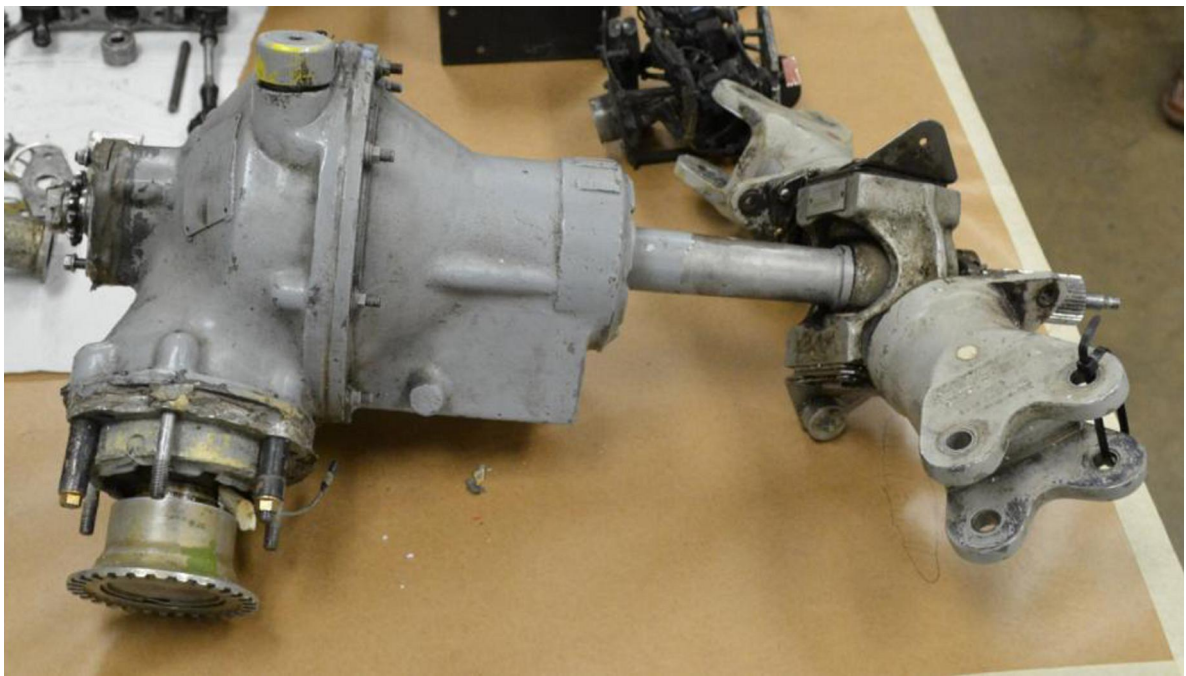
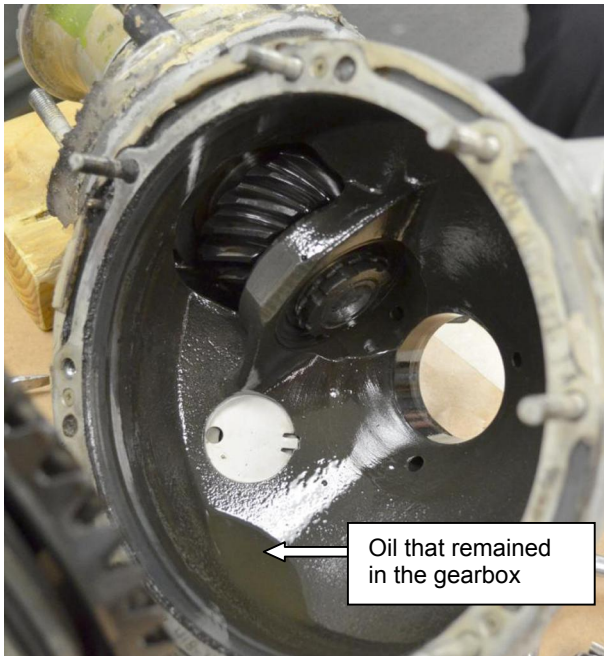
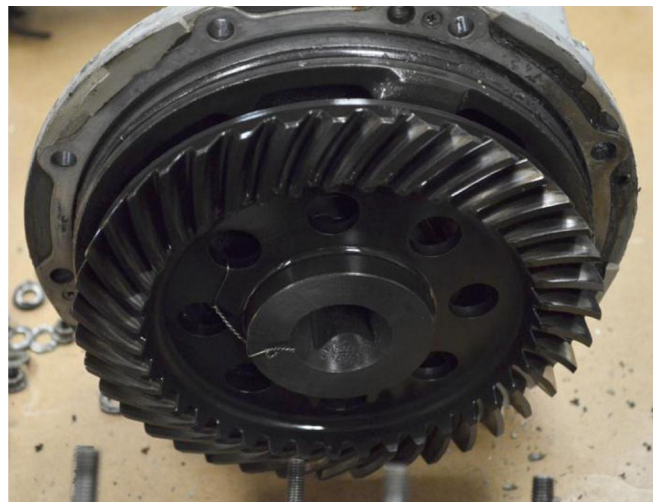
The 90° tail rotor gearbox and hub assemblies are shown in Figure 19. The input and output gears and bearings were free to rotate by hand. The magnetic chip detector was removed and no noticeable accumulation of chips was observed. Almost no oil was present in the gearbox. The temperature indicator on the input coupling was not discoloured. The tail rotor yoke and pitch change bearings were also free to move and rotate by hand.

**Figure 19.** The 90° tail rotor gearbox

The gearbox contained almost no oil.

All gears and bearing were free to rotate by hand.

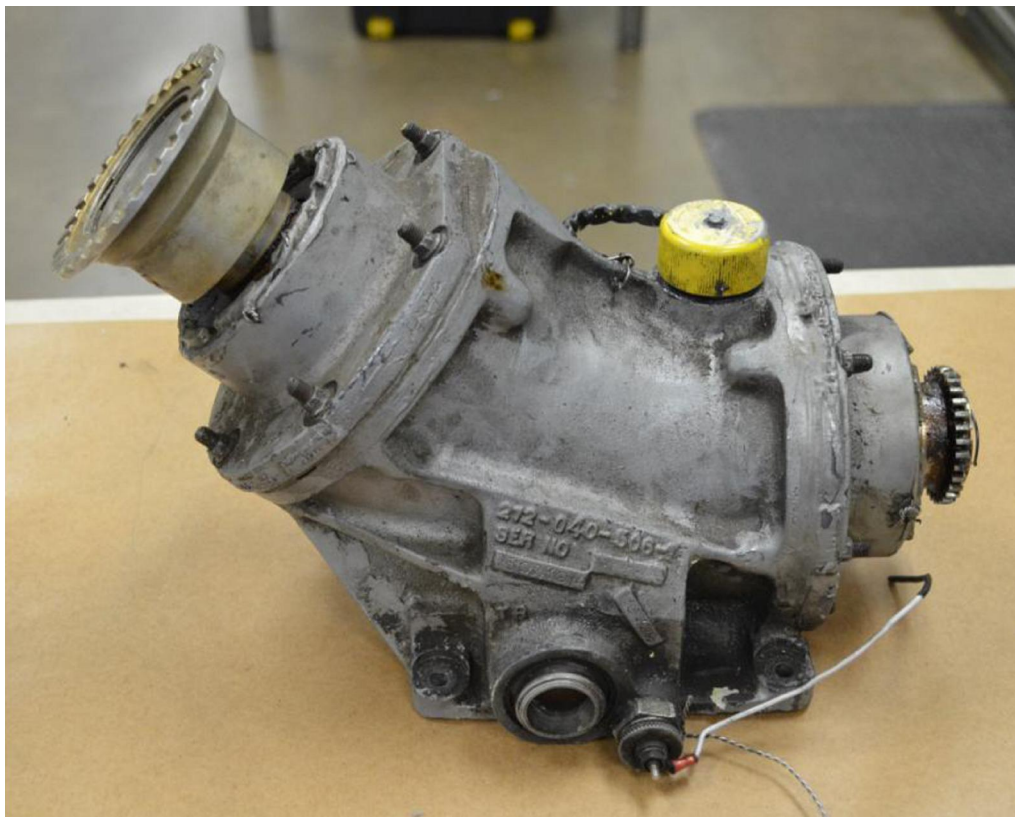
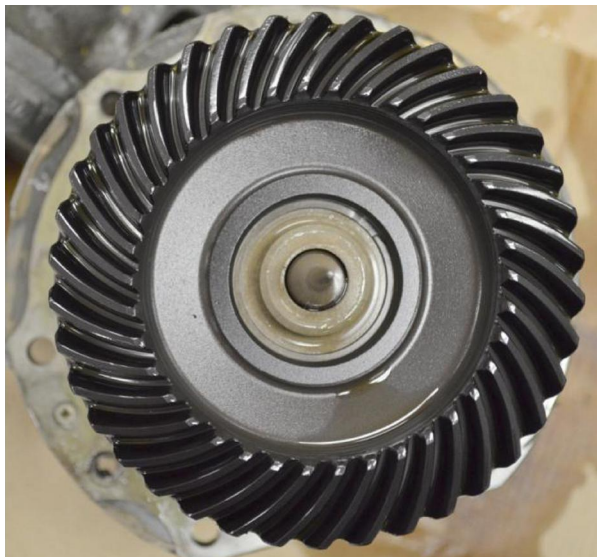
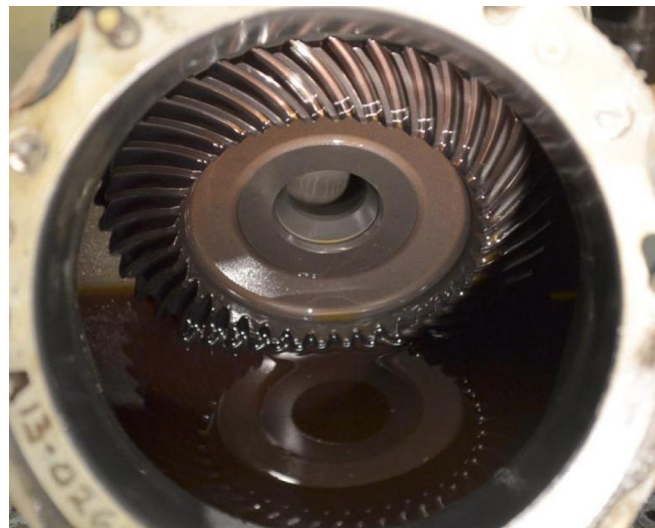
The 42° intermediate tail rotor gearbox is shown in Figure 20. The gears and bearings were free to rotate by hand. The magnetic chip detector was removed and no noticeable accumulation of chips was observed. The output quill assembly was removed from the housing. There was no noticeable damage to the gears of both input and output quill assemblies. The temperature indicator on the output coupling was not discoloured.

**Figure 20.** The 42° intermediate tail rotor gearbox

The gears and bearings were free to rotate by hand.

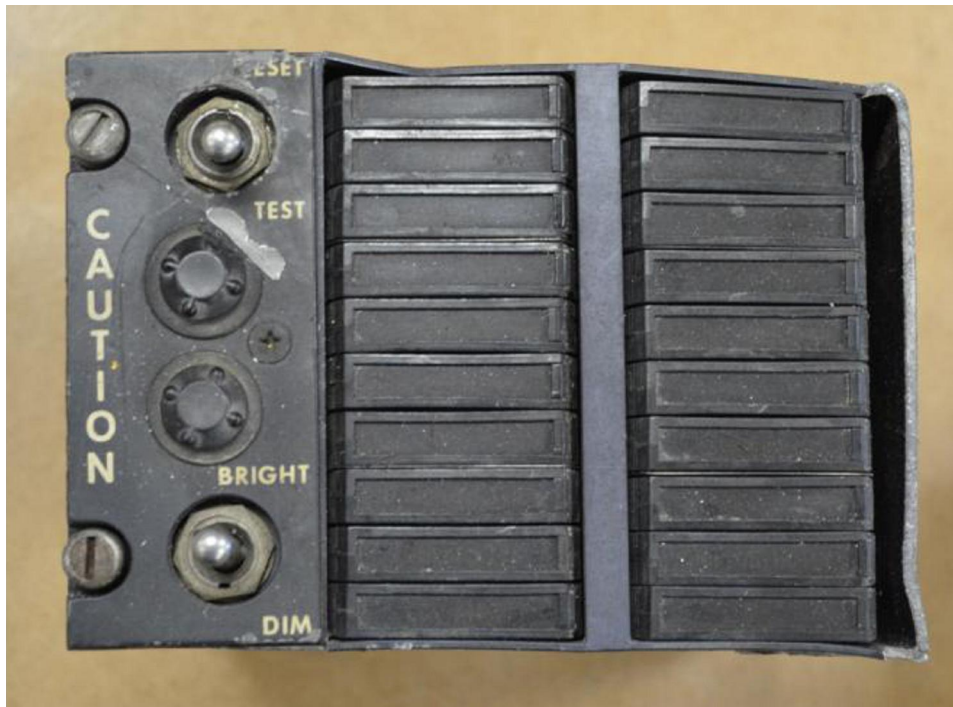
The master caution/warning indicator panel and the force trim, hydraulic control and chip detector indicator panel were examined as shown in Figure 21 and 22. Both these units were located in the cockpit and sustained fire damage. The hydraulic control switch was observed in the “ON” position. The light bulb filaments were examined to determine if any indicator lights were burning upon impact with the ground, such as the chip detector indicator lights. The tungsten filaments become ductile when hot and stretch, provided there is enough G-force. Examination of the

Figure 21. The master caution/warning indicator panel

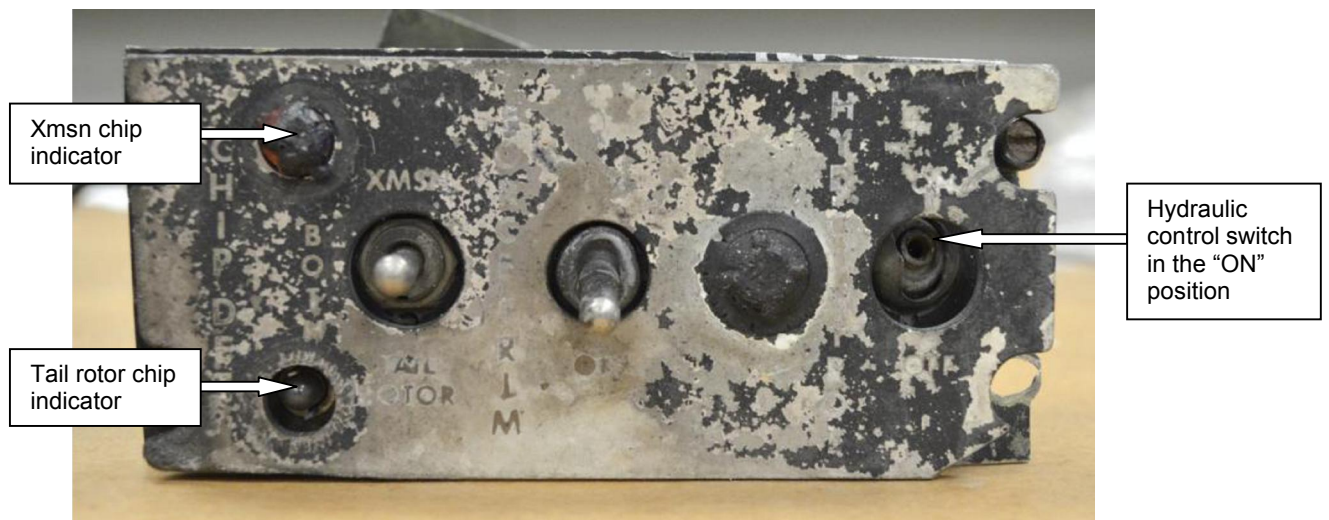
Figure 22. Force trim, hydraulic control and chip detector indicator panel
