<b>AIRCRAFT ACCIDENT REPORT AND EXECUTIVE SUMMARY</b>
---

Reference:	CA18/2/3/9420	
<b>Aircraft registration</b>	ZS-HBV	<b>Date of accident</b>	8 March 2015		<b>Time of accident</b>	1000Z
<b>Type of aircraft</b>	Garlick UH-1H (Helicopter)		<b>Type of operation</b>	Fire fighting		
<b>Pilot-in-command licence type</b>	Commercial		<b>Age</b>	71	<b>Licence valid</b>	Yes
<b>Pilot-in-command flying experience</b>	Total flying hours		10 970.7		Hours on type	227.6
<b>Last point of departure</b>	Newlands Forest Station, Western Cape					
<b>Next point of intended landing</b>	Cape Point National Park, Western Cape					
<b>Location of the accident site with reference to easily defined geographical points (GPS readings if possible)</b>						
Open field in the Cape Point National Park (GPS position: 34°15.771' South 018°25.101' East)						
<b>Meteorological information</b>	Surface wind: ±160°/10kt gusting 20kt, Temperature: 16°C, Visibility: + 10 km					
<b>Number of people on board</b>	1 + 0	<b>No. of people injured</b>	0	<b>No. of people killed</b>	1

<b>Probable cause</b>						
<p>The pilot was unable to regain control of the helicopter following a loss of tail rotor thrust, which was cause

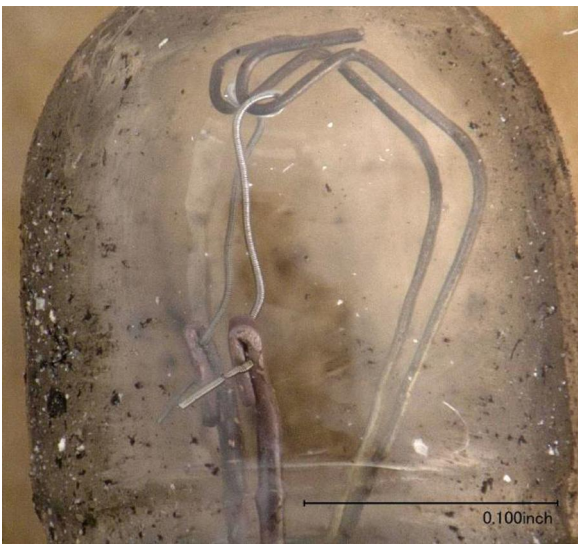
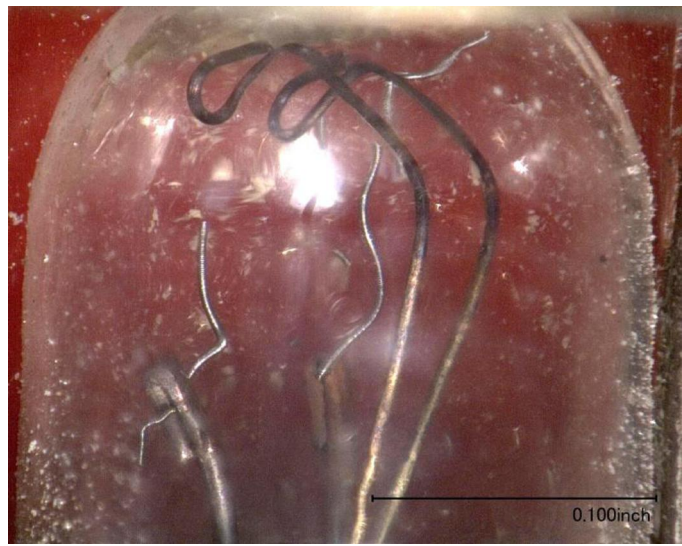
filaments revealed no stretching, which indicated no bulbs were burning during impact or there was not enough G-force to stretch any burning bulb filaments.

No stretching of the light bulb filaments from the tail rotor chip indicator (a) and the Xmsn chip indicator (b) was observed

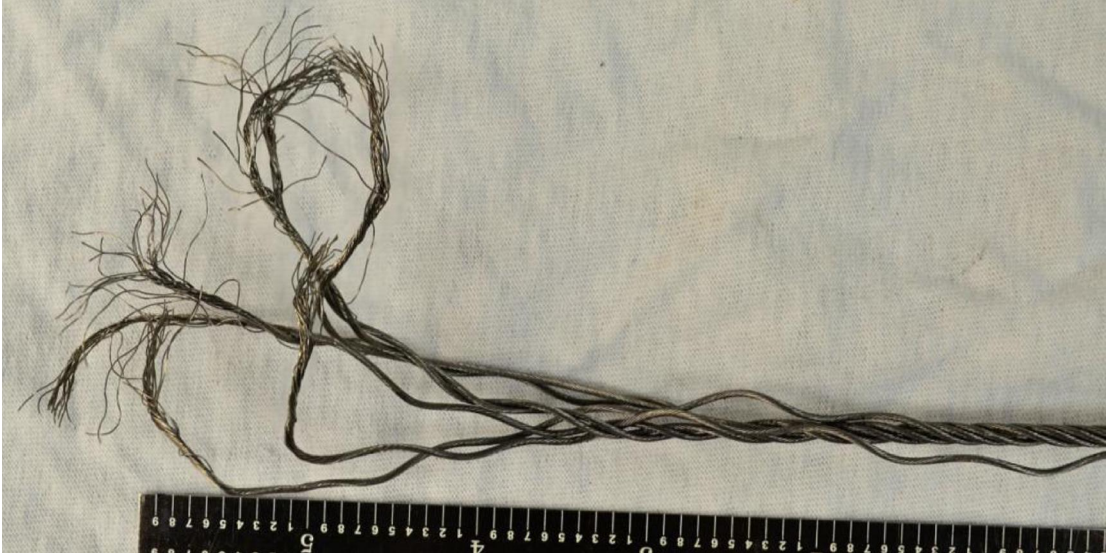
The forward right-hand control cable (Figure 24) and aft left-hand control cable (Figure 25) were received. Both these cables were fractured. The forward right-hand cable exhibited more unravelling at the fracture than the aft left-hand cable. This indicated that a relatively high energy event took place to fracture the forward cable, while a relatively low energy event fractured the aft cable.

**Figure 24.** Fractured forward right-hand control cable

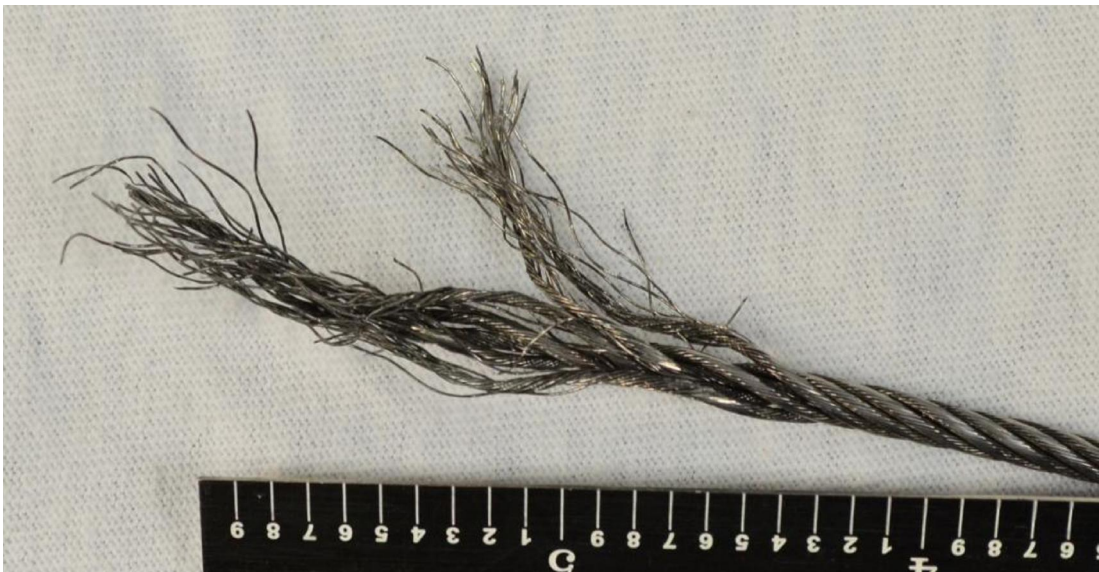
**Figure 25.** Fractured aft left-hand control cable

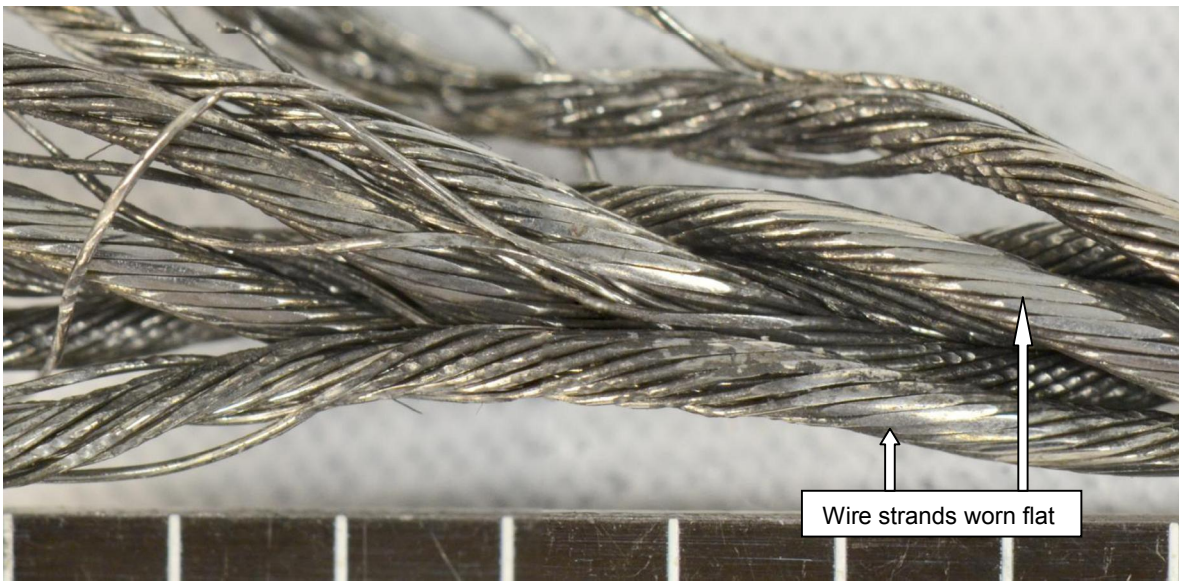
Closer examination of both right and left-hand aft cables revealed worn flat areas around the entire circumference of the outer surface (see Figure 26), which resulted from repeated contact with the pulleys. The aft cable fractured 32-34 cm (12.5-13.5 inches) from the forward end. The intact right-hand aft cable had a fractured wire strand protruding from it.

**Figure 26.** Close up view of the aft left-hand control cable showing the extent of wear

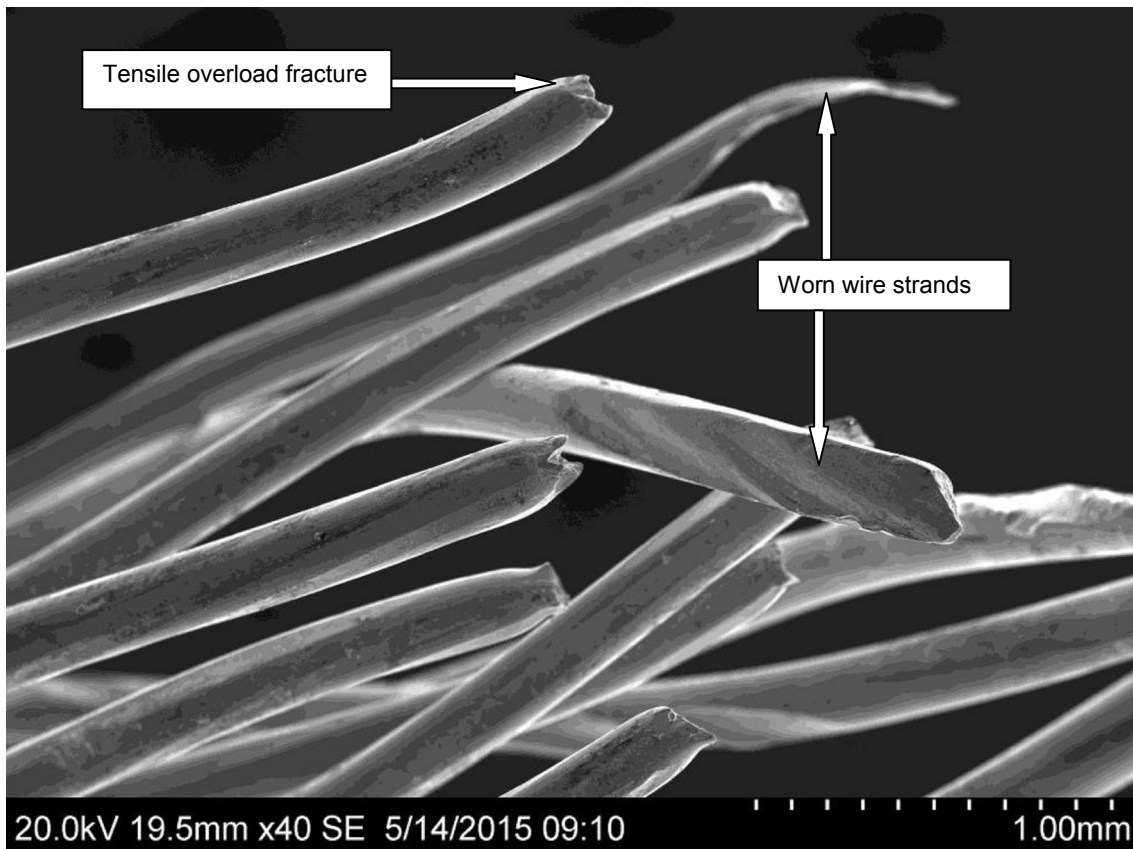
Figure 27 shows two fracture mechanisms of the left-hand aft cable wire strands. Approximately 92 of the 133 strands (7 bundles of 19 strands each) were worn completely through the wire thickness. Approximately 20 of the 133 strands fractured in tensile overload and approximately 21 strands fractured in overload that had roughly half the cross-sectional area worn away. An intact strand had an average diameter of 0.229 mm (0090 inches).

**Figure 27.** Scanning electron microscope photograph of wire strands displaying fractures due to wear

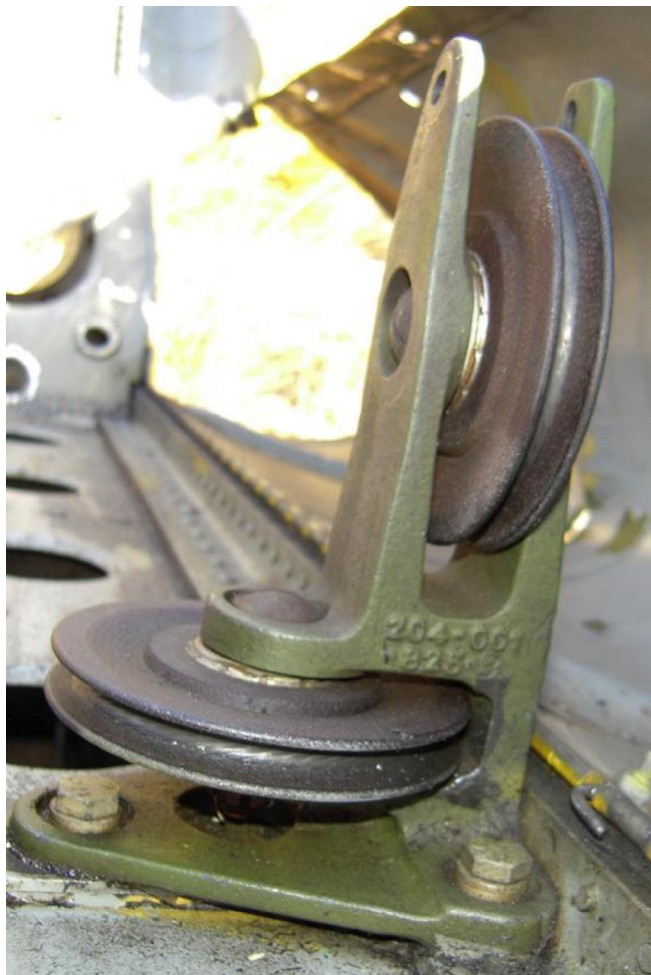
The pulleys were not received in the laboratory for inspection of the bearing condition. A seized pulley bearing would wear the control cable faster than a bearing that was free to rotate. The photograph in Figure 28 shows the condition of the pulley grooves for the aft control cables. A wear pattern that appeared similar to the braided cable was observed in the pulley grooves. The aft control cable that failed was supported by the lower (horizontally positioned) pulley.

**Figure 28.** The pulleys that supported the aft control cables

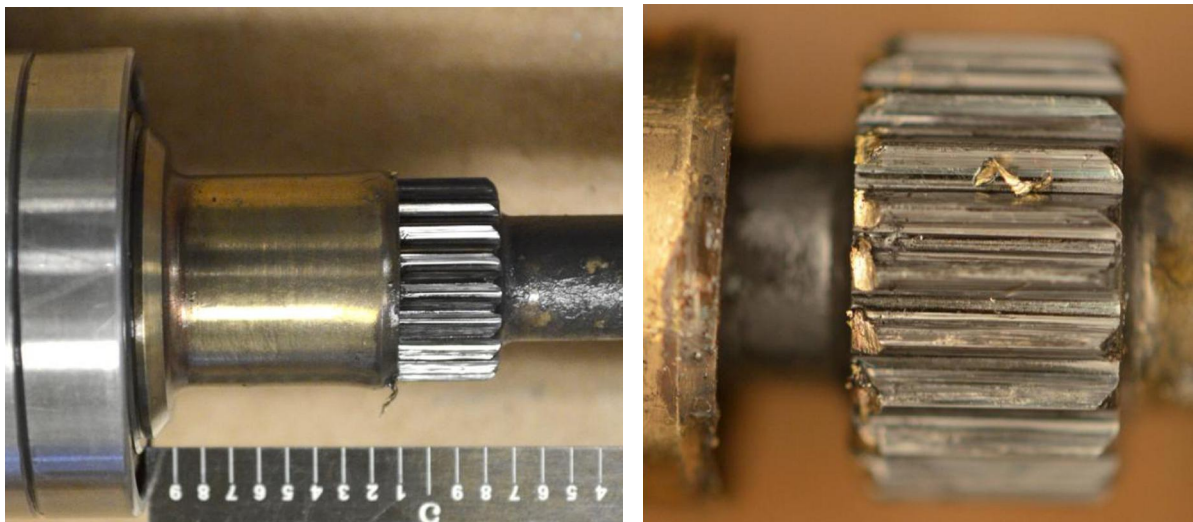
Removal of the control quill and control rod from the 90° tail rotor gearbox revealed that the pitch control rod slider spline jammed into the brass control nut as shown in Figure 29. This indicated that there was a significant force on the intact right-hand control cable after the left-hand aft control cable fractured from wear. The significant force was the main rotor blade strike to the forward end of the tail boom. During this event, the intact right-hand forward control cable drove the control rod into the brass control nut and fractured due to tensile overload. The control nut and rod had to be separated using a hydraulic press. The control rod threads, which retain the crosshead bearing, were sheared in the direction consistent with a significant force on the intact right-hand control cables (see Figure 30). Damage to the sprocket teeth was also observed.

**Figure 29.** The pitch control rod slider spline that was jammed into the brass control quill nut

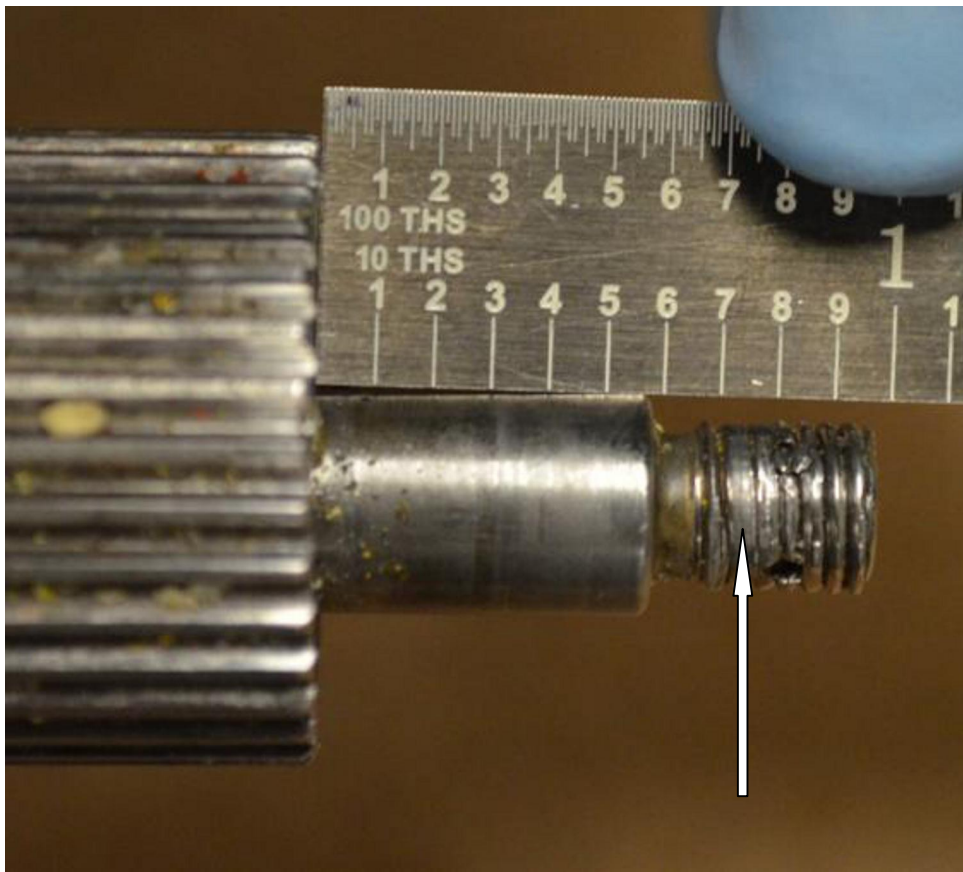
**Figure 30.** Pitch control with sheared threads that retained the crosshead bearing (see arrow)

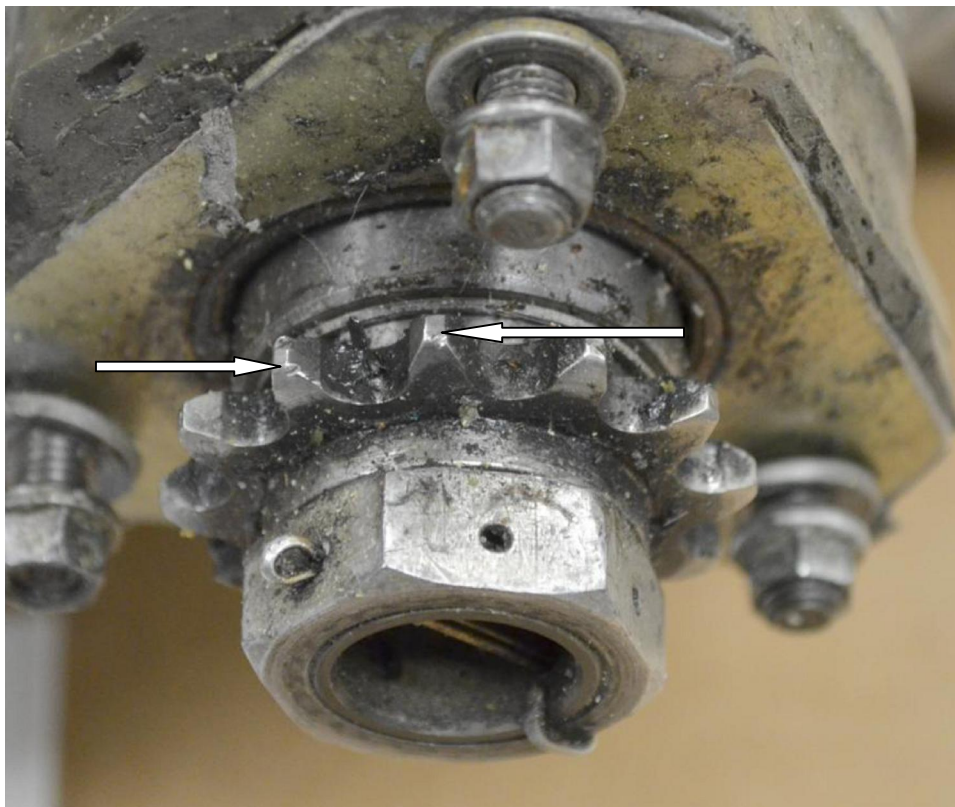
**Figure 31.** The sprocket teeth displayed mechanical damage (indicated by arrows)

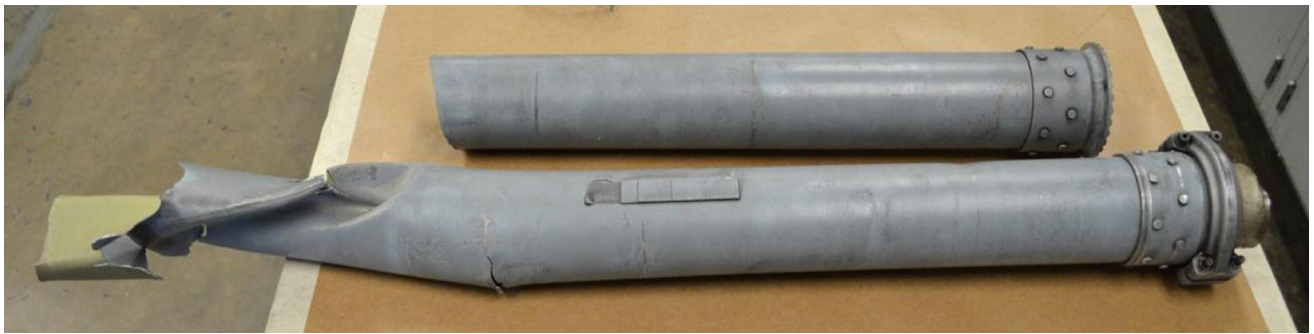
Figure 32 below shows the fractured tail rotor driveshaft, located just forward of the 42° intermediate gearbox, as received in the laboratory. Aft of the overload fracture was a twist in the driveshaft. The direction of twist indicated a sudden rotational stoppage in the drivetrain aft of the twist. It was reported that the tail rotor blades did not reveal any damage that could have contributed to the sudden stoppage. A photo of the wreckage showed that the female coupling attached to the fractured driveshaft was wedged between its mating male coupling attached to the 42° intermediate gearbox and the driveshaft enclosure. Damage observed on the female coupling and male coupling teeth confirmed this scenario after the female coupling was disengaged. This occurred after the left-hand aft control cable fractured and before the main rotor blade struck the tail boom.

**Figure 32.** The twist direction on the tail rotor driveshaft indicates a sudden rotational stoppage aft of the twist.

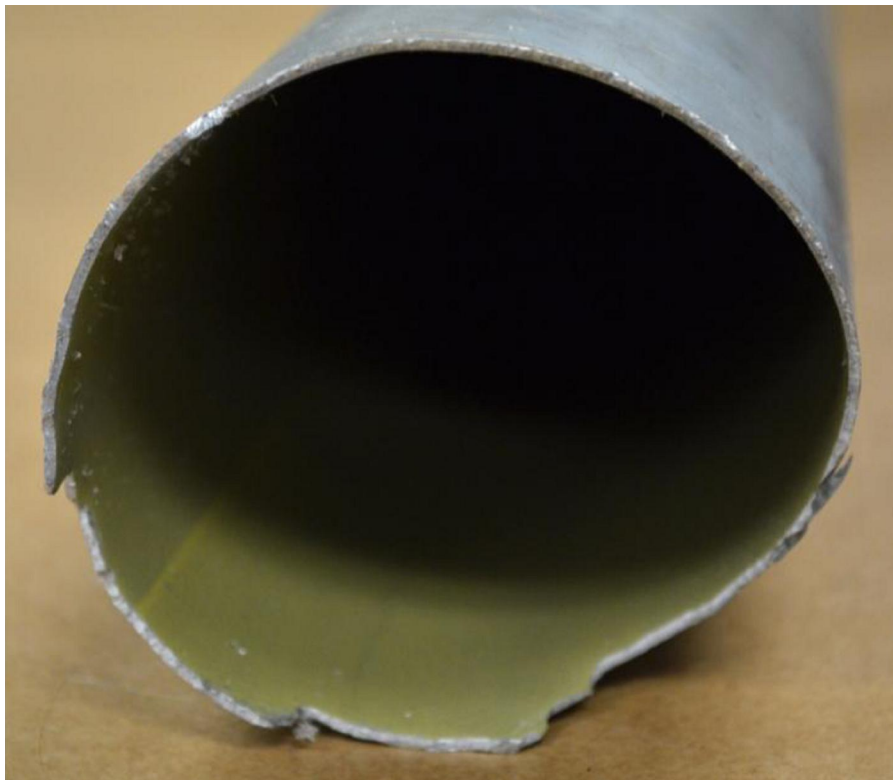
**Figure 33.** The fractured tail rotor driveshaft that failed in overload

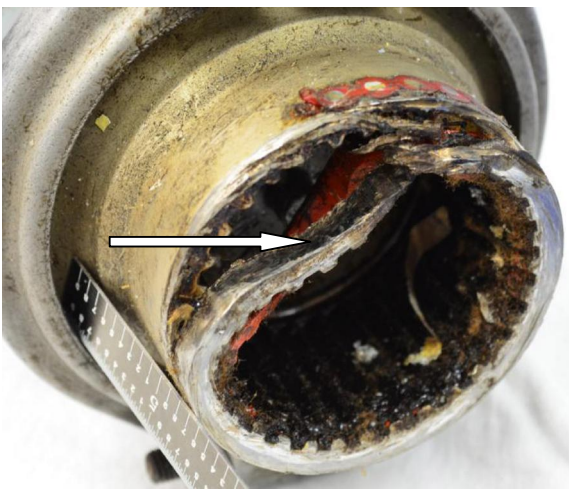
(a)

**Figure 34.** Contact with male coupling (see arrow)

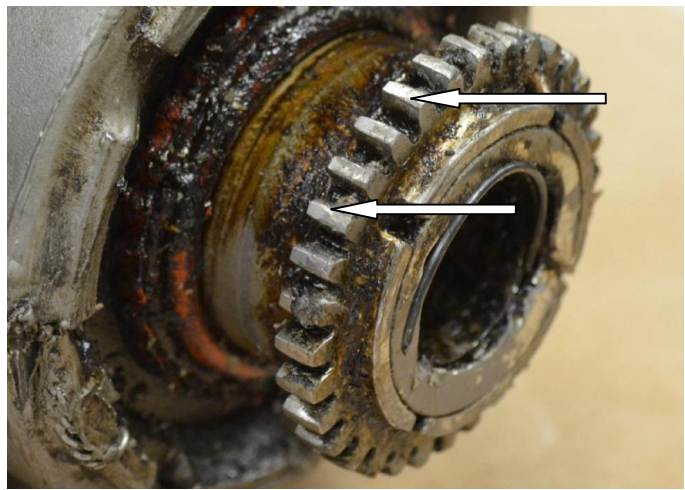
(b)

Damaged male coupling teeth (see arrows)

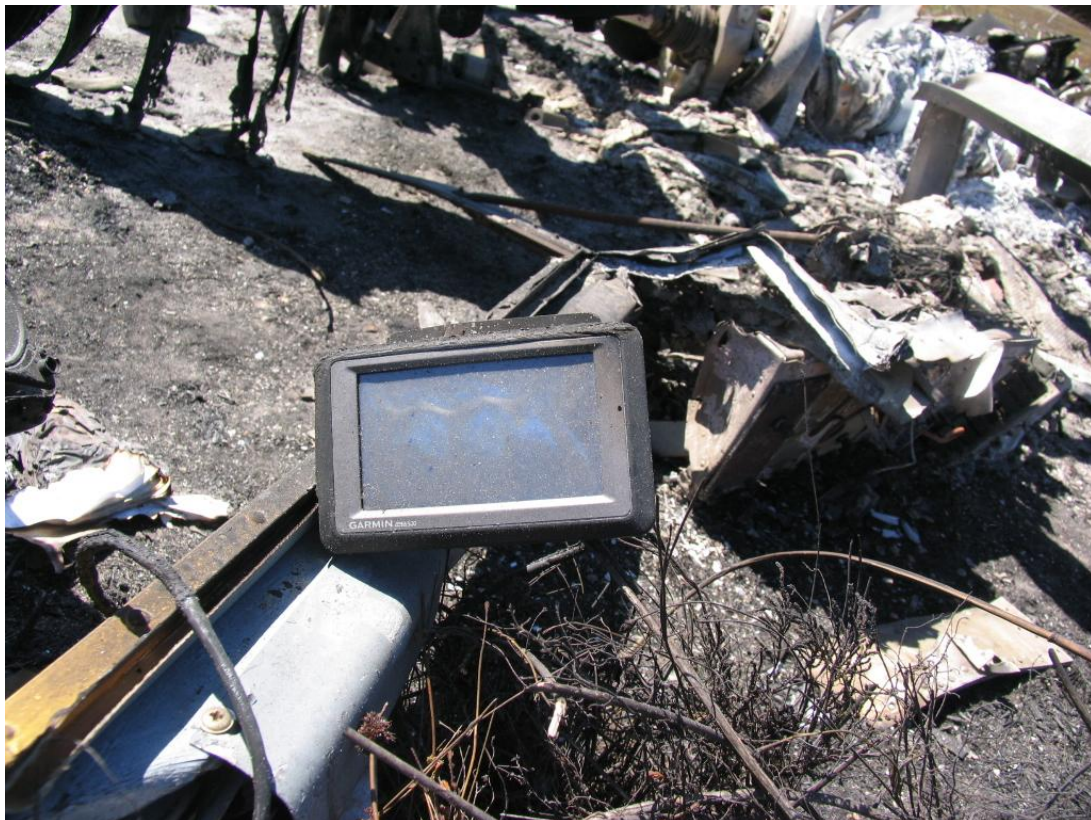
During the on-site investigation a Garmin Aera 500 GPS unit, which had sustained substantial heat damage, was recovered from the scene (Figure 35). The unit was forwarded to the National Transportation Safety Board (NTSB) Vehicle Recorder Division in Washington D.C in order to assist with the extraction of any possible data pertaining to the accident flight. The information contained below, including Figures 36 and 37, was extracted from the NTSB report.

**Figure 35.** The damaged Garmin Aera 500 GPS (taken during the on-site investigation)

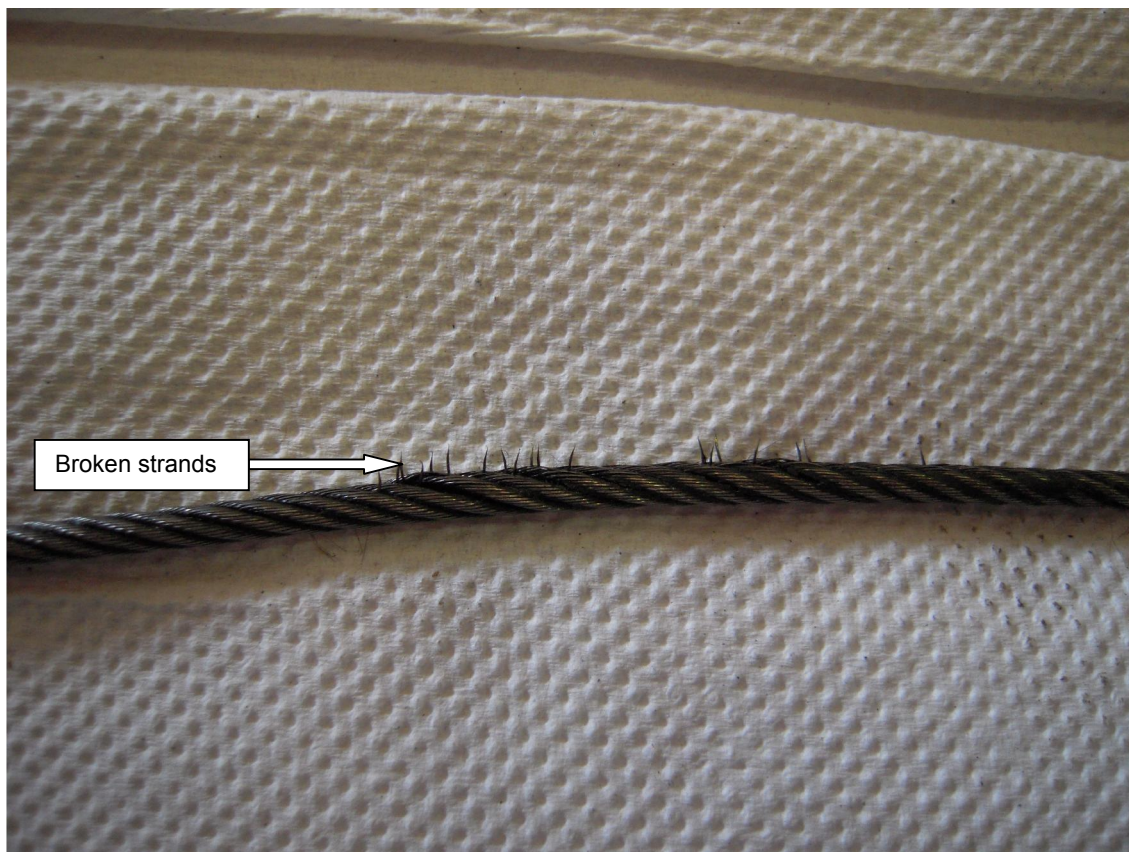
Routine maintenance requires a visual inspection of the control cables and their attachments. Maintenance personnel usually make use of a rag which they drag over the cable (if access allows such an action and if any wear on the cable is suspected). The rag will catch on the broken cable strands. The aft control cable on the UH-1H type helicopter was one of the cables that were accessible for a visual inspection to maintenance personnel following the opening of the tail rotor drive cowling as shown in Figure 15 on page 22 of this report. The aft control cable on this helicopter was between 8 to 13 feet from the ground. In order to inspect the cable an AME was required to make use of a proper maintenance stand or a long stepladder and open the tail rotor drive pylon cowling to gain access to the cables.

**Figure 39.** Several broken strands were visible on the aft control cable
