AIRCRAFT ACCIDENT REPORT AND EXECUTIVE SUMMARY

Reference:	CA18/2/3/9432	
Aircraft Registration	ZS-RBS	Date of Accident	17 April 2015		Time of Accident	1230Z
Type of Aircraft	Robinson R22 Beta		Type of Operation	Commercial		
Pilot-in-command Licence Type		Commercial (H)	Age	41	Licence Valid	Yes
Pilot-in-command Flying Experience		Total Flying Hours	7825.2		Hours on Type	3998.5
Last point of departure		Grahamstown aerodrome (FAGT): Eastern Cape province				
Next point of intended landing		Private air strip in Somerset East: Eastern Cape province				
Location of the accident site with reference to easily defined geographical points (GPS readings if possible)						
On a game farm south of Somerset East at GPS Co-ordinates: S32° 54' 56", E025° 21' 31"						
Meteorological Information		Wind direction: 180° at 10kts; Visibility: 10000ft; Cloud base: 8000ft				
Number of people on board	1+1	No. of people injured	2	No. of people killed	0	
Synopsis

AIRCRAFT ACCIDENT REPORT

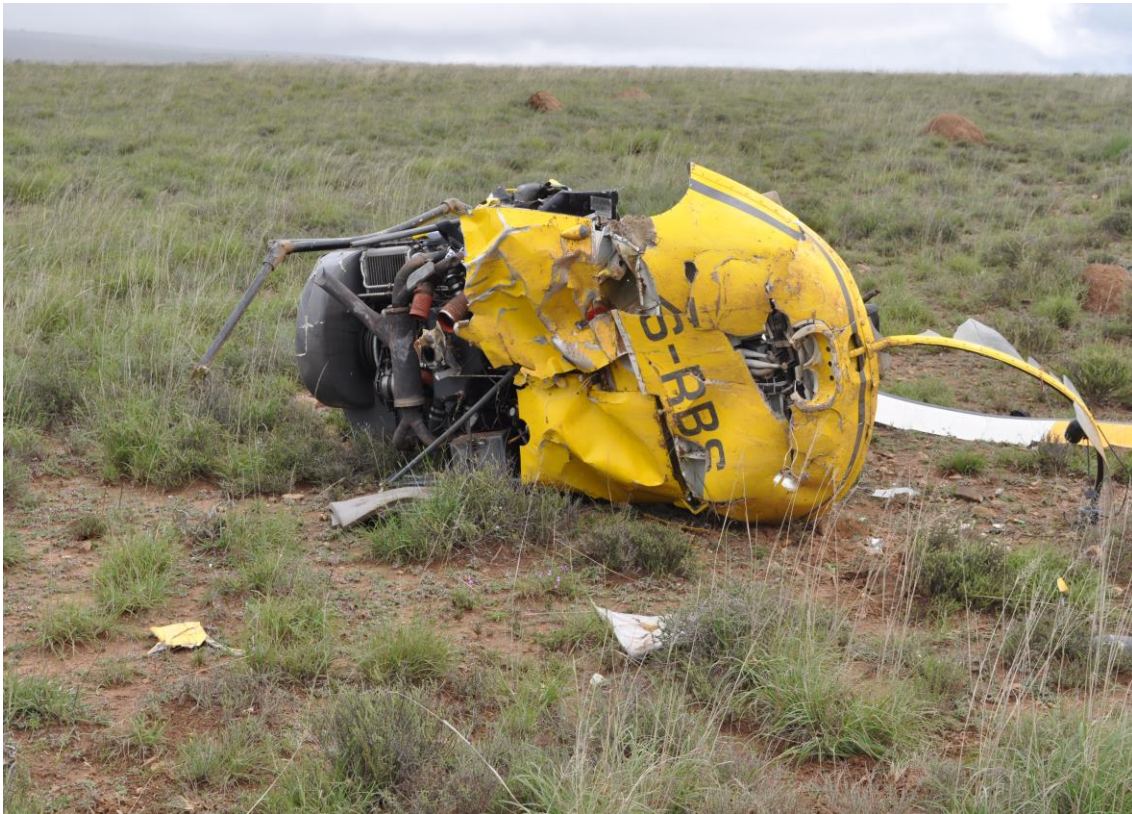
- 1.3.1 The helicopter was destroyed by impact forces during the accident sequence.

The photograph in Figure 1 below shows the damage sustained during the accident

Figure 1: The condition of the helicopter at the accident site

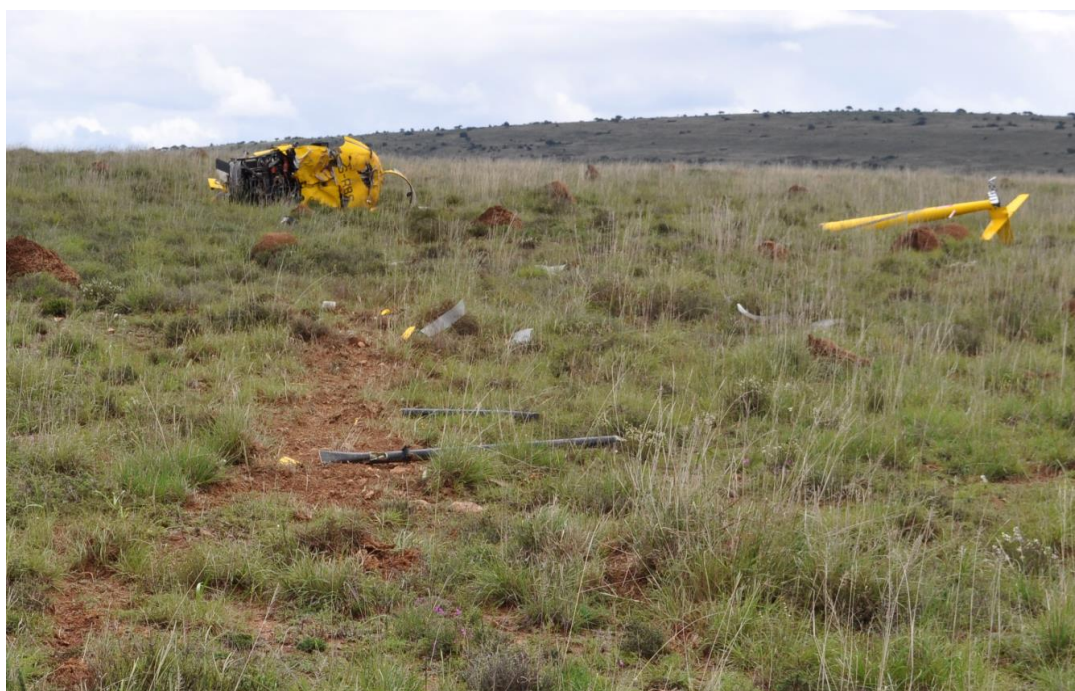
1.12.1 The area where the helicopter crashed is an open uneven surface with many

anthills. Ground marks were made during the post-impact sequence and these were identified and accounted for to obtain information on the accident sequence. The wreckage distribution was located within a radius of approximately 20 metres.

Figure 2: The accident site terrain

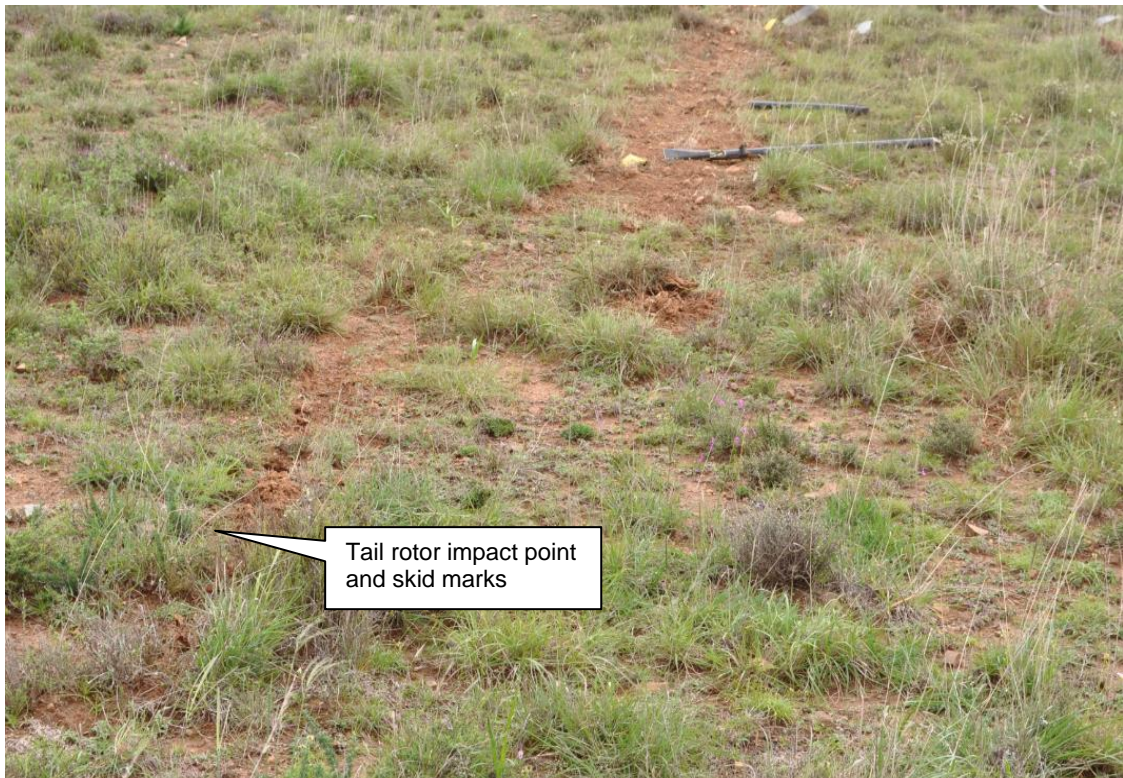
1.12.2 During game darting, the helicopter experienced loss of main rotor RPM, followed by a loss of height whilst at a hovering configuration. The pilot attempted to arrest the rate of descent by initiating the recovery procedure. He then pushed the helicopter nose forward with the cyclic control to gain lift but was unsuccessful. Because of the high rate of descent he realised that impact with the ground was imminent and he pulled the nose up to avoid a nose-first collision with the ground.

In the ensuing investigation, the ground marks resulting from the accident were studied. It was found that the tail boom of the helicopter first made a hard contact with the ground and this was followed by an impact by the skid which was hard enough to break it off. The main rotor severed the tail boom during the hard impact. The helicopter continued to roll over and was destroyed during the post-impact sequence.

Figure 3: Ground marks that show the sequence of impact
