<b>AIRCRAFT ACCIDENT REPORT AND EXECUTIVE SUMMARY</b>
---

Reference:	CA18/2/3/9433	
<b>Aircraft Registration</b>	ZU-UHI	<b>Date of Accident</b>	22 April 2015		<b>Time of Accident</b>	1405Z
<b>Type of Aircraft</b>	Bell 205 – UH-1H		<b>Type of Operation</b>	Fire Fighting - Part 137		
<b>Pilot-in-command Licence Type</b>		Commercial	<b>Age</b>	39	<b>Licence Valid</b>	Yes
<b>Pilot-in-command Flying Experience</b>		Total Flying Hours	2 914		Hours on Type	1 567.4
<b>Last point of departure</b>		Tulbagh Forestry Station (Western Cape)				
<b>Next point of intended landing</b>		Bains's Kloof Pass area (Western Cape)				
<b>Location of the accident site with reference to easily defined geographical points (GPS readings if possible)</b>						
Bains's Kloof Pass area (GPS coordinates: S33°36'30.68' E019°6'29.18') and a field elevation of 2026ft						
<b>Meteorological Information</b>		Surface wind: 045 <sup>0</sup> at 12-15 kt, Visibility: CAVOK				
<b>Number of people on board</b>	1 + 1	<b>No. of people injured</b>	0	<b>No. of people killed</b>	2

**Name of Owner** : FFA Assets (Pty) Ltd  
**Name of Operator** : FFA Aviation (Pty) Ltd  
**Manufacturer** : Bell Helicopter Textron  
**Model**

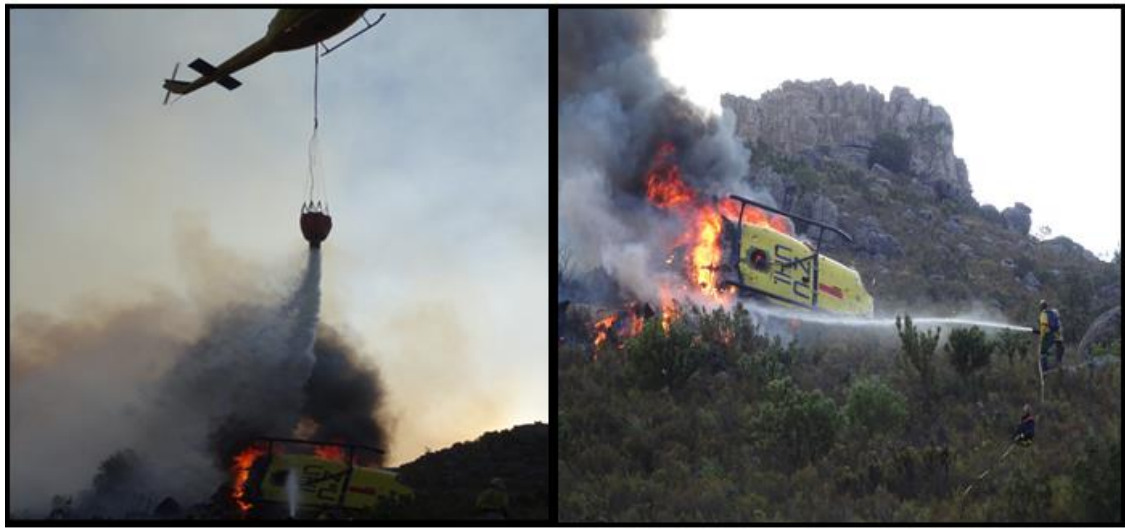
**Figure 2:** ZS-HBU helping the ground fire team to extinguish the ZU-UHI post-impact fire

1.1.3 The fire-fighting operations were stopped in order to assist with extinguishing the fire of the burning helicopter and rescue the occupant. The helicopter ZS-HBU was requested to fly to the crash site to drop its load on top of the burning ZU-UHI helicopter. The fire-fighting ground crews also assisted with the extinguishing of the fire and they were successful in suppressing it. Both occupants were fatally injured as a result of the accident. The HSL sustained fatal injuries as a result of impact forces and the post-impact fire. The pilot suffered fatal injuries as a result of impact forces. The helicopter wreckage was further destroyed by overnight veld fire.

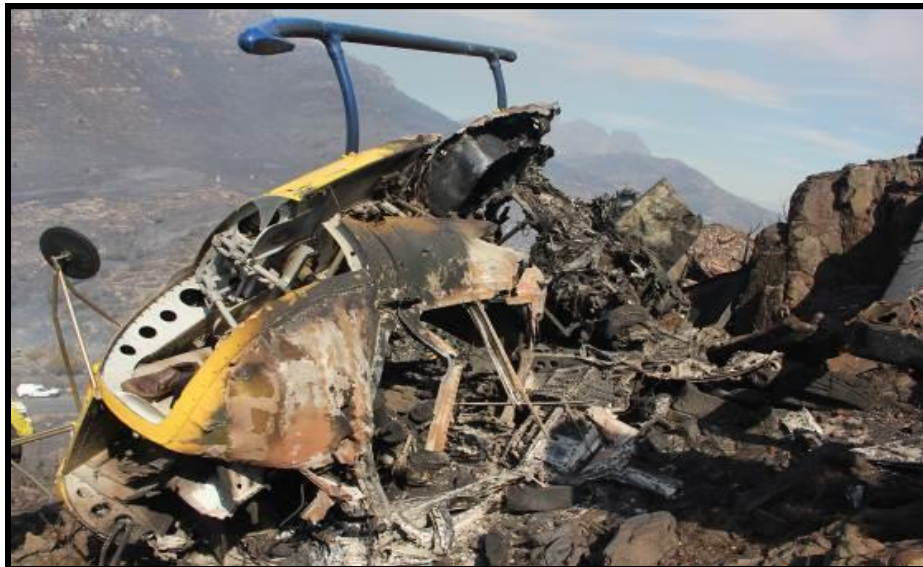
**Figure 3:** Damage to the helicopter

1.3.1 The helicopter was destroyed by impact forces and post impact fire which was extinguished and by the overnight veld fire which father destroyed the helicopter.

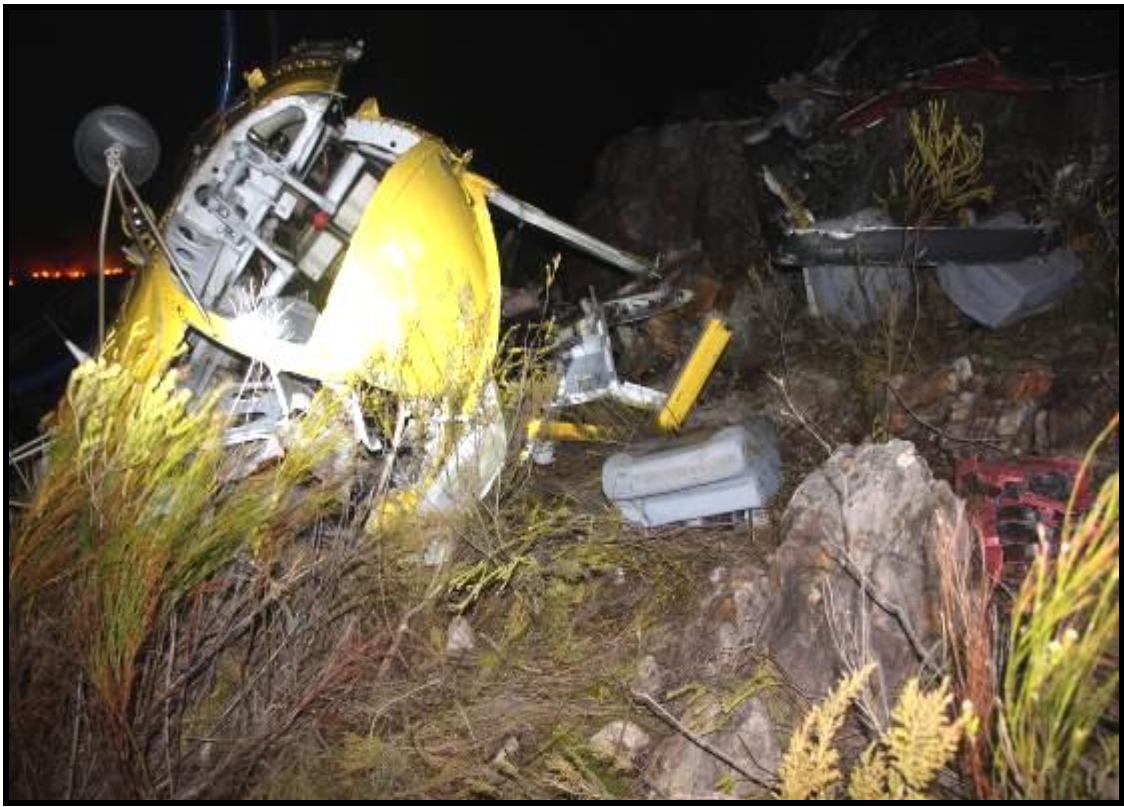
**Figure 8:** The helicopter before it was destroyed by veld fire overnight

- The fuselage was destroyed, and the seats and some of the instrument panel components had been thrown out. The damage was consistent with the helicopter impacting hard with the terrain.

- Figure 8 shows the helicopter wreckage lying on its left-hand side following successful post-impact fire suppression. Helicopter debris was scattered around within a radius of 5 m.
- The helicopter wreckage was destroyed by both impact forces and fire (post impact and veld).

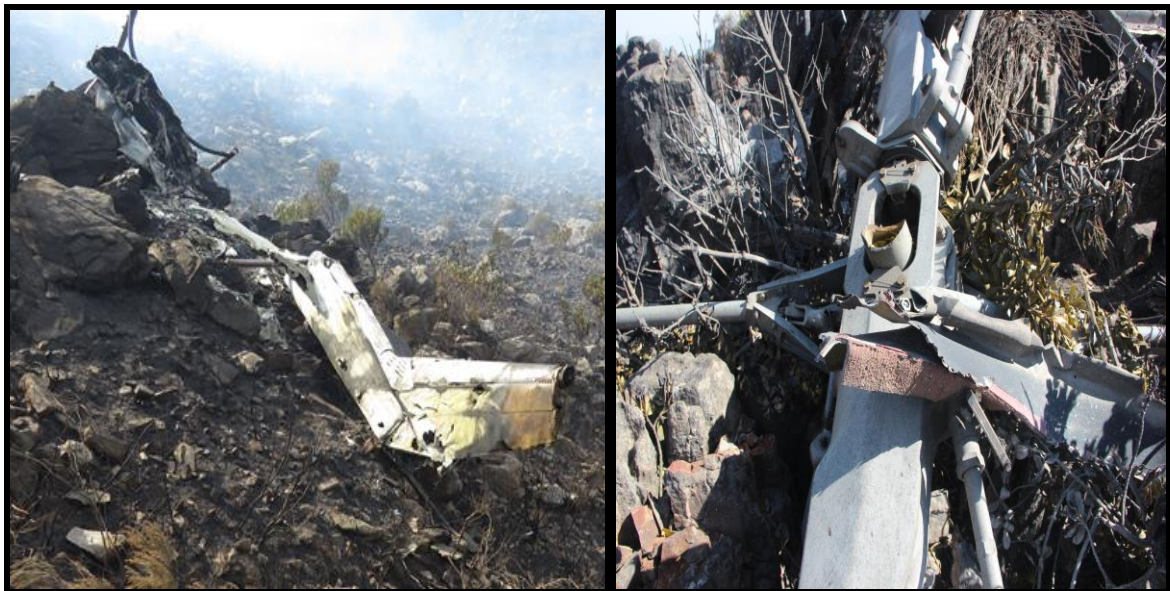
**Figure 9:** The damaged tail boom and tail rotor blade respectively.

- The tail-boom was destroyed by both impact forces and fire.
- The tail rotor assembly and the tail rotor blades separated from the helicopter.

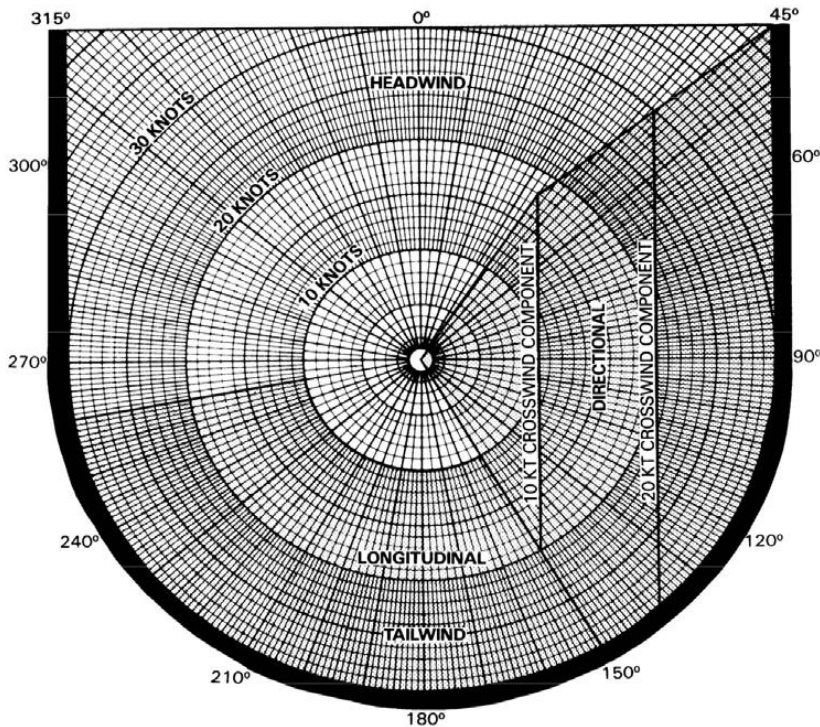
Figure 10: Control Margin Transitional Flight

1.16.2 The investigation identified that the aircraft was approaching to land at low speed in to a 12-15kt wind. The aircraft was turned left exposing the tail rotor to a cross wind component which could have led to the loss of tail rotor effectiveness. The chart below indicates the limits of the cross wind components. Cross wind within the shaded area of the chart could drastically affect the pilot's ability to control the aircraft.

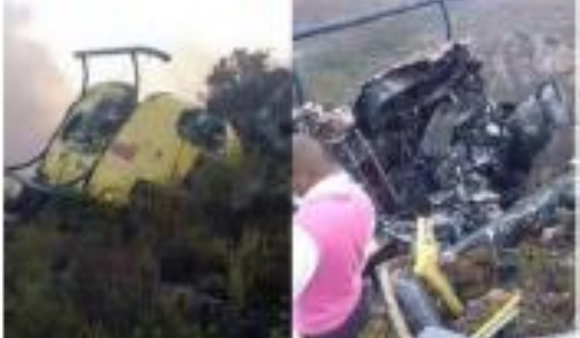
Photo 2: Impact site

1.3. The Bell UH-1H aircraft was involved in a Cat 5 accident. Post impact fire damages were caused by a secondary veld-fire and not by impact (Photo 2).

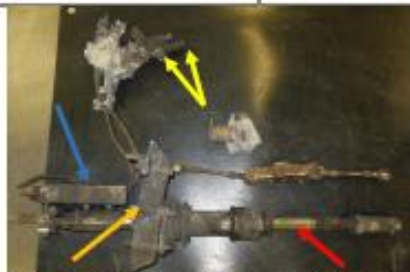
Photo 5: As received condition of Hydraulic Servo assy. (digital)

The visual inspection of the as-received Hydraulic Servo unit (Diagrams 1, 2 and 3: Red dashed squares; Photo 5) revealed a fractured attachment bracket (orange arrow) and extensive post-impact fire damages with a clear indication of the servo jack position after impact (Photo 6, red arrow).

The supplied hydraulic feedlines and connectors revealed extensive external fire damages (Photo 5, yellow arrows) but no clear indications of internal blockages. No seals and/or O-rings survived for inspection.

- 8.1. ITEM 1: Taking into account the negative effects of hydraulic support failure towards the controllability of the aircraft as well as the complexity thereof, it is recommended that the Main Rotor hydraulic assist system in its totality be exposed to a detailed inspection, if possible.

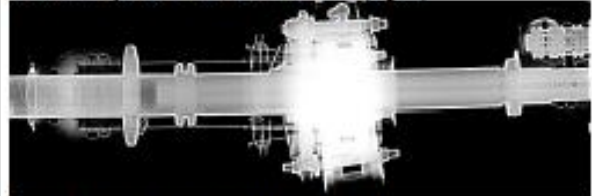
Photo 12: Hydraulic Servo Assembly (X-ray)

The Hydraulic Servo assembly was exposed to a -x-ray inspection prior to final teardown (Photo's 12, 13, 14 and 15). No clear indications of blockages, fractures or other discrepancies were noted.

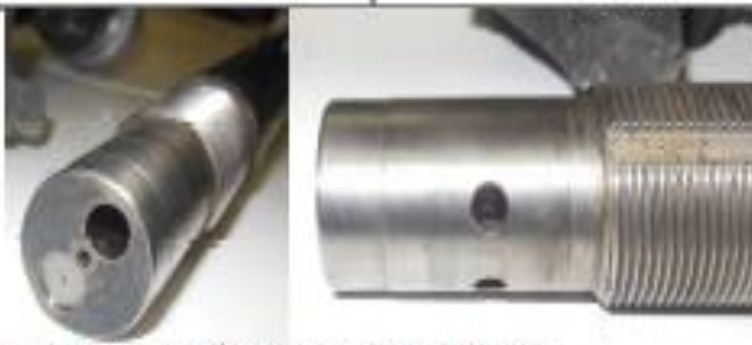
Photo 18: Feed holes – Control Tube (digital)

The Hydraulic Control Valve (Photo 17) and Control Tube Internal hydraulic feed lines (Photo 18) revealed no clear indication/s of obstruction and passed a low-pressure flow test.

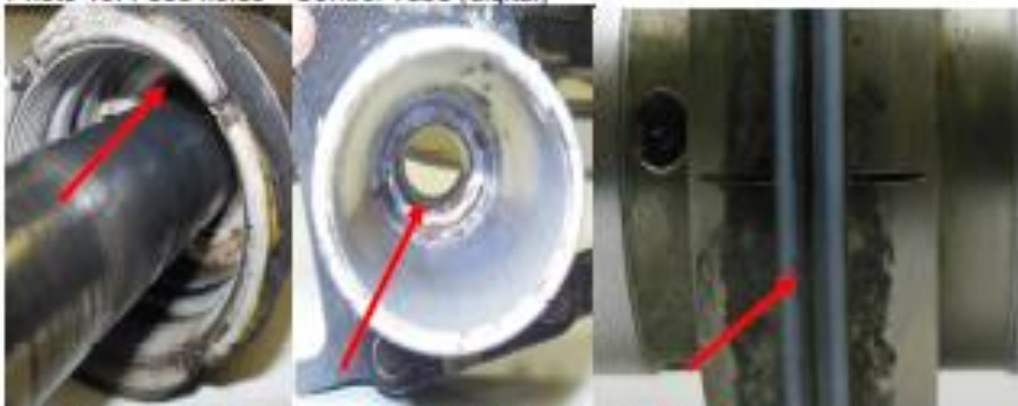
Photo 20: Hydraulic seal conditions – 3x positions – Control Tube (digital)

All three hydraulic seals (Photo 19, red arrows) proved to be in good condition with no clear indications of fractures, excessive wear or collapse.

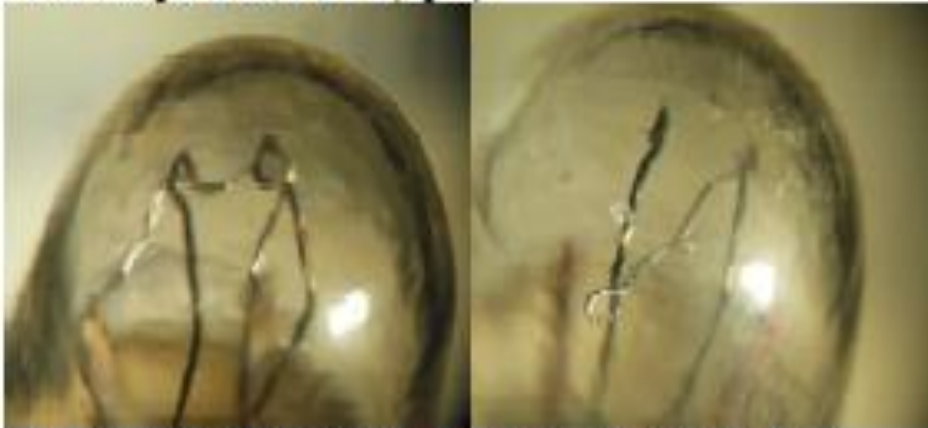
Photo 25: Hydraulic Pressure – light bulb filament condition (stereo)

Inspecting the HYD PRESSURE warning indicator bulbs in isolation proved that the filament fractured under low temperature conditions signifying that it was inoperative at the time of impact.
