Incident Final Report

State File Number: I13940227EPMNI
Type of Occurrence: Incident
Date of Occurrence: 17 May 2015
Place of Occurrence: Republic of Armenia
Aircraft Type: A300B4-600
Registration: EP-MNI
Operator: MahanAir
Date of Issue: 15 July 2016

State File Number: I13940227EPMNI
Type of occurrence: Incident
Date of occurrence: 17 May 2015
Place of occurrence: "Zvartnots" International Airport (UDYZ) .Republic of Armenia
Aircraft Model: A-300B4-603
Registration: EP-MNI
Operator: Mahan Air

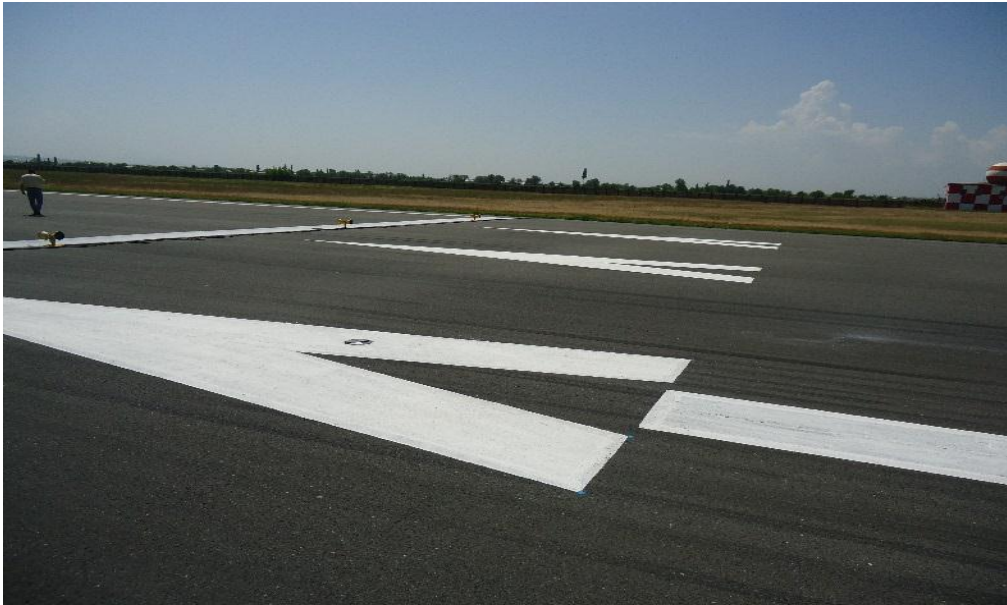
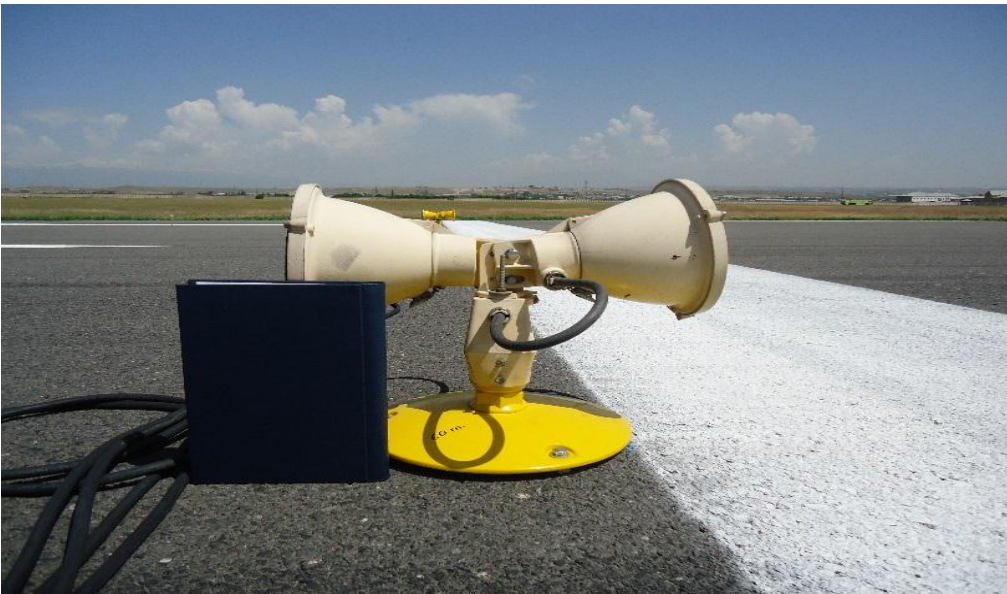
There was a lined threshold sign marking with elevated lights on the displaced threshold with ended white chevrons on beginning of RWY 09.

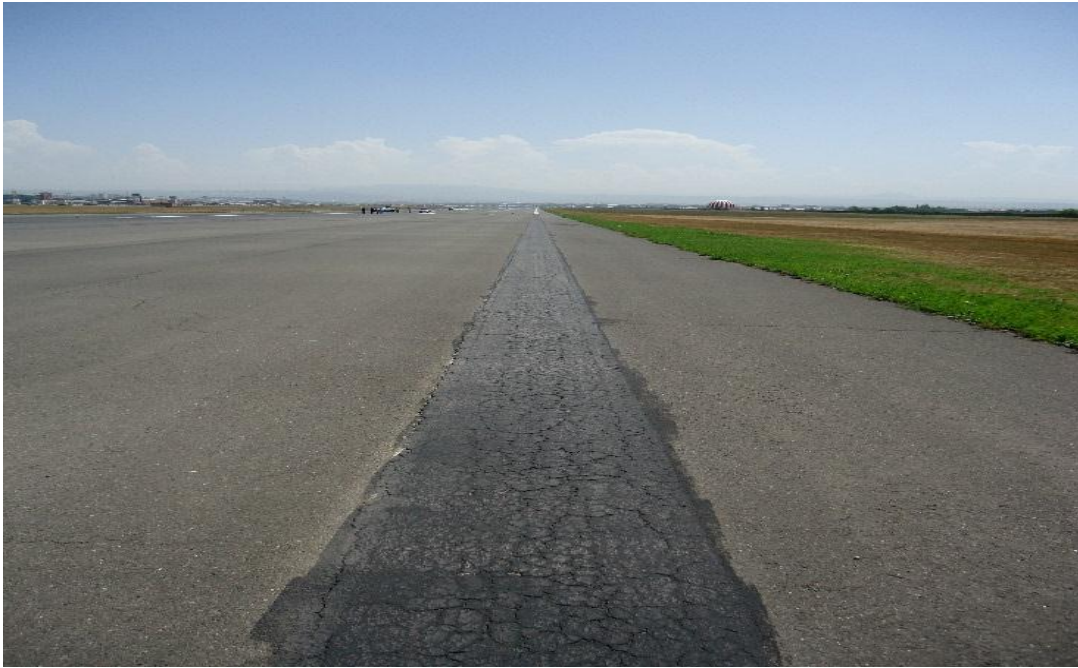
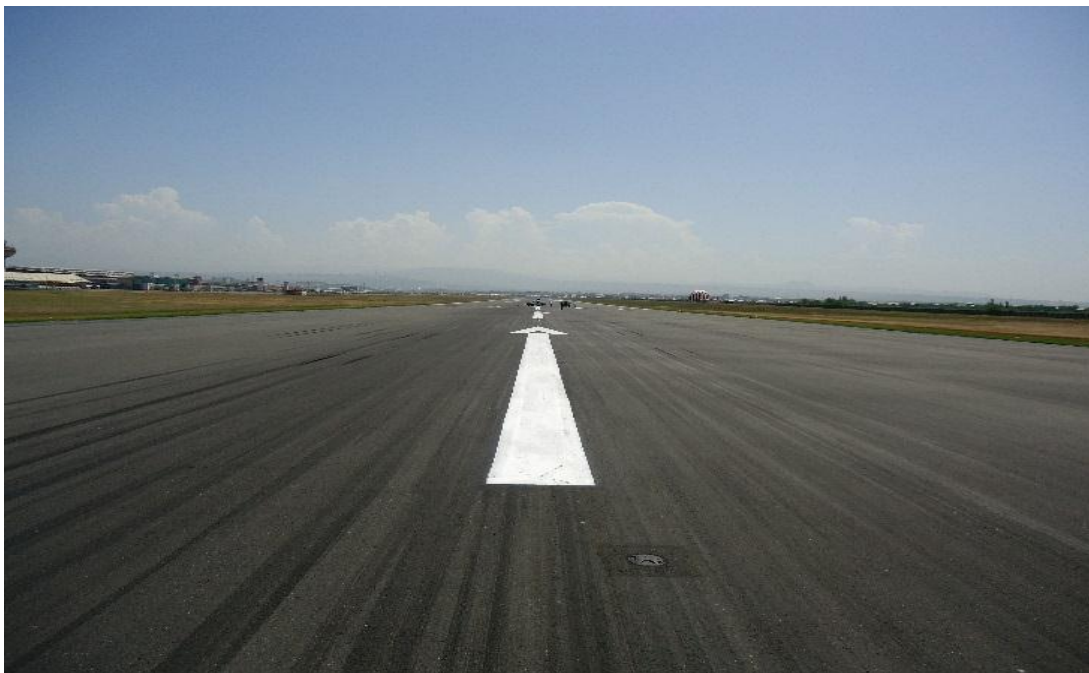
On the beginning of the displaced area, there was a row of elevated lights which used as approach lights. In this area, the edge line of RWY before displaced threshold was covered by black color. While displacing of this runway, closed marking signs in displaced area could help pilot to distinguish more about displaced area.

Although considering those mentioned matters for the real root cause of the incident; there were not enough closed marking signs before threshold lights to prevent landing in this unauthorized displaced area according standard criteria in Annex14. It was recommended in annex 14 that:

7.1.1 A closed marking shall be displayed on a runway or taxiway or portion thereof which is permanently closed to the use of all aircraft.

7.1.2 **Recommendation.**— *A closed marking should be displayed on a temporarily closed runway or taxiway or portion thereof, except that such marking may be omitted when the closing is of short duration and adequate warning by air traffic services is provided.*

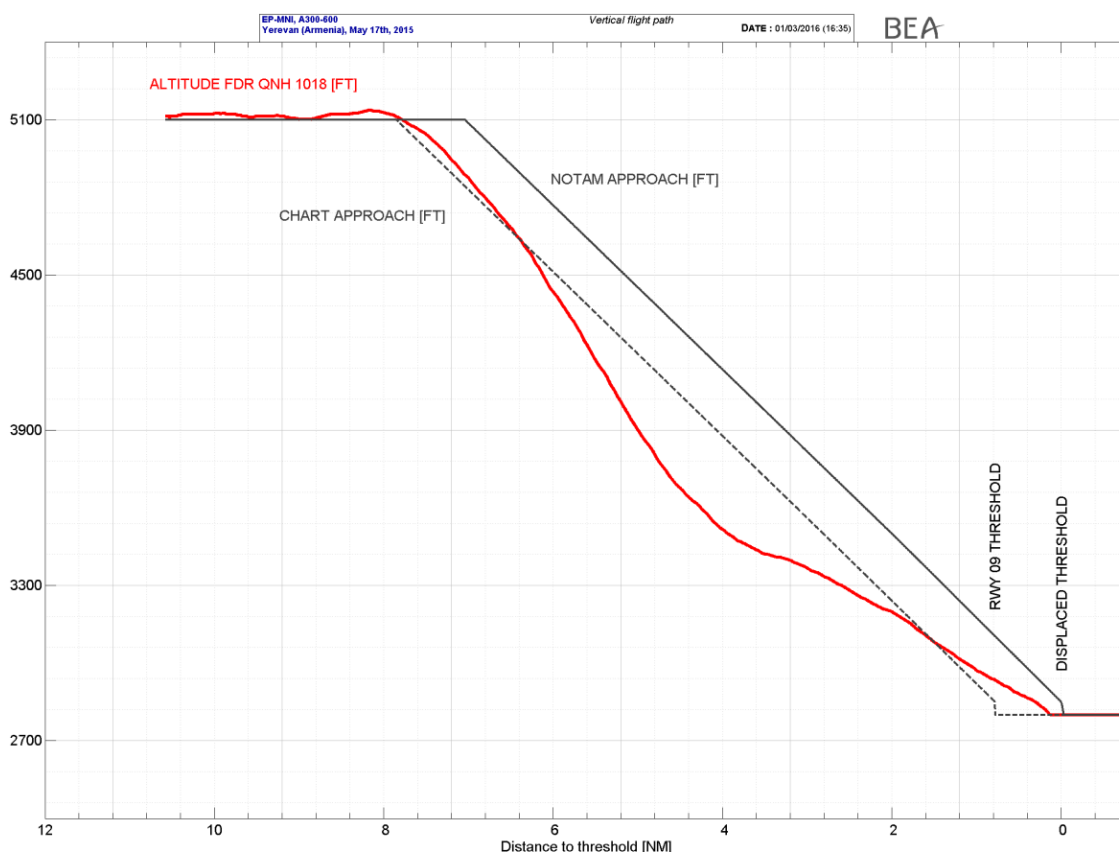
A vertical flight path was computed from recorded pressure altitude and distance to the displaced threshold. On the following plot, FDR altitude values were corrected with QNH 1018 and levelled to 2800 ft when recorded below 2800 ft.

The flight path is compared to the approach path described in the NOTAM and the approach path of the approach chart (dashed line).

With this correction, the flight should be level off from 5100 feet about 7 DME from the threshold but the pilot began it from 8 DME according to JEPPESEN available approach chart in his IPAD and the text of NOTAM was not considered by the pilot so he made VOR/DME approach chart for RWY 09 based on uncorrected chart. While the pilots were informed about displaced runway , the pilot decided to continue flight at visual approach and use maximum length of the shorten runway so the flight path shows below glide path. Since provided NOTAM have not been read completely by the cockpit crew, so they were not fully informed about the situation mentioned in the NOTAM

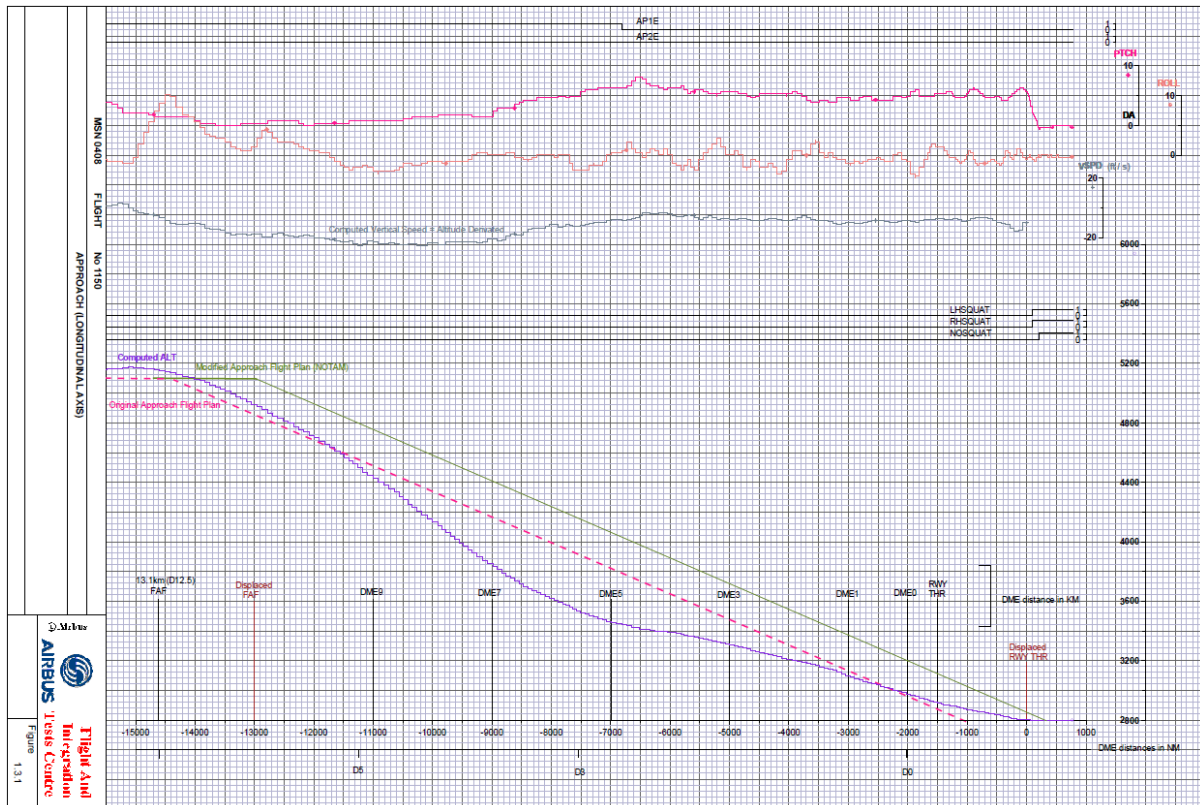
The flight safety office of the Airbus Co. also performed a vertical flight path computation which has similar results.
