AIRCRAFT ACCIDENT REPORT AND EXECUTIVE SUMMARY

Reference:	CA18/2/3/9447	
Aircraft Registration	ZU-BMS	Date of Accident	7 June 2015		Time of Accident	0630Z	
Type of Aircraft	Windlass Trike		Type of Operation	Training			
Pilot-in-command Licence Type	Student		Age	27		Licence Valid	Yes
Pilot-in-command Flying Experience	Total Flying Hours		36.8		Hours on Type	27.5	
Last point of departure	Kroon airfield, Gauteng province.						
Next point of intended landing	Kroon airfield, Gauteng province.						
Location of the accident site with reference to easily defined geographical points (GPS readings if possible)							
The accident happened in bushy terrain on the base leg for Runway 11 at Kroon airfield (GPS position S 25°39'46" 027°59'33").							
Meteorological Information	Wind: Calm, Visibility: 10 000m, Temperature: 8°C, Dew point: 1°C, Cloud cover: Clear sky.						
Number of people on board	1	No. of people injured	0	No. of people killed	1		
Synopsis	<p>The student pilot took off from Runway 11 at Kroon airfield on a solo training flight. After flying a circuit he executed a landing which was uneventful.</p> <p>During his second circuit, when turning on the cross-wind leg for Runway 11

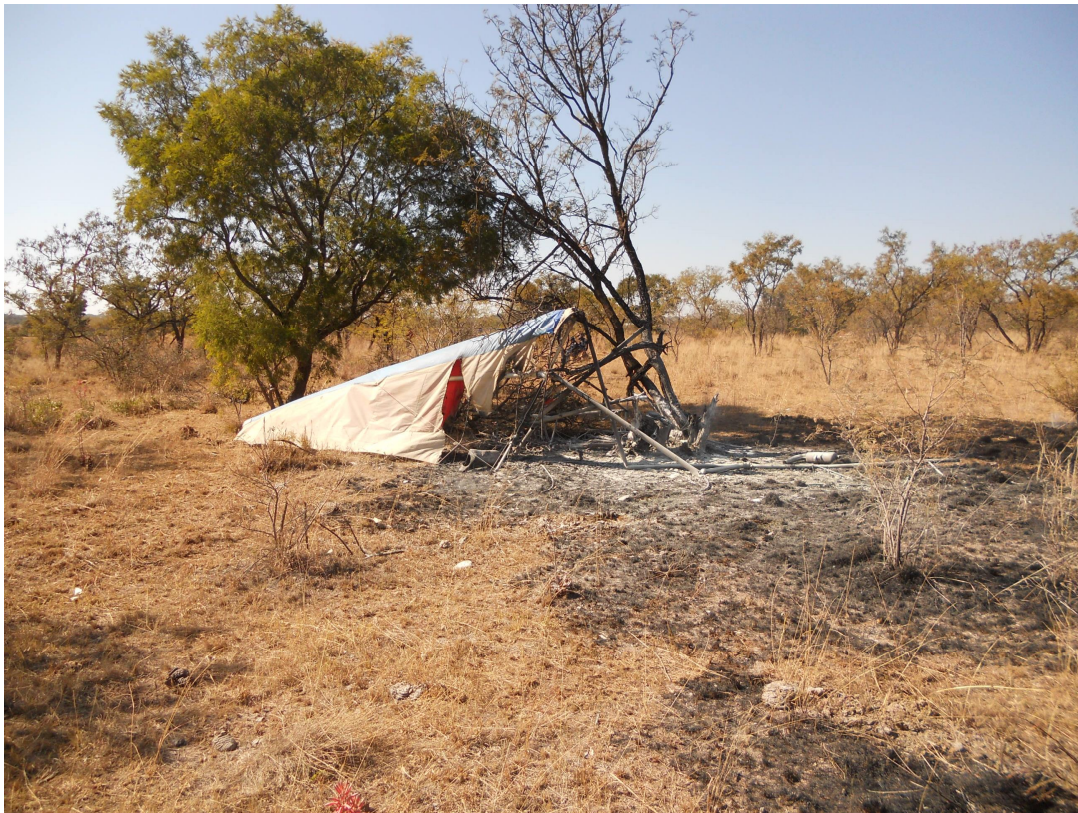
- 1.12 On arrival, he saw the wreckage of the aircraft engulfed in flames. He and a worker from the flight school tried to extinguish the post-impact fire but to no avail.

Figure 1. Position of the wreckage as it came to rest.

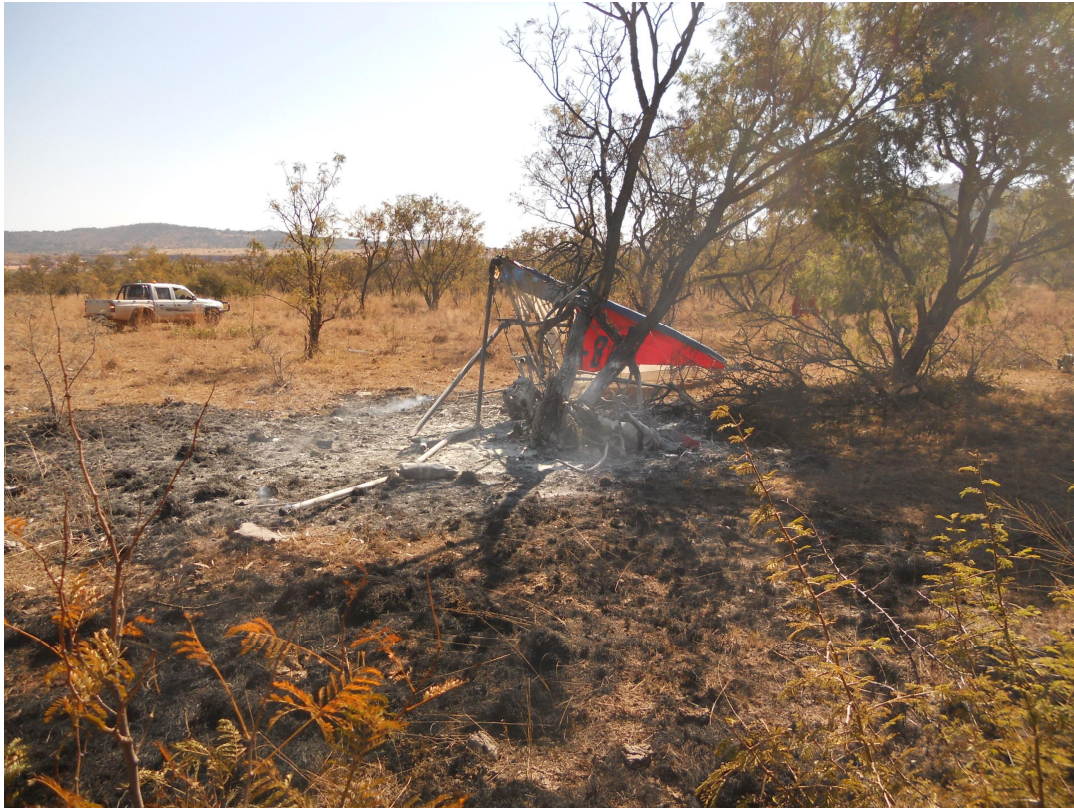
1.3.1 Apart from the left wing, the aircraft was destroyed by the post-impact fire. People at the scene tried to extinguish the fire with hand- held fire extinguishers but to no avail.

Figure 2 The wreckage.

1.12.1 The carriage (cockpit area), including the engine and the right wing was significantly crushed during the impact sequence and was destroyed by the post-impact fire. The left wing was folded around a tree but still attached to the right wing frame.

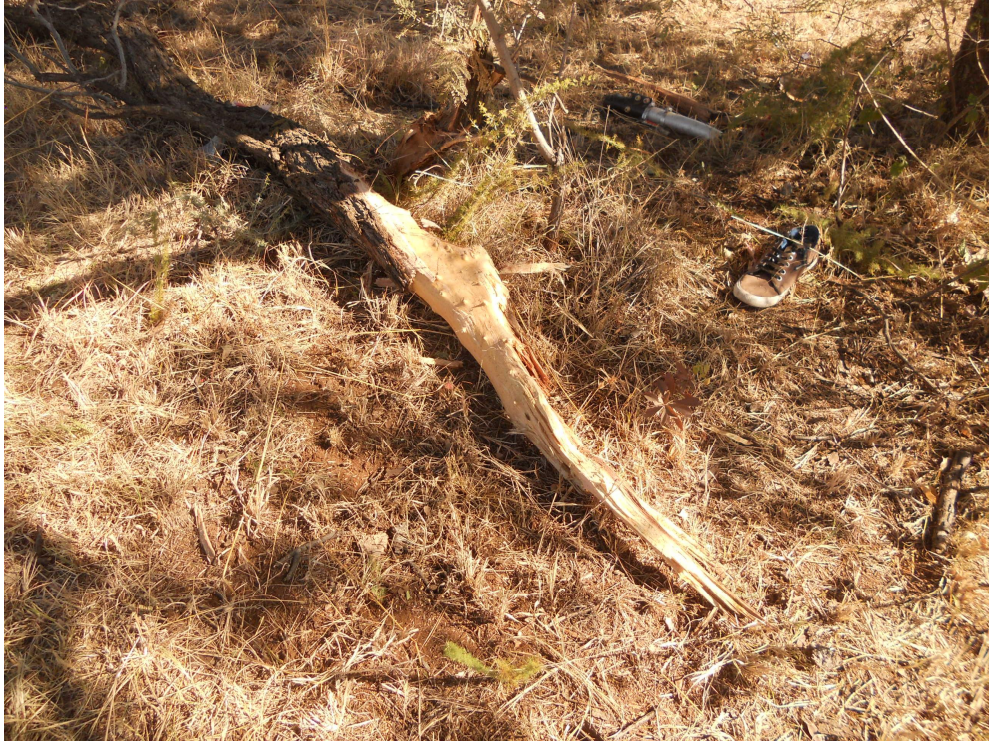
1.4.1 The main impact was with a tree, resulting in damage to the tree, and the post-impact fire damaged the surrounded vegetation.

Figure 3 Broken branches from the tree.

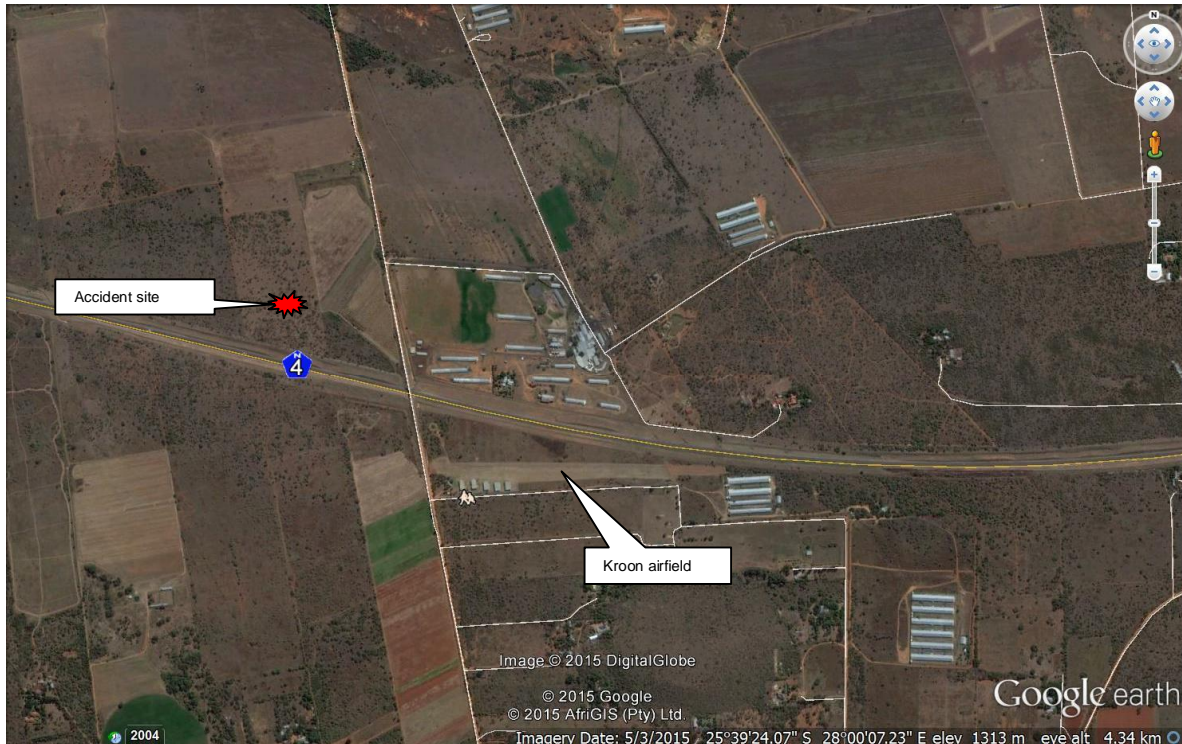
Figure 4 The accident site in relation to the airfield.
