Air, Maritime and Railway Traffic Accident Investigation Agency

FINAL REPORT

ON ACCIDENT OF THE AIRCRAFT Lake LA-4-200, 9A-DLA

Resnik near Split, 25 June 2015

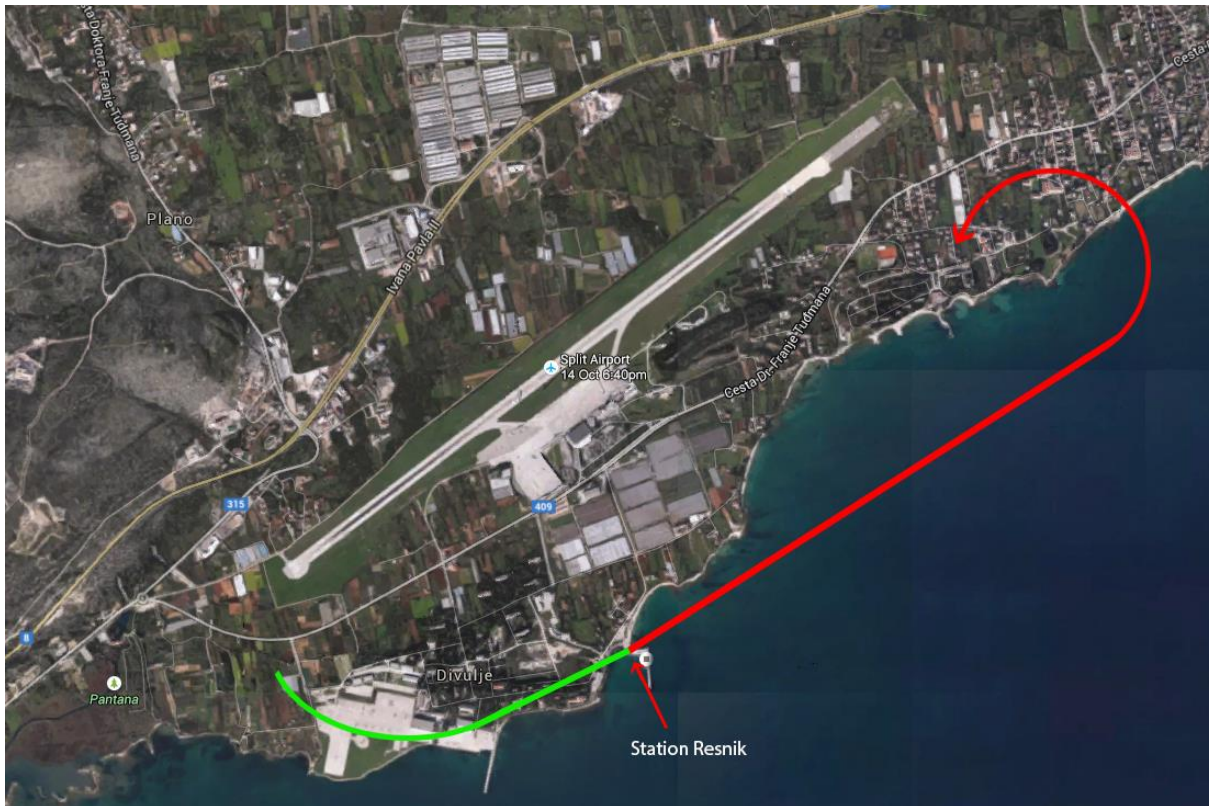
Based on the eyewitness statement, also a pilot, a flight sketch was made (Picture2). Part of the aircraft flight path with normal engine operation is marked green, and part of the flight path after the engine failure is marked red. The estimated aircraft altitude at the moment of engine failure, according to the eyewitness's statement, was 700-800 ft or just over 200 m.

Picture 2 – sketch of the flight path of 9A-DLA

The eyewitness who saw the crash (controller in the tower) stated that it seemed that in the last, left turn the aircraft stalled, turned over the left wing and vertically hit the sea.

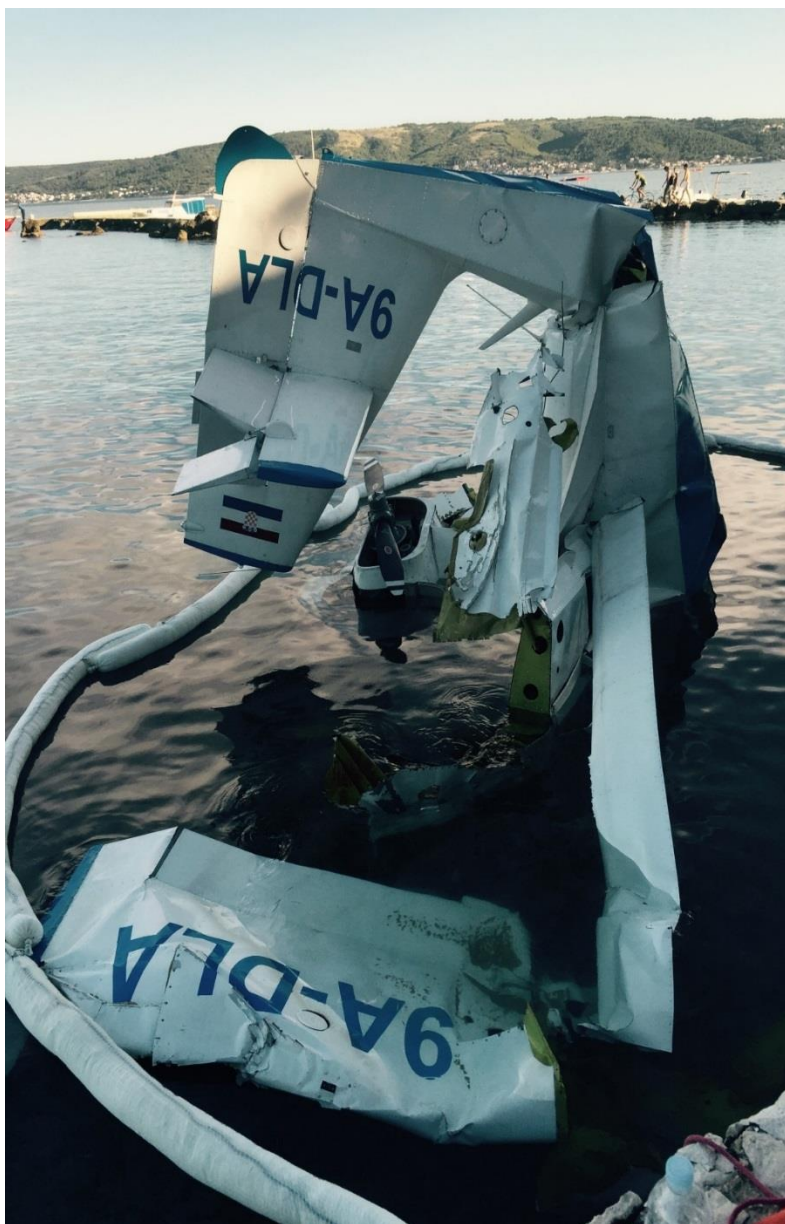
In this accident the aircraft 9A-DLA was completely destroyed. The aircraft crashed into the shallow sea near the coast and remained lying in the water of about 1 meter of depth. There was no fire.

Picture 3 - Aircraft 9A-DLA wreckage at the accident site
