## *Final report RL 2016:05e*

**Accident at Malmö Sturup Airport on 27 June 2015 involving aircraft SE-GIC of model Piper-PA34-200T, Seneca II, operated by South Sweden School of Aeronautics AB.**

File no. L-61/15

2016-09-02

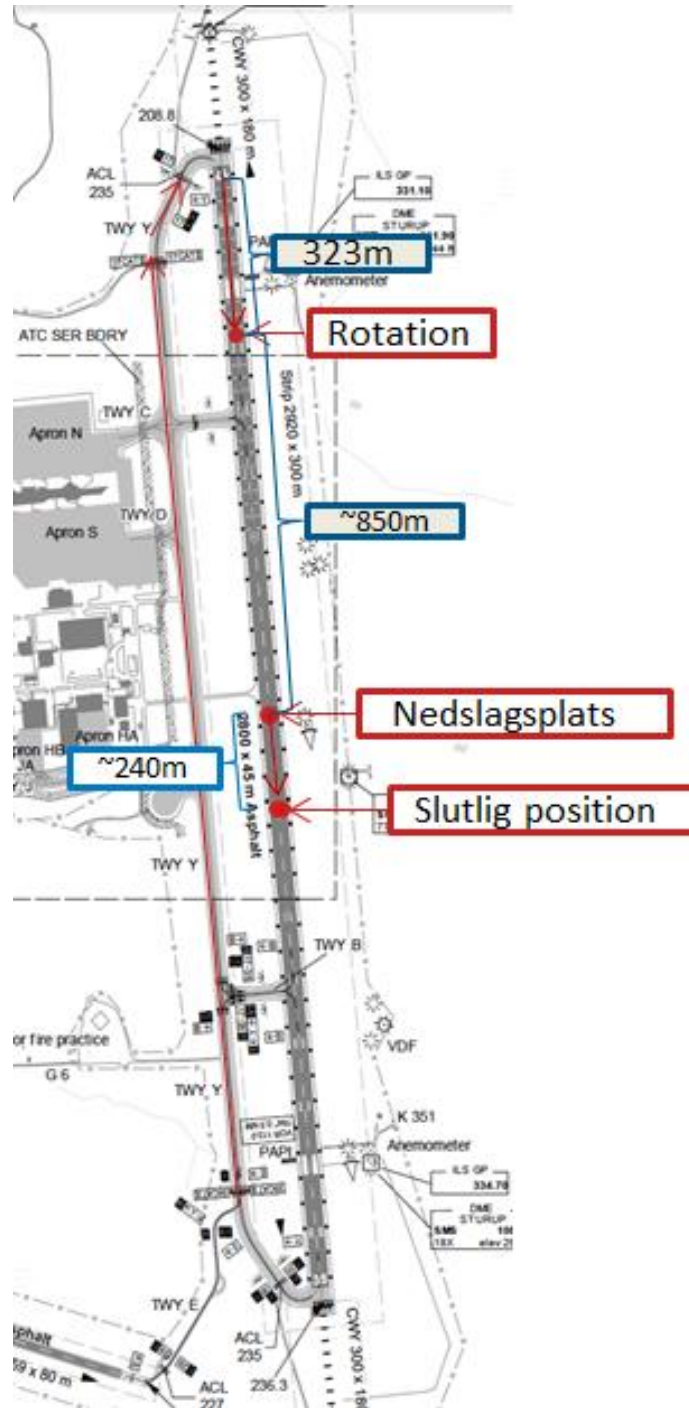
Figure 2. Sketch of the accident sequence and accident site. [Note: Nedslagsplats - Point of impact; Slutlig position - Final position.]

After impact on the runway, the aircraft slid approximately 240 metres before coming to a final stop about 1,450 metres from the beginning of runway 17. An assumed average speed of 70 knots from lift-off to impact means an approximate time of 24 seconds during which the aircraft was airborne.

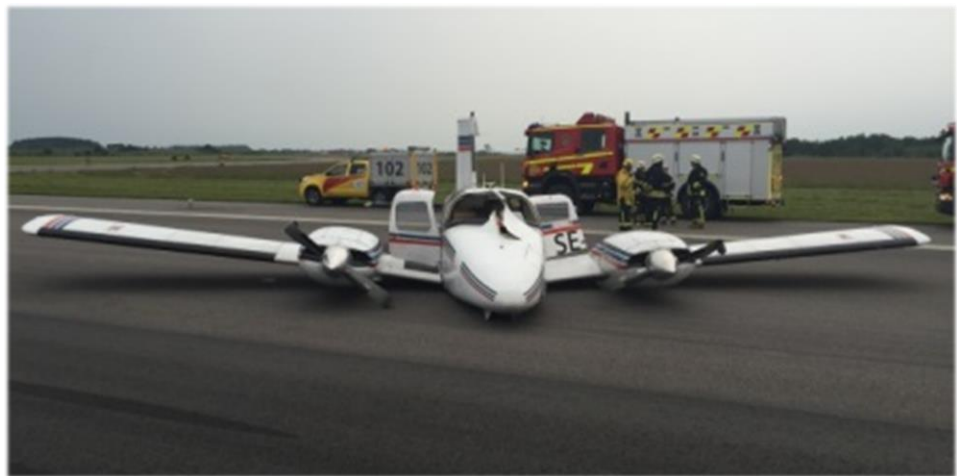
The aircraft sustained substantial damage. See Figures 3 and 4.

- Both main landing gear were damaged.
- The nose landing gear was pressed into the fuselage.
- The windscreen was broken.
- Damage to the right stabiliser – probably caused by the damaged main landing gear on the right side.
- Both propellers had damage indicating that they had developed low thrust at impact.
- Damage to wings, wing flaps and to the underside of the fuselage.

Figure 3. The aircraft after the crash. Photo: Emergency services Malmö/Sturup.

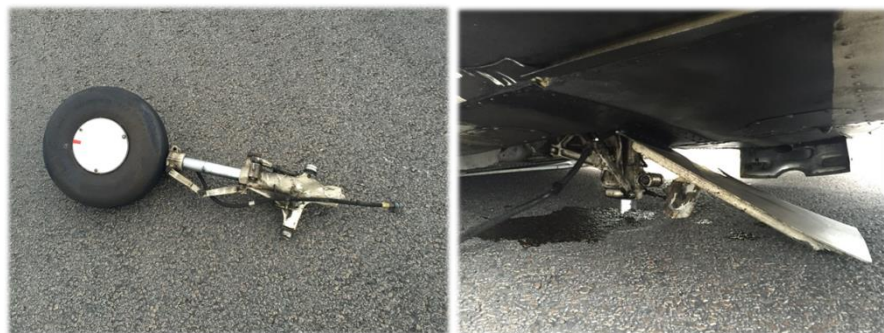
Figure 4. Left and right main gear. Photo: Emergency services Malmö/Sturup.

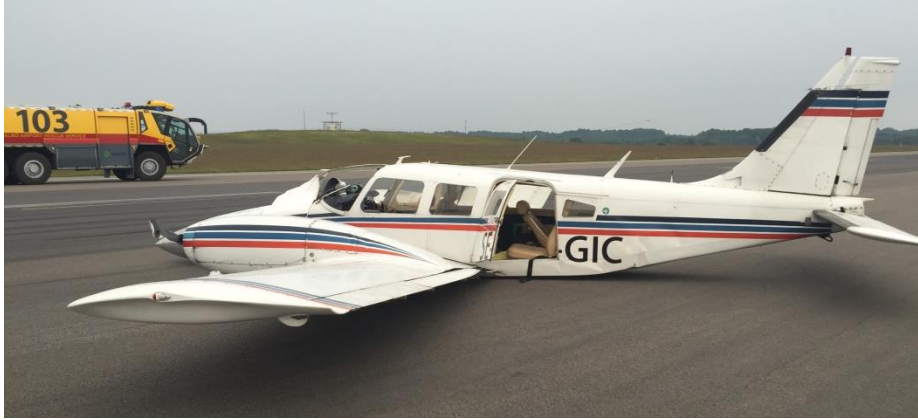
Figure 6. The aircraft after the accident. Photo: Emergency services Malmö/Sturup.
