<b>AIRCRAFT ACCIDENT REPORT AND EXECUTIVE SUMMARY</b>
---

Reference:	CA18/2/3/9454	
<b>Aircraft registration</b>	ZS-HXP	<b>Date of accident</b>	2 July 2015		<b>Time of accident</b>	1230Z
<b>Type of aircraft</b>	Robinson R22		<b>Type of operation</b>		Game capture (Part 137)	
<b>Pilot-in-command licence type</b>	Commercial		<b>Age</b>	30	<b>Licence valid</b>	Yes
<b>Pilot-in-command flying experience</b>	Total flying hours		3050.0		Hours on type	99.0
<b>Last point of departure</b>	Private farm Oufontein, Victoria West Area, Northern Cape					
<b>Next point of intended landing</b>	Private farm Oufontein, Victoria West Area, Northern Cape					
<b>Location of the accident site with reference to easily defined geographical points (GPS readings if possible)</b>						
Farm Oufontein, Victoria West district (GPS position: 31°14.762 Souh 023°45.556, elevation 4073ft AMSL)						
<b>Meteorological information</b>	Surface wind: 270°/3 knots; Temperature 17°C; Visibility: 8000 m

## AIRCRAFT ACCIDENT REPORT

**Name of Owner** : Mossel Bay Helicopters  
**Name of Operator** : Kukamata Game Capture  
**Manufacturer** : Robinson Helicopter Company  
**Model** : R22 Beta  
**Nationality** : South A

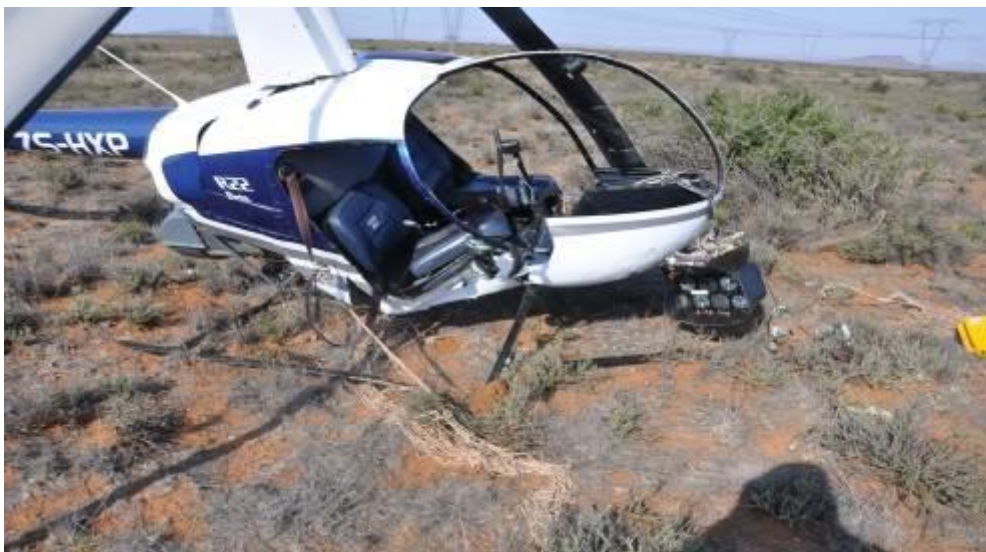
- 1.3.1 The helicopter was substantially damaged during the impact sequence.

Figure 1: The main wreckage

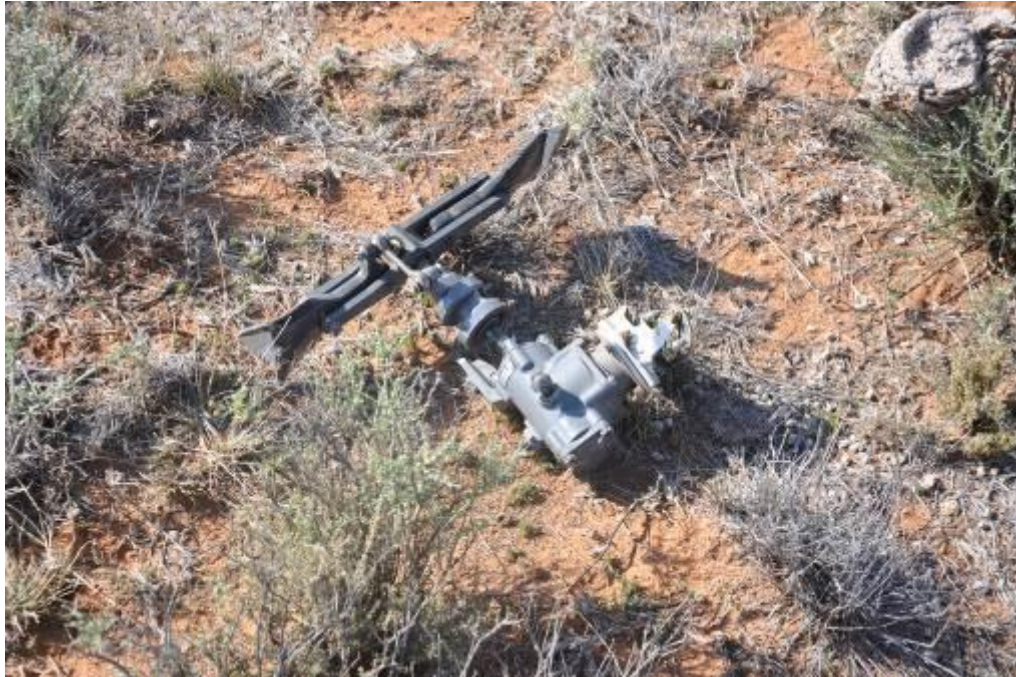
1.12.1 During the impact sequence, the main rotor blades impacted and subsequently severed the tail boom and tail rotor from the fuselage. One of the main rotor blades also impacted the cabin area, causing extensive damage to the helicopter.

**Figure 2:** The main wreckage as it came to rest

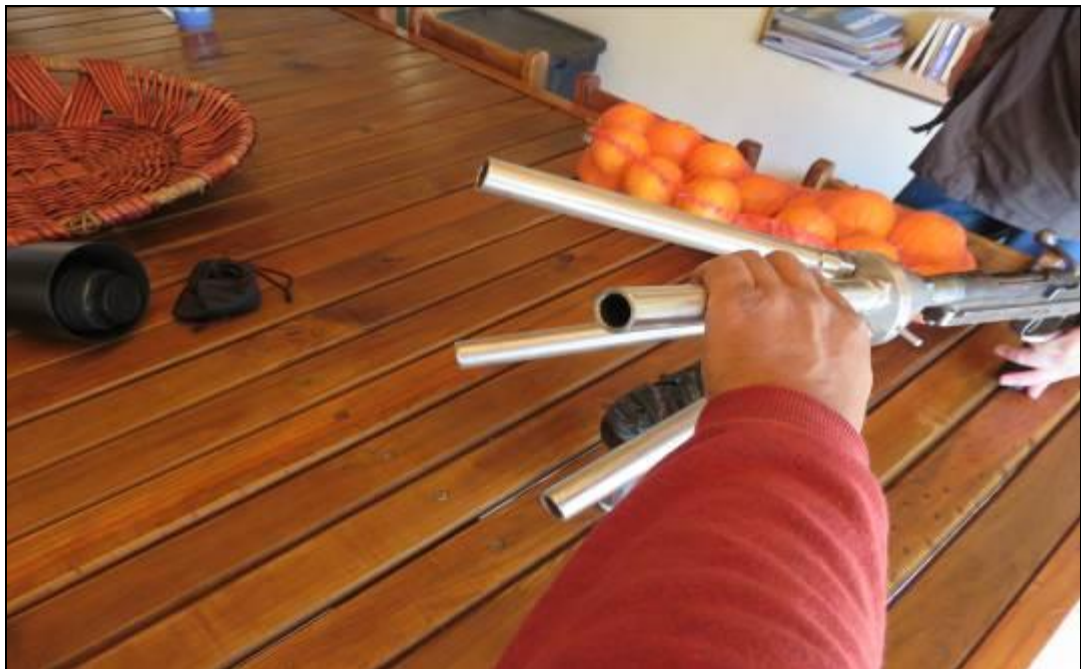
**Figure 4:** The net-gun displayed with the four barrels where the weights are fired from

- 3.2.1 One of the four net weights became stuck in the barrel of the net gun when it was fired, which caused the net to swing into the tail rotor. The pilot lost control of the helicopter when it started spinning in a clockwise direction and impacted the ground.

- 4.1 The Safety message to the operator operating aircraft fitted with net-gun machine must ensure that all equipment (net-gun machine) to be carried in their aircraft and used by any person (net-gun operator) in their operations is serviceable and adequate training is provided for the use of the net-gun machine.
