# Near mid-air collision, near Lelystad Airport

*The Hague, August 2018*

Occurrence number:	2015077
Classification:	Serious incident
Date and time of occurrence:	1 August 2015, 17.48 <sup>1</sup>
Location of occurrence:	Near Lelystad Airport, the Netherlands
Aircraft registration number:	D-IROL
Aircraft model:	Dornier Do-228-100
Aircraft type:	Twin-engine turboprop aircraft
Flight type:	Non-scheduled passenger flight
Flight phase:	Approach
Damage to aircraft:	None
Number of crew members:	Two
Number of passengers:	Sixteen
Aircraft registration number:	PH-4D3
Aircraft model:	Tecnam P92 Echo Super
Aircraft type:	Microlight aircraft
Flight type:	Private flight
Flight phase:	Approach
Damage to aircraft:	None
Number of crew members:	One
Number of passengers:	One

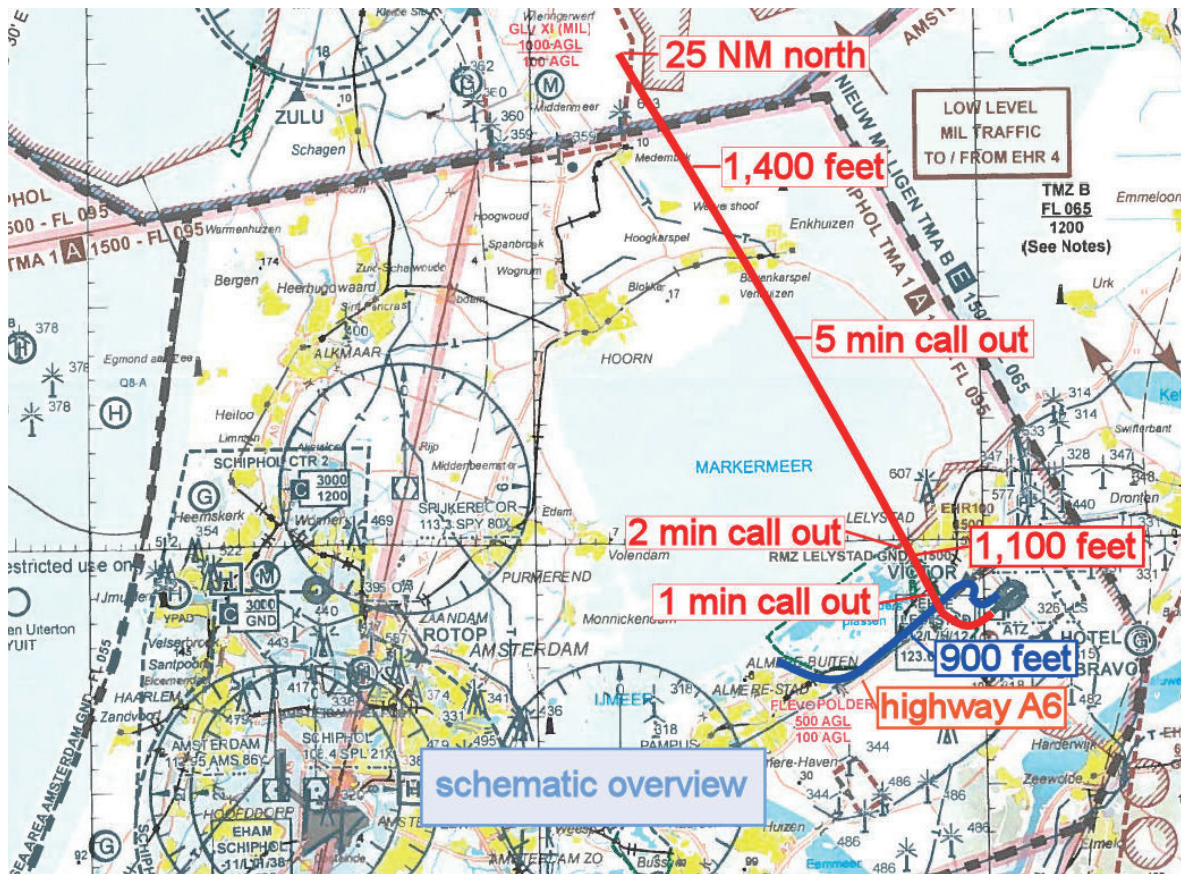
Figure 1: Aeronautical Chart ICAO, The Netherlands: D-IROL in red and PH-4D3 along highway A6 in blue.

Radar information indicates that by this time the ground speed had reduced to 161 knots. Near highway A6 (see figure 1 and figure 4 in appendix A), at approximately 1,100 feet, the descent rate changed from 100 feet to approximately 650 feet per minute. When starting the descent, the crew extended the landing gear and flaps.

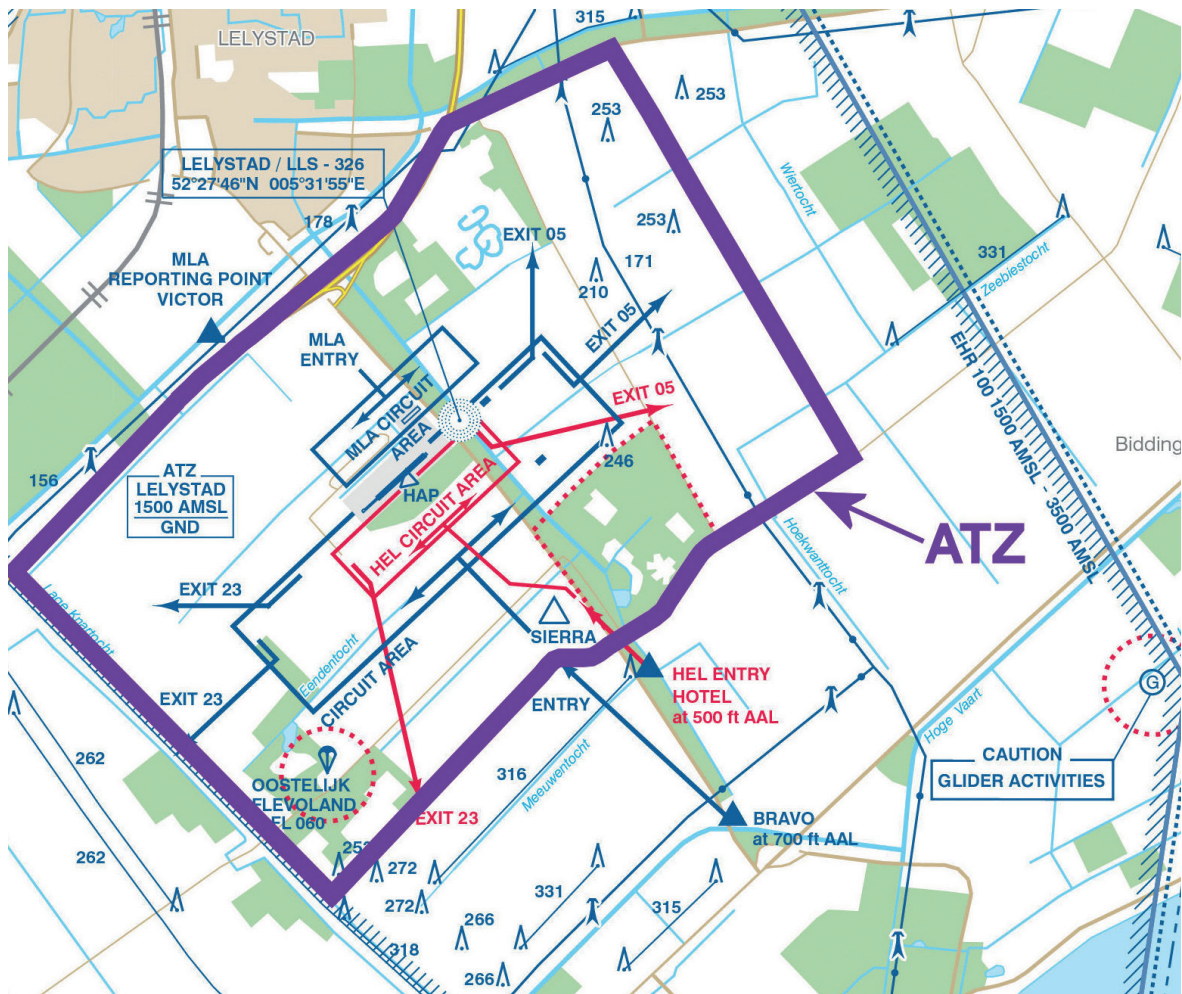
The aerodrome traffic zone (ATZ) is an airspace of defined dimensions established around an aerodrome for the protection of aerodrome traffic, see figure 2. As for Lelystad Airport, its ATZ<sup>11</sup> is G-airspace. Two-way radio contact with Lelystad Radio is required.

Figure 2: Aerodrome traffic zone (ATZ) in the visual approach (VAC) chart of the Dutch AIP.

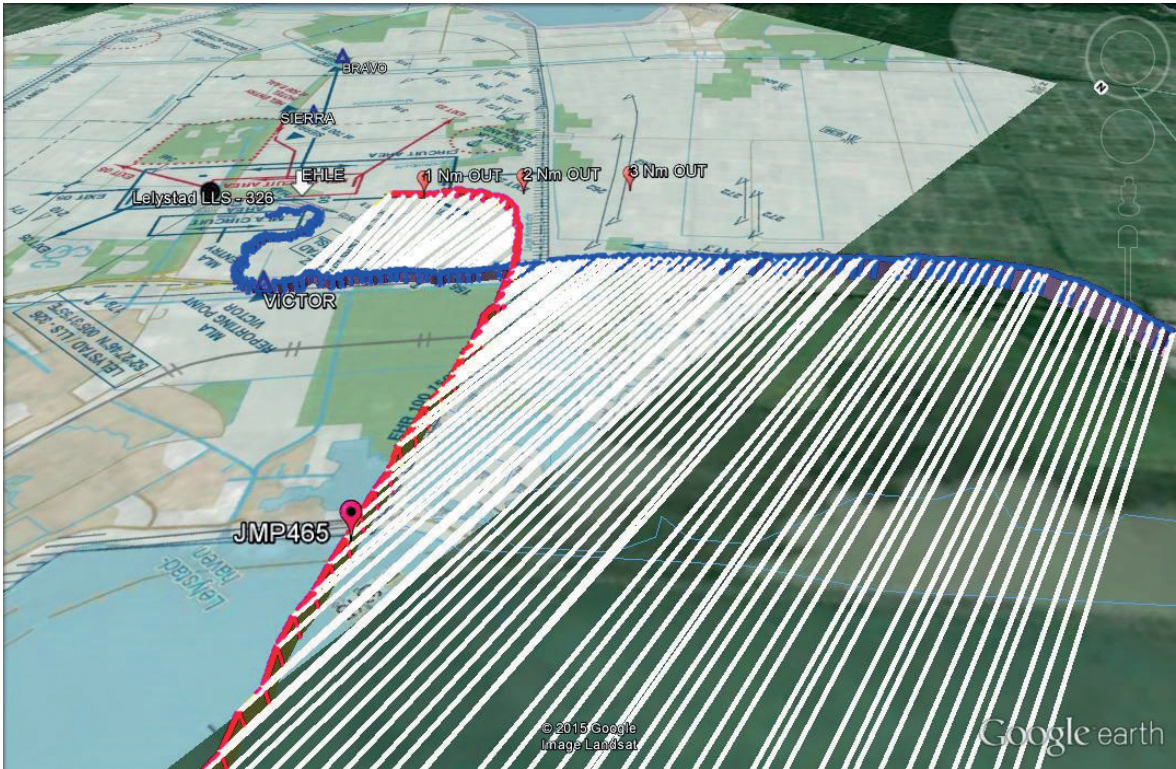
The pilot of PH-4D3 stated that he was approaching reporting point Victor from the southwest on a course parallel to highway A6. At his 10 o'clock position he suddenly noticed a twin-engine aircraft at approximately the same altitude at a close range. The pilot stated that because the Dornier had such a nose down altitude he saw sunlight reflecting on the upper part of the wings of the Dornier. He immediately brought down the nose of his aircraft, after which the twin-engine aircraft passed overhead towards Lelystad aerodrome. According to the pilot, his action prevented a mid-air collision. For the flight paths of both aircraft, see figure 3 in appendix A.

Figure 3: Flight paths relative to aerodrome and ATZ showing relative constant bearing angles (white). The PH-4D3 microlight path is blue, the D-IROL Dornier Do-228 path is red. View is from northwest.

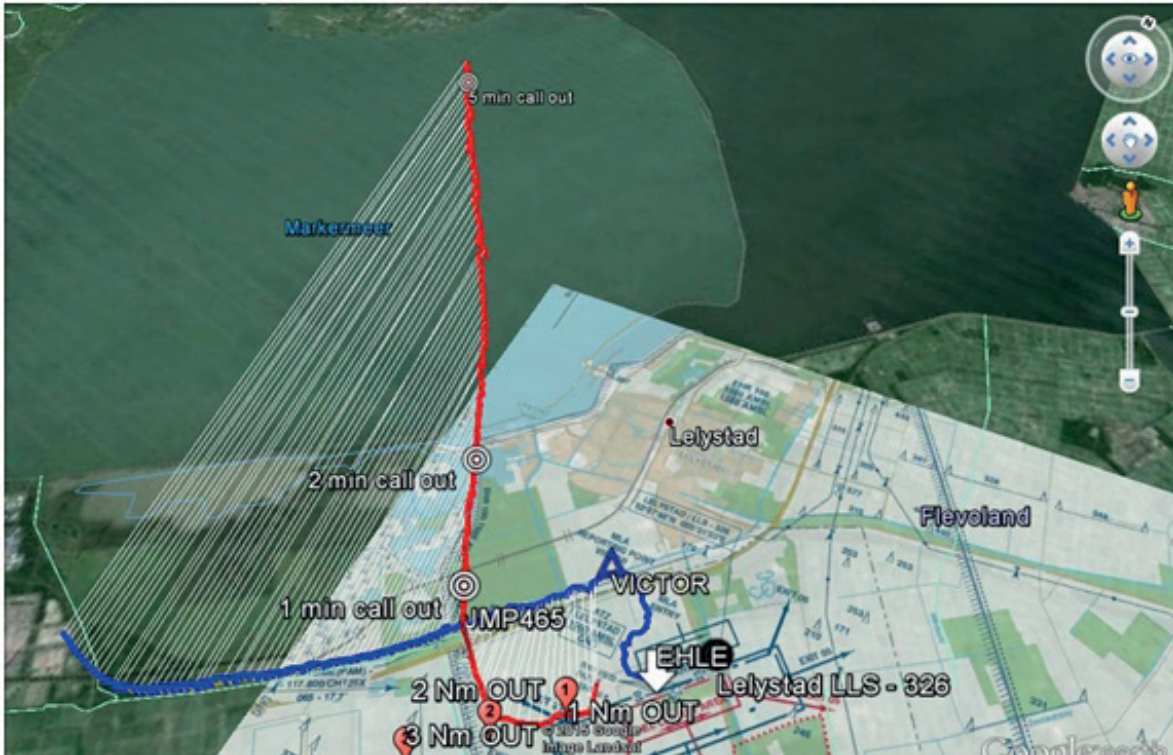
Jump Run 465 reported that it was 5 minutes out (see appendix A, figure 4) which was acknowledged by Lelystad Radio. Additionally, Lelystad Radio then requested Jump Run 465 to report at 2 minutes out, which was acknowledged by the captain. The crew declared they started landing preparations over lake Markermeer. According to radar information the Dornier started the descent by approximately 100 feet per minute over Markermeer. Once Markermeer had almost been crossed and by using visual aids, the flight crew adjusted the course to the right in order to get southwest of the runway. When just above land, the flight crew made the 2 minutes call to Lelystad Radio.

Figure 4: Flight path of Dornier aircraft with call out positions and distances in NM from runway threshold on extended centreline. For orientation, the top of the page is north and the bottom of the page is south.

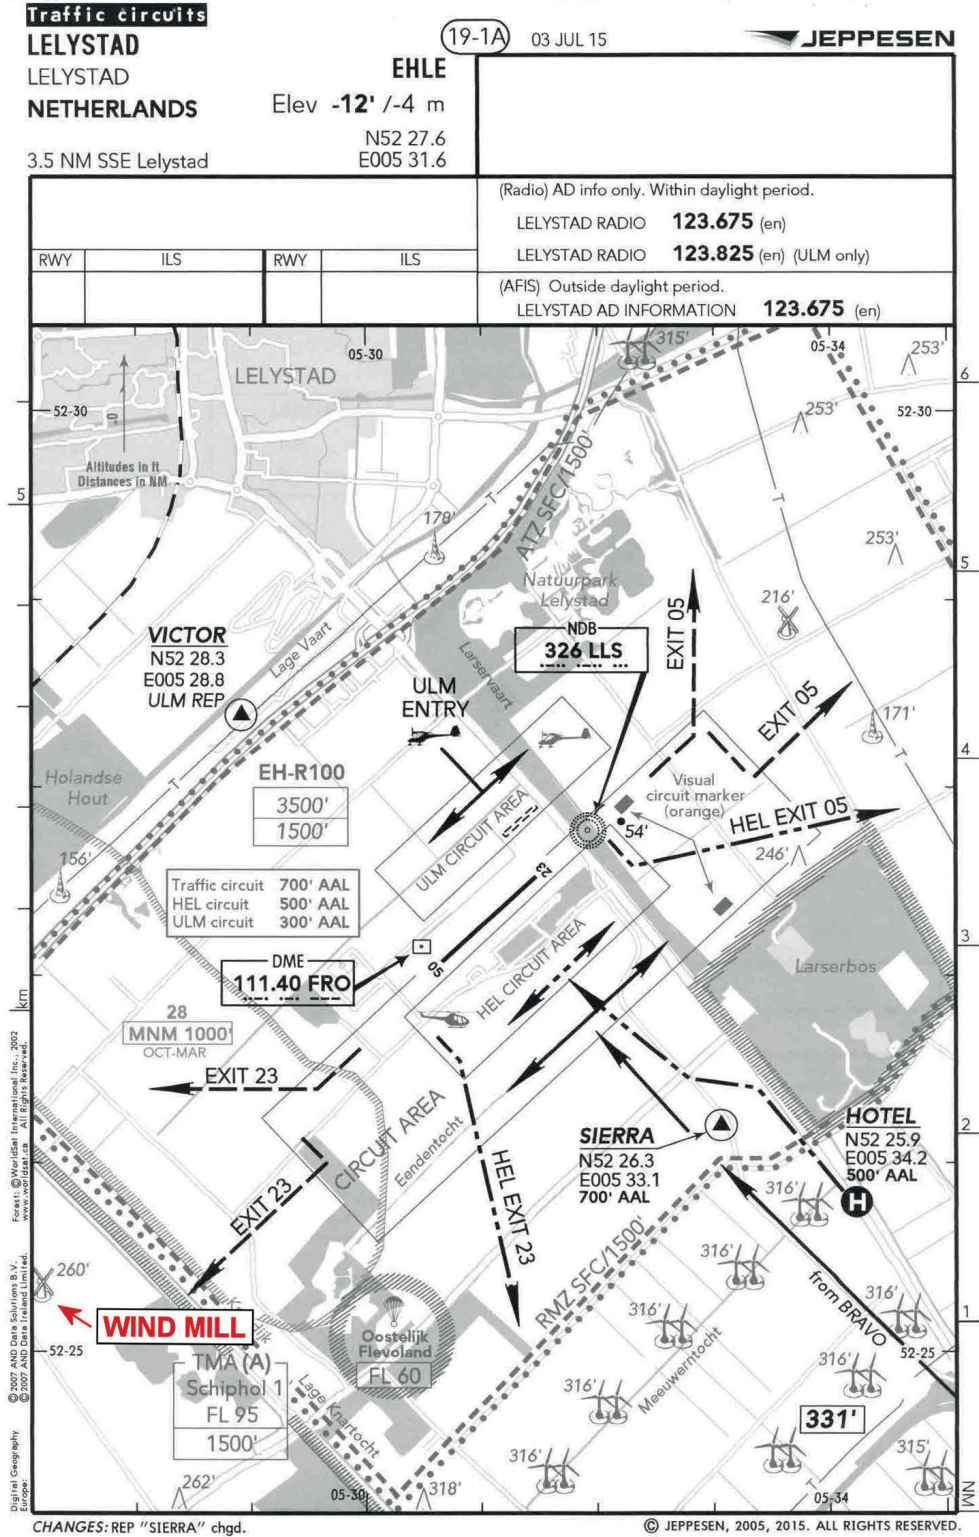
The co-pilot observed another aircraft at a position to the right and below the Dornier, but he considered this aircraft was not close enough to pose a risk for their flight. A passenger stated that when approaching Lelystad he had not seen any other aircraft nor noticed any disturbance with the flight crew which he could see as the cockpit was open. At about 0,5 NM northwest of highway A6, Jump Run 465 called it was 1 minute out. As for EHLE, the crew explained they aimed for the wind mill as indicated on the JeppView chart for a 3 NM final.

Prescribed flight paths being part of approach procedures, either standard or non-standard like a 'straight-in', form primary information to pilots. However, the VAC of Lelystad Airport (both in AIP and in Jeppesen) does not depict the flight path of the 'straight-in approach' procedure, nor does it refer to the chapter in the AIP where the applicable 'straight-in approach' procedure is described. It is found embedded in the AIP, see appendix C under *VFR Flight Procedures*. This is less effective to safety, for pilots always need the VAC to determine the flight path.

Figure 5: Visual approach chart from JeppView including the wind mill icon.

2. Visualise (draw) all VFR approach flight paths in Visual Approach Chart(s).
