AIRCRAFT ACCIDENT REPORT AND EXECUTIVE SUMMARY

Reference:	CA18/2/3/9462	
Aircraft Registration	ZU-RHO	Date of Accident	8 August 2015		Time of Accident	0519Z
Type of Aircraft	RAF 2000 GTX SE F1– Gyroplane		Type of Operation		Private Operation – Part 94	
Pilot-in-command Licence Type		National Pilot Licence (NPL)	Age	45	Licence Valid	Yes
Pilot-in-command Flying Experience		Total Flying Hours	125.0		Hours on Type	125.0
Last point of departure		Avontuur Airfield, Eden District, Western Cape				
Next point of intended landing		Graaff-Reinet Airfield, Cacadu District, Eastern Cape				
Location of the accident site with reference to easily defined geographical points (GPS readings if possible)						
Runway 06, Avontuur Airfield						
Meteorological Information		Wind: NNE/2kt; Temperature: 8°C; Dew point: Unknown; Clouds: Nil; Visibility: Good.				
Number of people on board	1 + 1	No. of people injured	2	No. of people killed	0	
Synopsis						
<p>During take off from Avontuur, The pilot reported that he felt a vibration and he was unable to control the aircraft. After climbing to a height of approximately 3.2m above ground level, the aircraft sank without warning and struck the ground, sust

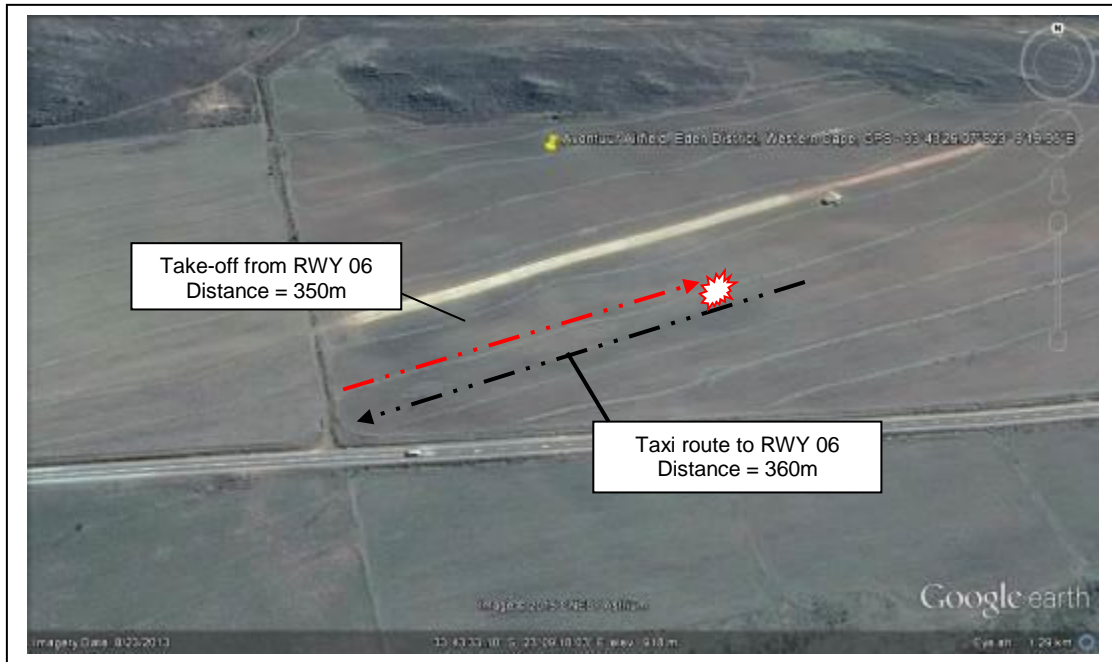
Figure 1: The position of the crash relative to the runway.

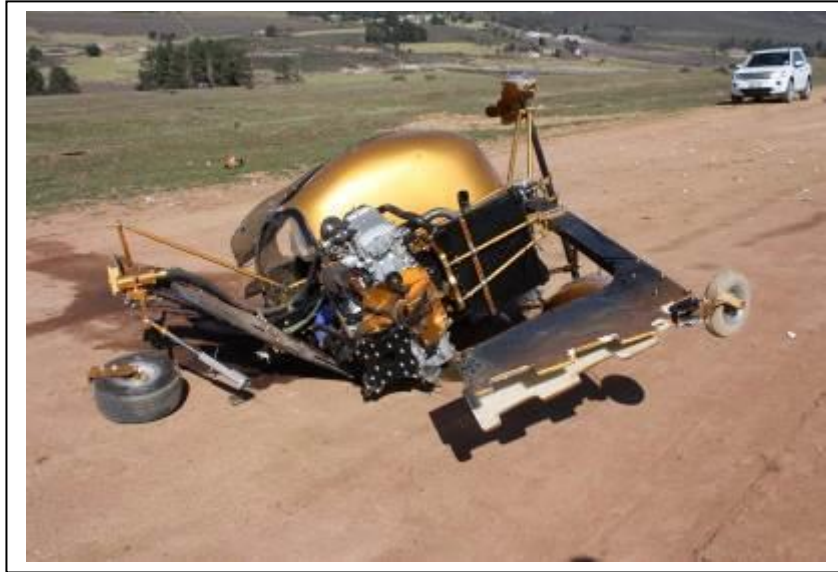
1.3.1 The aircraft sustained substantial damage in the accident.

Figure 2: Rear view of ZU-RHO, showing the extensive damage.

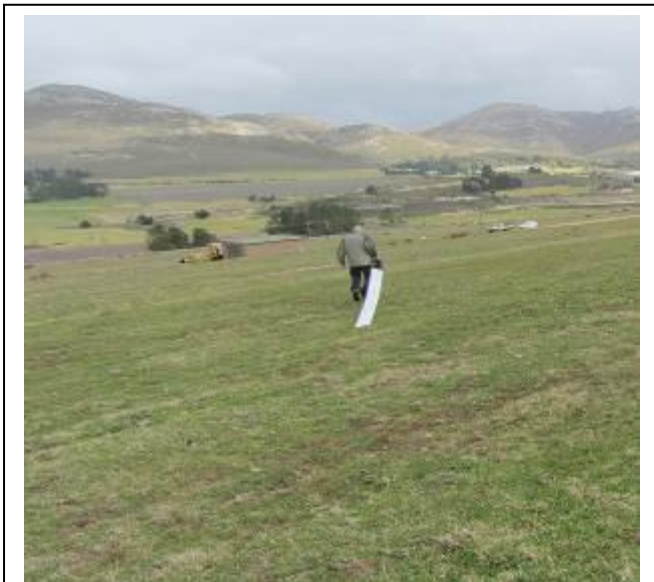
Figure 3: The winglet s/n B.A.A.S 6038.2 was flung onto open grass on the left of runway 06.

- (i) The rotor winglet s/n B.A.A.S 6038.2 was found 195m from the wreckage on a heading of 315° true (north-westerly), at the coordinates 33°43'25.35"S 23°9'26.05"E. This was on the left side of the runway. There was no structural damage to the winglet and the leading and trailing edge were still intact. The fibre glass outer skin from the root to the tip displayed flutter damage and there were soil stains on the tip caused by ground strike. The point of impact could not be identified as the area was grassed.

- (ii) Close-up examination of this winglet showed evidence of rotor hub bar failure. The RAF 501 ANS bolt had broken, causing the winglet to separate from the aircraft during take-off. The broken bolt head had sheared off completely, resulting in the winglet disconnecting from the hub bar assembly.

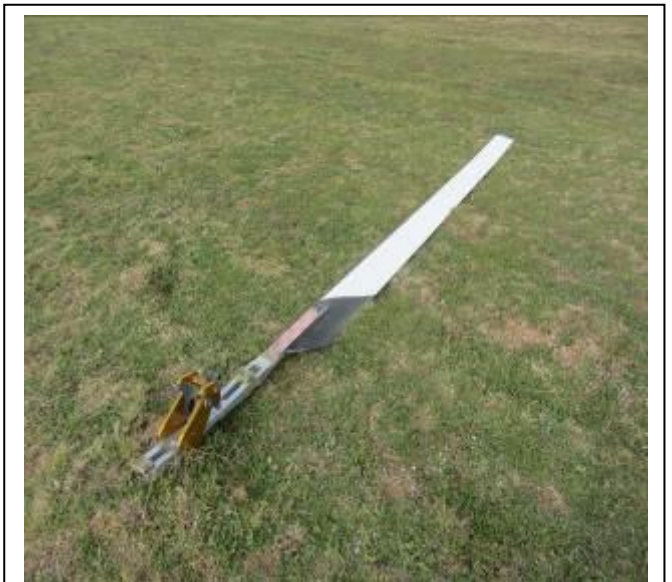
Figure 4: The winglet s/n B.A.A.S 6036.2 was flung onto open grass on the right of Runway 06.

- (iii) The rotor winglet s/n B.A.A.S 6036.2 was found connected to the hub bar assembly. The winglet was found 95m from the wreckage on the heading 135° true (south-easterly) at the coordinates 33°43'28.86"S 23°9'24.60"E. This was on the right side of the runway. This winglet did not have any visually noticeable structural damage. The leading and trailing edge and fibre glass outer skin were all intact.

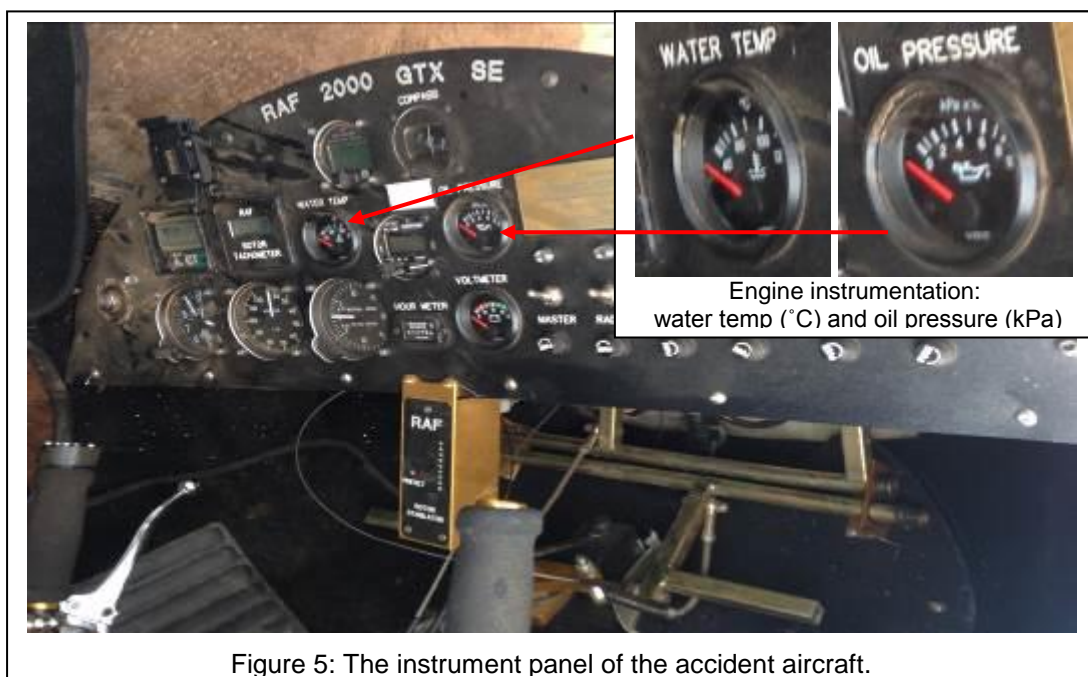
Figure 5: The instrument panel of the accident aircraft.

1.6.5.1 The water temperature and oil pressure markings are in degrees Celsius (°C) and kilopascals (kPa), which differ from the degrees Fahrenheit (°F) and pounds per square inch (psi) published in the flight operations manual. This implies that the pilot would have had to constantly make conversions throughout the flight when reading engine information. In addition, the instruments had different markings (green arc, yellow arc and red line) to those required by SACAA regulations.

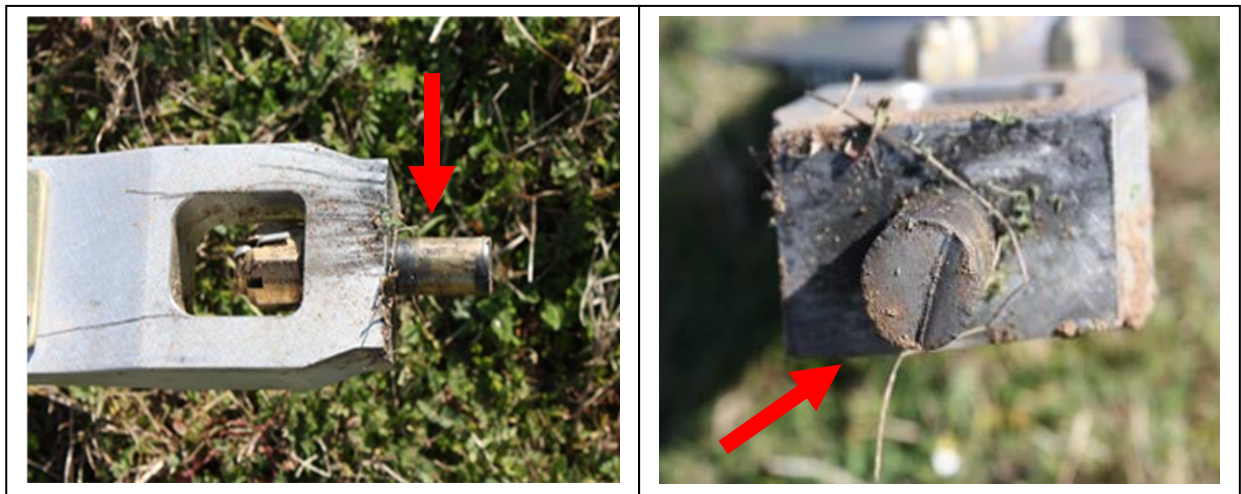
1.6.6.2 During the onsite investigation, evidence was found indicating that the aircraft had experienced rotor hub assembly component failure. As indicated above, the winglets separated from the aircraft during take-off. The preliminary finding was that the RAF NAS bolt, part no. RAF 501012, installed to secure the winglet s/n B.A.A.S 6038.2 to the hub bar broke.

Figures 6 and 7: Side and front views of the sheared RAF NAS bolt, part no: RAF 501012.

- (ii) According to the metallurgist's report, the failure of the bolt was associated with fatigue fractures after exposure to reverse bending loads in the horizontal/lead-lag operational plane. The primary cause can be attributed to operational exposure or assembly/design issues, or both. More significantly, the metallurgist found that the washer installed at the bolt head end exceeded the dimensions of the slotted sections in the hub bar. This might have resulted in a false torque value during fitment of the bolt. Thus, when exposed to normal centrifugal loads during operation, this washer mechanically interacted with the hub bar, as seen by the resulting bending damages. This might have led to lowering the applied torque, with resultant movement of the hub bar/bolt assembly in the shear direction (horizontal/lead-lag) as well as the inducement of excessive forces on the fracture-prone bolt head radius.

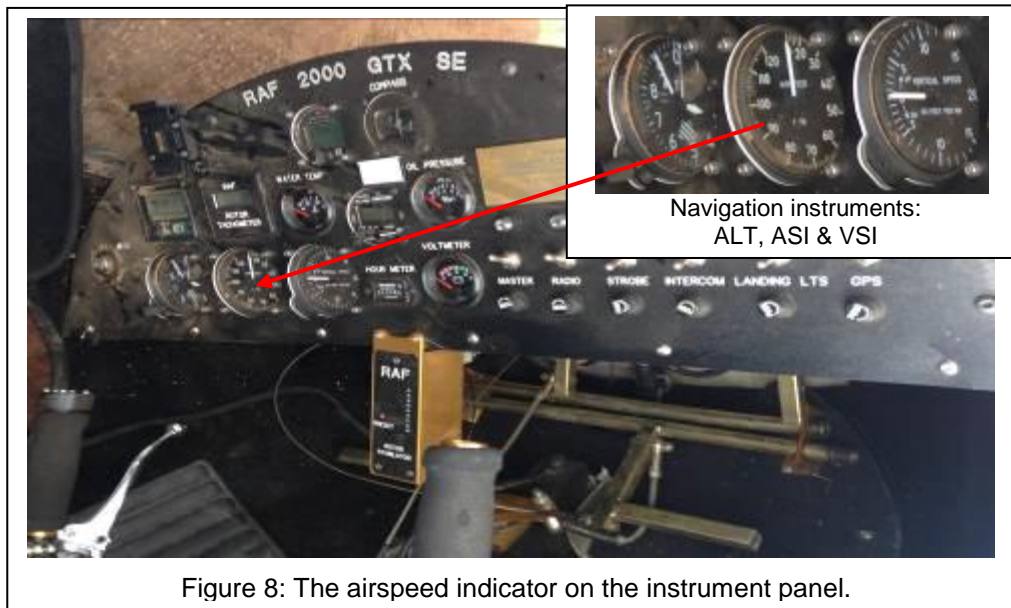
Note: The airspeed indicator (ASI) was not fully compliant with the marking requirements published in the RAFSA flight operations manual. The instrument represented a danger to the pilot and occupants as it did not clearly indicate a green arc (normal operation airspeed range), a yellow arc (caution airspeed range), and a red line (never-exceed airspeed range markings).

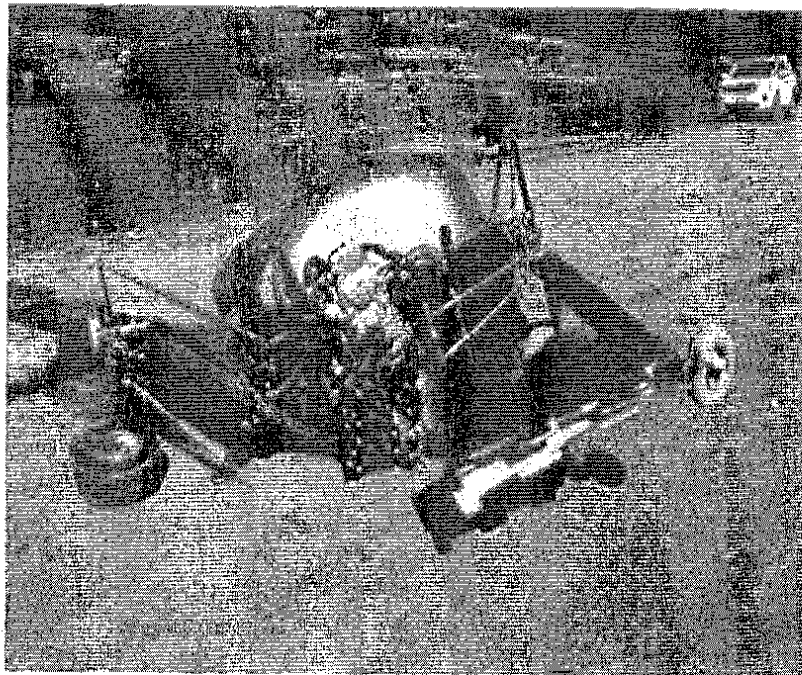
Figure 1 shows the wreckage of the accident aircraft

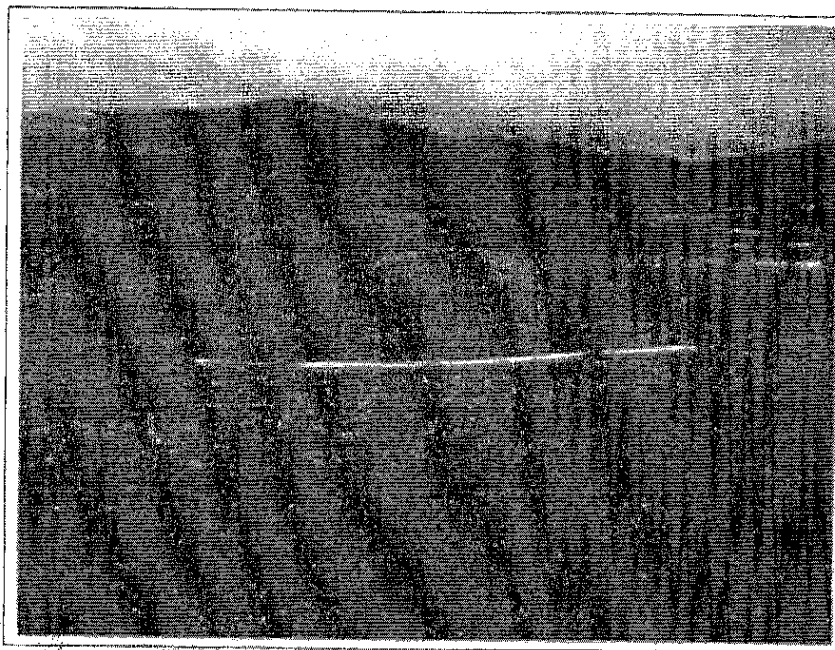
After the accident was reported, the AIID dispatched to the scene to conduct an onsite investigation. The investigation determined that during the take-off phase, the winglet (main rotor blade) of the aircraft broke and separated from it in the initial climb. Both winglets were subsequently found approximately 200 meters in different directions away from the main wreckage.

Figure 2 shows the winglet which broke and separated from the aircraft

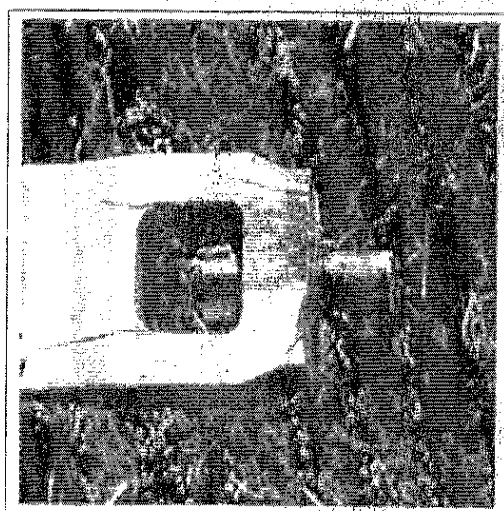
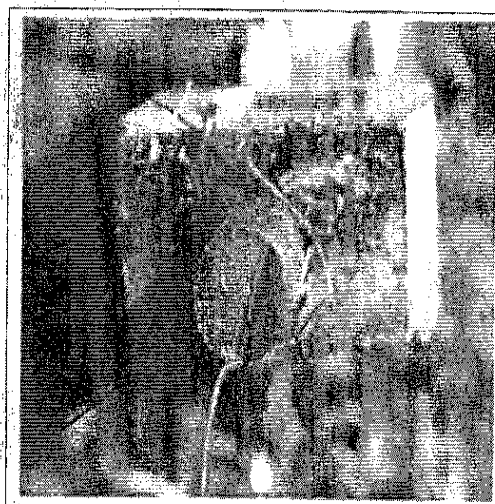
Further investigation was conducted to determine the cause of the winglet failure. It was determined that the bolt (Part No: RAF 501012) which are installed between the rotor hub bar and winglet assembly failed. The head of the identified bolt broke off as indicated below:

Figure 3 and 4 shows the broken bolt

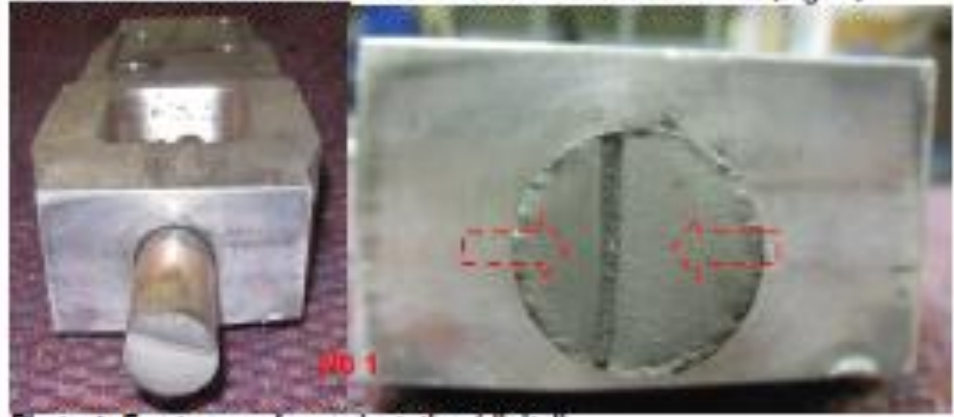
Photo 4: Fracture surface orientation (digital)

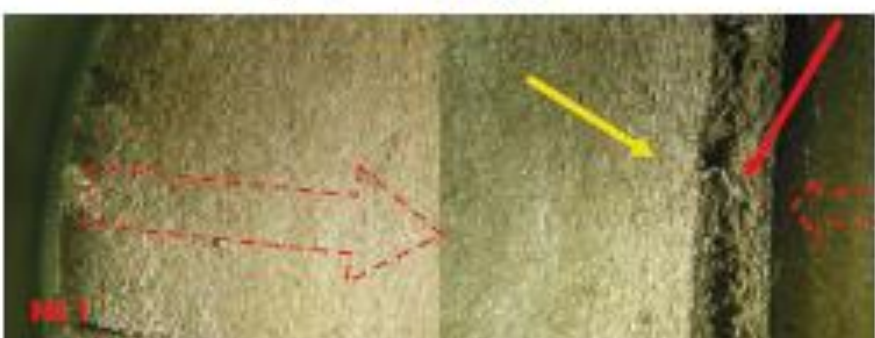
Photo 8: Fracture surface, No 1 bolt (stereo)

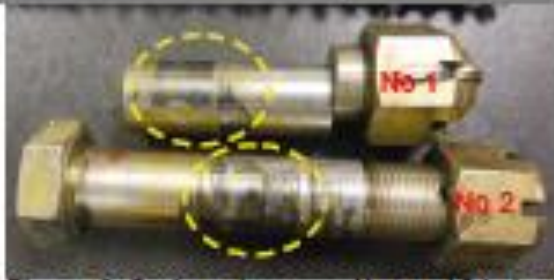
Photo 10: Surface damages, No1 and 2 bolts (digital)

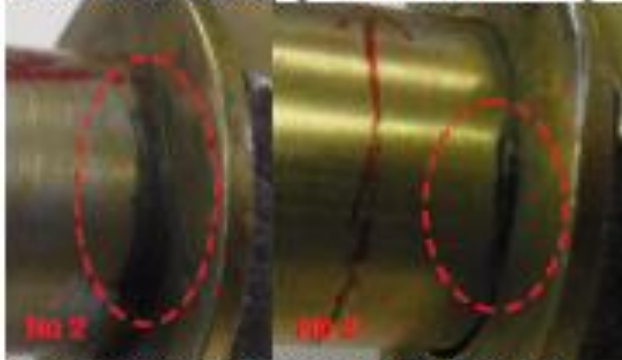
- (iii) The winglet S/N B.A.A.S 6036.2 was also inspected visually. It was found that its bolt (p/n AN12-34A) installed between the hub bar and winglet was still intact. However, this bolt revealed indications of fracture initiation that bore similarities with the bolt of winglet s/n B.A.A.S 6038.2.

Photo 11: Surface damages, No 2 bolt (digital)

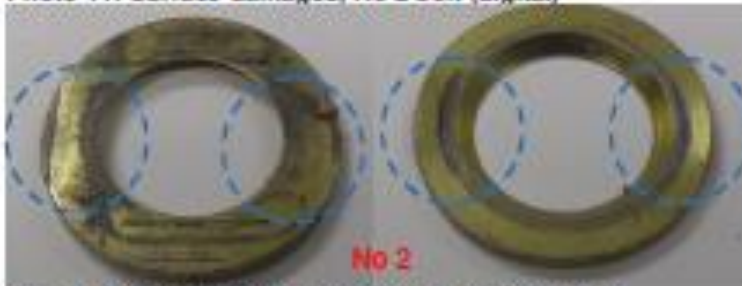
Photo 12: Washer, bolt head end, No 2 bolt (digital)

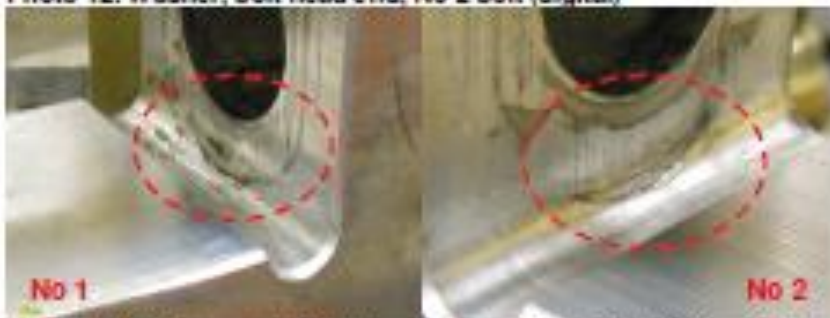
- *Assembly/Design. The investigation results have shown that the washers (No. 1 and No. 2) at both the bolt head ends dimensionally exceed the slotted sections in the MR blade attachment brackets. During fitment this may render a “false” torque value. When exposed to normal centrifugal loads during operation, the washers mechanically interact with the MR blade attachment bracket with resulting bending damages noted. This may lead to lowering the applied torque with resultant movement of the bracket/bolt assembly in the shear direction (horizontal/lead-lag) as well as the inducement of excessive forces on the fracture-prone bolt head radius”.*

Photo 13: Washer and MR blade attachment bracket interface, No 1 and 2 bolts (digital)

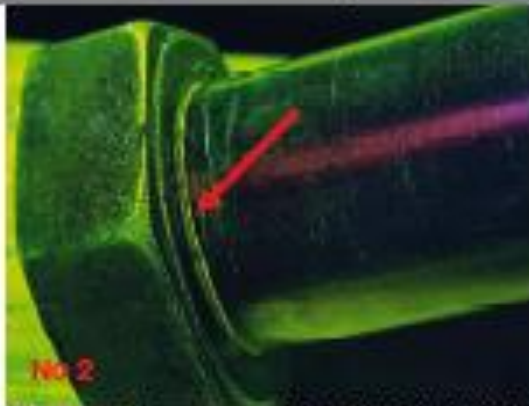
Photo 14: Fracture position, No 2 bolt (NDI - digital)

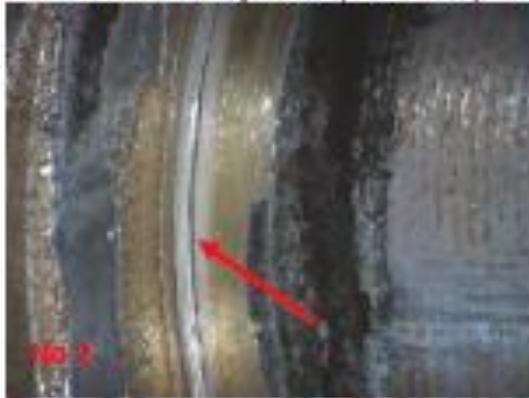
Photo 15: Fracture position, No 2 bolt (digital)
