AIRCRAFT ACCIDENT REPORT AND EXECUTIVE SUMMARY

Reference:	CA18/2/3/9461	
Aircraft registration	ZS-WVV	Date of accident	08 August 2015		Time of accident	±1135Z
Type of aircraft	Challenger II (Aeroplane)		Type of operation	Part 94		
Pilot-in-command licence type	National Pilot		Age	66	Licence valid	Yes
Pilot-in-command flying experience	Total flying hours		68.5		Hours on type	62.5
Last point of departure	Morningstar aerodrome in Cape Town: Western Cape province					
Next point of intended landing	Morningstar aerodrome in Cape Town: Western Cape province					
Location of the accident site with reference to easily defined geographical points (GPS readings if possible)						
Onto the field at Blouberg farm, Cape Town at GPS co-ordinates determined to be S33° 43.´ 49" E018° 30.´ 13" at an elevation of 338 feet AMSL.						
Meteorological information	Temperature: 17°C, Dew-point: 11°C, Wind direction: 160, Wind speed: 6 knots, Scattered clouds at 2 000ft AGL, Barometric pressure: Q1021hPa.

Probable cause						
Incapacitation of pilot.						
SRP date				Release date

Registration Marks : ZS-WVV

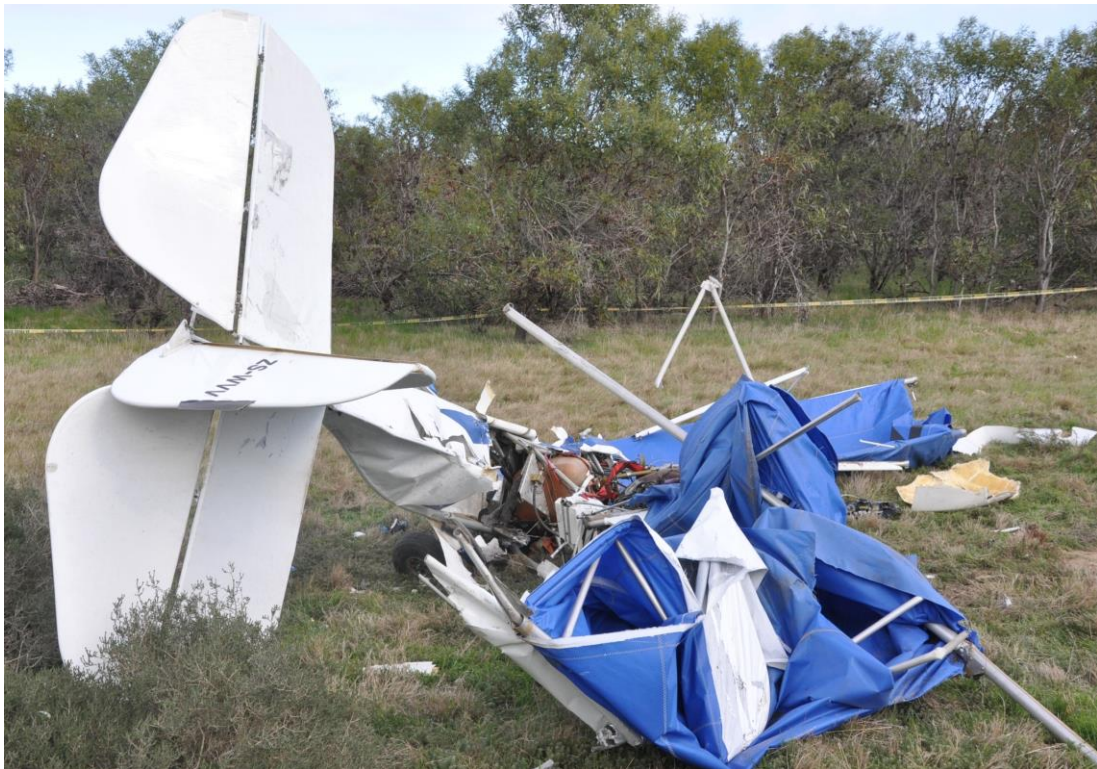
1.3.1 The aircraft was destroyed by impact during the accident sequence.

Figure 2: The wreckage as found at the accident site

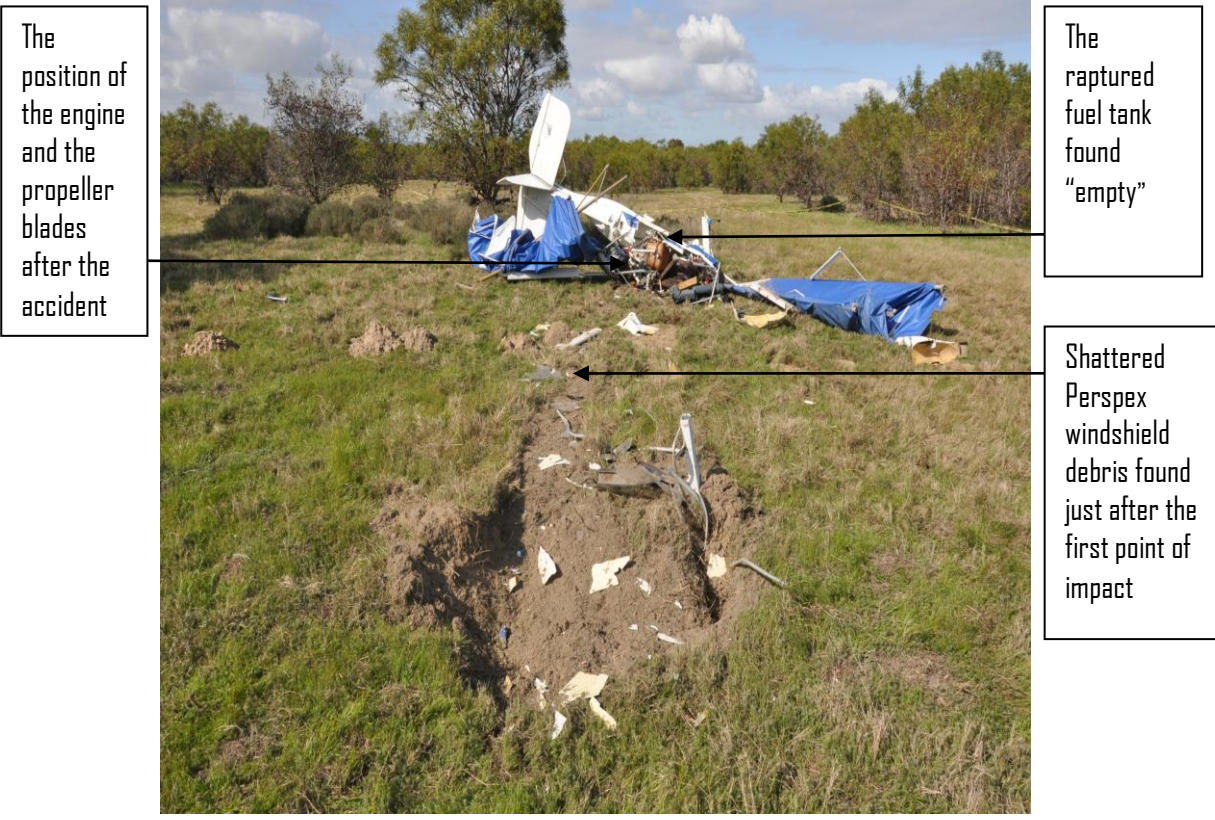
1.12.1 The aircraft broke into pieces after impact. The investigator in charge examined the entire wreckage and found it complete; no flight controls were missing. The aircraft had collided with the ground nose-low in a northerly direction. The cabin was destroyed on impact. The aircraft seat and safety harnesses had failed and the Perspex windshield had shattered during the accident sequence. The altimeter, the fuel gauge and the exhaust temperature gauge was damaged. The landing gear struts broken due to overload but the wheels were intact and were deflated during the on-site investigation. The wing support spars and the flaperon flight control system were destroyed. The horizontal and vertical stabilizers and the rudder remained attached. The engine had detached from the airframe during the accident sequence. Examination revealed that the drive belt was in place and the engine rotated freely by hand. The propeller was still attached to the engine. Attached below is a photo of the accident site.

Figure 7: The aircraft first point of impact and the final position of the wreckage

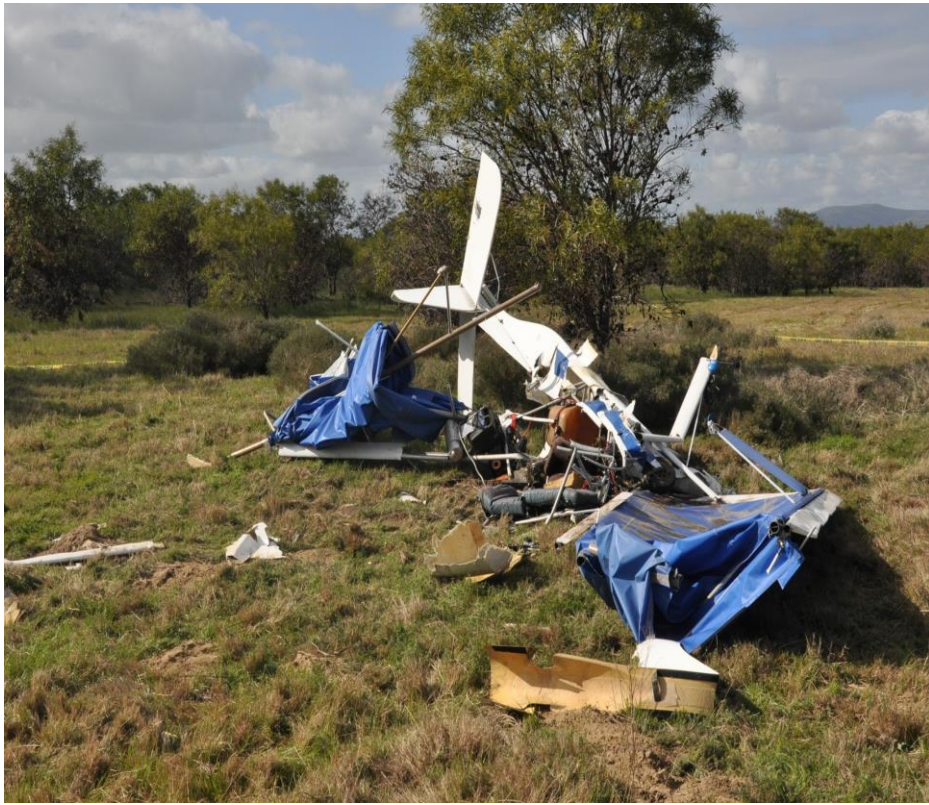
1.12.2 Power train continuity was confirmed. All the spark plugs displayed a light greyish colour associated with normal engine operation. Both carburettors bowls contained two stroke fuel that was free from contaminants. Inspection of the fuel pump revealed no evidence of pre-impact failure or malfunction. The fuel filter contained fuel; the unit was drained into a clean glass container and found to be of the correct grade and free of contamination. Both propeller blades tips had fractured; five pieces were recovered in the debris. The fuel in the filter was found to be uncontaminated. Attached below are pictures shot at the accident site.

Figure 8: The wreckage from another angle

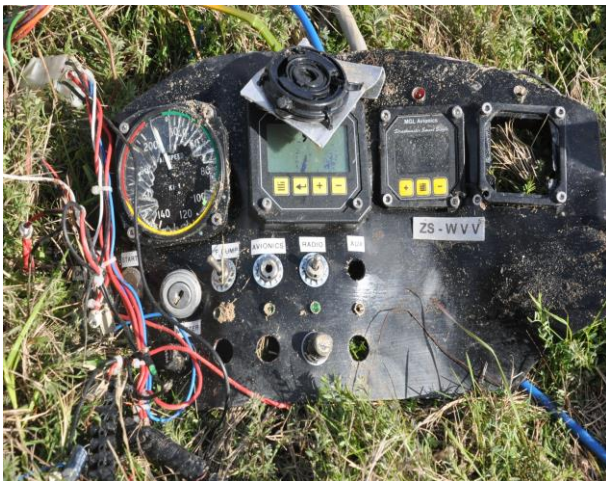
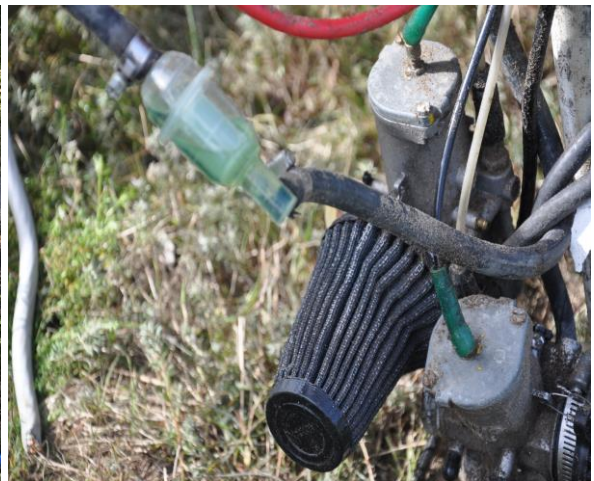
Figure 9: The instruments panel showing the fuel pump switch and the radio both in the “ON” position as well as the altimeter, fuel consumption gauge and the exhaust temperature gauge. None was of any use in the investigation

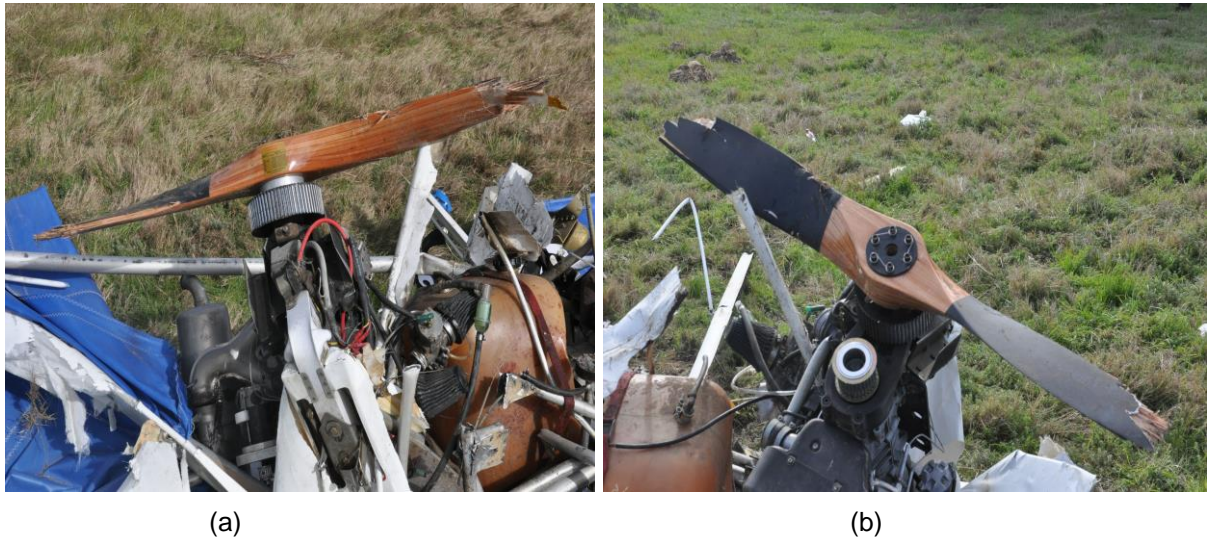
1.12.3 Severe damage to the propeller tips indicated that the engine was providing power at the time of impact. See the pictures below.

Figure 10: The propeller was attached to the engine and displayed tip damage; indicating that the engine had been providing power at the moment of impact
