AIRCRAFT ACCIDENT REPORT AND EXECUTIVE SUMMARY

Reference:	CA18/2/3/9463
Aircraft Registration	V5-NRS	Date of Accident	16 August 2015	Time of Accident	0429Z
Type of Aircraft	Cessna 441 (Aeroplane)		Type of Operation	Commercial (Medical Rescue, Part 138)	
Pilot-in-command Licence Type	Commercial (Namibia)	Age	53	Licence Valid	Yes
Pilot-in-command Flying Experience	Total Flying Hours	6353.0	Hours on Type	1357.9	
Last point of departure	Oranjemund Airport (FYOG) Namibia				
Next point of intended landing	Cape Town International Airport (FACT) Western Cape				
Location of the accident site with reference to easily defined geographical points (GPS readings if possible)					
On the farm Maastrecht, approximately 8 nm to the North of FACT. (GPS position S 33°50'56.3" E 018°34'57.5") elevation 468ft AMSL.					
Meteorological Information	Wind: 160°M/15 Knots; Visibility: 6000m; Temperature: 11°C; Dew point: 11°C; Cloud cover: Broken; Cloud base: 500ft.

Probable Cause					
The aircraft collided with terrain during instrument meteorological flight conditions while on the VOR approach for Runway 19 at FACT.					
SRP Date	12 September 2017	Release Date	20 September 2017

Name of Owner : Namibi

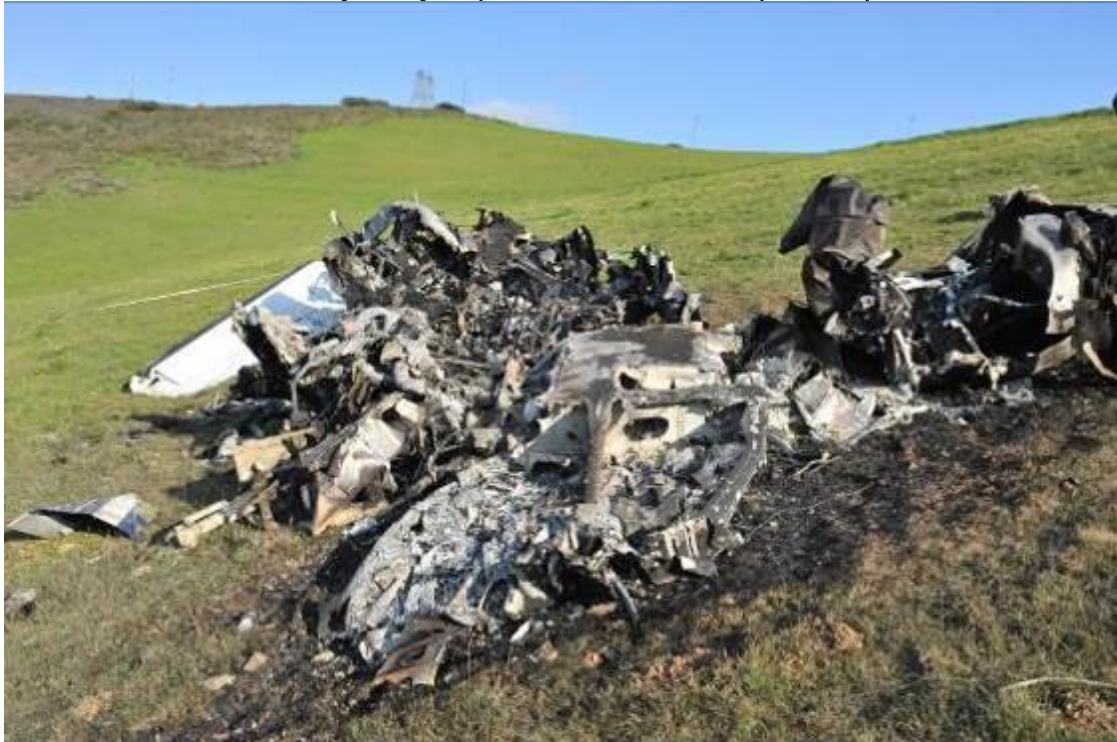
1.3.1 The aircraft was destroyed by impact forces and the post-impact fire.

Figure 1: The aircraft wreckage after the accident

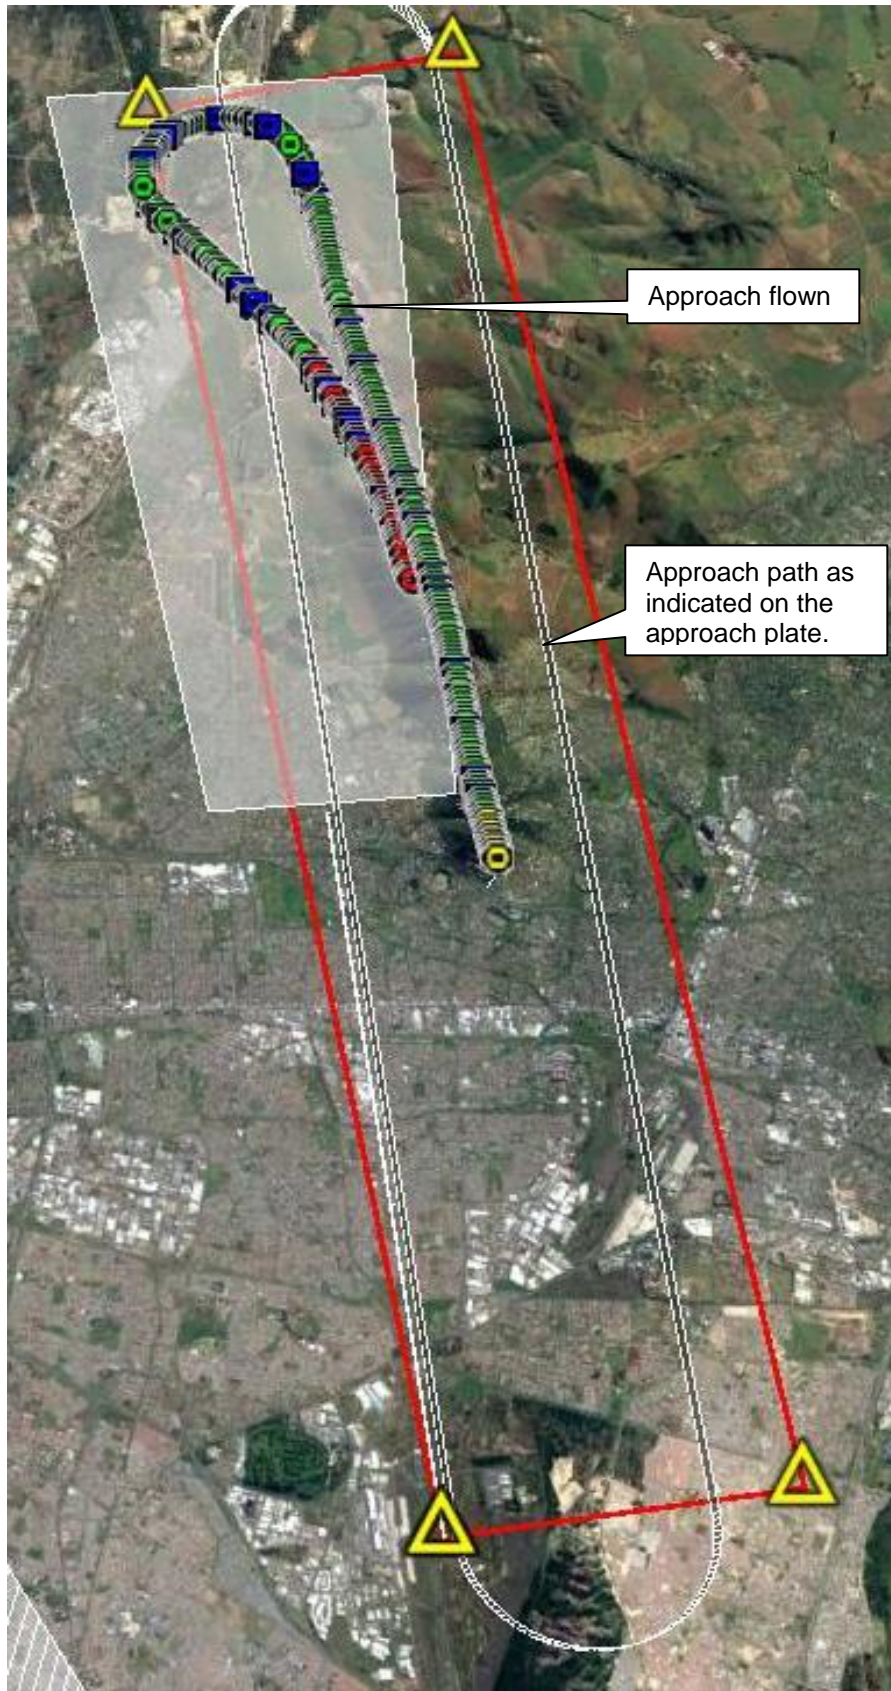
Figure 9: Reconstruction of the profile flown by the crew during the approach

1.10.6 The reconstruction in Figure 9, when each point as indicated and analysed, it indicates the last minute of flight that the aircraft's rate of descent was approximately 1100 feet/minute. The last speed before impact was 135 knots in a direction of 153°T.

2.4.2 During several stages of the approach onto the VOR for Runway 19, the aircraft was below the minimum obstacle clearance altitude (MOCA) as indicated by the approach plate for a specific point. The aircraft also failed to fly the correct heading/tracks during certain phase of the VOR approach, which the crew failed to correct.

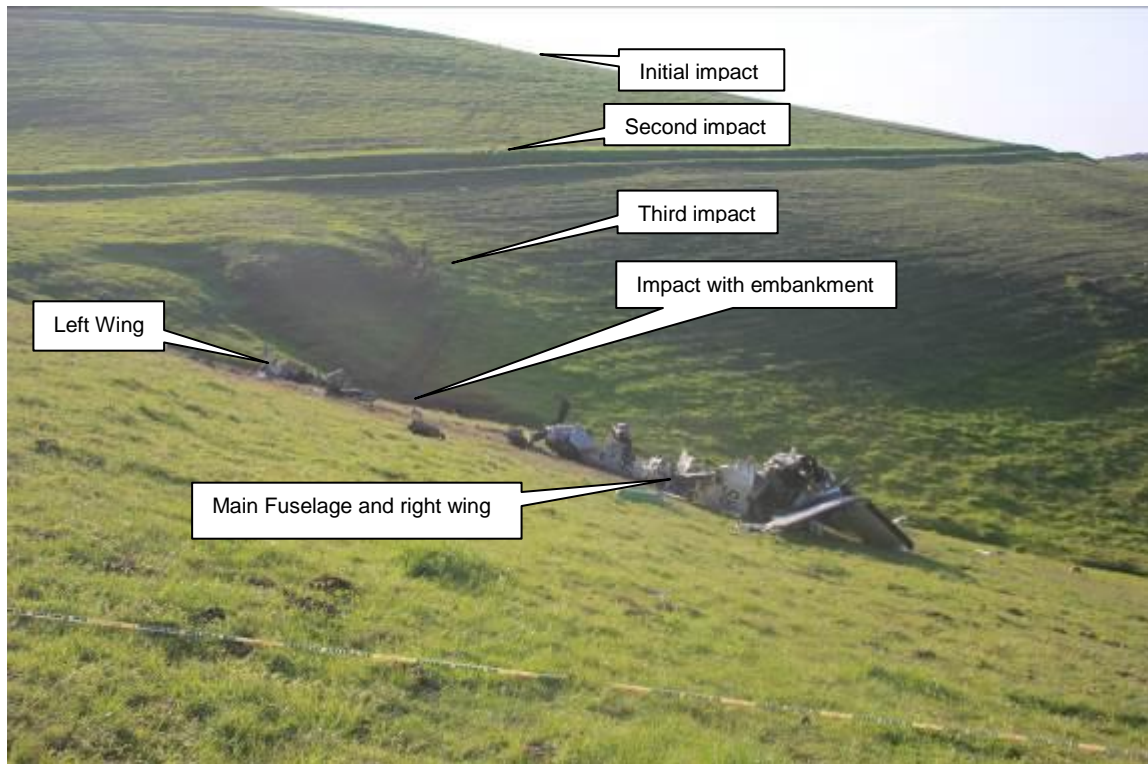
Figure 10: Impact sequence (Include an arrow to name the road)

- 1.12.1 The cockpit/cabin was crushed and destroyed by the impact forces and post-impact fire.
- 1.12.2 Both the left-hand and right-hand engines remained retained inside the engine mounting support, although heavy impact damage was displayed.

- 1.12.3 Two of the left propeller blades separated from the propeller hub when the aircraft hit the embankment. They were later found embedded in the embankment where the aircraft impacted the terrain.

- 1.12.4 After the impact with the embankment, the left wing separated from the fuselage.
- 1.12.5 The right wing remained attached to the fuselage during the sequence of the accident. All three right propeller blades remained attached to the propeller hub, although they were substantially damaged.

- 1.12.7 The left wing was found approximately 37m after the impact with the embankment.
- 1.12.8 The main wreckage was found in an inverted and twisted position, approximately 55m after the impact with the embankment. The general heading of the fuselage after the accident was approximately 045°true north.

- 1.12.9 Although the nose landing gear remained attached to the fuselage, the wheel had separated and was found in close proximity to the main wreckage in the direction of the impact. Both main landing gear legs broke off and was found in close proximity of the wreckage.

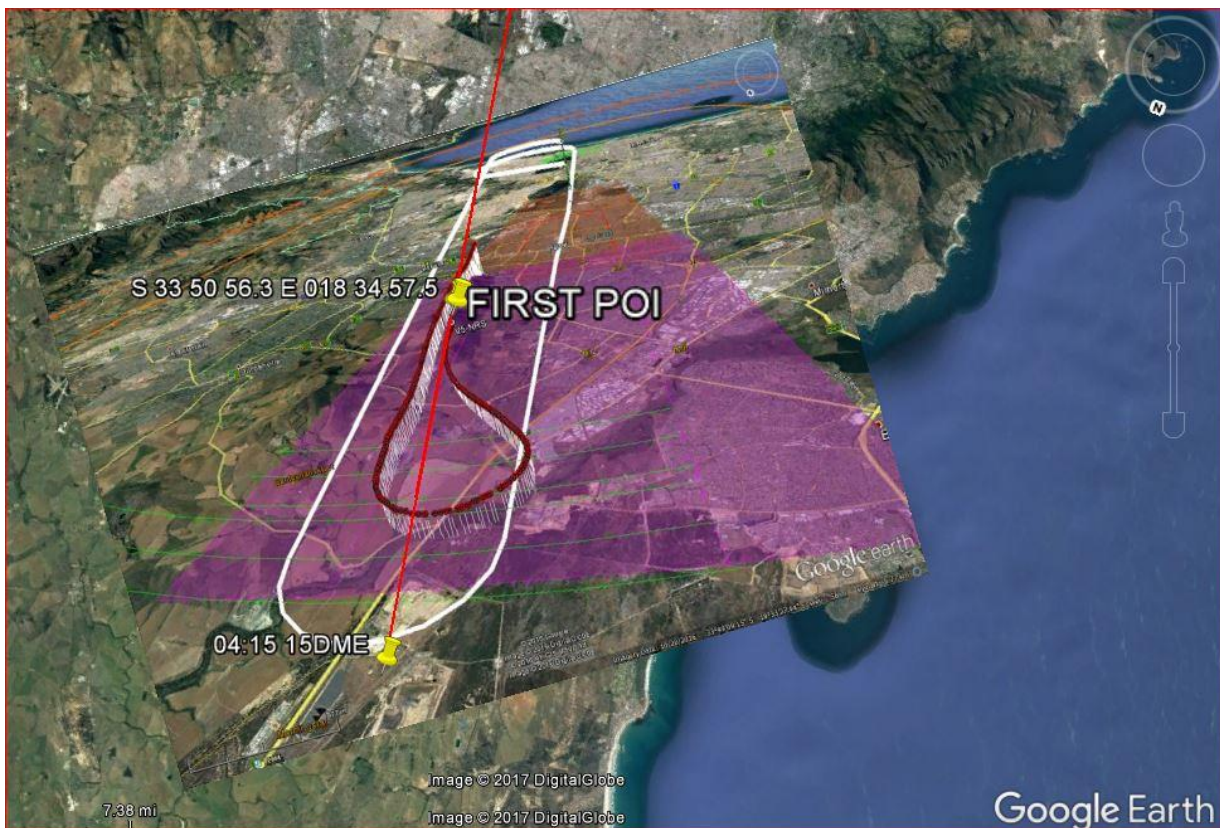
Figure 13: The red dots is the path flown by the aircraft and the white line is the pattern to be followed. Throughout the route the aircraft was tracking radial 010

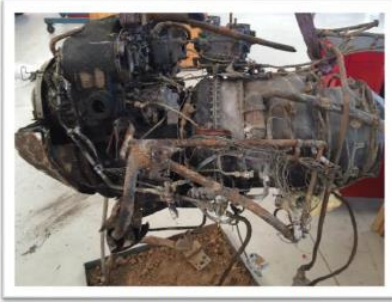
Image #1: The dark deposit/discolouration on the engine is indicative of exposure to fire.

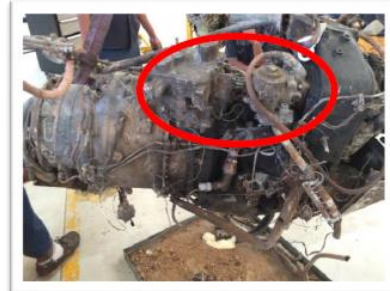
Image #2: The F.C.U. was noted to have broken off the Fuel Pump Assembly at F.C.U. – Fuel Pump split line.

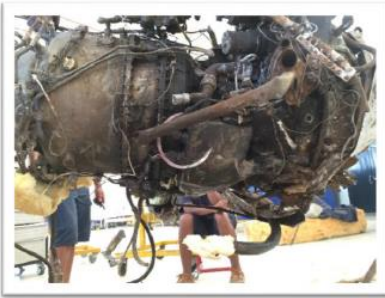
Image #3: Most externally mounted components were burnt and/or severely damaged.

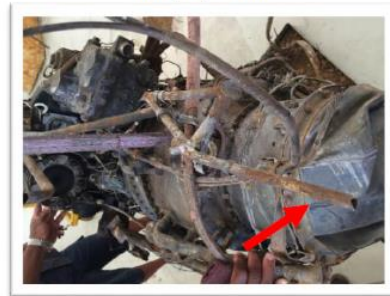
Image #4: The Exhaust Duct was noted to be bent severely.

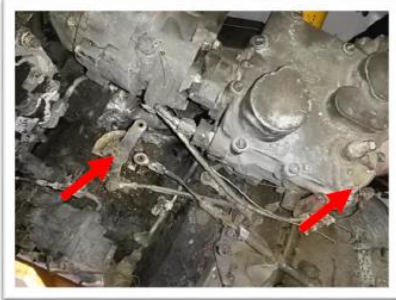
Image #5: Upon disassembly of the engine it was noted that the P.P.C. and F.C.U. protractors were possibly indicating the cockpit power lever position to have been at 60 degrees Power Lever Angle.

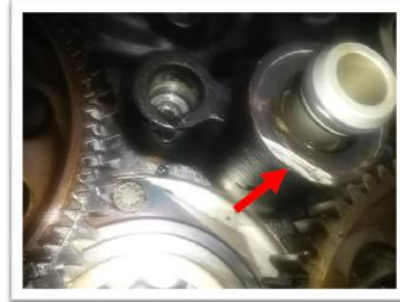
Image #6: Abnormal wear noted on the inside of the Accessory Housing in numerous areas.

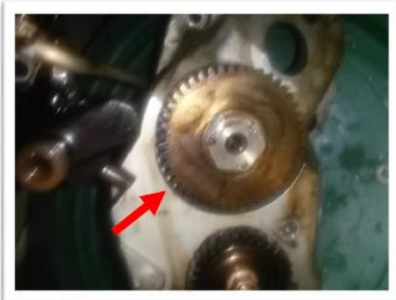
Image #7: In conflict to standard disassembly procedure, it was not possible to remove the Pilot Valve from the Hydraulic Torque Sensor.

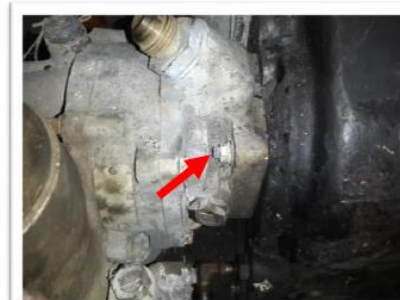
Image #8: The run-off torque was very low on most of the fasteners.

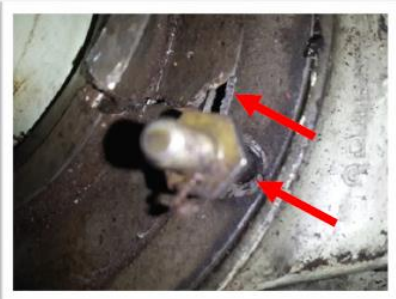
Image #9: The Output Housing Carbon Seal Carrier was noted to be cracked severely. Also, the retaining studs were noted to be missing or migrated forward.

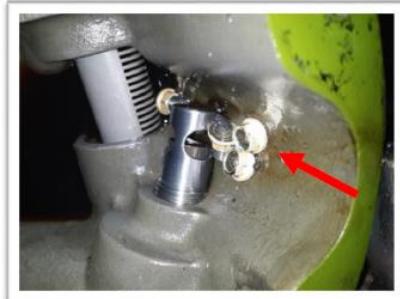
Image #10: The nuts and retaining studs securing the Output Housing Seal Carrier were found sheared within the Output Housing.

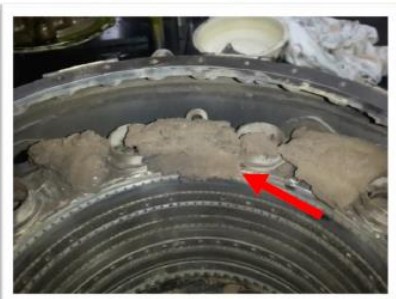
Image #11: Indications of soil ingestion were noted between the Combustion Chamber and the Combustion Liner.

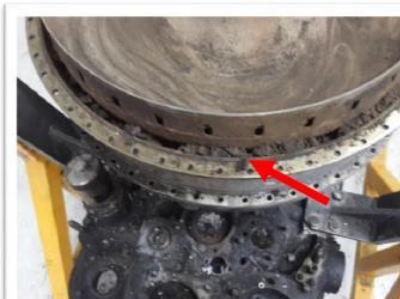
Image #12: Further indications of soil ingestion were noted between the Compressor Housing and the Outer Transition Liner.

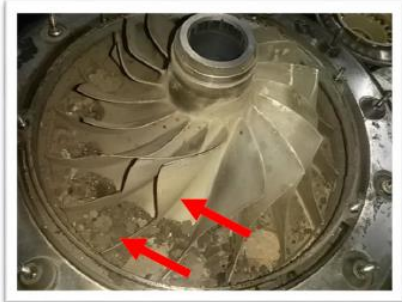
Image #13: Numerous vanes of the 1st Stage Impeller were found to be bent severely. Indications of soil ingestion found between the vanes.

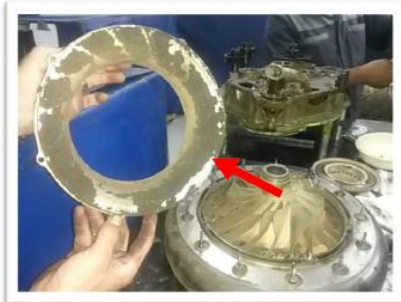
Image #14: Indications of soil ingestion noticed on the 1st Stage Shroud. No Impeller to Shroud contact noted.

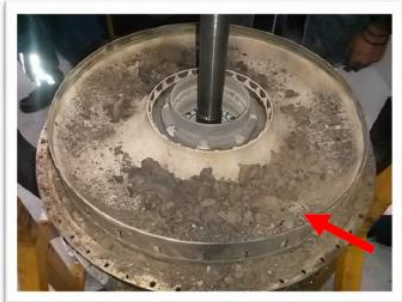
Image #15: Indications of soil ingestion noted on the Outer Transition Liner.

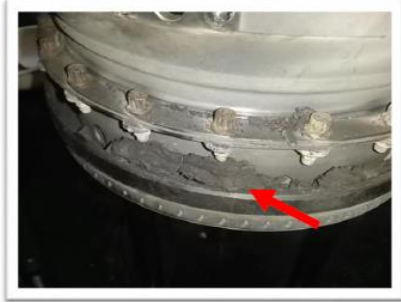
Image #16: Indication of soil ingestion noted within the Inner Transition Liner.

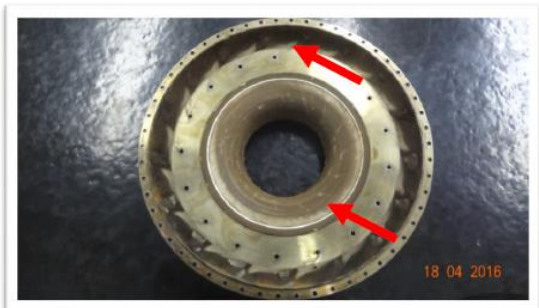
Image #17: Indications of soil ingestion noticed on the Compressor Housing. No Impeller to Shroud contact noted.

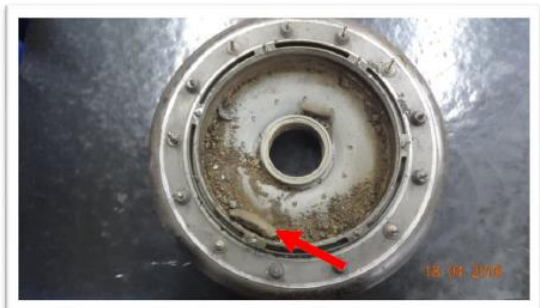
Image #14: Indications of soil ingestion noticed on the 1st Stage Diffuser.

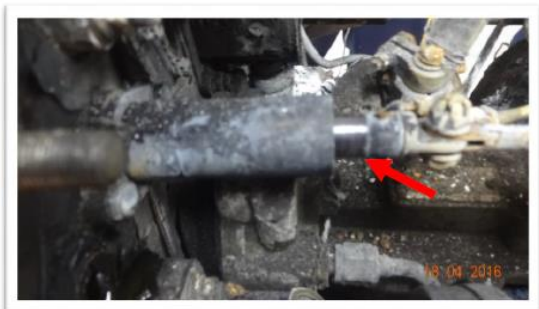
Image #19: The Feathering Valve did not appear to have been stroked at disassembly.

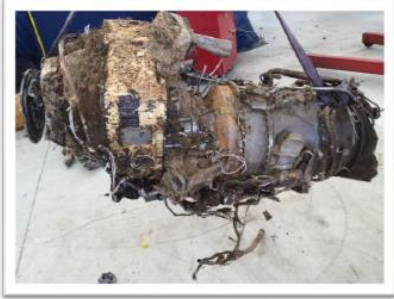
Image #1: Severe impact damage was noted on numerous components of the engine.

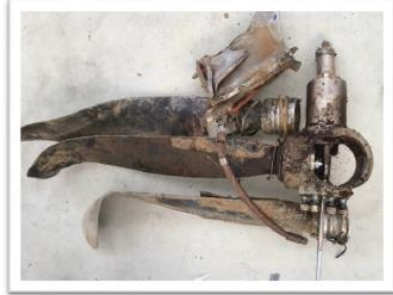
Image #2: The remains of the engine propeller were shipped with the engine.

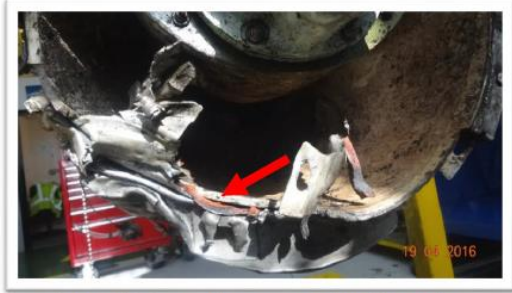
Image #3: Severe damage noted to the engine intake.

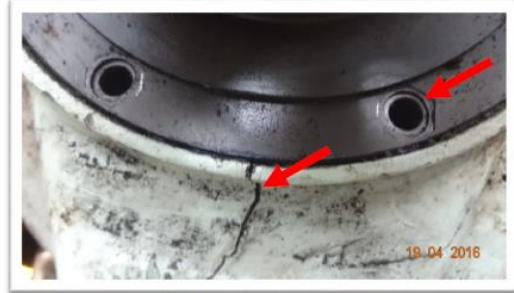
Image #4: Output Housing severely damaged. Retaining studs on Output Housing Carbon Seal carrier are missing.

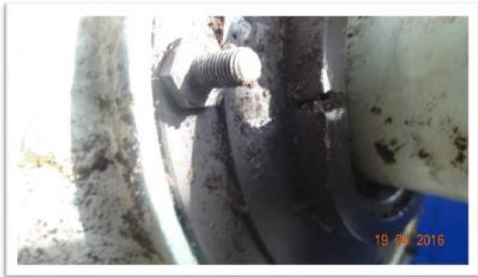
Image #5: Output Housing Carbon Seal Carrier severely damaged.

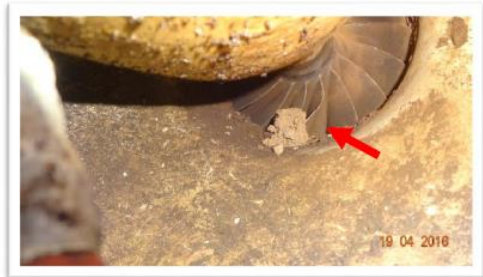
Image #6: Deposits of soil found within the engine intake. Numerous vanes on the 1st Stage Impeller are damaged.

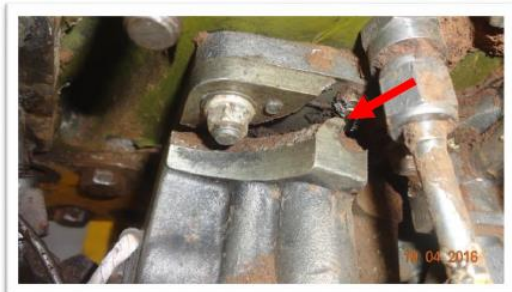
Image #7: Propeller Governor found parted from the mounting pad.

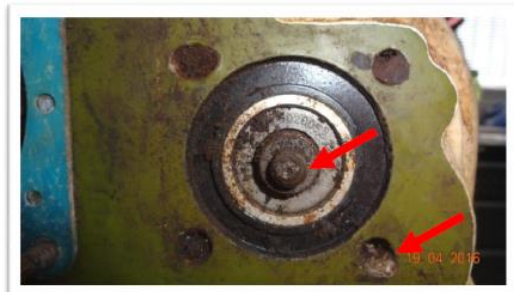
Image #8: Fuel Pump Assembly mounting studs missing from Accessory Housing. Splined drive shaft was noted to be sheared.

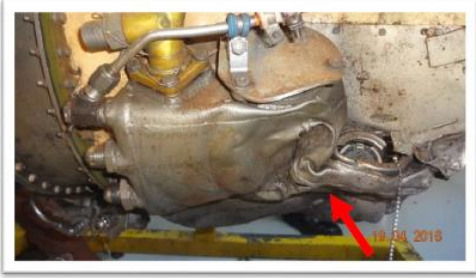
Image #9: Oil Tank appears to be crushed.

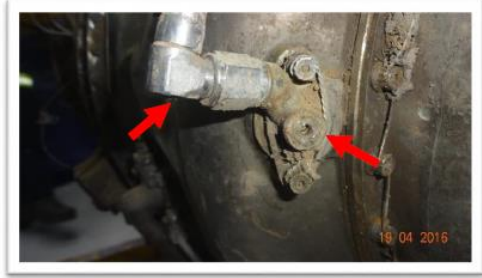
Image #10: Sections of the fuel manifold and fuel nozzles were broken off.

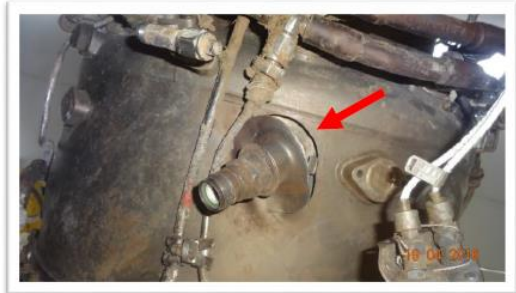
Image #11: Igniter boss appears to have partially parted from Combustion Chamber.

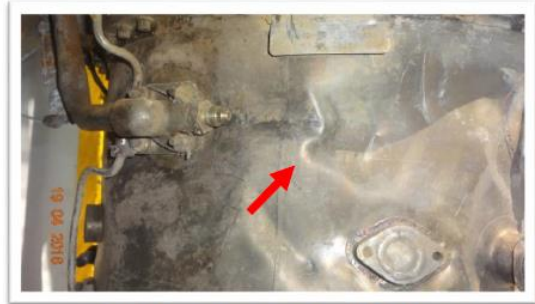
Image #12: Combustion Chamber has been distorted in numerous areas.

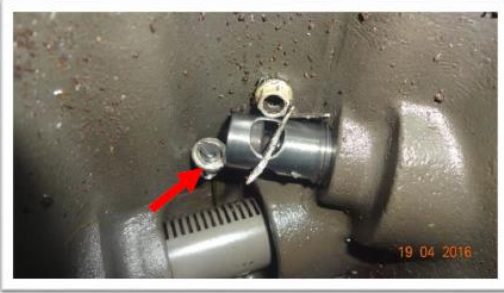
Image #13: Remains of retaining studs and nuts from Output Housing Carbon Seal Carrier found in bottom of Output Housing.

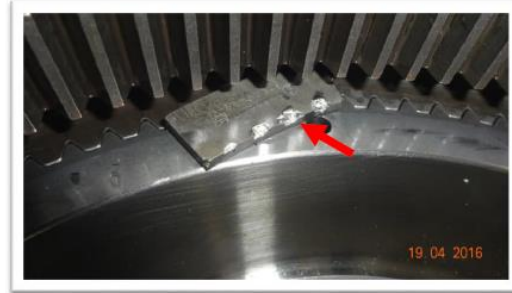
Image #14: Abnormal wear noted on the retention plate retaining the ring gear.

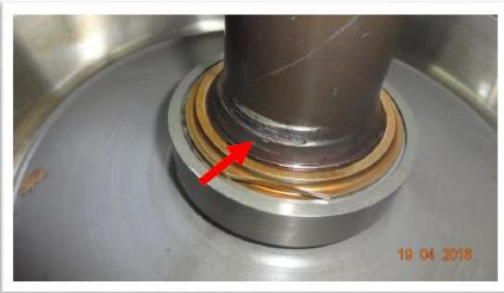
Image #15: Abnormal wear noted on Propeller Shaft, possibly caused by rub from the Sun Gear.

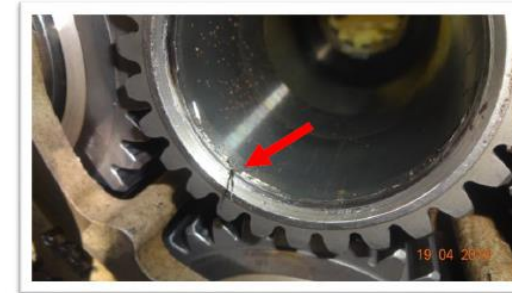
Image #16: Abnormal wear noted on the Sun Gear, possibly caused by rub from the Propeller Shaft.

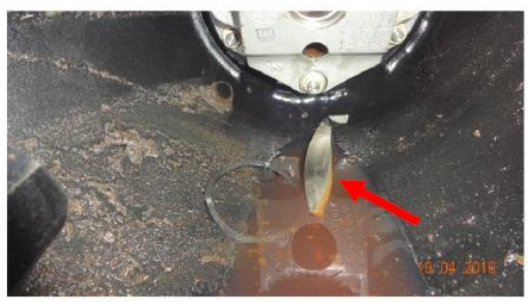
Image #17: Large metal debris found in the Accessory Housing suspected origin from the No. 1 Bearing Assembly.

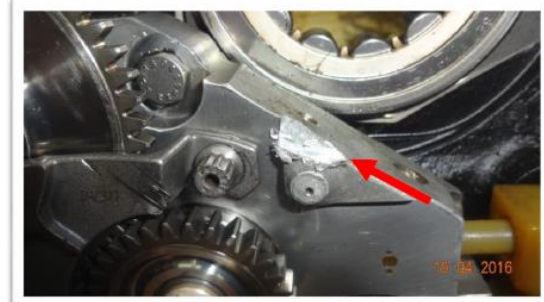
Image #18: Abnormal wear noted on the Torque Sensor body.

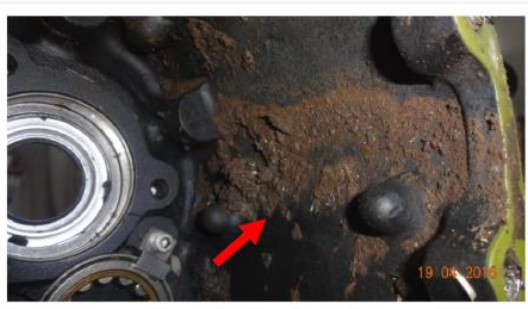
Image #19: Indications of soil deposits within the Accessory Housing.

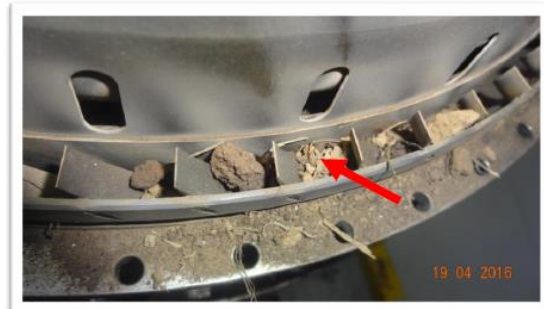
Image #20: Deposits of soil noted within the Deswirl Vane in the Combustion Section.
