**GOVERNMENT OF INDIA**  
**CIVIL AVIATION DEPARTMENT**

**INVESTIGATION REPORT**

**INCIDENT TO AIR INDIA AIRBUS A-320 A/C VT-ESI WHILE  
OPERATING FLIGHT AI-405 (VARANASI-DELHI) ON 07-09-2015**

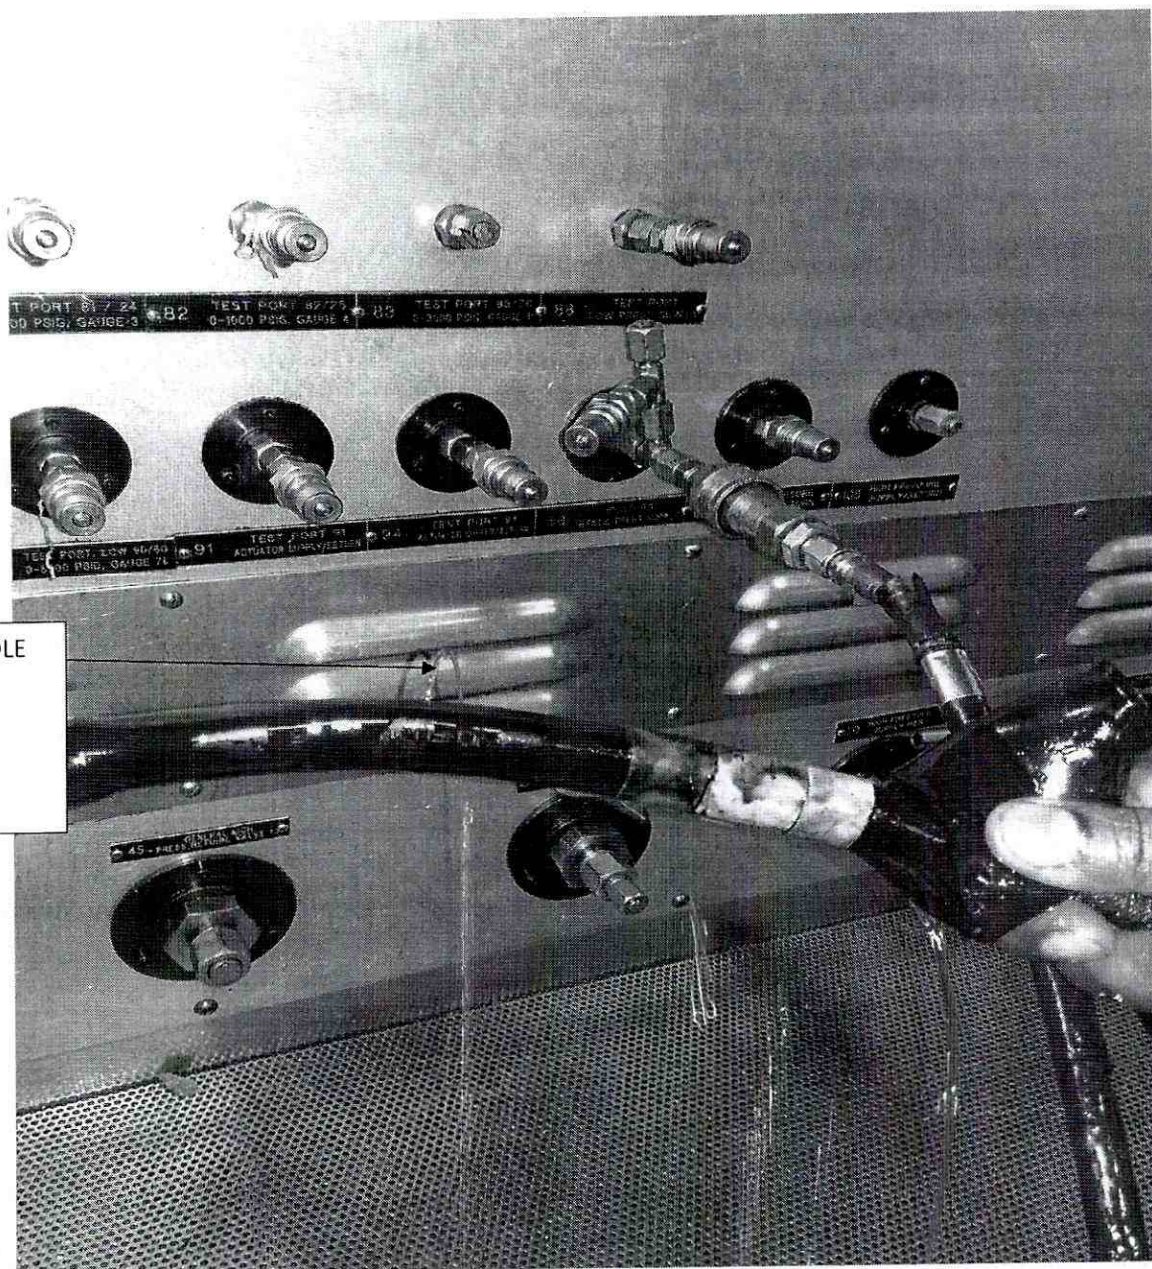
**1.16. Tests & Research:** The flexible hose of no. 6 'brake assembly' was tested for 'leak' on a hydraulic test rig facility of Air India at New Delhi . When a pressure of 150 PSI was applied, a pin hole leak was observed in the hose. With increase in pressure , the leakage of hydraulic fluid also increased. Hydraulic System pressure in A-320 aircraft is 3000 PSI.

**2.4. Leak Test of Flexible Hose :** During 'leak test' of flexible hose of no. 6 'brake assembly' on a hydraulic test rig, it was found that it had developed a pin-hole leak and hydraulic fluid began to leak on application of 150 PSI pressure. Hydraulic System pressure in A-320 aircraft is 3000 PSI. Leakage at such pressure would be considerably high.

PIN-HOLE  
LEAK  
FROM  
HOSE

The flexible hose was subjected to 'leak test' on a Hydraulic Test Rig. It began to leak at 150 PSI pressure.
