FINAL REPORT

AIC 15-1004

**PAPUA NEW GUINEA
ACCIDENT INVESTIGATION COMMISSION
SHORT SUMMARY REPORT**

Aircraft overturned during landing

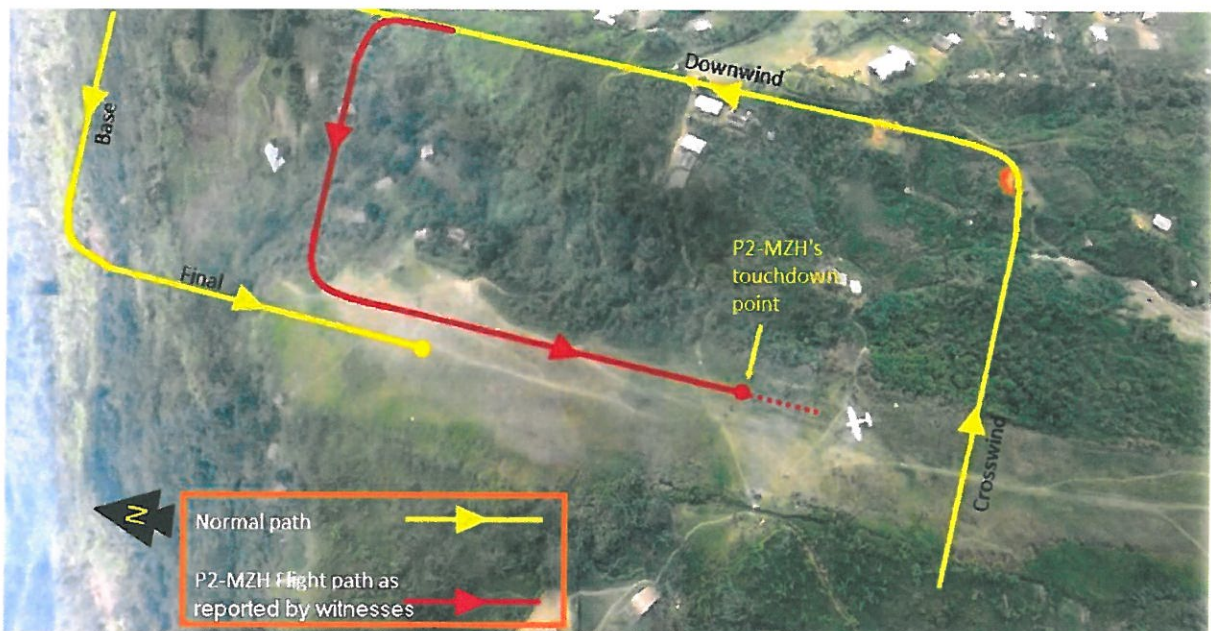
Figure 1: Aerial view of Kombaku airstrip

At 02:08 UTC¹ on 7 September 2015, a Cessna U206G Robertson STOL aircraft, registered P2-MZH, owned and operated by Islands Airways, was being operated from Madang to Kombaku airstrip, Madang Province under the visual flight rules (VFR). The aircraft was chartered by the Madang Provincial Government to deliver stationary in preparation for the opening of a new classroom at the Kombaku community school. There were three persons on board; the pilot and two adult passengers. On arrival overhead Kombaku, the pilot cancelled SARWATCH (search and rescue watch) and completed a circuit to inspect the surface conditions and wind. He subsequently joined left base and then final for strip 18 (Figure 1).

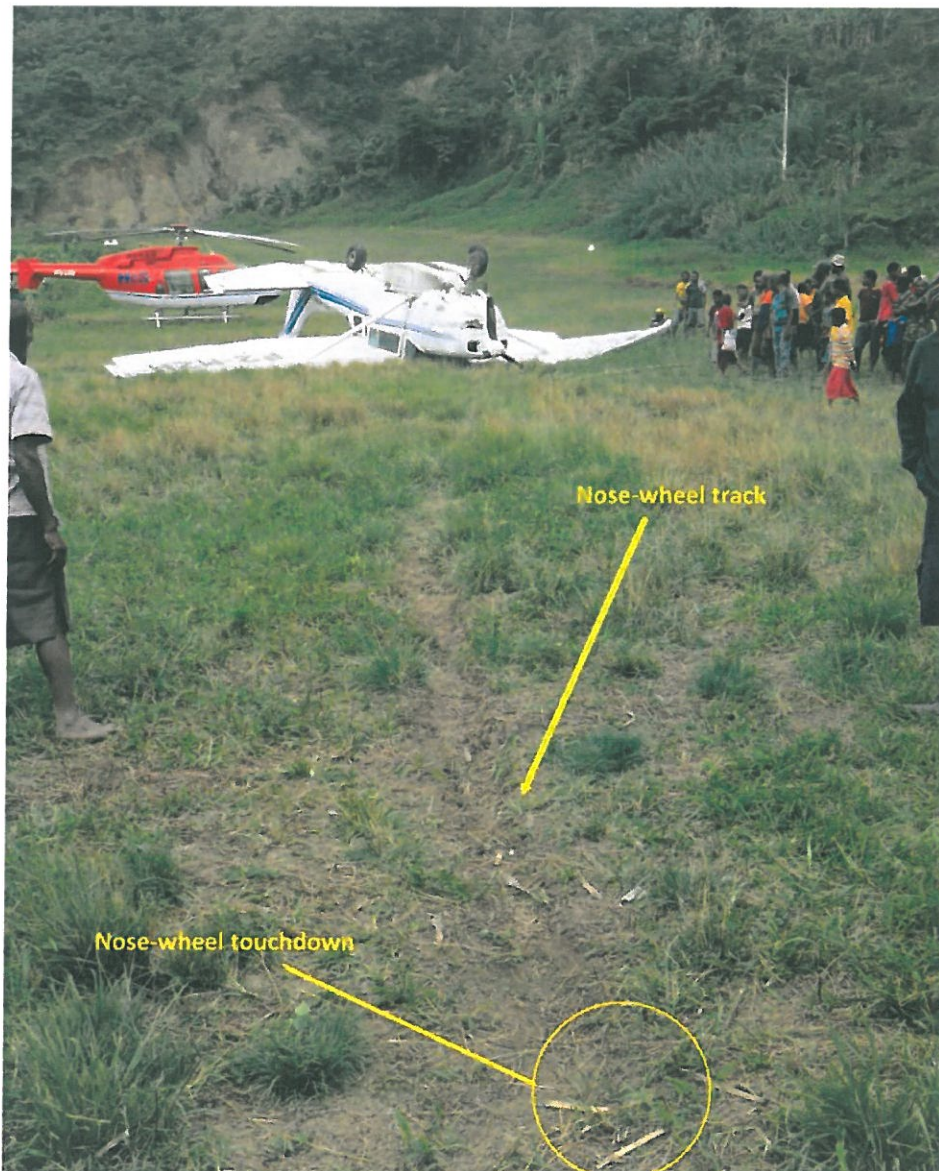
Figure 2: Nose-wheel track

The aircraft's nosewheel touched down heavily on the strip about 140m from the threshold and left of the centre line. The aircraft subsequently 'wheelbarrowed' for about 40m, digging into the soft grassy surface of the strip. There was no evidence of the main wheels making contact with the strip surface. The nosewheel dug into the surface, the propeller struck the ground, and the aircraft 'cart-wheeled' and came to rest inverted.

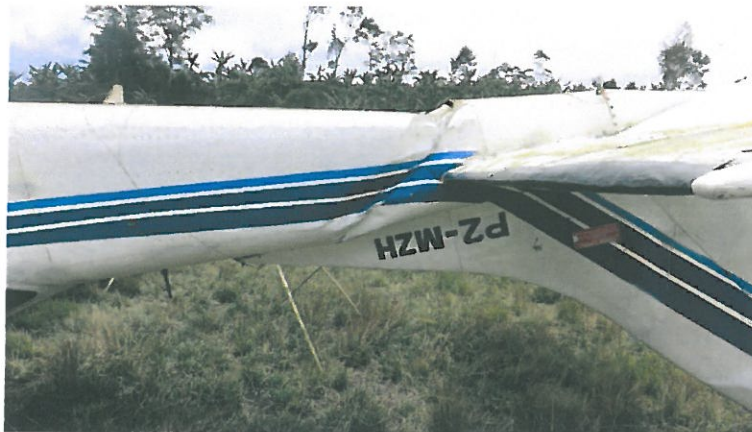
Figure 4: Damage to the tail section

The aircraft was substantially damaged. The rear fuselage was fractured and bent by impact forces when the fin and rudder struck the ground when the aircraft overturned (Figure 4). The wings were destroyed during the impact (Figure 5).

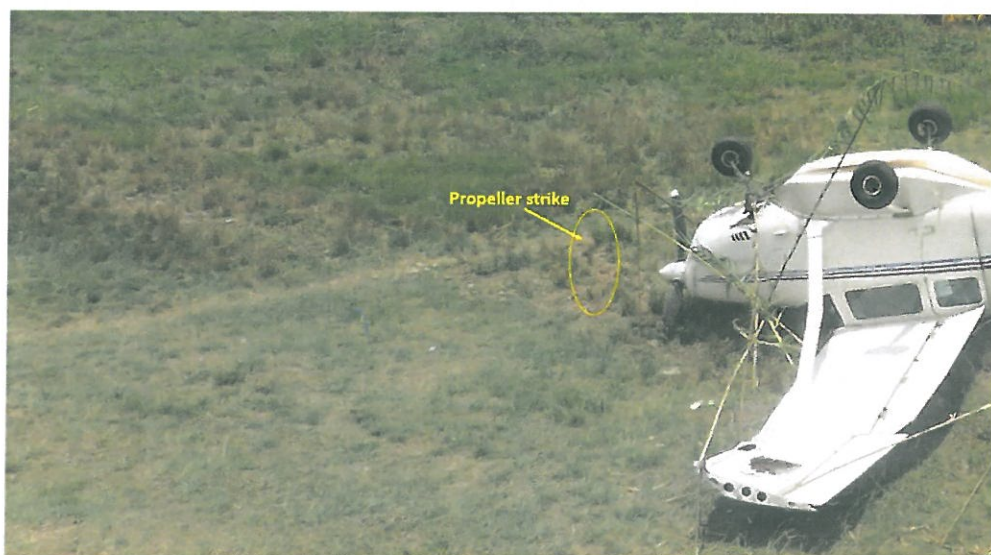
Figure 6: Propeller ground strike

One of the propeller blades was substantially bent at the tip (Figure 7) suggesting that this blade contacted the ground (Figure 6) while the aircraft was ‘wheel-barrowing’. The other blades were substantially damaged as the aircraft impacted the ground inverted.
