SHORT REPORT AND EXECUTIVE SUMMARY

Reference:	CA18/2/3/9481	
Aircraft registration	ZS-OCB	Date of accident	24 September 2015		Time of accident	1430Z
Type of aircraft	AS350B2 (Helicopter)		Type of operation		Private (Part 91)	
Pilot-in-command licence type		Private pilot	Age	67	Licence valid	Yes
Pilot-in-command flying experience		Total flying hours	830.5		Hours on type	259.4
Last point of departure		Grand Central Aerodrome (FAGC), Gauteng Province				
Next point of intended landing		Grand Central Aerodrome (FAGC), Gauteng Province				
Location of the accident site with reference to easily defined geographical points (GPS readings if possible)						
Open field west of Pelindaba (GPS position: 25°48'16.95" South 027°54'02.30" East), elevation 4126 feet						
Meteorological information		Surface wind: 315°/10 knots, Temperature: 25°C, CAVOK.				
Number of people on board	1 + 1	No. of people injured	0	No. of people killed	0	
Synopsis

AIRCRAFT ACCIDENT REPORT

Name of Owner : Cochrane Steel Products (Pty) Ltd
Name of Operator : Private (Part 91)
Manufacturer : Eurocopter
Model : AS350B2
Nationality : South African
Registration markings : ZS-OCB
Place : Open field near Pelindaba
Date :

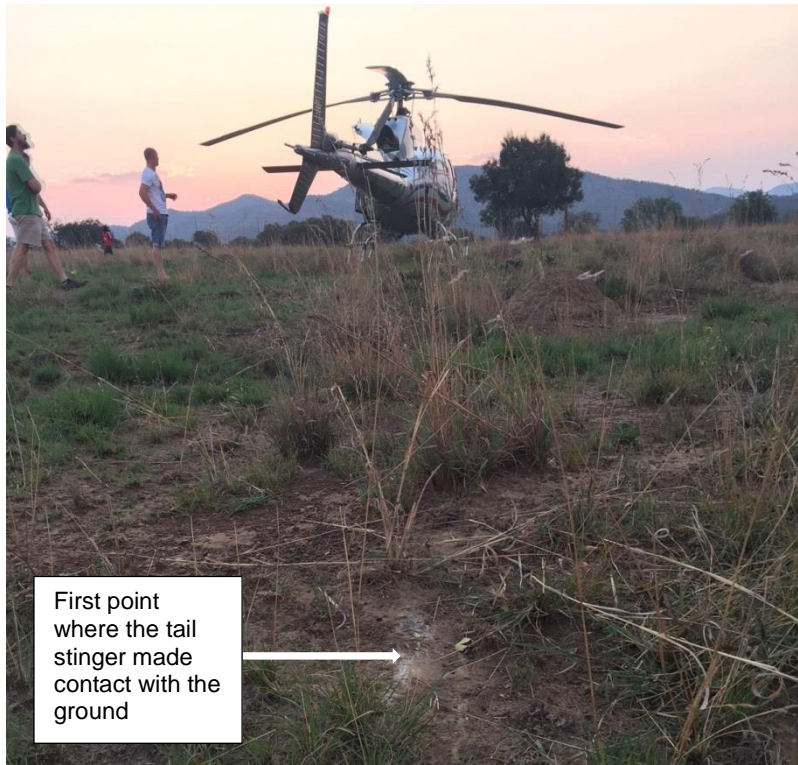
Figure 1: The wreckage as it came to rest

- 2.1.1 Hard landing following an autorotation due to obscured vision (smoke in cabin).

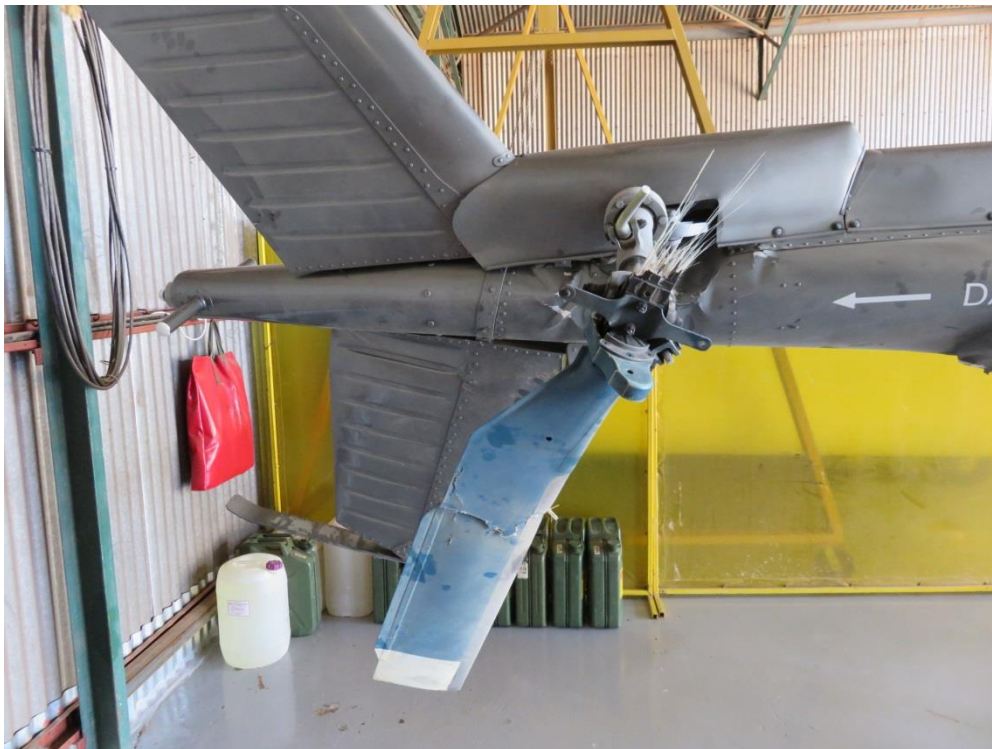
- 1.1.3 The aft tail boom structure was found to have twisted. The tail rotor blades made contact with the ground, with one of the blades separating from the tail rotor hub assembly. It was found that the air-conditioning drive belt had melted and smoke from the belt had entered into the cockpit/cabin area. The drive belt was recovered from the transmission platform. Nobody was injured in the accident, but the helicopter sustained substantial structural as well tail rotor drive train damage.

Figure 2: The damage to the tail rotor, with one of the blades broken off

- 1.2.9 The helicopter sustained substantial damage to the tail boom structure and the tail rotor drive train.
- 1.2.10 The pilot experienced obscured vision due to smoke in the cockpit/cabin.

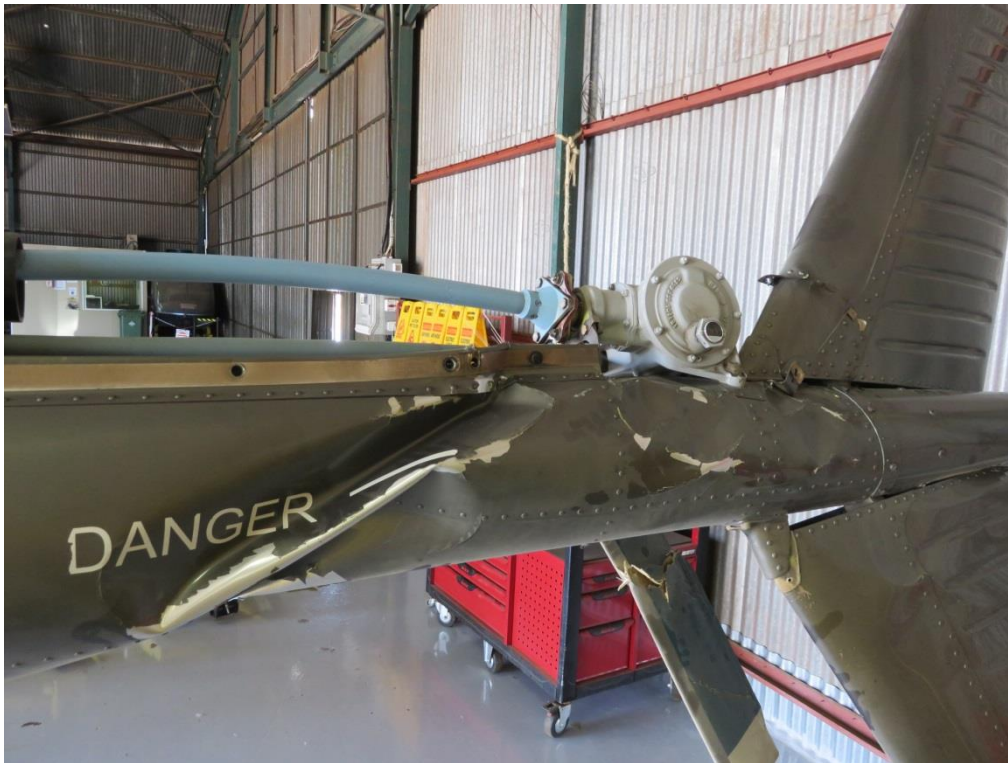
Figure 3: The twist to the aft tail boom structure

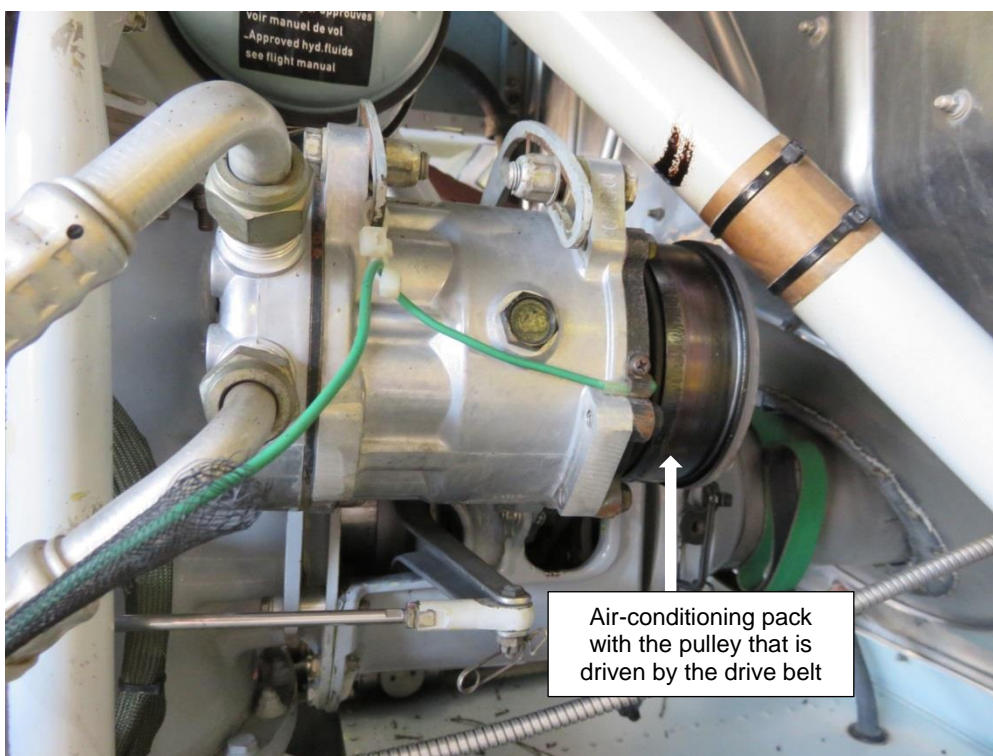
Air-conditioning pack with the pulley that is driven by the drive belt

Figure 4: The air-conditioning pack that was driven by a drive belt

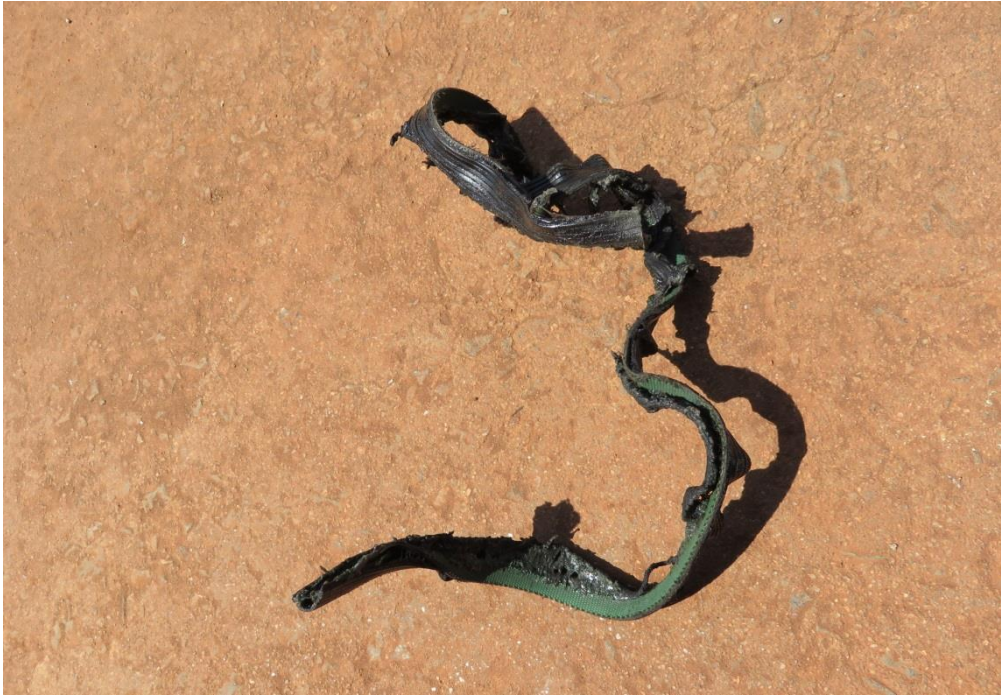
Figure 5. The air-conditioning drive belt that was found melted on the transmission platform

- 1.2.11 The prevailing weather conditions at the time had no influence on the accident.
- 1.2.12 The cause for the melting of the air-conditioning driving belt could not be determined.

- 2.2.1 The smoke in the cabin was as a result of air-conditioning drive belt melting.

- 3.1 Safety Message: Pilots needs to adhere to the procedures issued by the manufacturer, organisation and the regulation as they are issued as a prevention measure for possible accident and incidents.
