AIRCRAFT ACCIDENT REPORT AND EXECUTIVE SUMMARY

Reference:	CA18/2/3/9486	
Aircraft Registration	ZS-CJV	Date of Accident	1 October 2015		Time of Accident	15:15Z
Type of Aircraft	Cessna 175		Type of Operation	Commercial- Part 135		
Pilot-in-command Licence Type		Commercial pilot	Age	52	Licence Valid	Yes
Pilot-in-command Flying Experience		Total Flying Hours	4 381		Hours on Type	1480.10
Last point of departure		Weltevrede airstrip: Western Cape Province				
Next point of intended landing		Weltevrede airstrip: Western Cape Province				
Location of the accident site with reference to easily defined geographical points (GPS readings if possible)						
Weltevrede airstrip (GPS S34 ° 25' 35" E 019 ° 28' 23") elevation 135 feet AMSL						
Meteorological Information		Wind direction:090 ° wind speed: 5kts CAVOK temperature 20 °				
Number of people on board	1+2	No. of people injured	0	No. of people killed	0	
Synopsis						
<p>The pilot, accompanied by two passengers, departed from Weltevrede airstrip on a scenic flight. The aircraft routed via Pearly Bay, which is 15nm from Weltevrede, and then back via Gansbaai. On arrival at Weltevrede airstrip, the aircraft approached from the south at 160

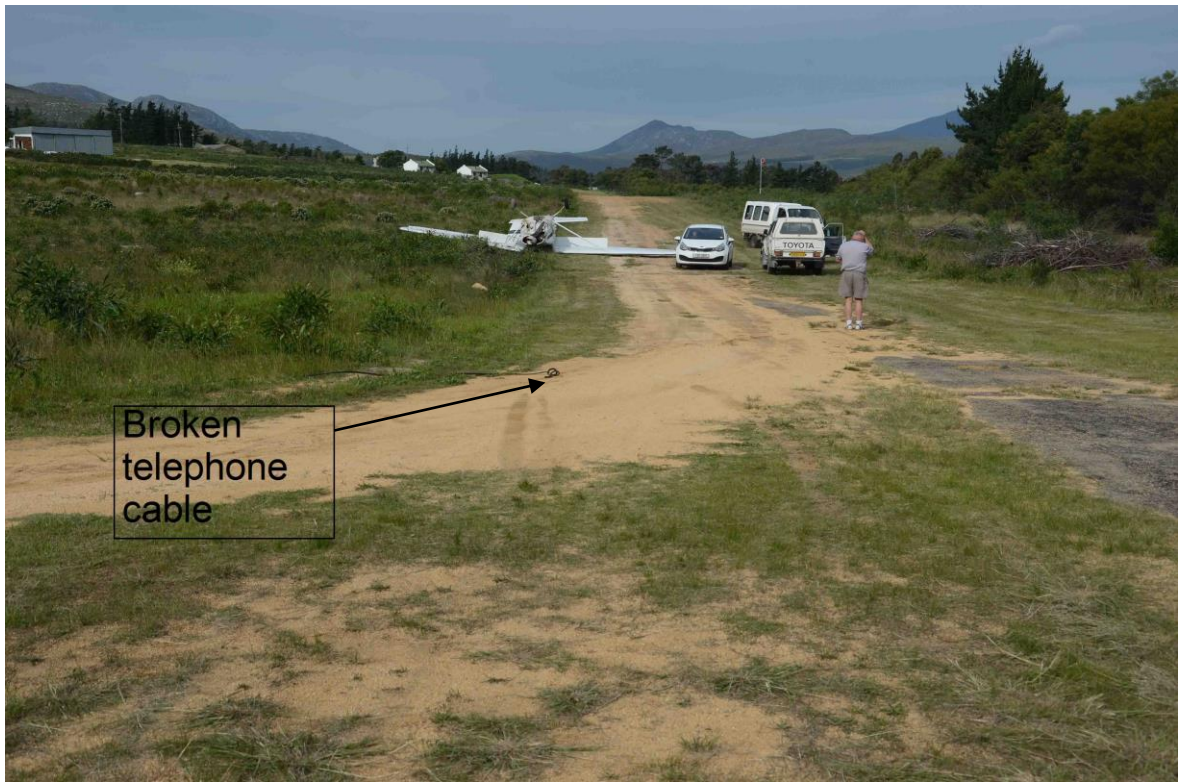
- 1.1.3 The aircraft passed below the bird. The nose gear got caught on a telephone cable located 580m from the threshold runway 11. The cable broke and got entangled around the nose gear oleo. The aircraft touched down in a nose high attitude and bounced.

1.4.1 Telephone cable, spanned across, was situated 580m from the threshold of runway 11.

Figure 2: View of the broken telephone cable

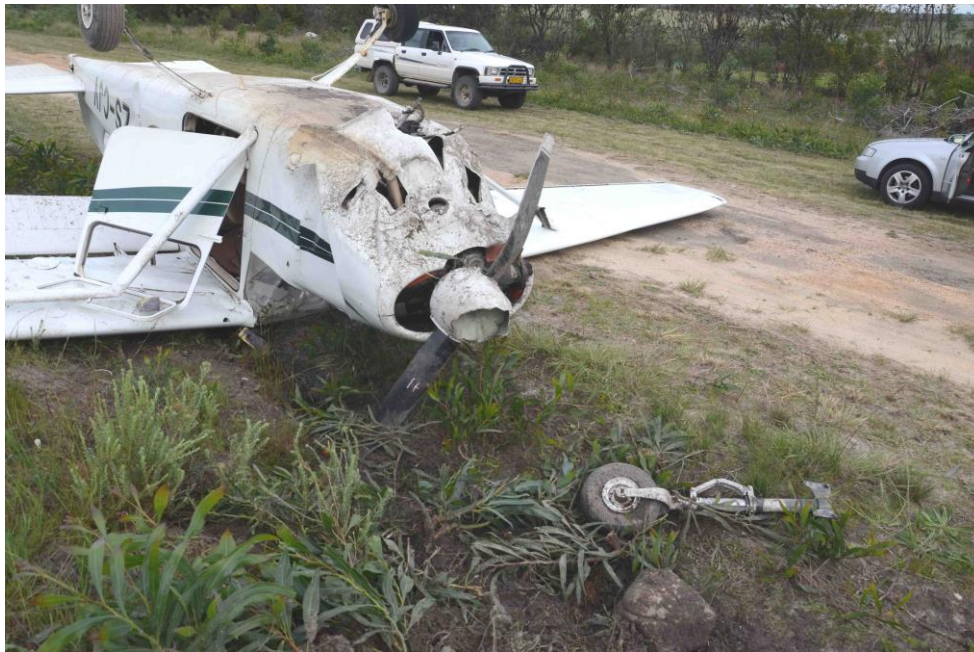
1.12.2 The aircraft touched down again left of the runway and ran into a shallow storm water drainage on the left-hand side of the runway. The nose gear oleo broke off and the aircraft gently flipped onto its back and came to rest.

1.12.3 The propeller struck the ground. The cowling, the fuselage and the vertical stabiliser were also damaged. The nose wheel broke off. The wings and wing support struts were also damaged.

Figure 3: View of the aircraft after it came to rest
