AIRCRAFT ACCIDENT REPORT AND EXECUTIVE SUMMARY

Reference:	CA18/2/3/9492	
Aircraft Registration	ZS-MRM	Date of Accident	16 October 2015		Time of Accident	Unknown	
Type of Aircraft	Beech Bonanza F33A		Type of Operation		Private (Part 91)		
Pilot-in-command Licence Type		Commercial Pilot	Age	22	Licence Valid	Yes	
Pilot-in-command Flying Experience		Total Flying Hours	unknown		Hours on Type	unknown	
Last point of departure		Wonderboom Aerodrome (FAWB), Gauteng Province					
Next point of intended landing		Wonderboom Aerodrome (FAWB), Gauteng Province					
Location of the accident site with reference to easily defined geographical points (GPS readings if possible)							
Motlatse Canyon Provincial Nature Reserve in an area called Erasmushoek close to Bourkes Luck Potholes, Graskop, Mpumalanga (S24° 40.267 E030° 54.720 at 5207 feet elevation)							
Meteorological Information		Temperature: 12.2 °C; Dew point: 11.8; Wind 255°-264 ° /04 kt; Visibility: Reduced; Cloud cover: broken clouds.

AIRCRAFT ACCIDENT REPORT

Name of Owner : Intrax Investments 108 (PTY) LTD
Name of Operator : Private
Manufacturer : Beech Aircraft Corporation
Model : Beech Bonanza F33A
Nationality : South African
Reg

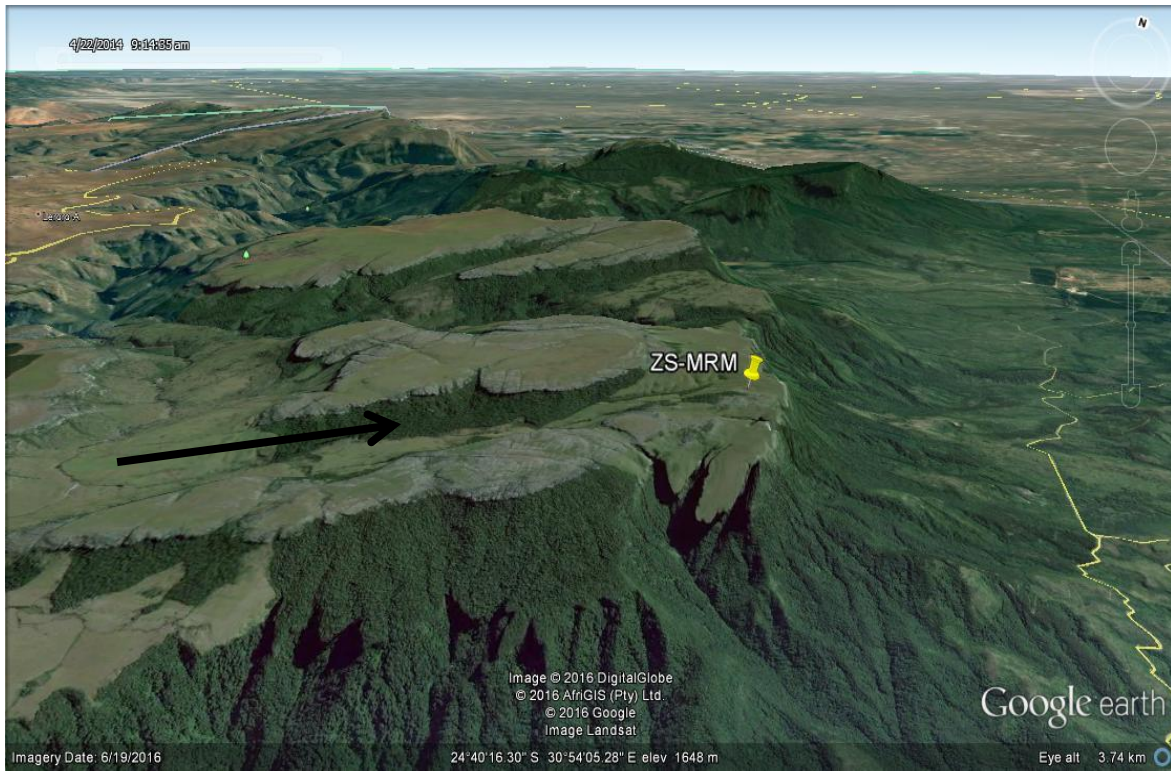
- 1.1 The wreckage of ZS-MRM was found to have crashed onto mountains in the Motlatse Canyon Provincial Nature Reserve in the Erasmushoek area close to Bourkes Luck Potholes, Graskop, Mpumalanga. The pilot sustained fatal injuries during the accident.

Figure 1: Google Earth view of accident site

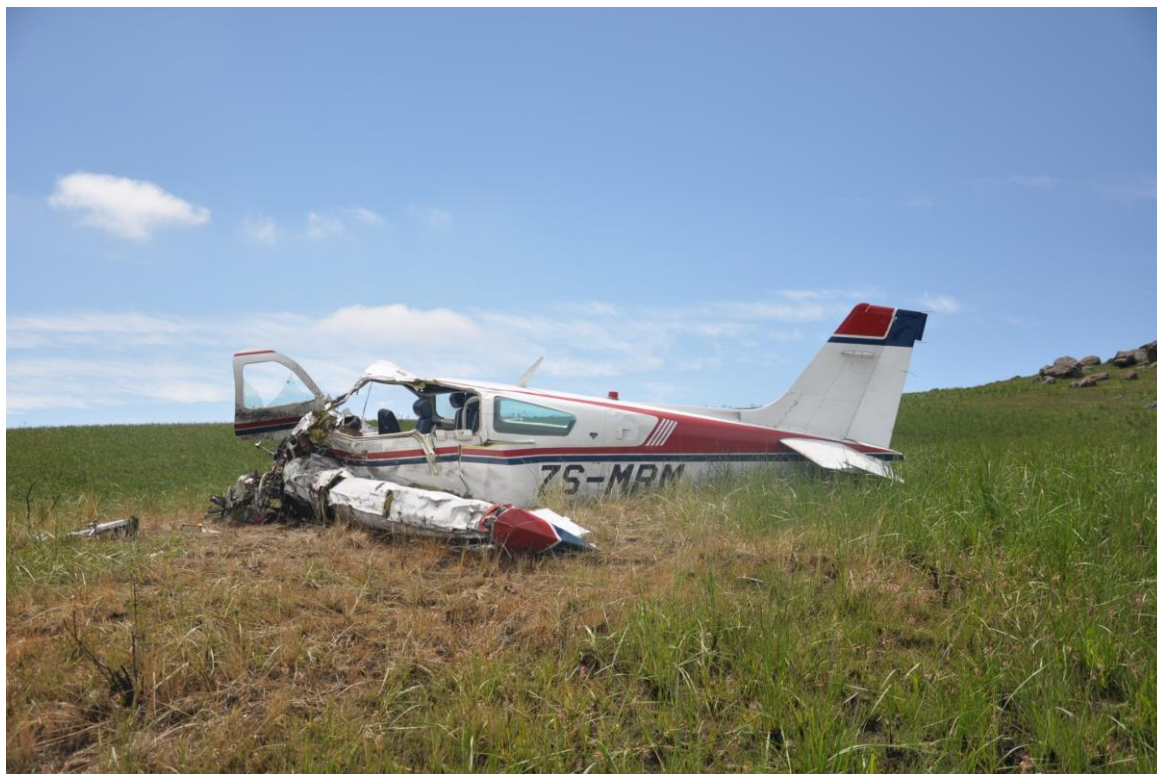
1.3.1 The aircraft was destroyed during the accident.

Figure 3: View of aircraft wreckage

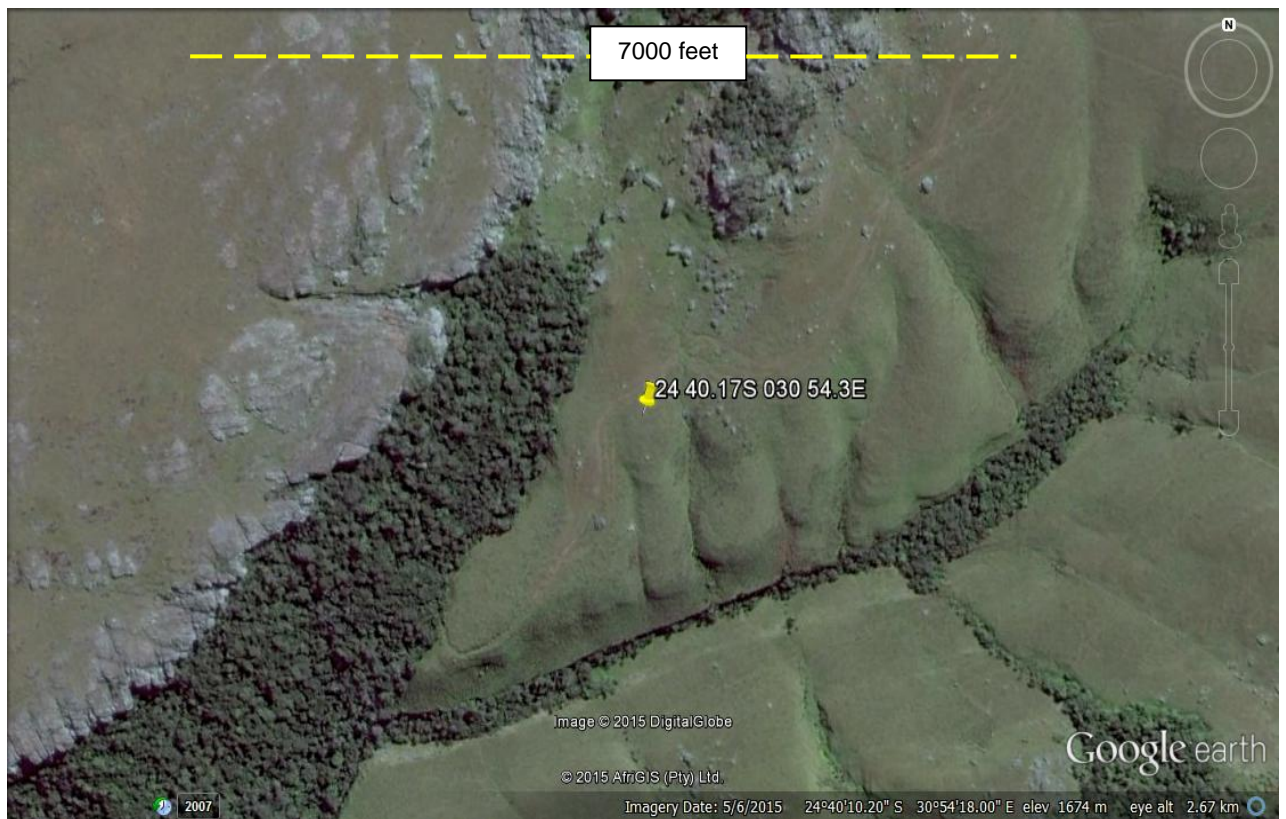
Looking at the Google Earth image below, with the Accident site indicated at 5495 feet and the cloud tops reaching around 7000 feet, which imply that the escarpment was covered in the low clouds.

Figure 5: Google Earth image and cloud height in the area.

The clouds had an average base of 1500-2000 feet/above ground level throughout the day and went up to 7200 feet/above mean sea level. Earlier the morning, over the escarpment the clouds could have dropped to as low as 900-1000 feet/above ground level in the valleys and therefore obscuring the mountain tops.

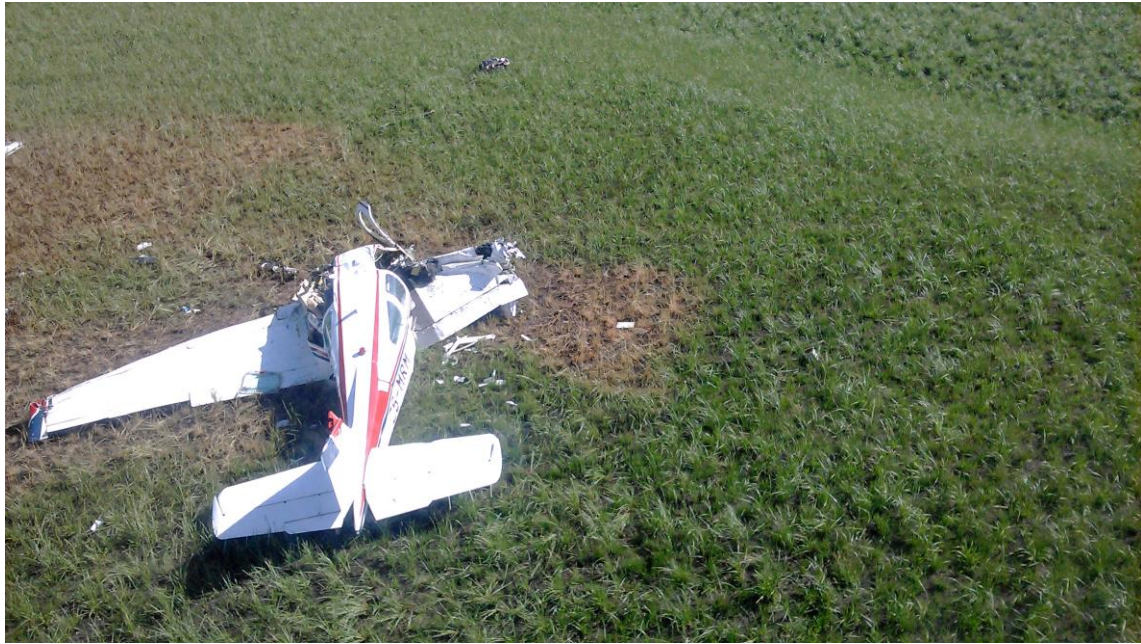
1.12.1 The wreckage path indicated that the aircraft impacted the ground in a left wing low attitude where after the right wing impacted the ground and part of it broke off. The main wreckage location was approximately 160m from the first point of impact.

- The damage sustained to the propeller indicated that the engine had power at the time of the impact sequence. The propeller broke from the engine and was found approximately 58 metres from the main wreckage.
- The engine broke from the fuselage and was found approximately 15 metres away.
- The fuselage including the cabin was destroyed.
- The cockpit area and forward part of the cabin was completely destroyed.
- Both wings of the aircraft were destroyed during the impact sequence. The outboard part of the right wing broke away from the wing.

- Both wing tanks disintegrated during the crash.
- The nose landing gear broke from the fuselage and both main landing gear sustained severe damage.

Figure 6: View of aircraft wreckage
