AIRCRAFT ACCIDENT REPORT AND EXECUTIVE SUMMARY

Reference:	CA18/2/3/9493	
Aircraft registration	ZS-HII	Date of accident	16 October 2015		Time of accident	1100Z
Type of aircraft	Guimbal Cabri G2 (Helicopter)		Type of operation		Part 141 (Training)	
Pilot-in-command licence type		Private	Age	28	Licence valid	Yes
Pilot-in-command flying experience		Total flying hours	172,1		Hours on type	102,4
Last point of departure		Mossel Bay Aerodrome (FAMO), Western Cape				
Next point of intended landing		Mossel Bay Aerodrome (FAMO), Western Cape				
Location of the accident site with reference to easily defined geographical points (GPS readings if possible)						
Farm Drie Fontein near Kleinberg, West of Mossel Bay (GPS position: 34°11.616' South 021°55.910' East)						
Meteorological information		Surface wind: 140°/8-10 kts; Temperature: 18°C; Visibility: +10 km				
Number of people on board	1 + 0	No. of people injured	1	No. of people killed	0	
Synopsis

Name of Owner : Starlite Africa Aviation (Pty) Ltd
Name of Operator : Starlite Africa Aviation (Pty) Ltd
Manufacturer : Guimbal Helicopters
Model : Cabri G2
Nationality : South African
Registration Marks : ZS-HII
Place : Farm Drie Fontein, Kle

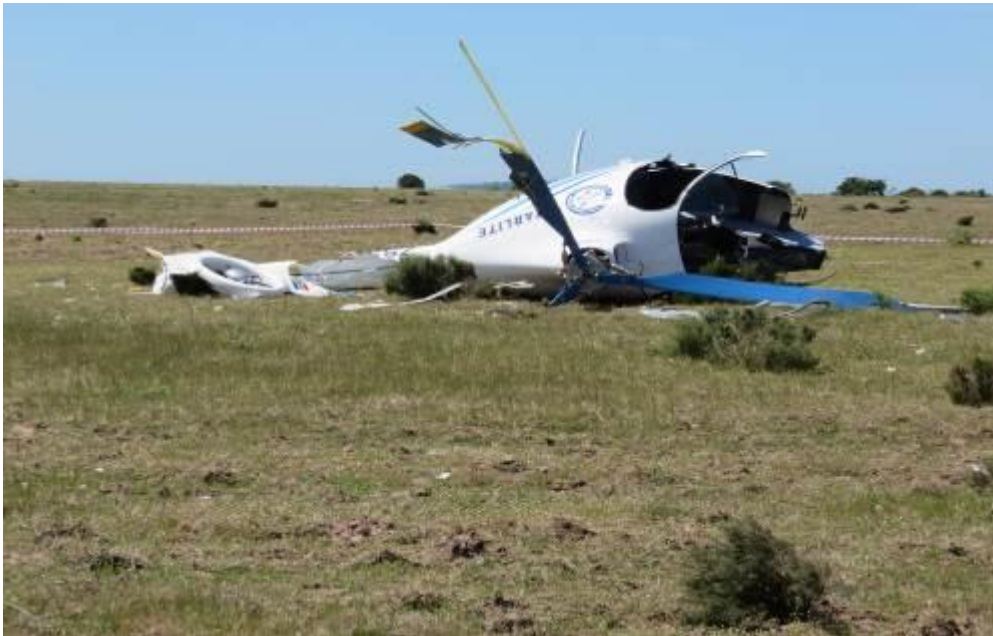
1.3.1 The helicopter was damaged beyond economical repair.

Figure 1. The helicopter at the crash site

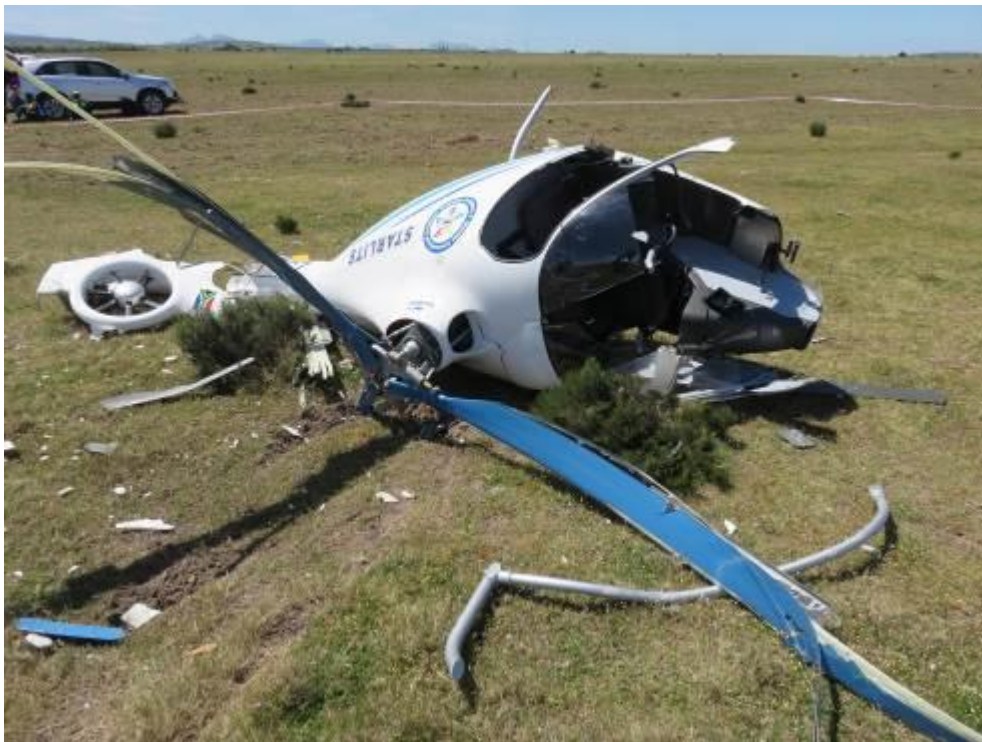
1.12.1 The accident occurred on an open piece of farmland. The ground impact markings indicate that the skid gear made contact with the ground. The next ground impact marking was caused by the tail rotor stinger and lower vertical fin following rotation in an anti-clockwise direction, approximately 120° in relation to the impact marks caused by the skid gear. Small fragments of debris from the reinforced-plastic tail rotor blades were found in this area. The inner circumference of the composite shroud structure indicate that blade contact was made during the impact sequence. The deformation of the tail rotor stinger and lower vertical fin confirmed the direction of rotation to be anti-clockwise, as both the stinger and lower composite structure were bent to the left when viewed from aft.

Figure 3. The helicopter as it came to rest

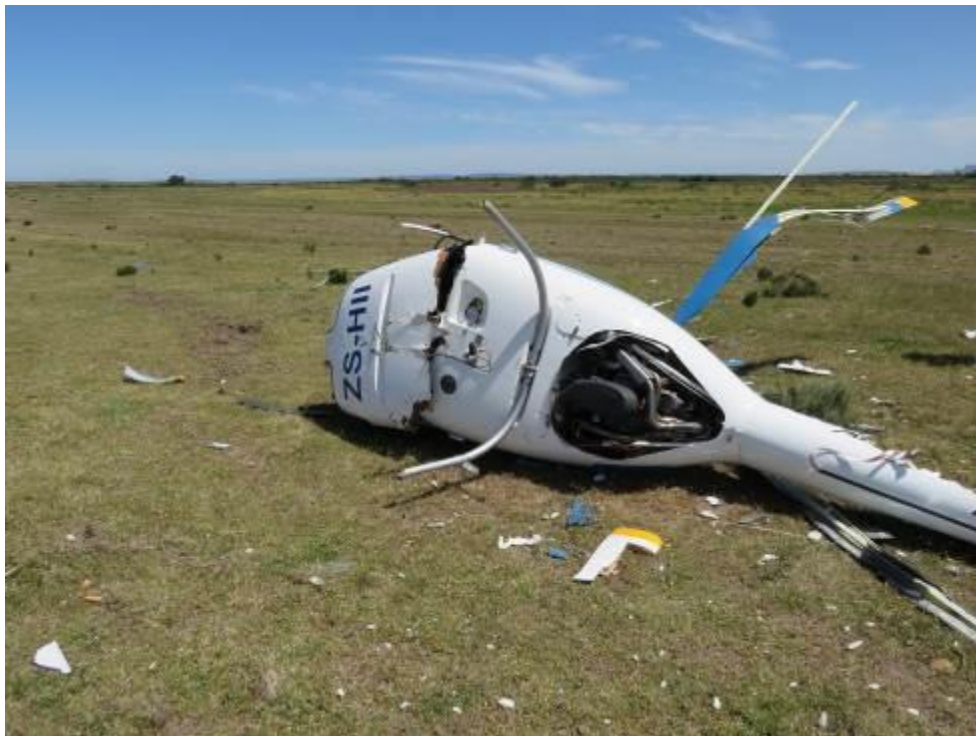
1.12.2 After the initial impacts, the helicopter started to rotate uncontrollably in an anti-clockwise direction in the air and crashed approximately 48 m further on in a steep nose-down attitude. The skid gear and the front cross tube assembly were separated from the fuselage. Main rotor blade impact markings were also visible in the area. All three main rotor blades displayed evidence of the severe deformation associated with an engine delivering power on impact. Such evidence is visible in Figure 5 where the leading edge lead balance weight of one of the blades was tangled around the remaining blade structure. Several fragments of the fibreglass reinforced composite blade material were scattered over the area. The helicopter came to rest on its right-hand side, facing in a southerly direction (200°M), which was opposite to the direction of its first impact with the ground. The cockpit/cabin area remained fairly intact. However, the entire plexiglass windshield was shattered and the lower floor structure and yaw pedals on both sides were distorted when the forward cross-tube assembly and skid gear broke off. The left door was also torn from the cabin structure and was located near the main wreckage. The two high-energy absorbing seats remained intact.

Figure 4. Lower fuselage, indicating the missing forward cross-tube and skid gear assembly

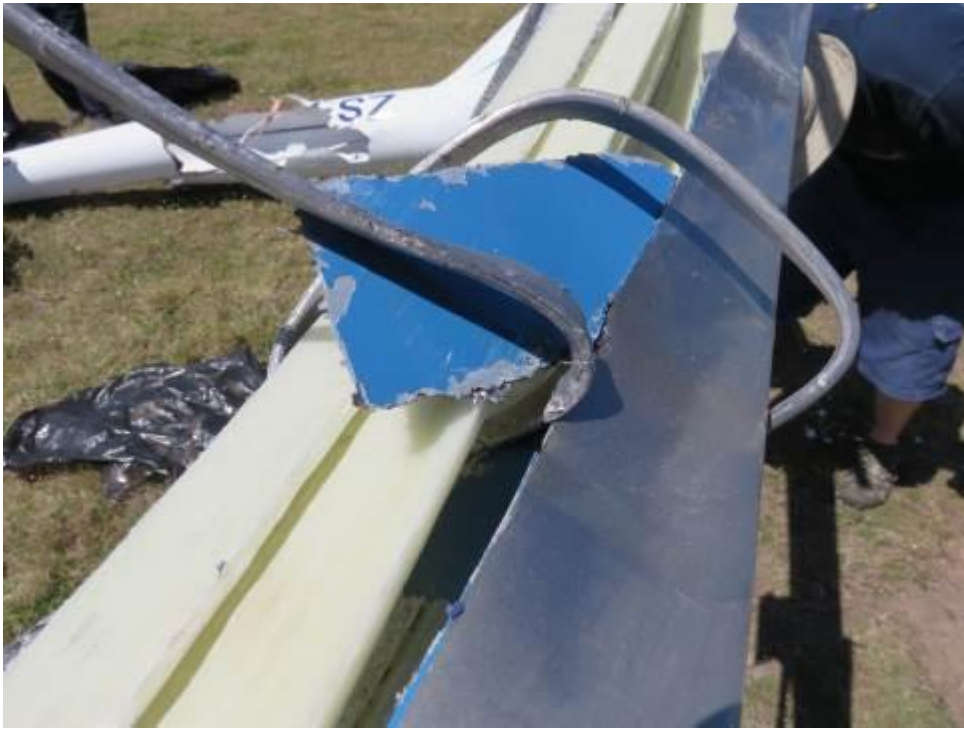
Figure 5. Deformation of leading edge lead balance weights of one of the main rotor blades

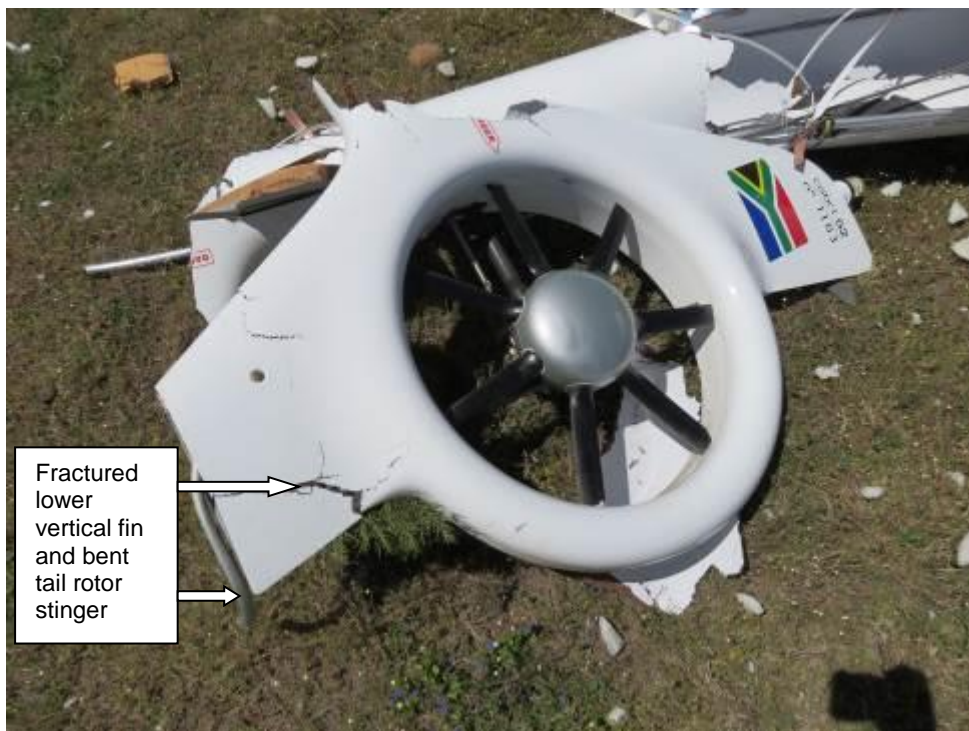
Figure 6. The vertical fin assembly and the shrouded tail rotor lying next to the tail boom

The deformation of the vertical fin during ground contact had a secondary effect, which fractured the vertical fin assembly together with the shrouded tail rotor where it joins with the tail boom structure. It further caused the tail rotor drive shaft to shear, resulting in a complete loss of tail rotor thrust, which caused an immediate yaw/rotation in an anti-clockwise direction. The situation was aggravated by the pilot when she increased the collective pitch lever, instead of lowering it and closing the throttle to reduce the torque effect. During this period, the helicopter rotated in an anti-clockwise direction several times before it crashed and came to rest on its right-hand side.

3.2.1 The pilot allowed the lower vertical fin to make contact with the ground during a manoeuvre close to the ground, which caused the vertical fin assembly and shrouded tail rotor to fracture from the tail boom, resulting in a loss of tail rotor thrust. She was unable to regain control of the helicopter and it crashed.

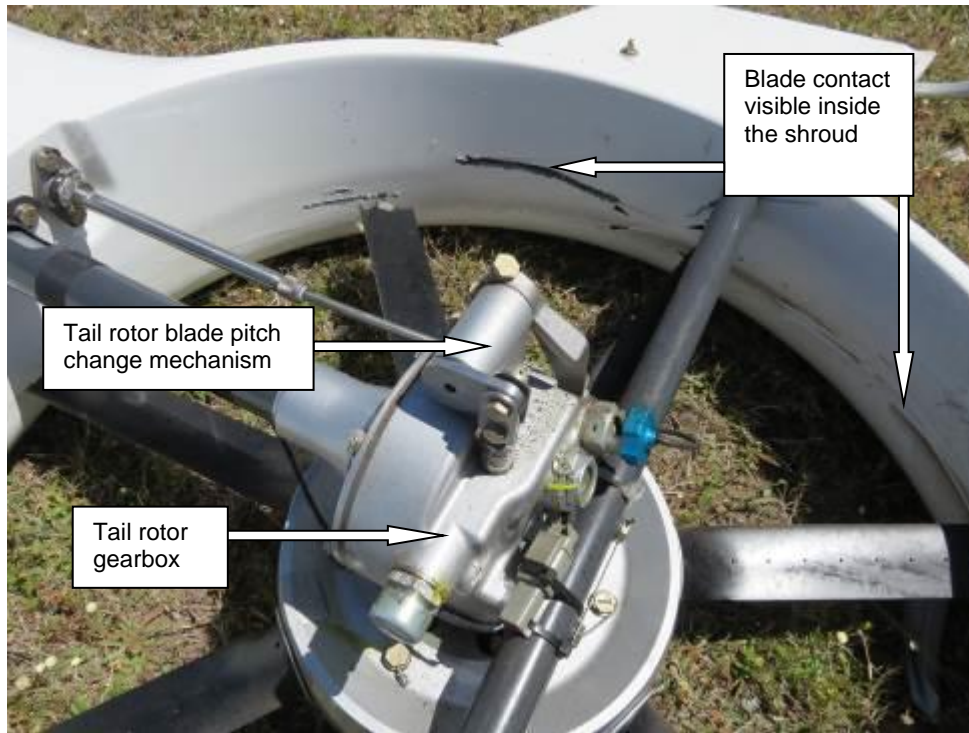
Figure 7. Tail rotor blades (reinforced-plastic) contact point visible inside the shroud

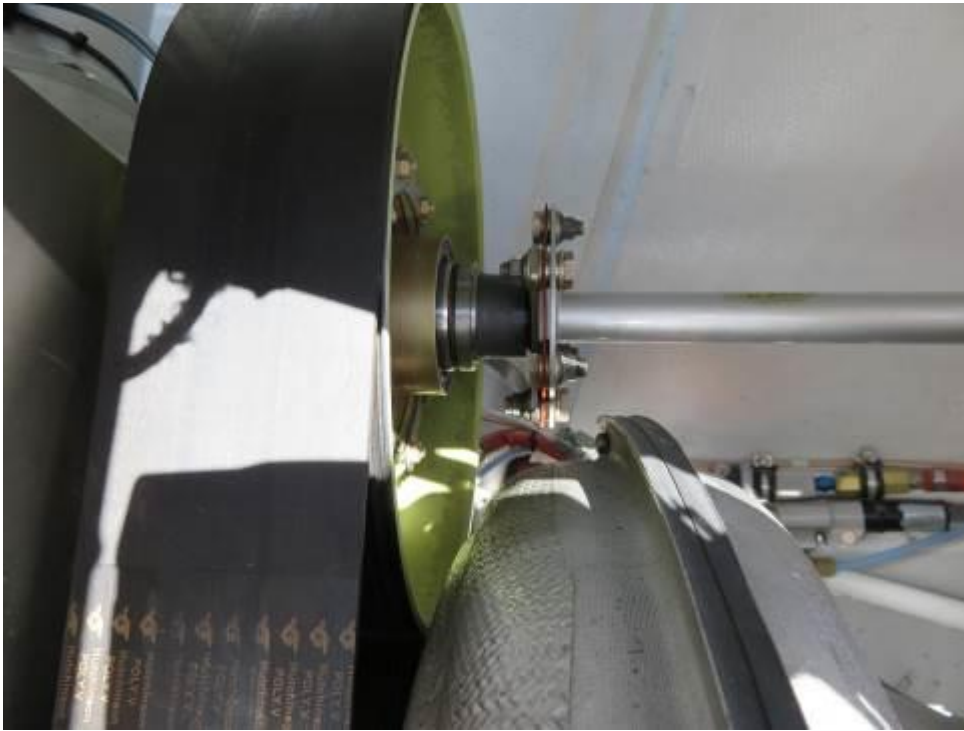
1.12.3 The primary transmission is composed of a pulley directly bolted to the engine output flange with a V-belt transmitting the power to the upper pulley connected through a free-wheel unit as can be seen in Figure 8 to the gearbox input, where the power is transmitted forward to the main gearbox and aft to the tail rotor transmission. The main rotor and the tail rotor drive systems were inspected and the fracture in the tail rotor drive shaft was found to be due to torsional overload. The main rotor drive system was not compromised. The engine did not sustain any damage during the accident sequence.

Figure 8. The drive belt and drive train remained intact

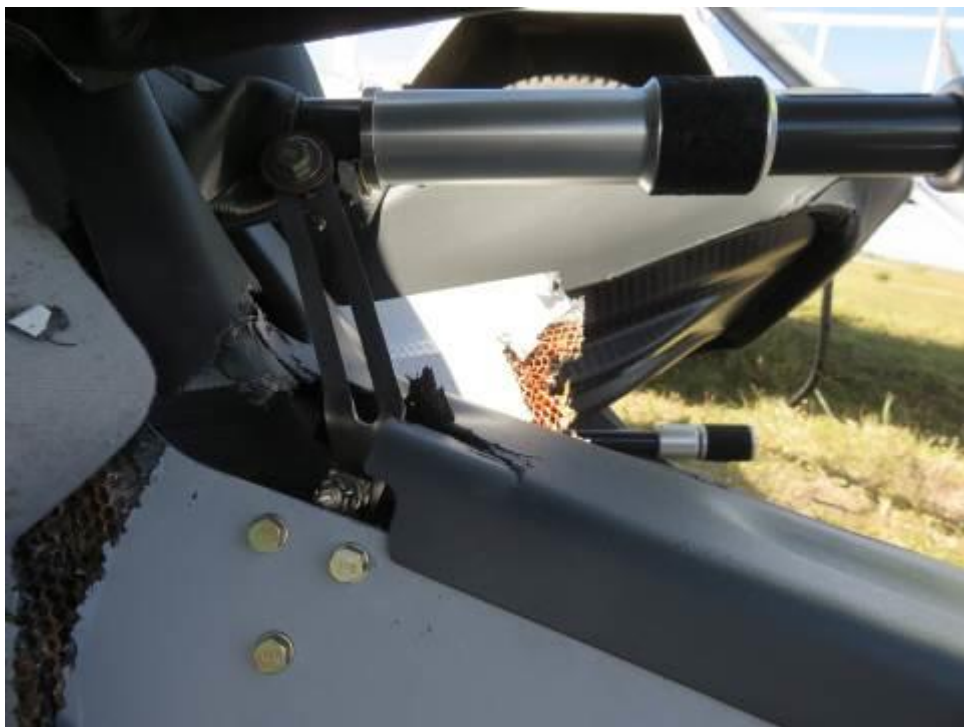
1.12.4 The collective pitch lever was found in the full up position. The cyclic control stick remained intact and the rudder pedals displayed some distortion associated with the helicopter's nose-down crash to the ground. Apart from the vertical fin assembly that fractured from the tail boom structure, it was found that flight control continuity had not been compromised.

Figure 9. The collective pitch lever in the full up position

3.3.2 The pilot increased the collective pitch lever when the lower vertical fin made contact with the ground, tail rotor drive continuity was compromised as a result, which aggravated the un-commanded rotation followed by a loss of control.

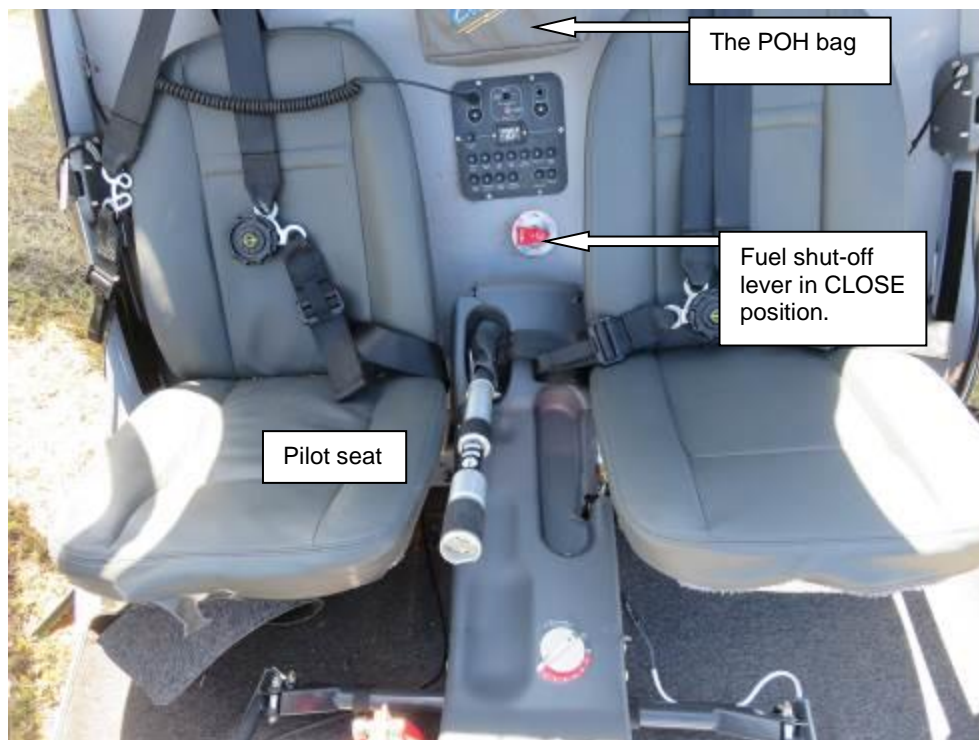
1.15.1 The un-commanded rotation occurred close to the ground, which was a significant factor of the pilot's survival. Contributing to her survival was the fact that the cockpit/cabin area remained fairly intact apart from the plexiglass windshield that shattered and the lower front floor structure that was disrupted during the impact sequence. The pilot's high-energy absorbent seat and instrument cluster remained intact. She was properly secured by means of the helicopter-equipped four-point safety harness. She was wearing a headset during the flight and suffered a blow to the left side of her head.

Figure 10. A view of the cockpit/cabin, where the seats absorbed the impact forces

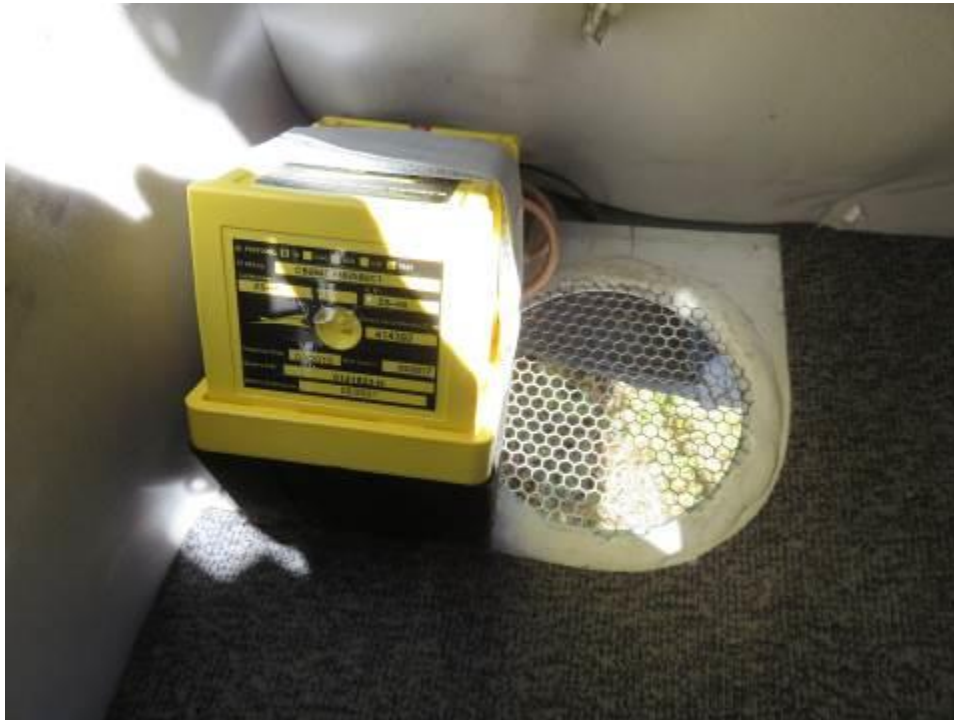
1.15.3 The helicopter was fitted with an emergency locating transmitter (ELT) that was located in the main baggage compartment. The unit was found to be properly secured and undamaged. The unit was armed during the flight and was switched off after the accident.

Figure 11. The ELT, positioned in the main baggage compartment

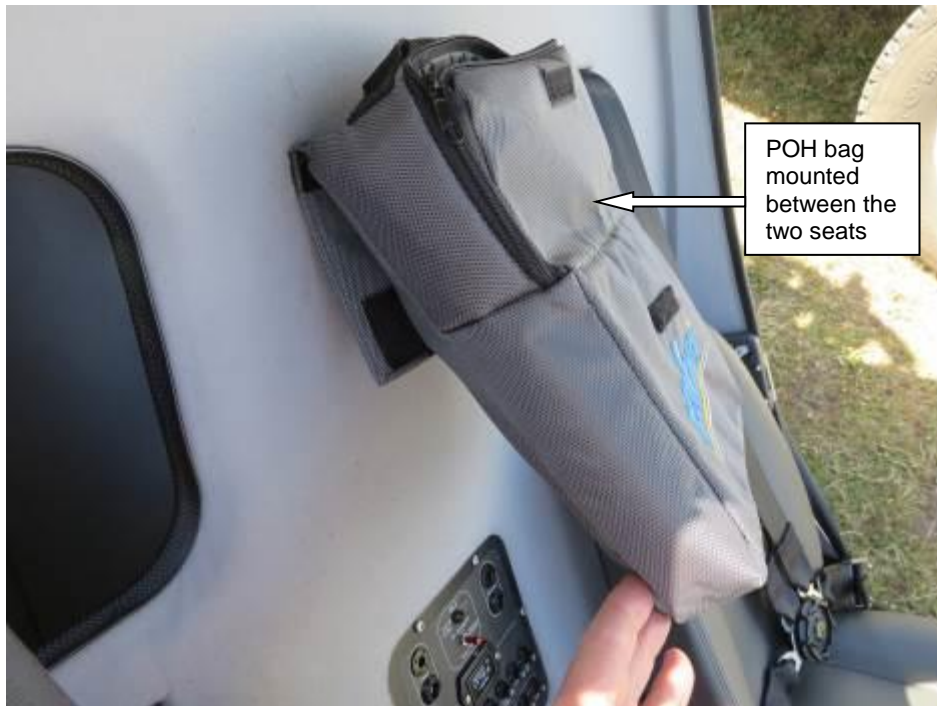
1.15.4 In the cabin, located between the two seats, the helicopter manufacturer had installed a bag to stow the pilot's operating handbook (POH). The location of the bag allowed the pilot to have easy/quick access to the POH during flight. However, it was found that the bag was secured to the firewall at the top only, as can be seen in Figure 12. This acts as a pivot point, which allows the bag to swivel and possibly cause injury. The pilot in this accident suffered from a blow to the left side of her head. She was not wearing a flying helmet but was flying with a headset.

Figure 12. The position and attachment of the POH bag

The accident was survivable. It is believed that the blow to the left side of the pilot's head was caused by the POH bag between the two seats that struck her during the un-commanded rotation of the helicopter or during the impact sequence, as she was not wearing a flying helmet. The portable in-cabin fire extinguisher remained secured to its bracket attachment located behind the pilot's left leg. The location of the unit was found to pose a potential safety risk; should the unit became dislodged during flight, for whatever reason, or during an accident sequence, it has the potential to interfere with the controls of the helicopter and can cause serious bodily harm.

- 4.3 It is recommended to the ATO as well as the helicopter manufacturer that the POH bag on the aft cockpit/cabin wall, located between the two seats, be properly secured. The investigation found that the POH bag was only secured on the top section and not on the bottom, which allowed the bag to swing from side to side, and could lead to injury, as was suspected to have happened in this accident (blow to the left side of the pilot head).

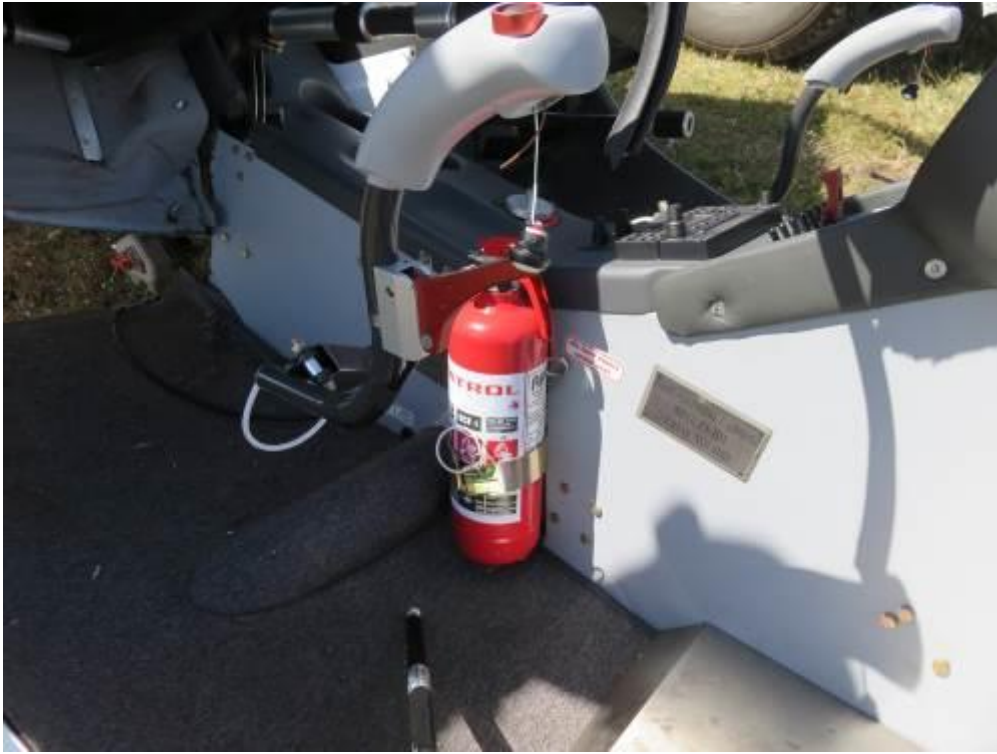
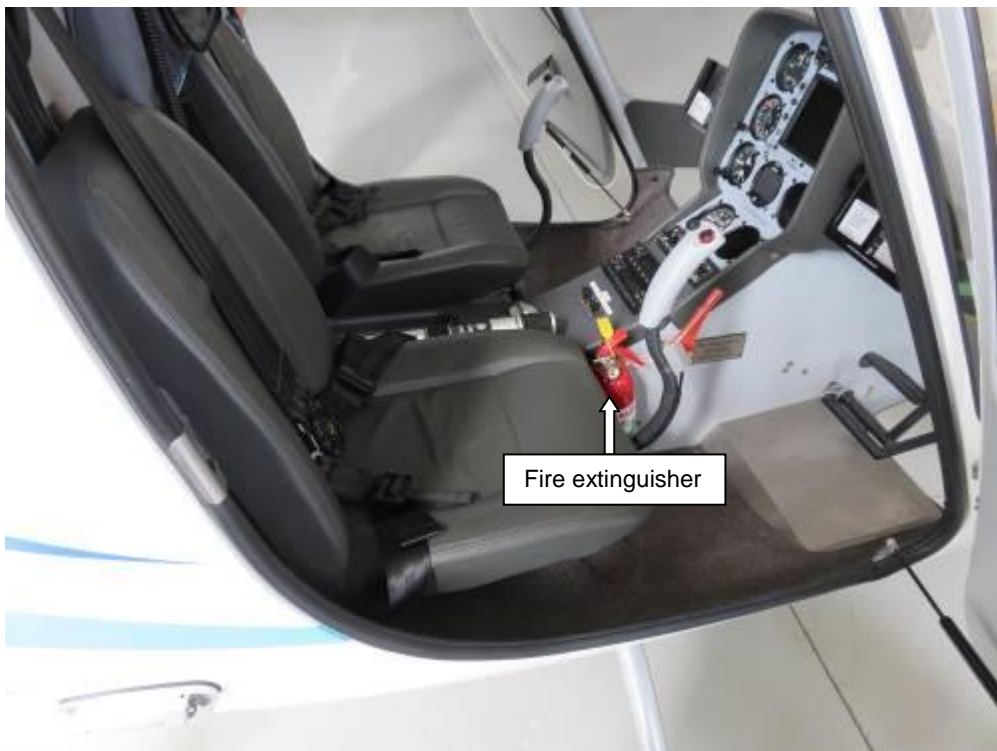
1.15.5 The portable in-cabin fire extinguisher was found to be located behind the pilot's left leg, when she was seated in the right-hand seat. The unit was attached to the side of the instrument cluster/centre console by a bracket, as can be seen in Figure 13. In this accident, the fire extinguisher remained secured. The location of the fire extinguisher as mounted was found to pose a serious safety risk. It has the potential to cause serious bodily harm or even death during an accident sequence, should it be dislodged from the bracket. During a visit to the ATO hangar by the Investigator-in-charge (IIC), he inspected several similar types of helicopters parked in the hangar and it was found that all of them was fitted with a portable in-cabin fire extinguisher mounted at exactly the same location as that of the crashed helicopter.

Figure 13. A view of the portable in-cabin fire extinguisher (accident helicopter)

Figure 14. The portable in-cabin fire extinguisher (serviceable helicopter)

- 4.4 It is recommended to the Director of Civil Aviation in conjunction with Certification and Airworthiness Divisions that the portable fire extinguisher currently located next to the pilot seat (right-hand side) be re-positioning within the cockpit/cabin area. The current location of the unit poses a safety risk to the pilot/occupants during an accident. The writer is well aware of the fact that the cockpit/cabin area does not allow many options but has nevertheless found the status quo to be unsafe.
