SHORT REPORT AND EXECUTIVE SUMMARY

Reference:	CA18/3/2/1140	
Aircraft registration	ZU-MJM	Date of incident	7 November 2015		Time of incident	0907Z
Type of aircraft	Jabiru J430 (Micro-light aircraft)		Type of operation		Private (Part 94)	
Pilot-in-command licence type		Private	Age	54	Licence valid	Yes
Pilot-in-command flying experience		Total flying hours	895.3		Hours on type	472.8
Last point of departure		Richards Bay Aerodrome (FARB), KwaZulu-Natal Province				
Next point of intended landing		Richards Bay Aerodrome (FARB), KwaZulu-Natal Province				
Location of the incident site with reference to easily defined geographical points (GPS readings if possible)						
Beach near Richards Bay Harbour (GPS position; 28°49'44.30" South 032°04'04.20" East), elevation 2 feet						
Meteorological information		Surface wind: 240°/10 knots, Temperature: 27°C, Visibility: +10km, CAVOK				
Number of people on board		1 + 1	No. of people injured	0	No. of people killed	0

AIRCRAFT SERIOUS INCIDENT REPORT

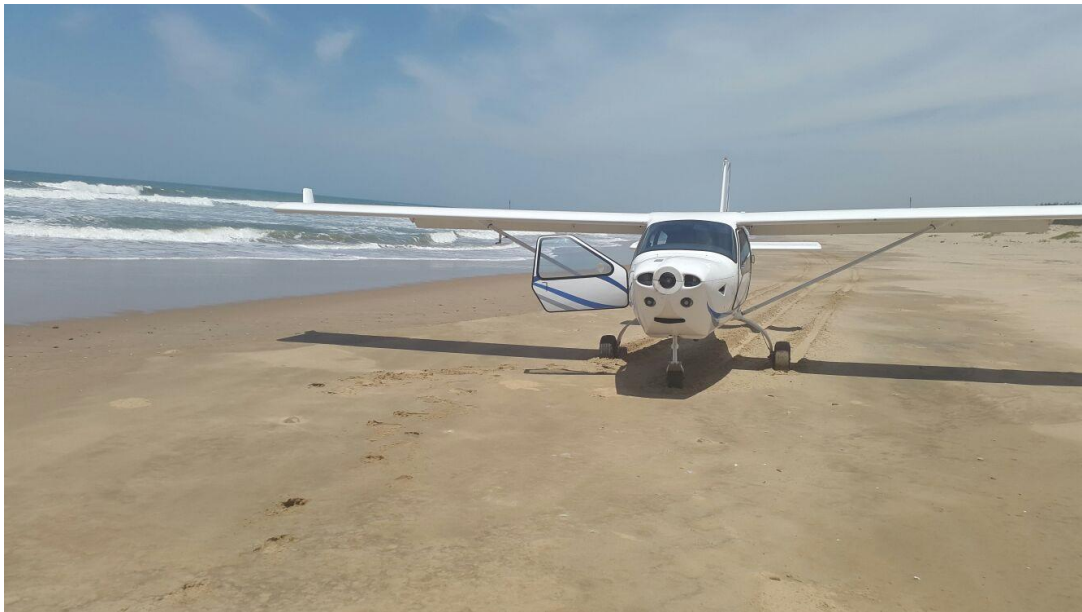
- 1.1.2 At 0857Z the pilot called air traffic control (ATC) at FARB *“inbound approaching the aerodrome from the south, experiencing a rough running engine”*. ATC requested the pilot if he was declaring an emergency? To which he replied, *“No the aircraft has full power and was able to maintain altitude”*. The pilot then requested a straight in approach for runway 05, at that stage the surface wind was 240° at 10 knots and runway 23 was in use. ATC acknowledge the pilot request and he was required to report final approach runway 05. At 0900Z the pilot reported a very rough running engine to ATC and indicated that he will be climbing as high as possible seawards of the coast. Abeam the Richards Bay Coal Terminal the engine stopped. At 0901Z the pilot reported to ATC that the engine failed 9 nautical miles (nm) south of the Richards Bay Harbour and he intended to land on the beach. ATC acknowledge the above and activated the crash alarm. ATC then requested the pilot to report further intentions and estimated position where he will be landing for search and rescue purposes. The pilot executed an uneventful forced landing on the beach above the water line. After he had disembarked from the aircraft he noticed that the propeller was missing. He informed ATC accordingly. Nobody was injured in the incident. The propeller was not recovered by the time this report was concluded.

Figure 1: The aircraft as it came to a halt on the beach without a propeller

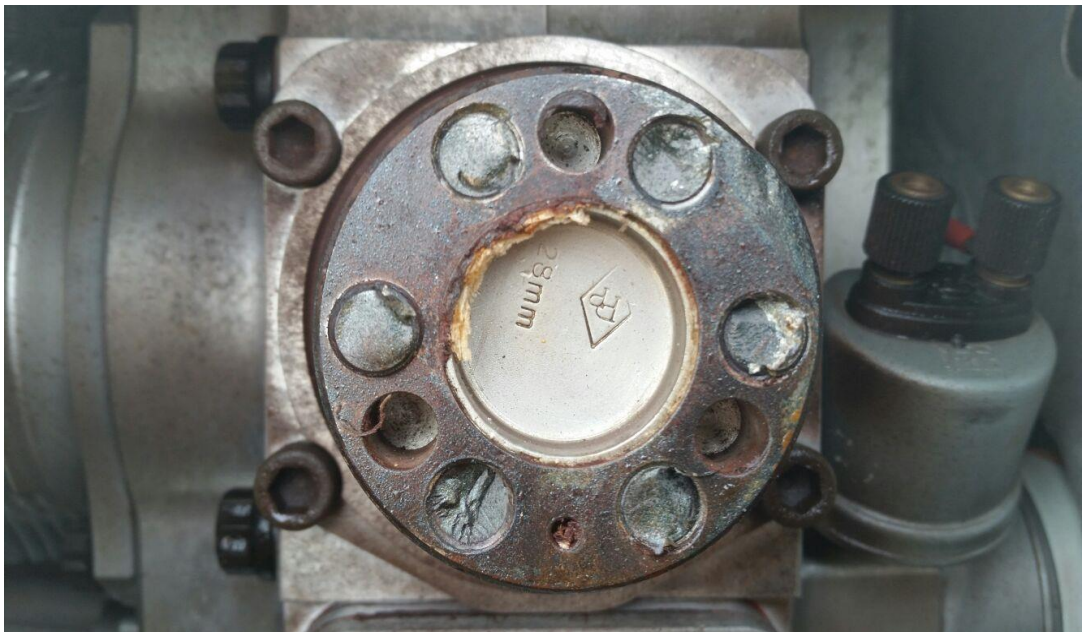
Figure 2: The crankshaft flange with the sheared propeller bolts visible

- 2.2.1 Inflight separation of the propeller and the cause could not be established.

- 3.1 It is recommended to the Director of Civil Aviation that all Jabiru aircraft fitted with the same type of propeller be made aware of this incident and that a maintenance advisory notice (MAN) be issued to prevent a re-occurrence.
- 3.2 Safety Message: A potentially serious accident was avoided by the pilot's adherence to emergency procedures and maintaining control of the aircraft after an in-flight engine stoppage.

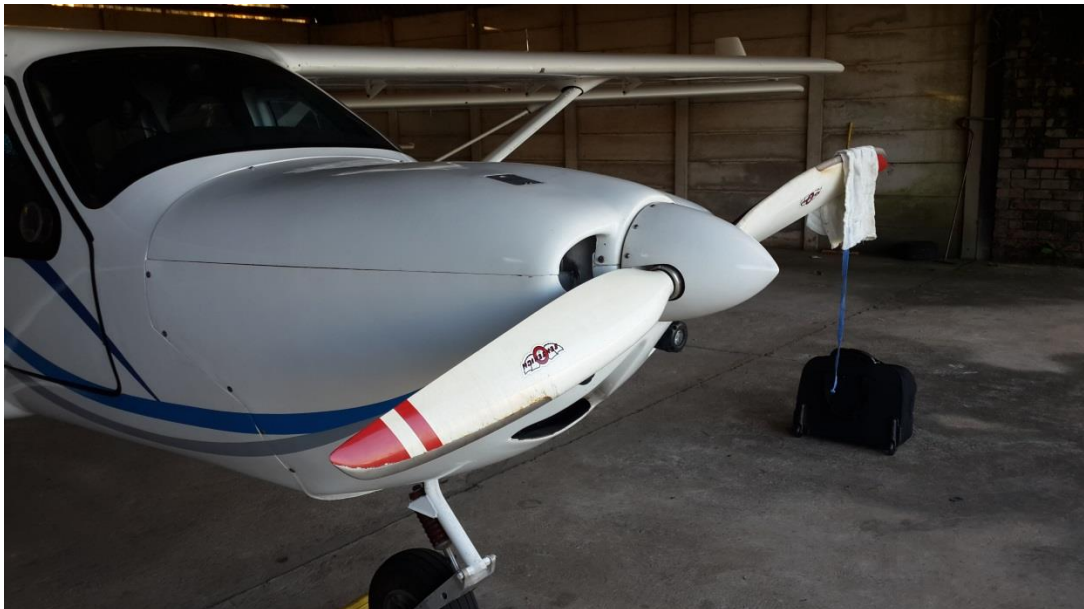
Figure 3: Photograph of the aircraft with the propeller installed – pre incident
