FINAL INVESTIGATION REPORT ON
ACCIDENT TO M/s HIMALAYAN HELI
SERVICES PVT. LTD. AS 350 B3
HELICOPTER VT- JKB ON 23-11-2015
AT KATRA, JAMMU

COMMITTEE OF INQUIRY VT-JKB

**FINAL INVESTIGATION REPORT ON ACCIDENT TO M/S
HIMALAYAN HELI SERVICES PVT. LTD. AS 350 B3 HELICOPTER
VT- JKB ON 23-11-2015 AT KATRA, JAMMU.**

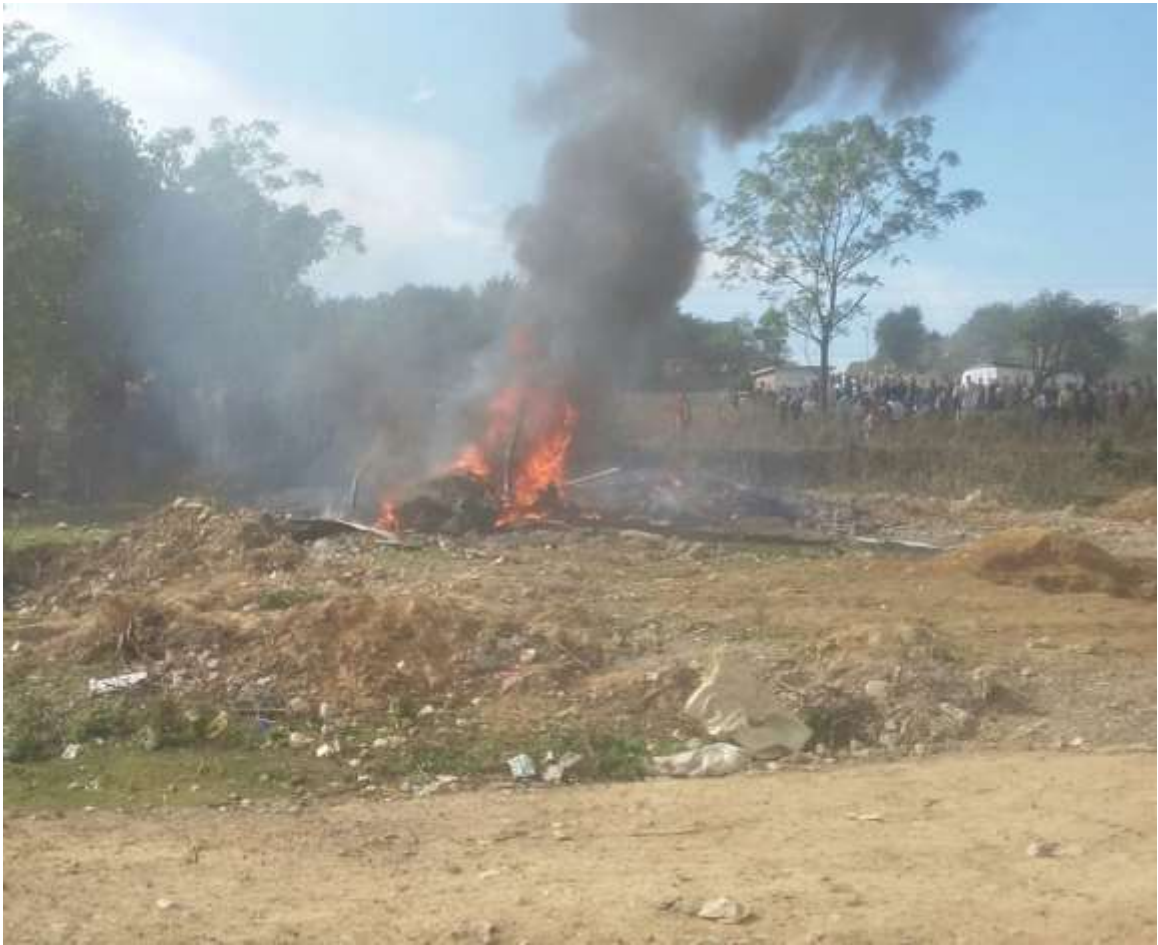
The helicopter after impact with ground engulfed in a ball of fire

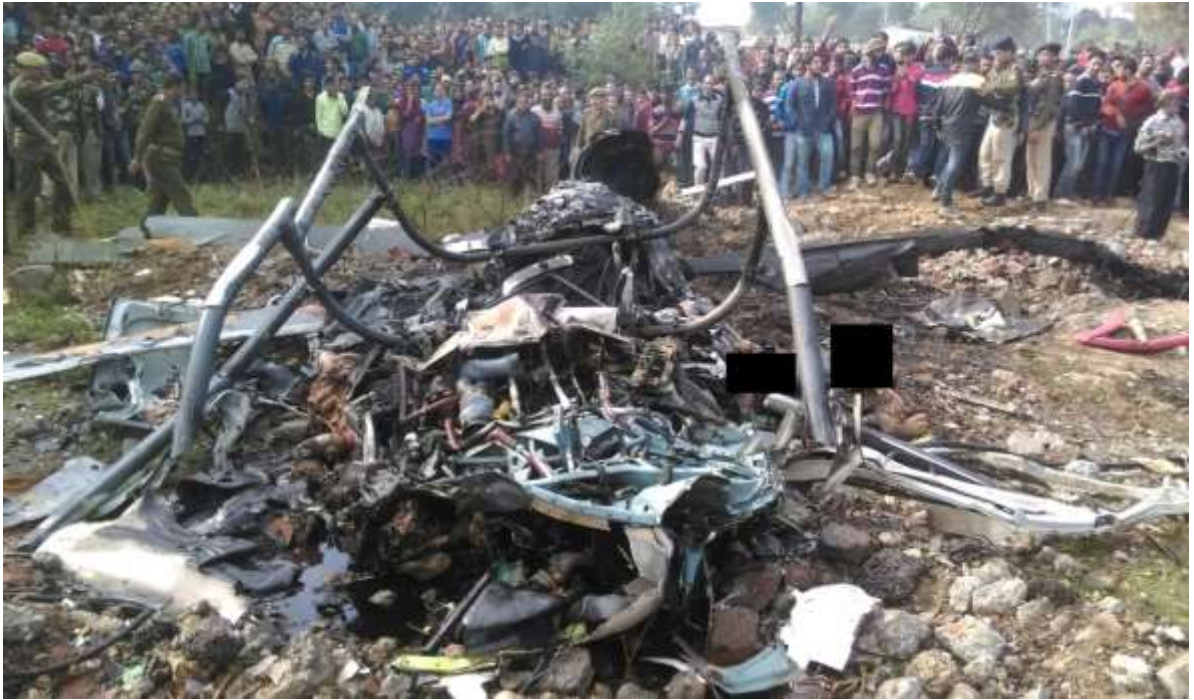
Helicopter lying upside down with skids facing upwards (Final resting position)

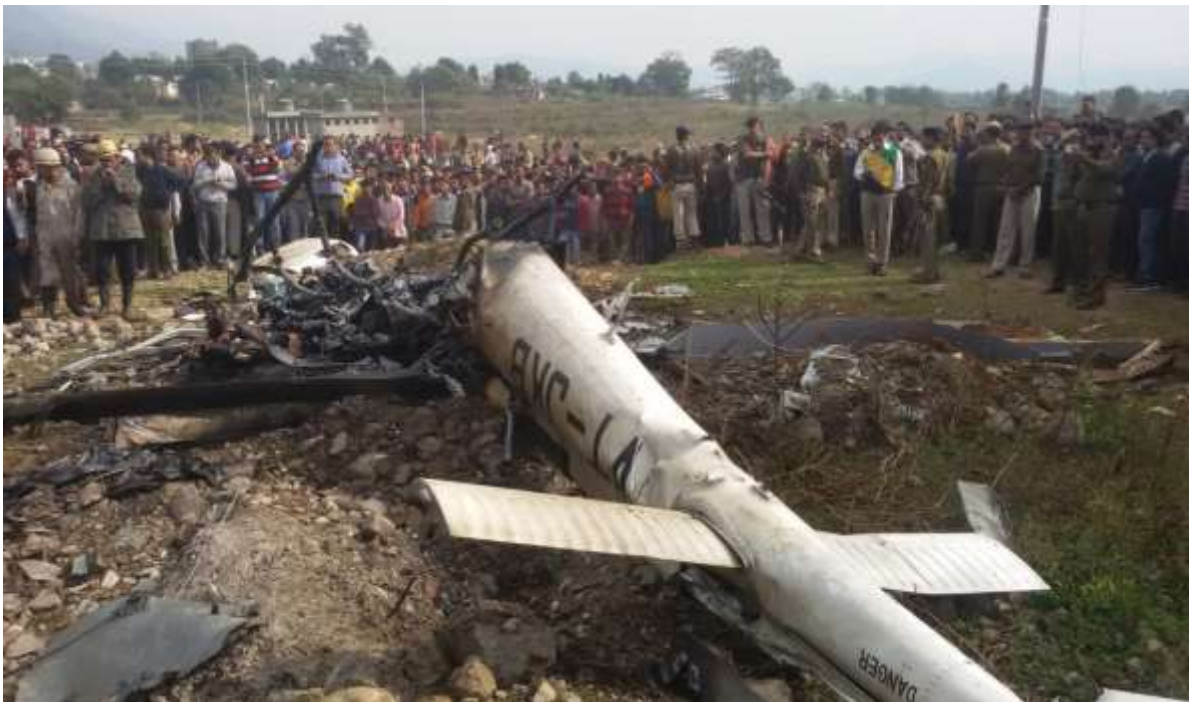
Damaged Tail boom (severed from the burnt fuselage).

The Tail boom was severed from the burnt fuselage and was damaged but not burnt. The tail rotor drive shaft was found broken at some places. The tail rotor gear box was still attached to the tail boom.

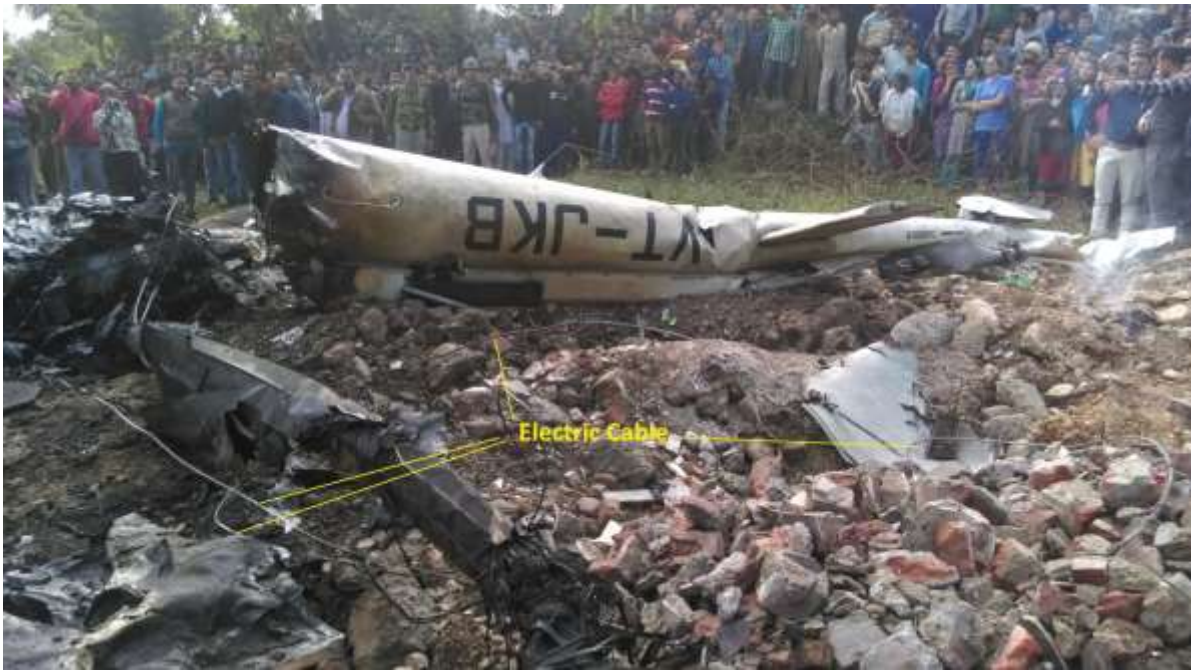
Broken electric cables were found under the wreckage and around it.

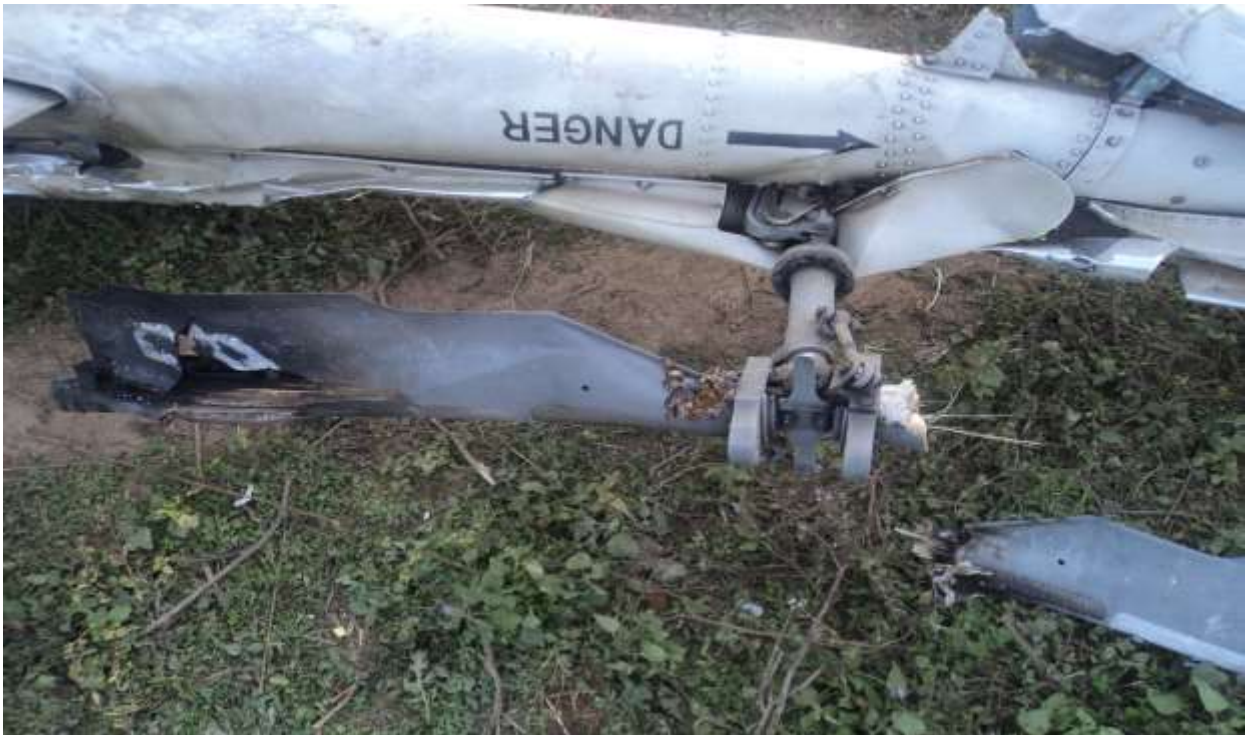
One of the tail rotor blades severed from the tail rotor hub

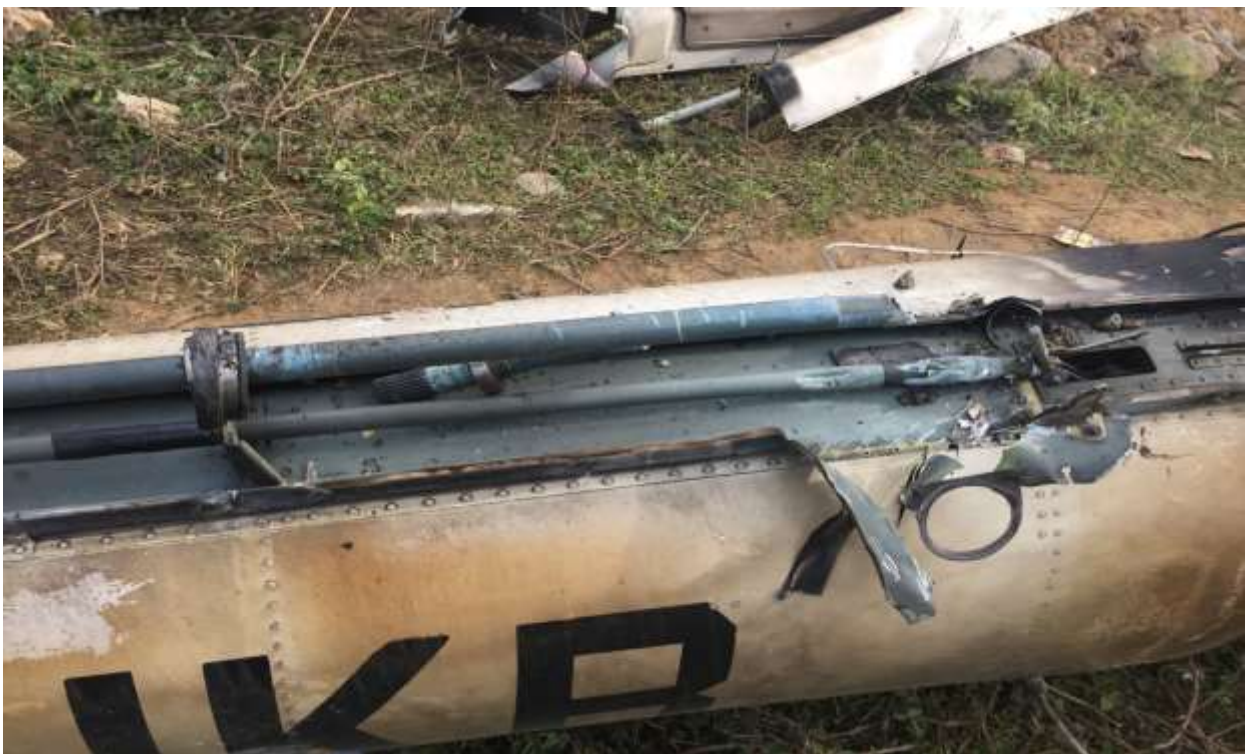
Tail rotor drive shaft was found broken

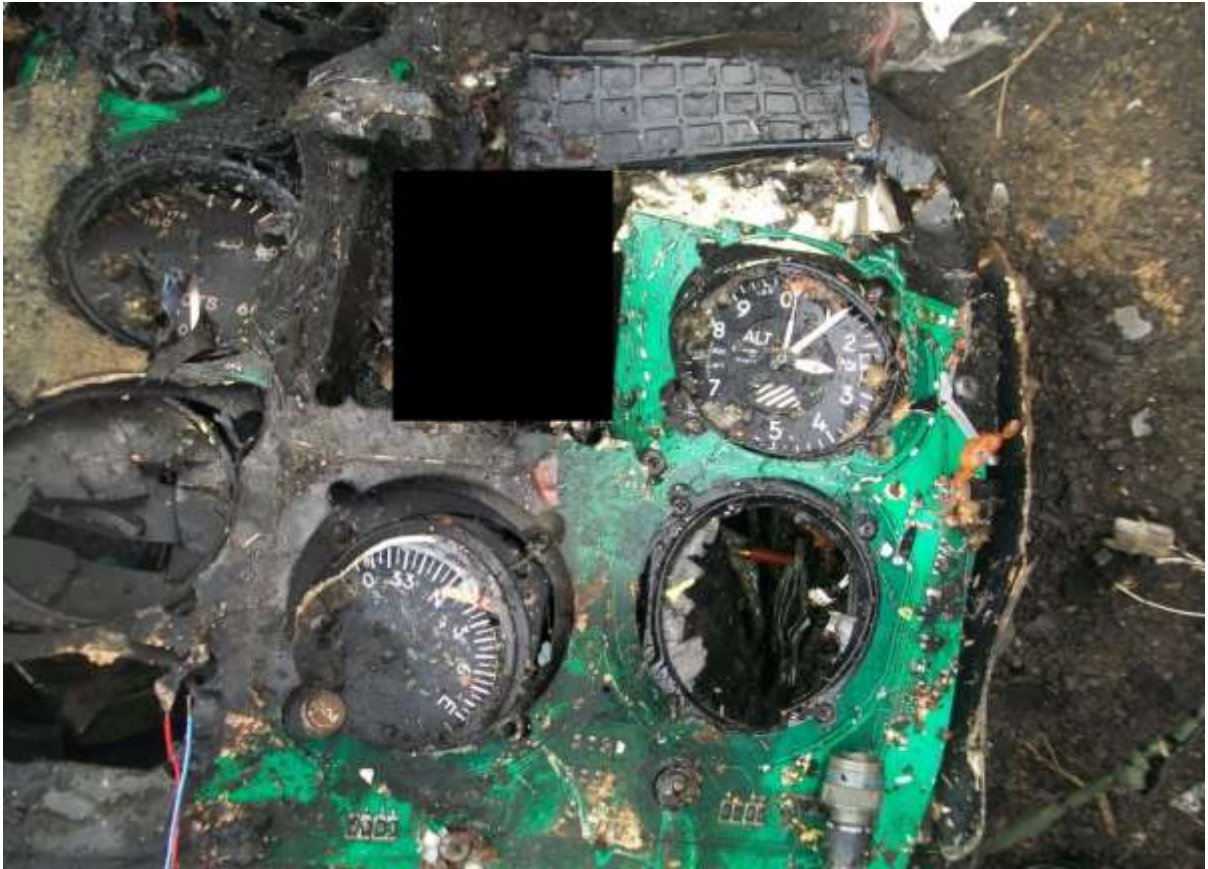
The cockpit instrument panel was completely damaged along with the instruments.

Most of the cockpit instruments were substantially damaged and partially burnt making it difficult to take proper readings. The altimeter was reading 2512 feet with QNH set to 1018 hPa.

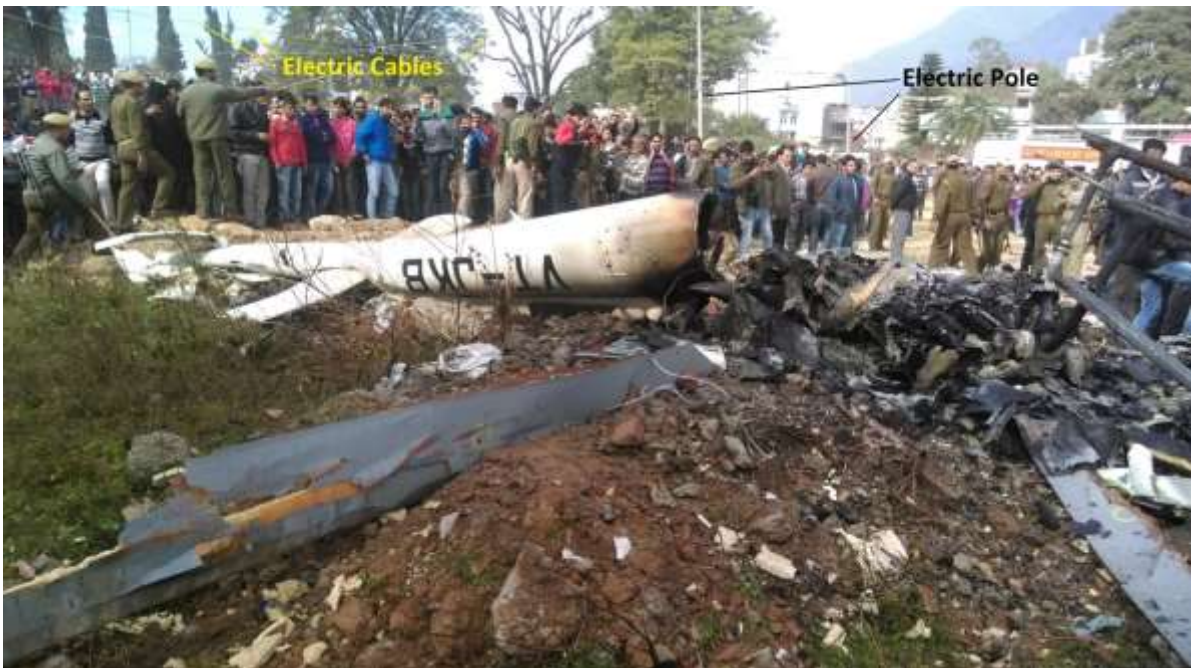
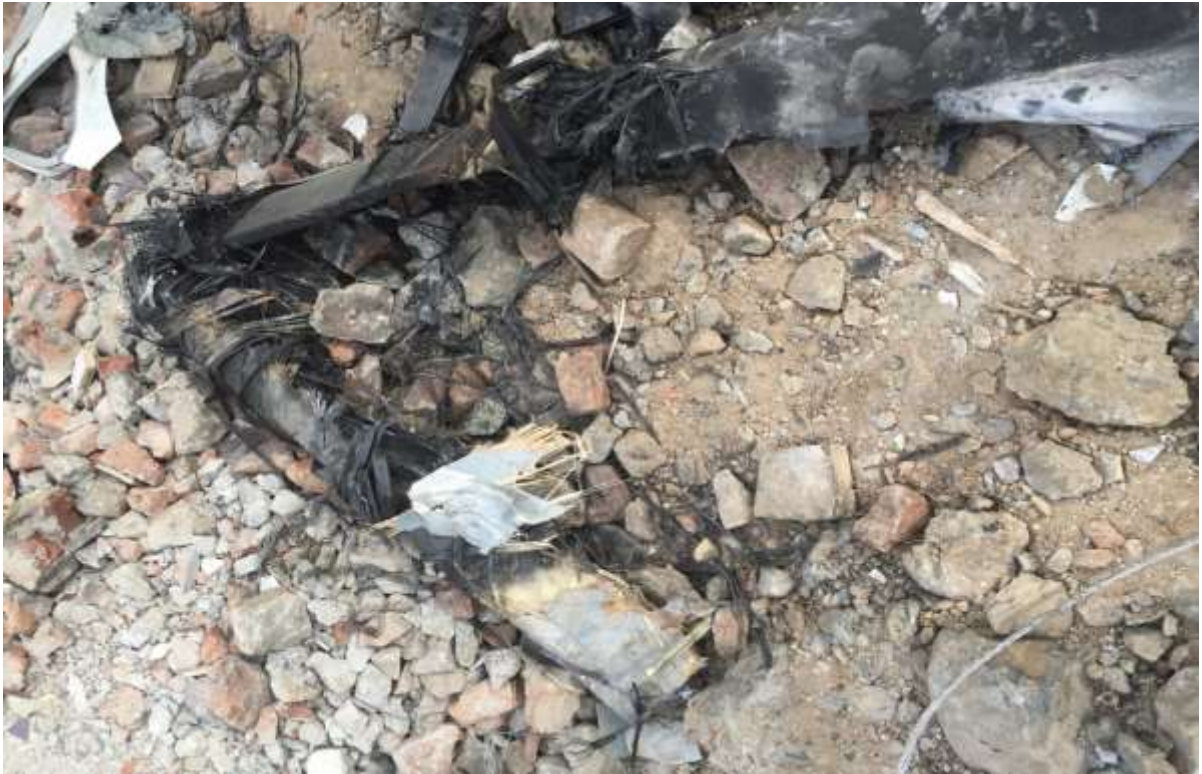
Two main rotor blade was substantially damaged and one was completely burnt

The Main Rotor Blades were found damaged and partially burnt. The leading edge of one of the blades was found dug into the ground, with broken electric cable entangled around it and another blade was found substantially damaged and burnt.

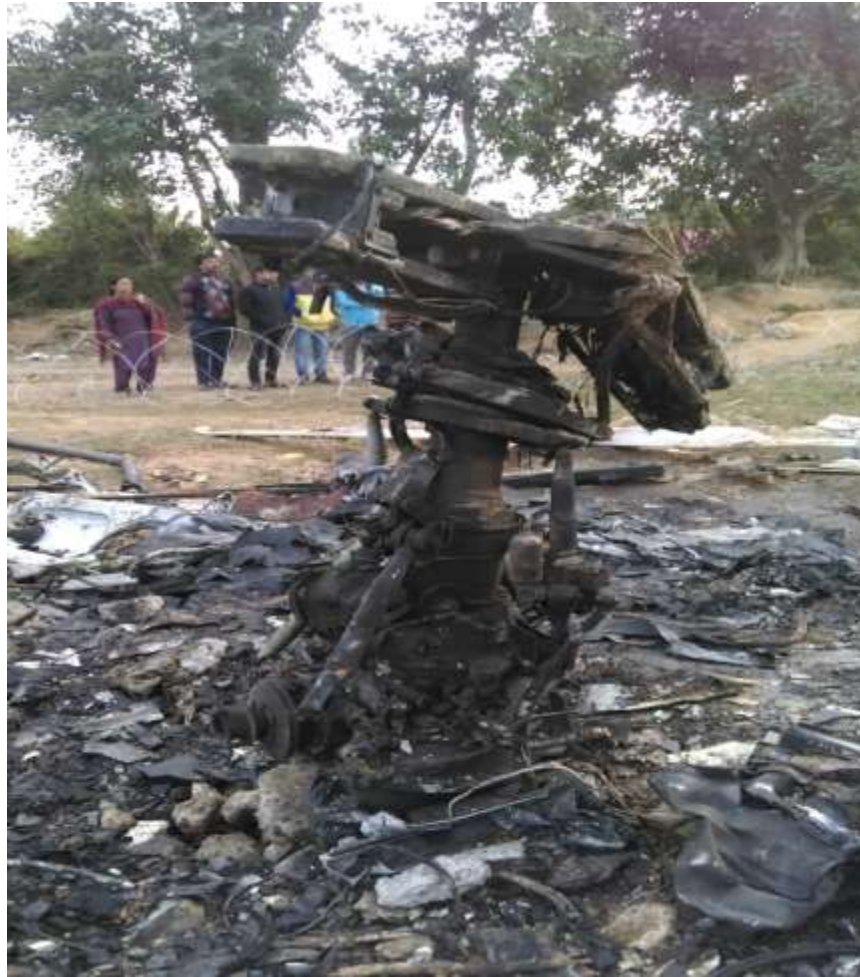
Damaged Main Rotor Gear Box

The main gear box was damaged and burnt. Due to extensive fire, no traces of MGB oil and hydraulic fluid were observed.

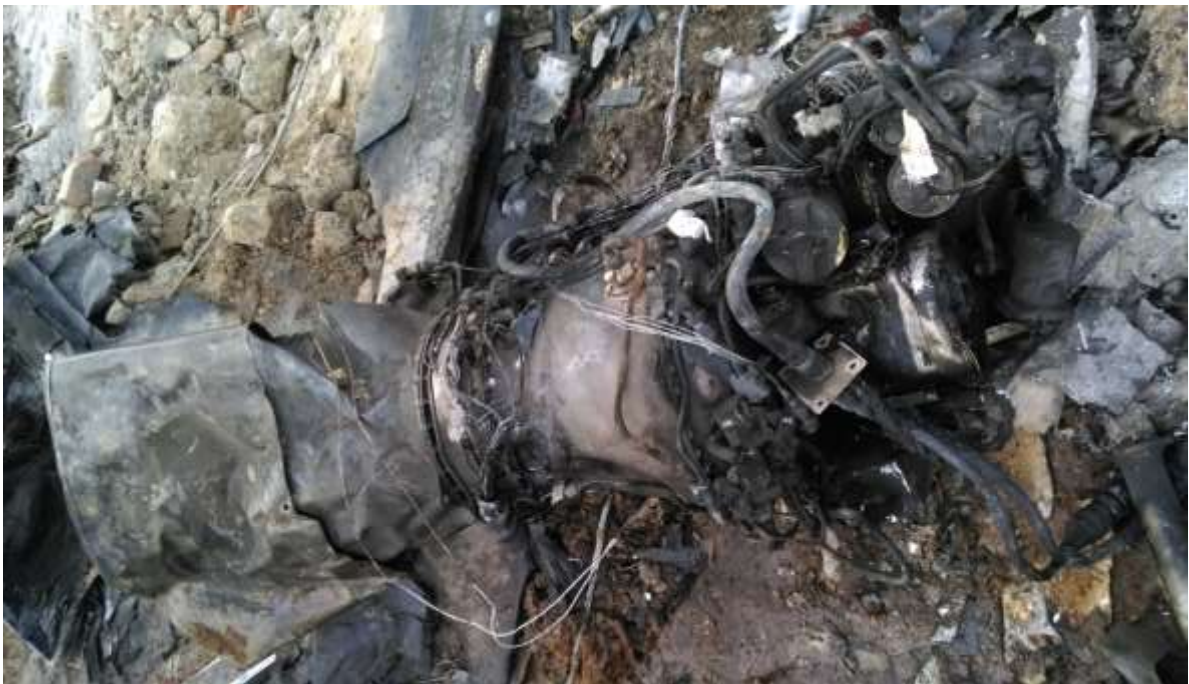
The engine was completely damaged. Due to impact and burning the engine mountings were not found in its actual position, the coupling to the drive shaft was still connected. Due to extensive fire the engine was externally burnt. Electrical Equipment and indicating system wires/cables were burnt. Due to impact, the exhaust ducts and intake, were severely damaged. The Combustion case was found damaged and mangled. Fuel pipelines and other pipelines, between the airframe and the engine, were severed. The engine oil tank was burnt and destroyed. Due to extensive fire, no trace of fuel or engine oil was observed on or around the engine.

Damaged and externally burnt engine

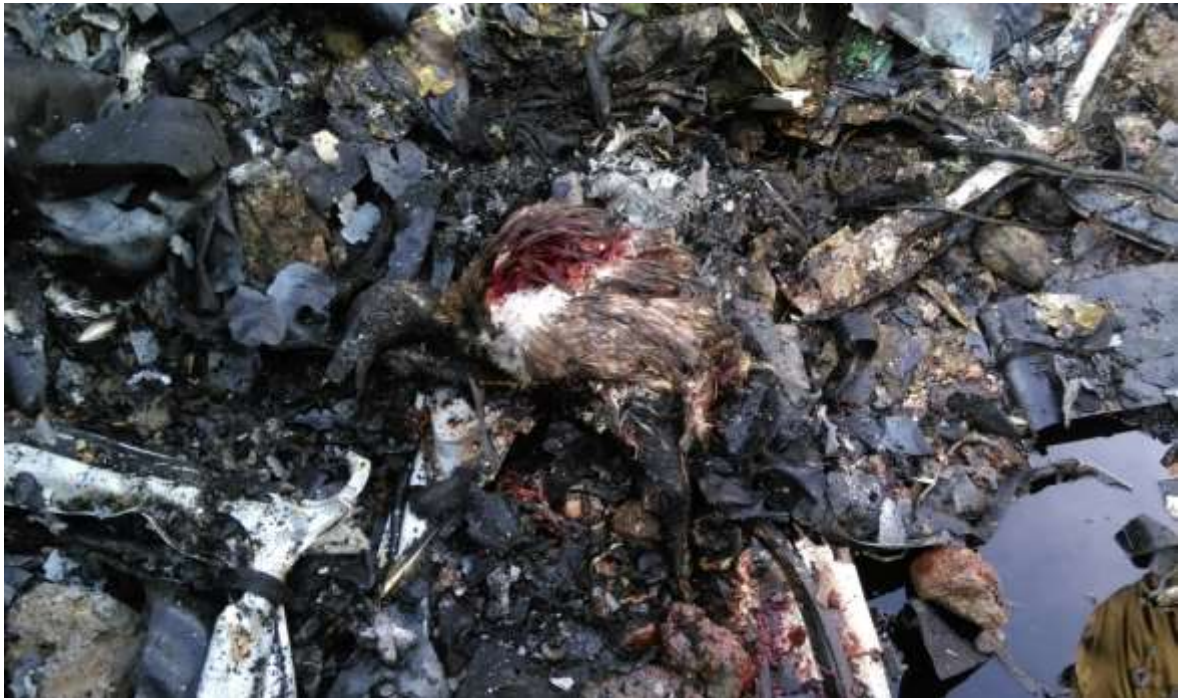
Carcass of vulture found in partially burnt condition

Carcass of a dead and partially burnt vulture was found underneath the wreckage, which was lifted to recover the bodies of the deceased. It was found at right side of the toppled and burnt cabin area of the wreckage.

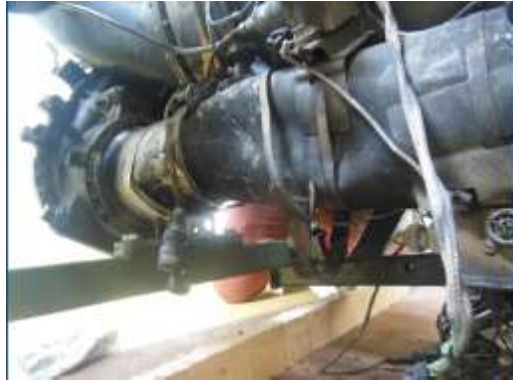
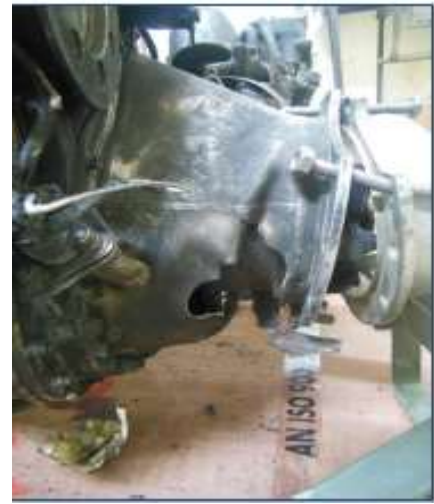
Module 1 (Accessories Gearbox and Transmission Shaft)

The link tube was bent and distorted in the area of the rear engine support due to an important (Heavy) vertical force. The front support flange was distorted and it was ripped on its side thus leaving a hole and torn metal.

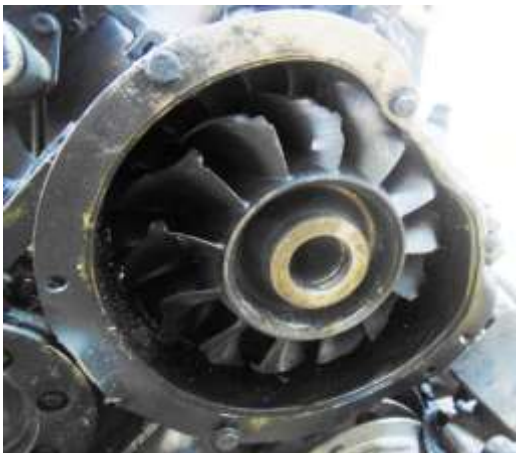
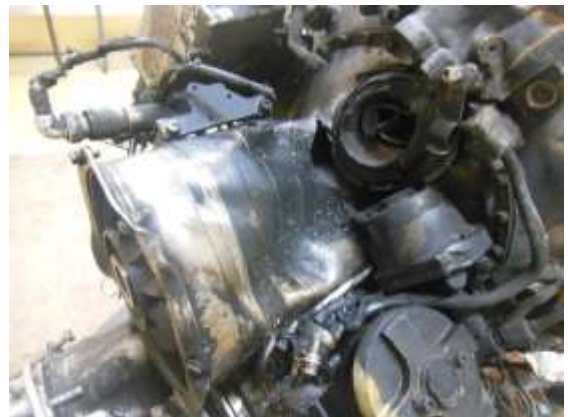
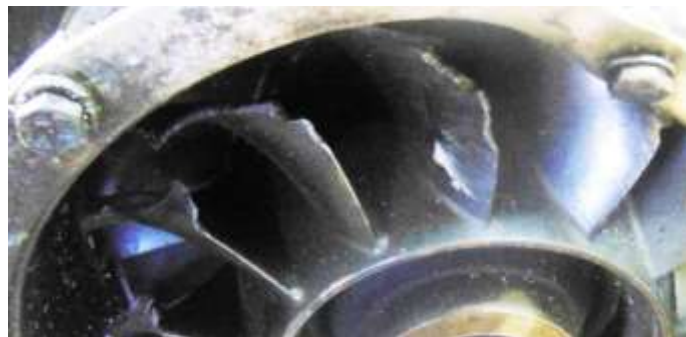
Module 2 (Axial Compressor)

The Gas Generator could not be rotated by hand. The casing was distorted and punctured in the upper part. All the blades of the axial compressor wheel were damaged and they had lost approximately a quarter of their height due to rubbing with the distorted casing. Such a level of damage indicates that the Gas Generator was rotating with power when the casing was crushed.

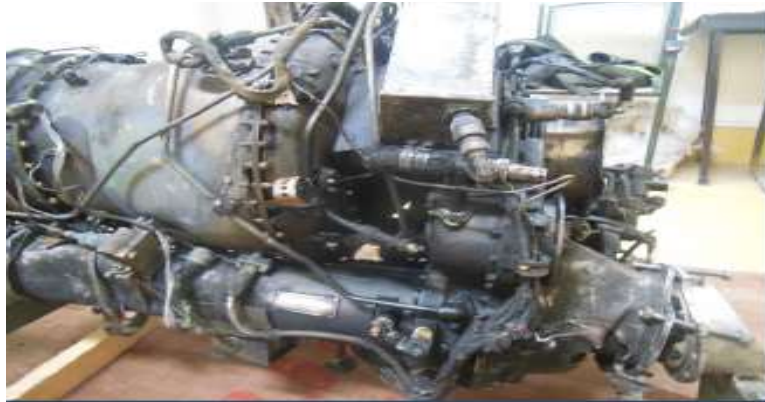
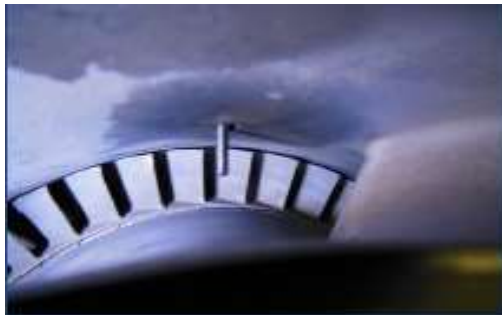
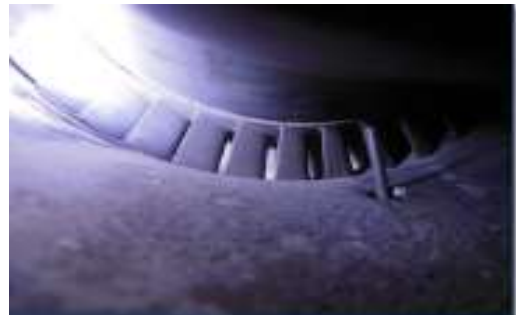
Module 3 (Gas Generator)

The module 3 casing was locally distorted and twisted. The engine was disassembled to reveal the High Pressure turbine. It was in good condition with only light tip rubbing. The blades were lightly splattered with shiny speckles indicating the ingestion of soft metallic FODs. Similarly, speckles could be seen on the Nozzle Guide Vanes' trailing edges. Such speckles originate from the ingestion of soft metallic FODs which subsequently melt when they reach the combustion chamber, thus indicating that the combustion was established in the combustion chamber at the time of the crash.

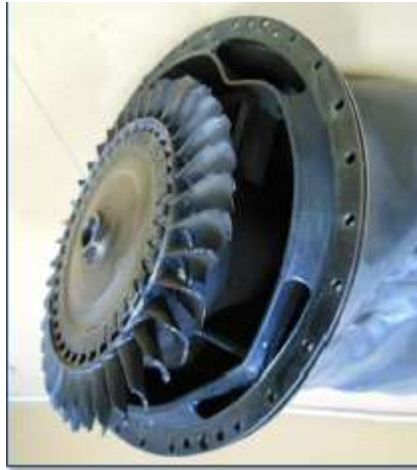
Module 4 (Power Turbine)

The module 4 appeared externally intact with local soot deposits. Once separated from the rest of the engine, it could be rotated by hand. Rubbing and some sticky points could be felt. Inside, the examination of the Power Turbine wheel showed that the bearing housing was no longer centred. It appeared to have moved in the vertical direction with the engine upside-down. Such damage can only originate from a very high vertical force and thus corresponds to the moment of the crash.

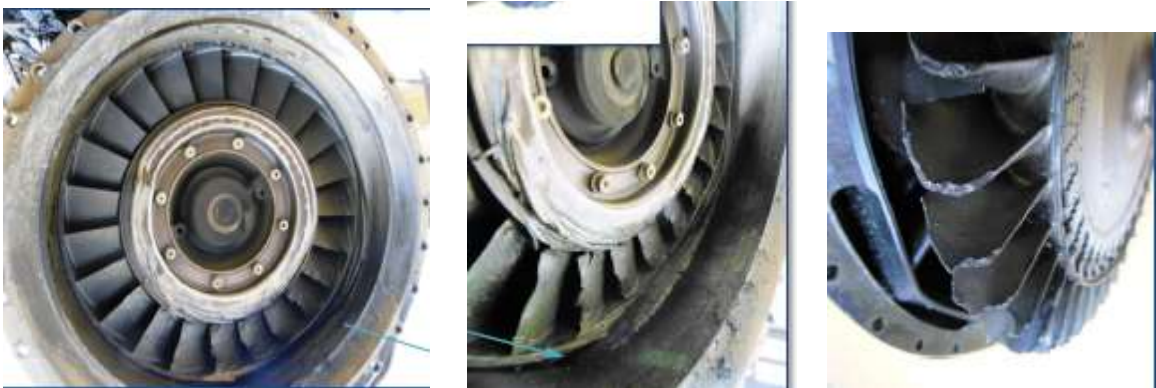
All the blades then came in contact with the shroud and lost approximately a quarter of their height. They also dug a groove in a section of the shroud corresponding to the lower position when the engine was upside-down. Such a level of damage indicates that the Power Turbine was rotating with power at the moment of the crash.

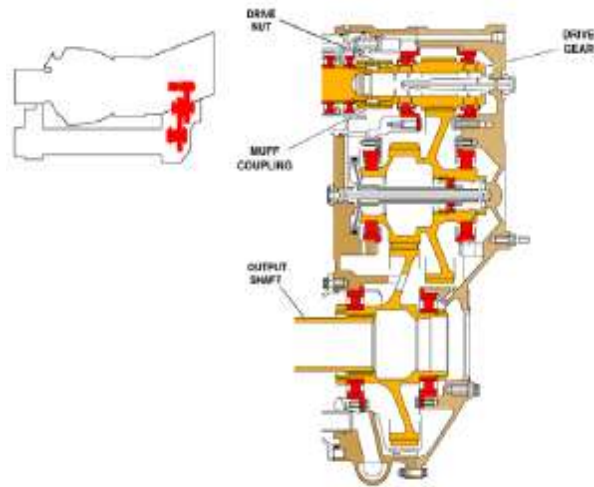
Module 5 (Reduction Gearbox)

The module 5 appeared externally intact with some soot deposits. It was separated from the Power Turbine module in order to reveal the splined drive nut on the drive gear's shaft. This nut transfers the torque delivered by the Power Turbine through the muff coupling to the reduction gearbox's gear train. Its position on the shaft is marked during the assembly process. Should the rotation of the reduction gearbox's output shaft be impeded during engine operation, then the torque applied by the Power Turbine on the nut will increase. During an accident, this may lead to an over-torque capable to rotate the nut on its shaft.

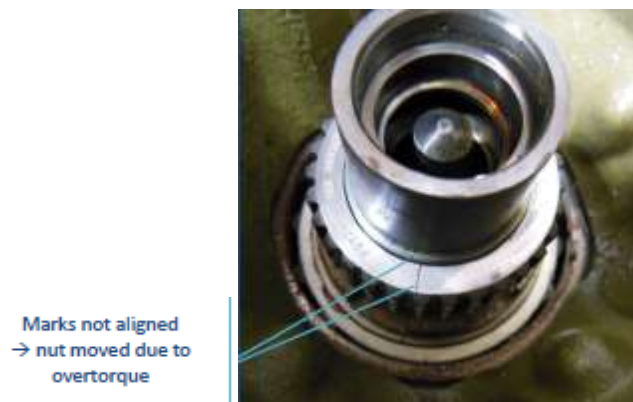
The drive nut's close examination revealed that the marks had moved by approximately 1.5mm. Consequently, the engine was delivering power at the time of impact.

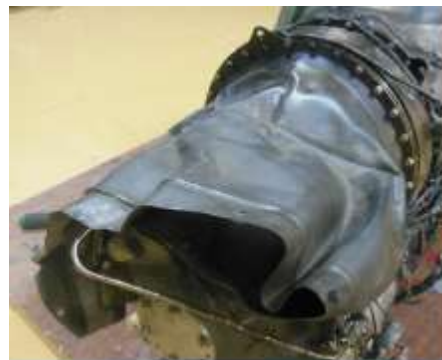
Exhaust pipe

The exhaust pipe was bent and distorted and exhibited a “flattened” shape corresponding to an upside-down engine at the moment of the crash.

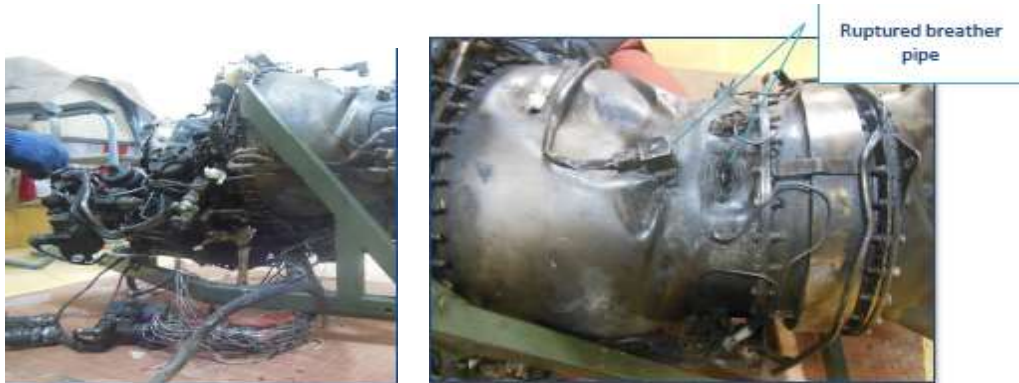
Dressing (pipes and harnesses)

Most pipes and harnesses appeared damaged, ruptured, burnt or crushed. The rear bearing assembly's breather pipe was sheared at its junction with the outer casing. The casing was significantly damaged in this area which corresponded with the top of the engine which hit the ground first as it fell upside down. No pipe was found with loose fixings and similarly, the harnesses' connectors were checked and found tightened.

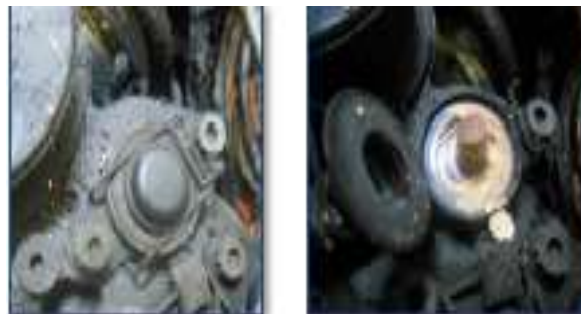
- Fuel filter and clogging indicator

The fuel filter was removed and the visual inspection showed that it was clean. The filter casing was totally dry. The clogging indicator cover was tarnished by soot and had to be opened to reveal that it had popped out. However, as the filter was clean, it probably popped out due to impact forces during the crash.

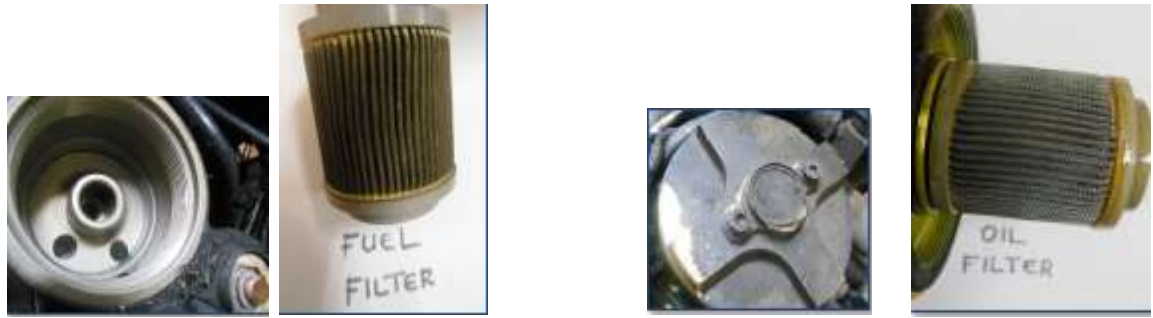
- Oil filter and clogging indicator

The oil filter was removed and the visual inspection showed that it was clean. The clogging indicator's cover had melted away but the indicator could still be checked: it did not pop out.

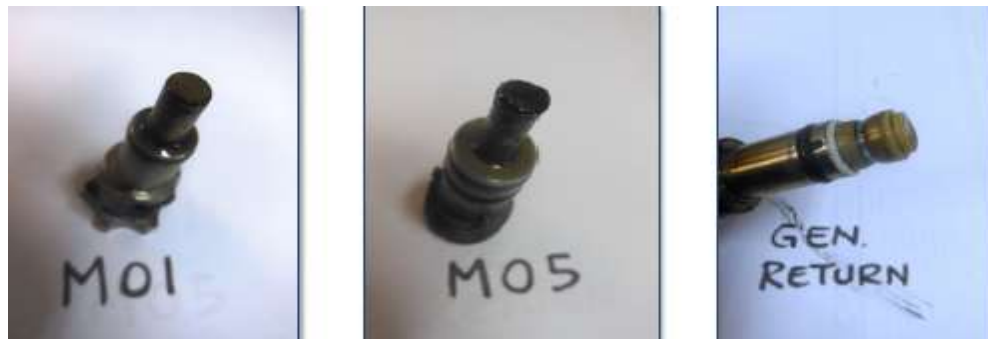
Magnetic Plugs

The magnetic plugs were checked and found clean or with non-significant amounts of particles.

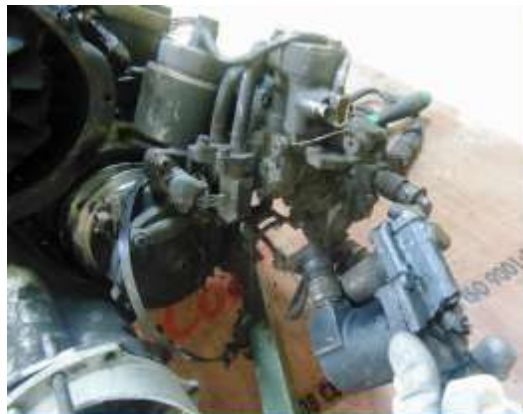
Hydro-Mechanical Unit (HMU)

The fixing clamp was ruptured and the HMU was held only by its pipes. The metering needle actuator was separated from the main body and hung by its wires. The body of the LP pump was broken and the impeller was exposed. No fuel pumping nor control would be possible with such an extent of damage thus indicating that the damage occurred during the crash.

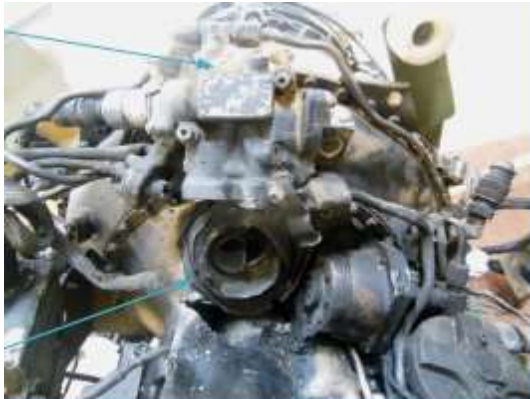
Valve Assembly

It was fixed to the engine with soil stuck around its upper part. This area could have been in contact with the ground when the engine was upside-down. Its support was slightly bent.

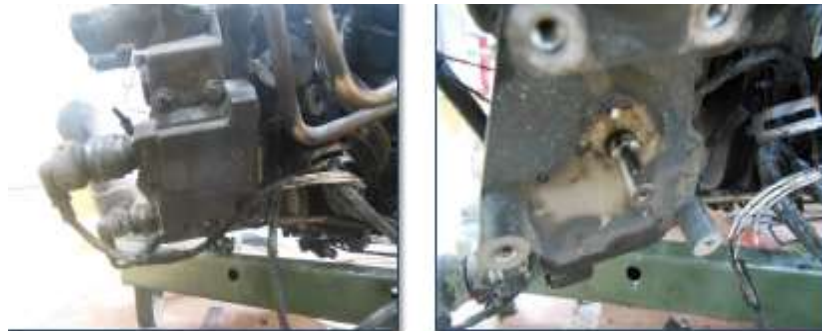
-EBCAU: this auxiliary device takes over the control of the engine fuel flow when the DECU is non-operational (in case of red “GOV” signal). The EBCAU was removed to expose the input drive shaft on the HMU. The key on the drive shaft was pointing North, thus indicating that it had not rotated and that the EBCAU was not operated during the flight.

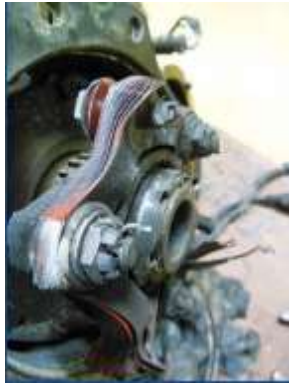
- Front Output Drive Shaft: the screws of the flector were ruptured thus indicating a separation from the drive shaft to the Main Gearbox during the crash.

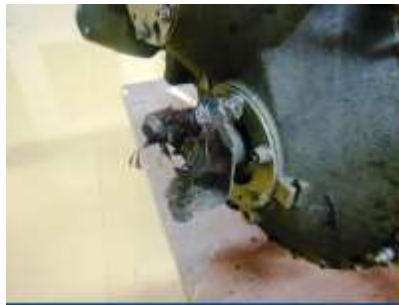
- Rear Output Drive: the rear drive flange was distorted and the flector was destroyed. By experience, this type of damage is found as consequence of a crash.
