# Air Accident Investigation Unit Ireland

**SYNOPTIC REPORT**

**Cessna 208B, N208B  
Ballyart, Co. Limerick  
13 December 2014**

AAIU Report No: 2015-020  
 State File No: IRL00914106  
 Report Format: Synoptic Report  
 Published: 12 November 2015

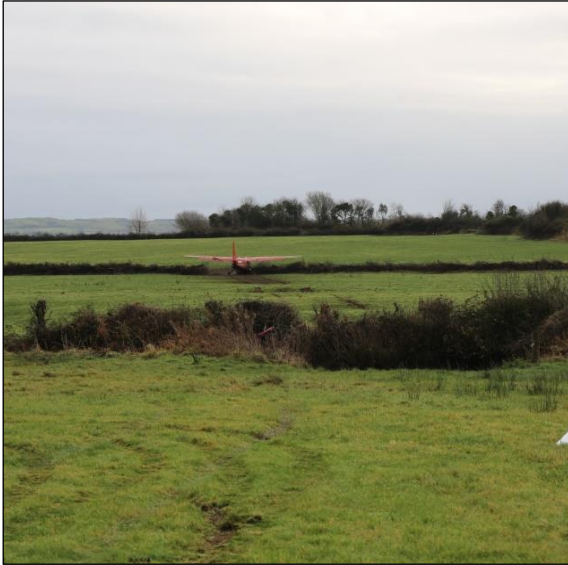
The ditch situated at the end of the runway had steeply sloping sides and contained water to a depth of approximately 0.5 m. The outer section of the left elevator had detached due to contact with a fence post and was found on the far side of the ditch embedded in the hedgerow (**Photo No. 1** and **Photo No. 2**).

**Photo No. 1:** End of runway and ditch

The Investigation suggested to the airfield owner that he should consider back-filling the entire ditch where it crosses the end of the runway to provide a safe over-run should a subsequent over-run event ever occur. The Airfield Owner agreed to this suggestion and as a result, no Safety Recommendation is made regarding this.

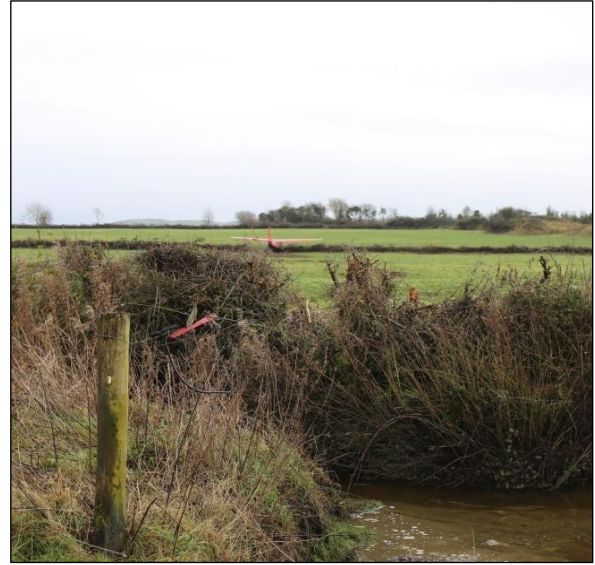
**Photo No. 2:** Close up of ditch with debris

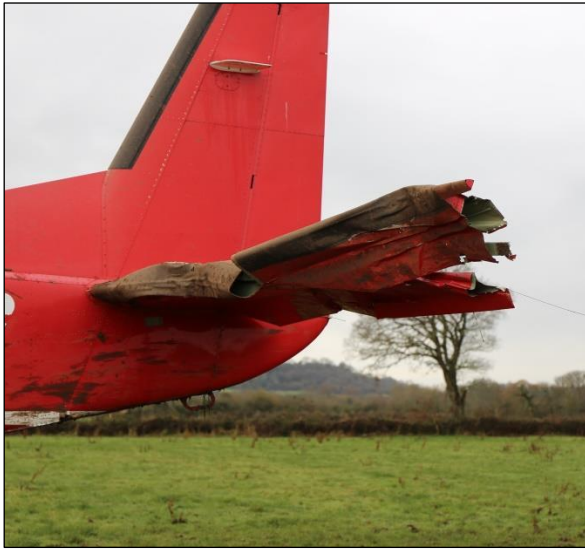
The aircraft sustained substantial damage. The aircraft made contact with several wooden posts and a section of pruned hedgerow which was situated at the end of the runway. The most severe damage was caused to the left tailplane (**Photo No. 3**), with compression buckling evident on the fuselage underneath the tailplane carry-through structure. The skin on the aft underside of the fuselage was torn with some damage to the lower fuselage frames. The propeller blades were bent at the tips due to contact with a piece of concrete at the entrance to the field where the aircraft came to halt (**Photo No. 4**).

**Photo No. 3:** Damage to left tailplane

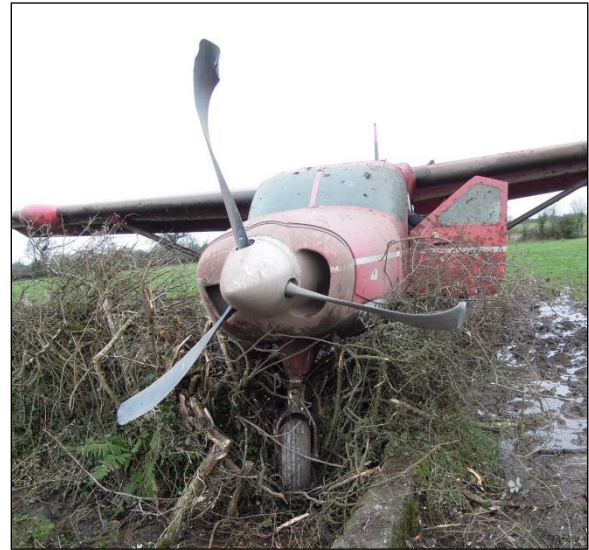
Repair work subsequently carried out on the engine and propeller revealed neither pre-accident defects nor any factor that may have contributed to a loss of power.

**Photo No. 4:** Damage to propeller blades

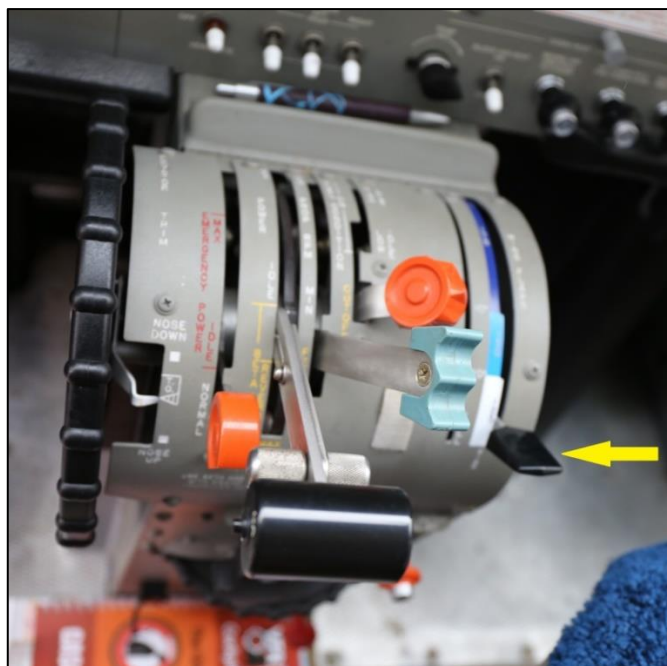
The Pilot recounted that he had set the wing flap selector to the FULL detent as part of his pre-flight inspection. During the inspection by the AAIU, the Pilot informed the Investigation that he had omitted to re-position the flap selection lever to the 20 degree detent following engine-start, the normal setting for take-off. This was consistent with the position that the flap selector was found during the cockpit examination by the AAIU (**Photo No. 5**).

**Photo No. 5:** Flap lever as found, set to FULL (indicated)

The acceleration of the aircraft during the initial part of the take-off run appeared normal to the Pilot. However, as the flaps had been inadvertently left in the FULL position drag was increased to such an extent that the acceleration of the aircraft to normal flying speed was not achieved in the take-off run available.

The flaps remaining selected in the FULL position following pre-flight checks, which resulted in increased drag and reduced aircraft acceleration during the take-off roll.

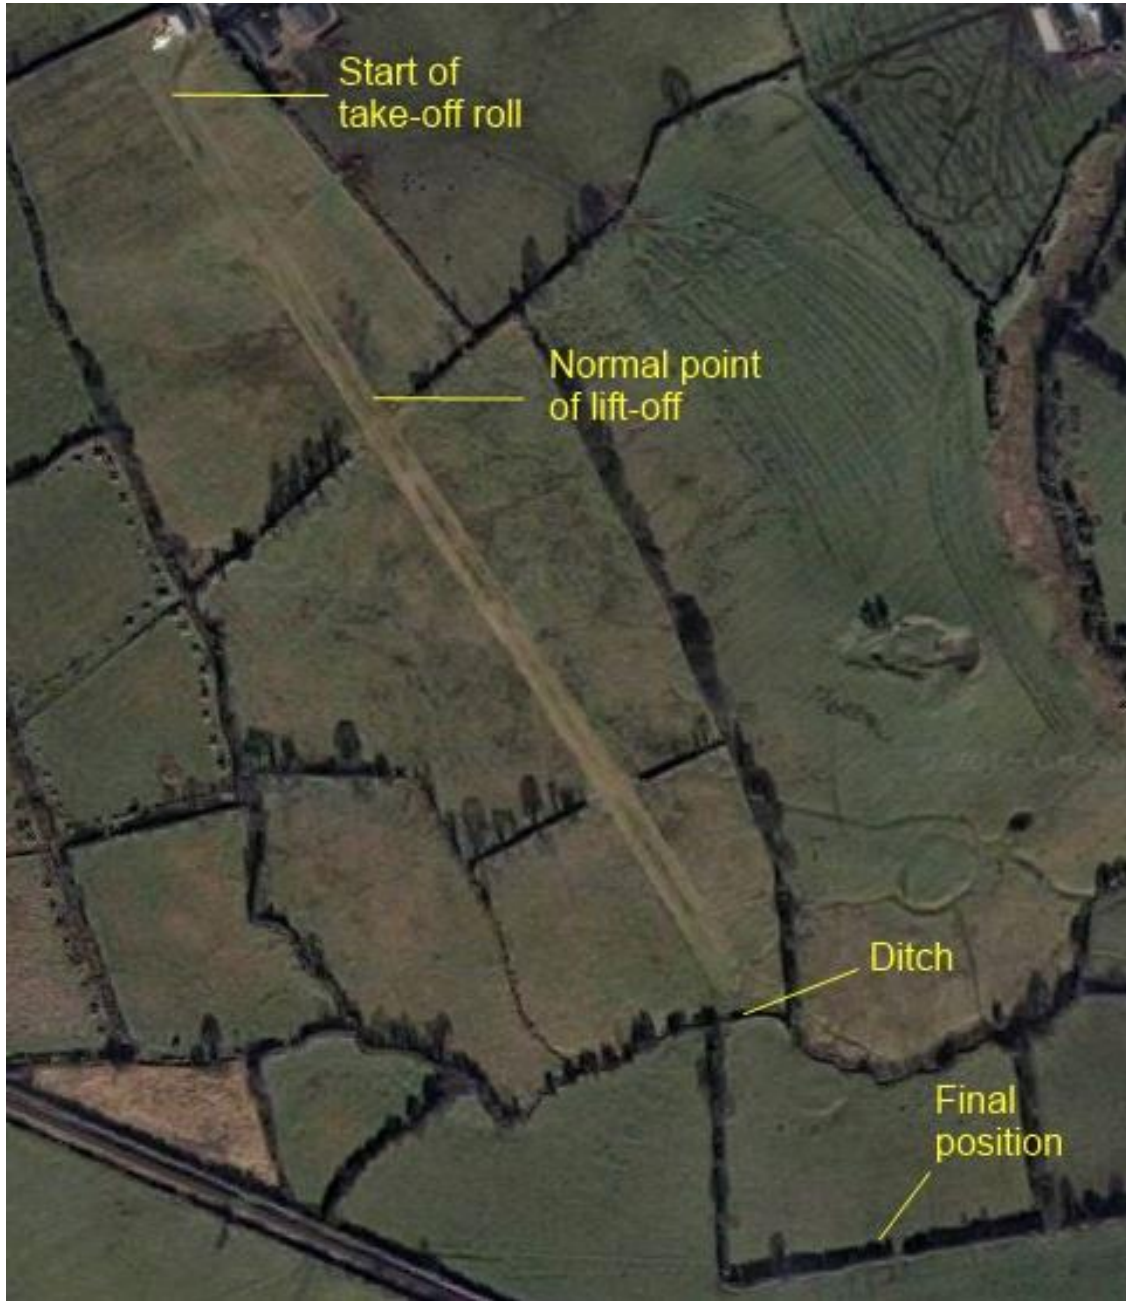
**Position at start of take-off, normal lift-off point at 300 m, ditch and final position of aircraft (based on Google Maps 2015)**
