**FINAL INVESTIGATION REPORT ON GROUND INCIDENT TO M/S  
ALLIANCE AIR ATR 42-320 AIRCRAFT VT-ABO WITH JET AIRWAYS  
PASSENGER COACH ON 22.12.2015 AT KOLKATA AIRPORT**

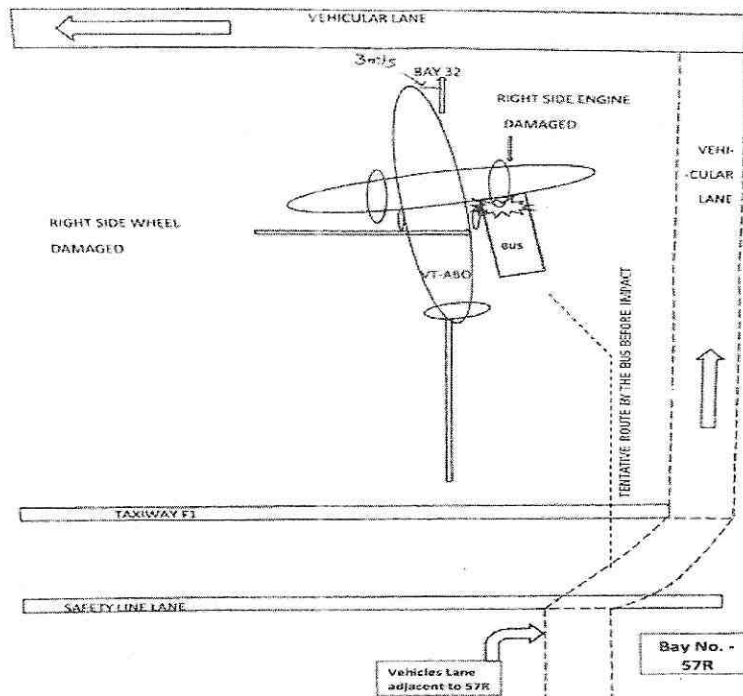
- a) The recording was not very clear probably because of the distant location of the bay from the CCTV.
- b) The Passenger coach had enough strong headlights to see anything ahead.
- c) The coach was seen following vehicular lane initially for very short span. It turned left before the designated turn close to Bay 32 and travelled straight. Suddenly it was observed taking sharp left turn and hitting the aircraft.
- d) It was also observed that the driver tried to reverse the vehicle subsequent to the impact but he could not succeed.

The approximate lay out of the Bay 32, the vehicular lane and the tentative deviated path followed by the passenger bus (based on the video footage) is depicted below:

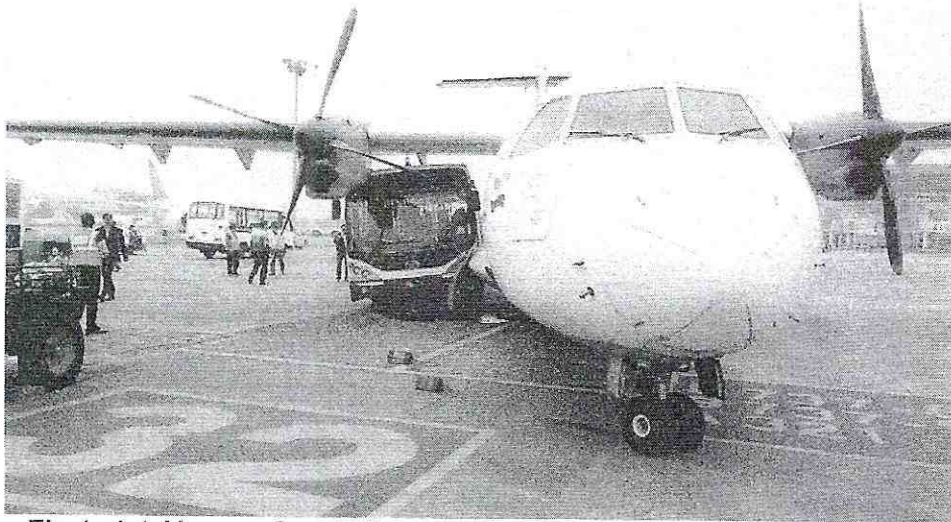
*Fig 1: Jet Airways Coach Rammed Into Alliance Air ATR-42, VT-ABO*

Involuntary dozing of the Driver while driving on the apron has resulted into collision of coach with the aircraft.

- 4.1 Aerodrome Operator may be advised to include this incident as a case study to be briefed to the applicants seeking Airside Driving Permits.
- 4.2 Airlines may review their policy on rostering the equipment Operators/Drivers for performing duties on consecutive nights.

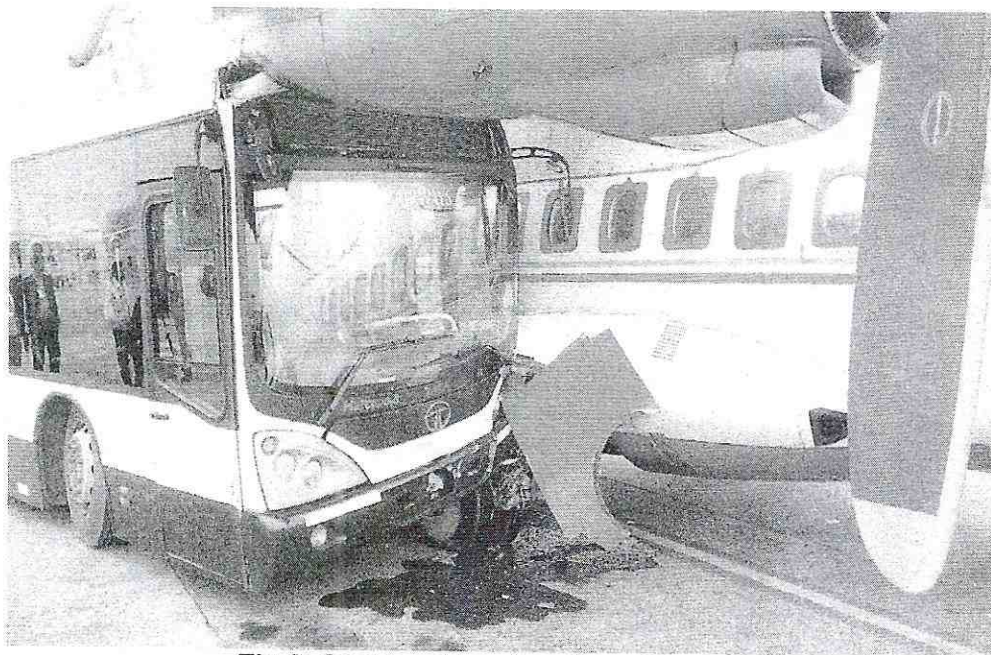
- a) No.4 Tyre burst & No.3 deflated with heavy cut mark.
- b) No.4 Wheel Hub assy. Broken.
- c) RH side Landing gear Ole bent.
- d) RH Landing gear front fitting assy. top & bottom portion material damaged.
- e) RH side Engine wing box damaged.
- f) RH side Engine Tail pipe with exhaust tail cone damaged.

*Fig 2: Starboard Landing Gear Damaged*

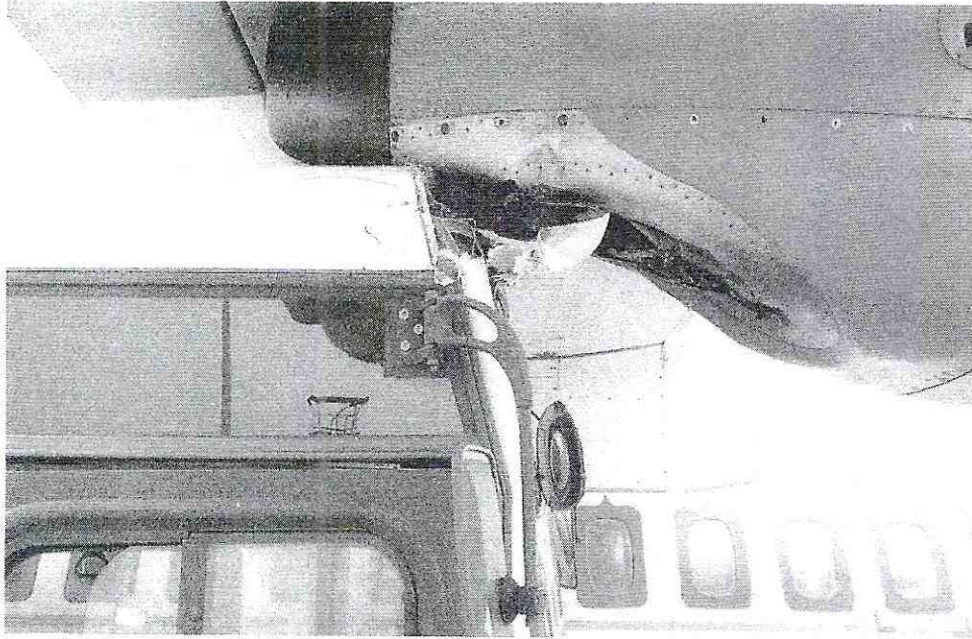
*Fig 3: Starboard Engine Tail Portion Damaged*

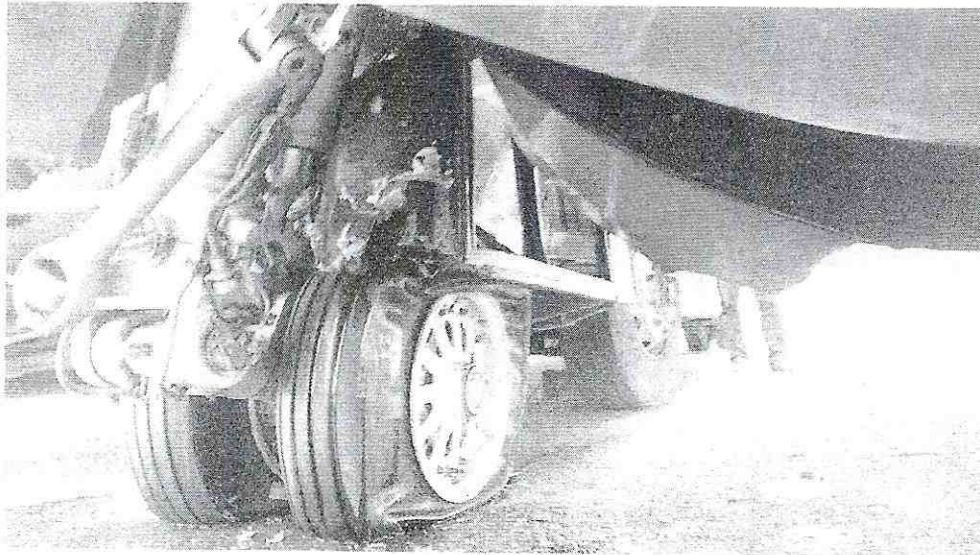
*Fig 4: Both Main Landing Gear Tyres of Starboard Side Deflated*
