AIRCRAFT ACCIDENT REPORT AND EXECUTIVE SUMMARY

Reference:	CA18/2/3/9510	
Aircraft Registration	ZU-RON	Date of Accident	30 December 2015		Time of Accident	0430Z
Type of Aircraft	Aeroprakt		Type of Operation	Private (Part 94)		
Pilot-in-command Licence Type		National Pilot	Age	53	Licence Valid	Yes
Pilot-in-command Flying Experience		Total Flying Hours	877.68		Hours on Type	540
Last point of departure		Vygeboom Dam private airstrip-Mpumalanga Province				
Next point of intended landing		Vygeboom Dam private airstrip-Mpumalanga Province				
Location of the accident site with reference to easily defined geographical points (GPS readings if possible)						
On water channel next to a dam in an area with GPS reading as: (S 25°52'39.57", E 030°37'13.66")						
Meteorological Information		Wind direction: 010°; Wind speed: 01kt; Visibility: 10km; Air temperature: 18°C; Dew point: 15°C; Cloud cover: Sct; Cloud base: 1500ft AGL				
Number of people on board	1+1	No. of people injured	2	No. of people killed	0

Name of Owner : Gemdam Trust
Name of Operator : Gemdam Trust
Manufacturer : Aeroprakt
Model : A-22
Nationality : South African
Registration Marks : ZU-RON
Place : Vygeboom Dam, Mpumalanga

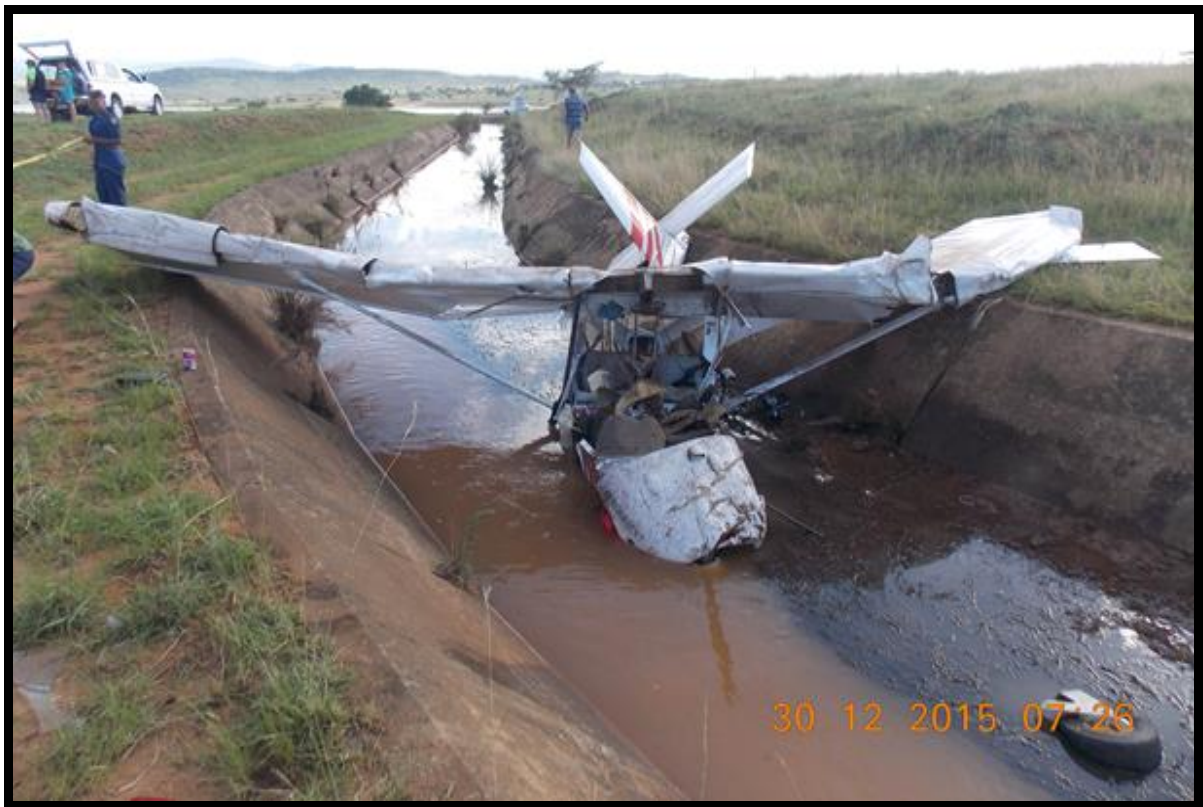
1.3.1 The aircraft was destroyed during the accident sequence.

Figure 2: Shows the aircraft after the accident

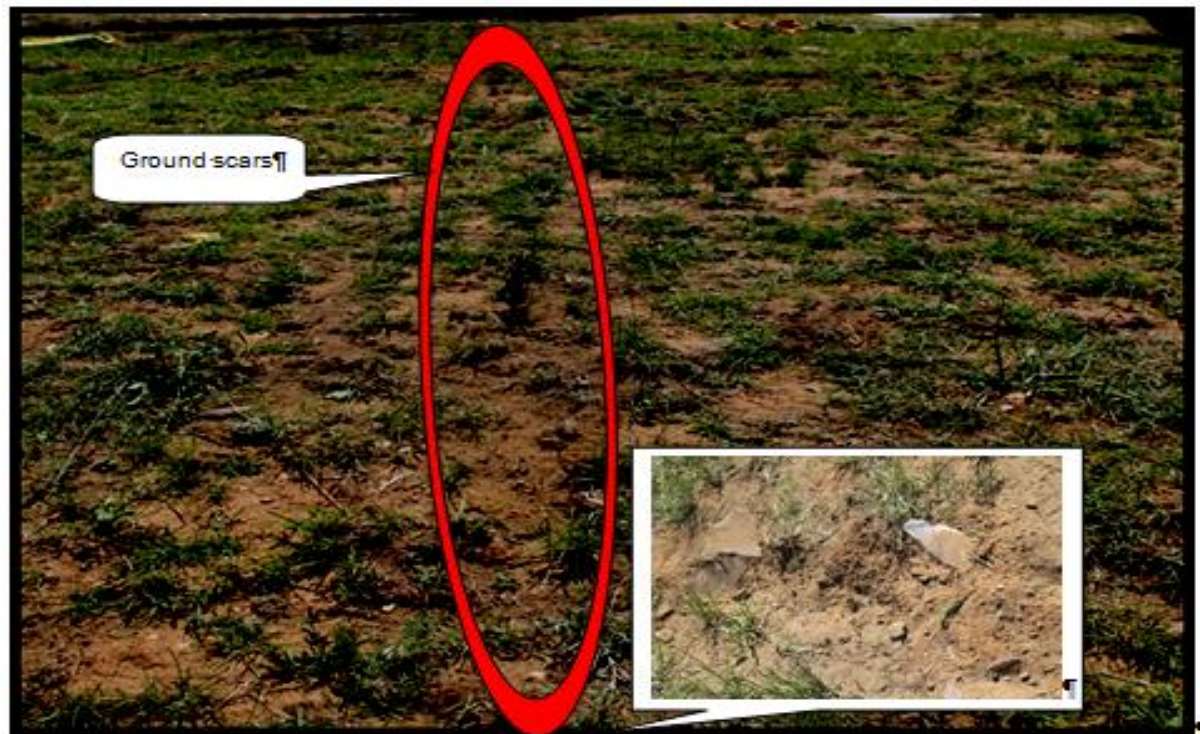
Figure 4: Shows the impact trail

1.12.2 According to the details of the ground impact marks, the initial impact contact with the ground was at a distance of approximately 46 m from the dam and continued

until it fell into a water canal. The aircraft wreckage showed evidence of impact with the right hand wing outer leading edge followed by the nose section. This was in relation with the ground scare marks on the accident site that showed a trail and a position of impact which was in consistence with damages on the wings and the fuselage. The wreckage damage pattern resembled the aircraft that experienced a stall.

1.12.3 The ground marks trail suggests that the right wing touched the ground first followed by the nose section which was pushed to the left on impact. Due to the low angle of impact the aircraft after initial impact, continued toward the water channel in which the left wing impacted hard with the concrete wall before turning clockwise and got stuck in between the channel walls. The aircraft remained at rest with its wings hanging on top of the water channel. The fuselage bottom was immersed in the water.

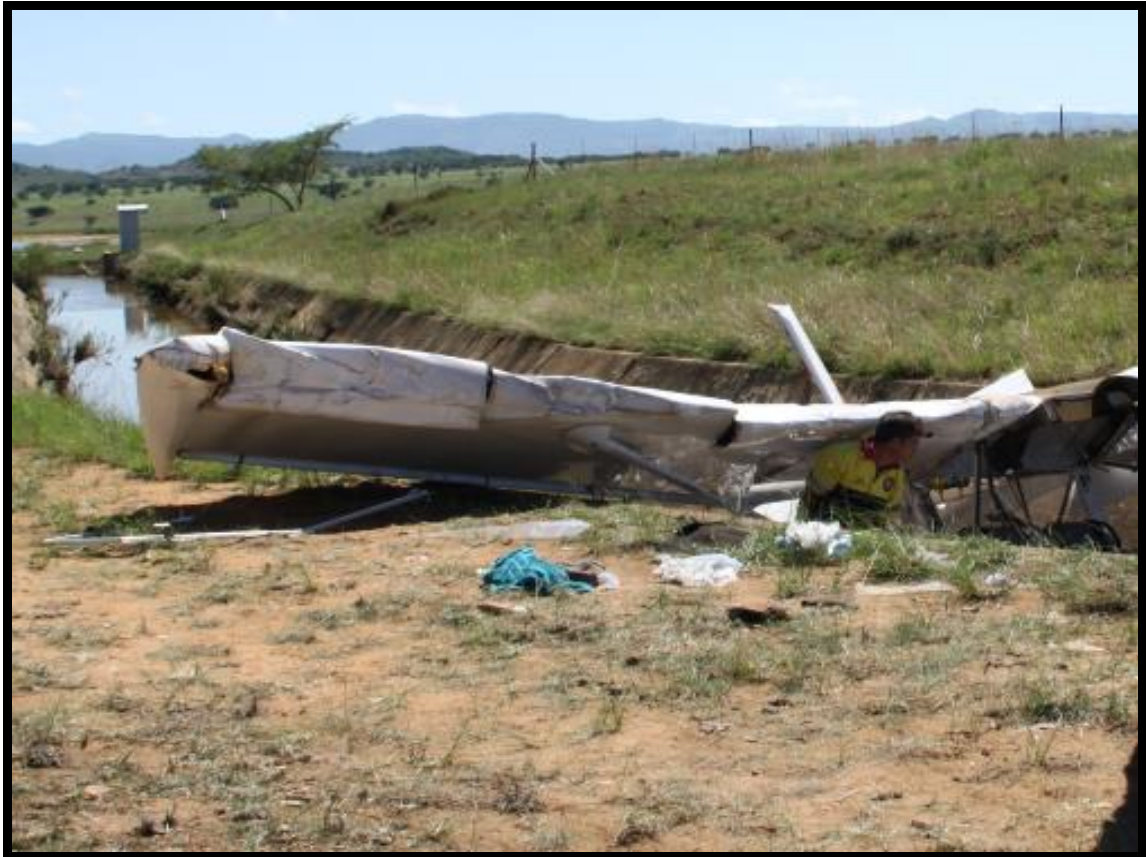
Figure 5: Shows damages on the right wing

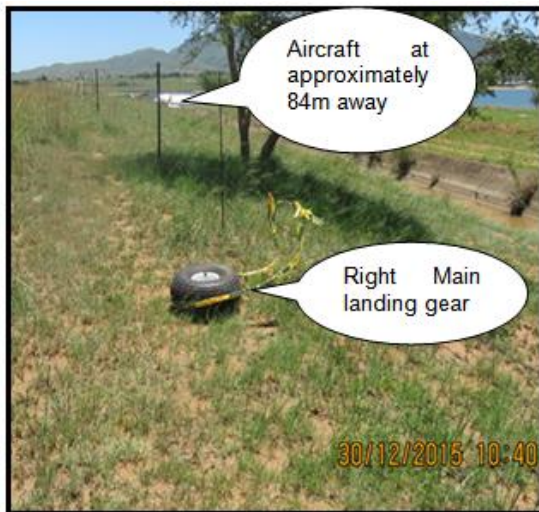
Figure 6: Right main landing gear

1.12.4 All landing gears detached from the main airframe following the impact sequence. The right main landing gear wheel was found at approximately 84m north of the crash point. Beside the right main landing gear, the other aircraft wreckage was

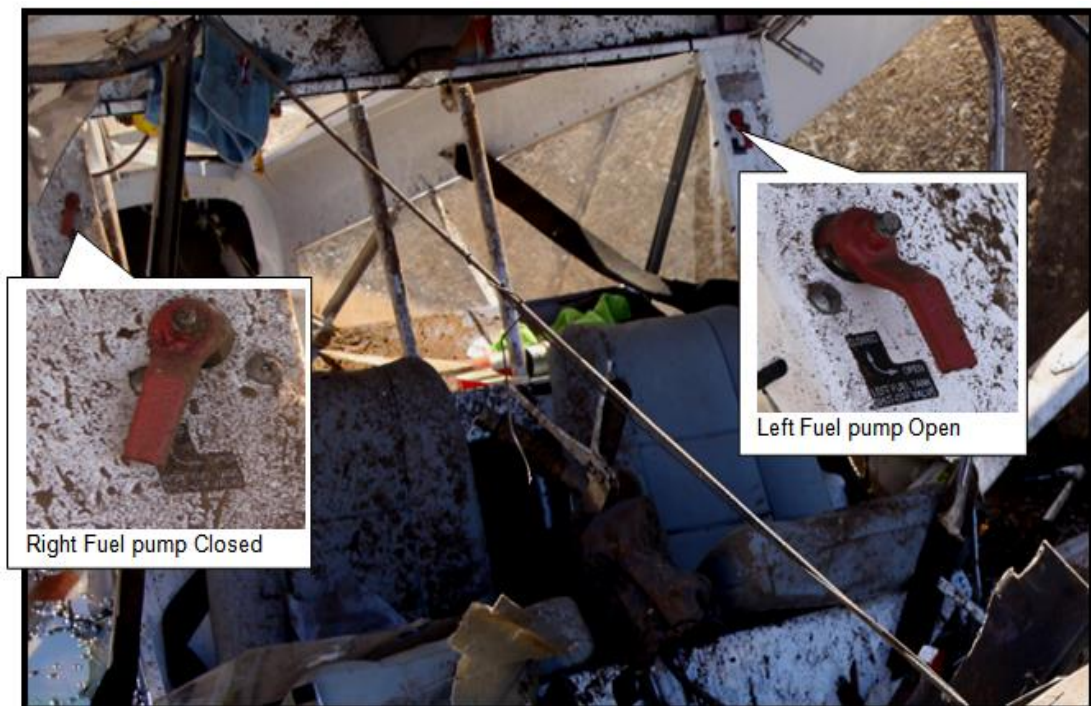
Figure8: Shows fuel pump positions

1.12.5 The observation of the wreckage and the photographic evidence also revealed that the right tank supply line valve was closed whereas the left tank was open during flight. The right hand seat belt (shoulder harness) was in a condition that shows that they were never used during flight whereas the left hand seat belt showed that were used during flight.

The investigation concluded that the engine failure was due to fuel starvation as there was enough fuel in the right hand tank during operation but not selected during flight. During starting with pre-flight less fuel was remaining in the left fuel which was enough to start the aircraft until failure during flight. At the time only the left wing tank was selected.

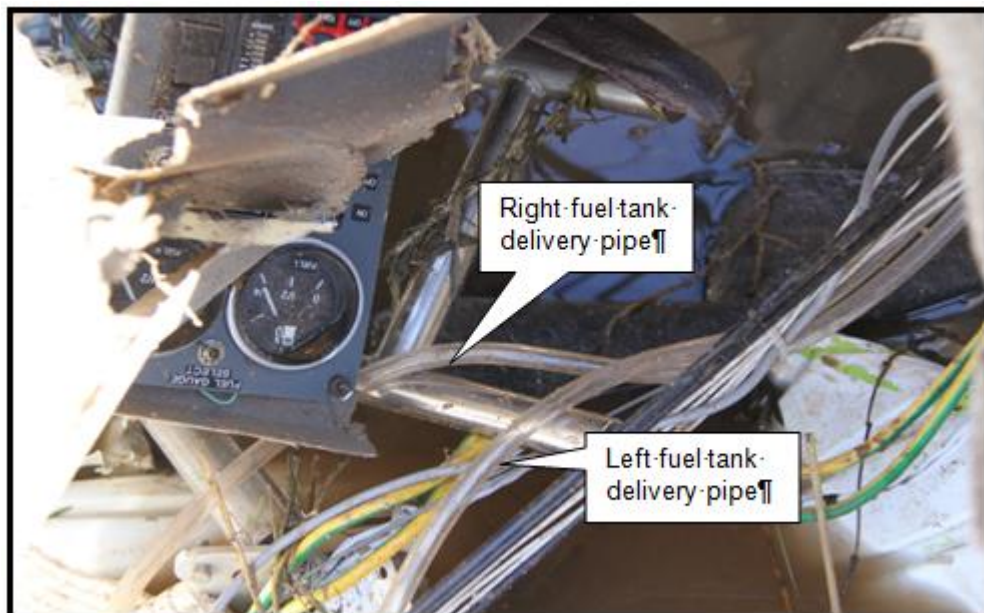
Figure 9: Shows the fuel lines from the fuel tanks

The observation on the fuel pipe lines showed no fuel from both fuel tanks. During investigation, when opening the right hand tank fuel valve, fuel was observed running out of the delivery fuel line in much quantity with no sign of restrictions. The left hand side tank unusable fuel was empty due to damages.

According to post-accident engine inspection, there was no fuel in the engine at the time of inspection. Also during on-site inspection, no fuel was found in the carburettor fuel cups. Less fuel spillage was observed from the left tank which was damaged.
