AIRCRAFT ACCIDENT REPORT AND EXECUTIVE SUMMARY

Reference:	CA18/2/3/9511	
Aircraft Registration	ZS-RZL	Date of Accident	02 January 2016		Time of Accident	0835Z
Type of Aircraft	Eurocopter EC-130 B4 (Helicopter)		Type of Operation		Part 91	
Pilot-in-command Licence Type	Private pilot licence	Age	65	Licence Valid	Yes	
Pilot-in-command Flying Experience	Total Flying Hours	858.7		Hours on Type	747.4	
Last point of departure	Private property Loch Vaal: Free State province					
Next point of intended landing	Private property Loch Vaal: Free State province					
Location of the accident site with reference to easily defined geographical points (GPS readings if possible)						
On a maize field in Parys at GPS co-ordinates determined to be S26° 55" 00 .3' E27° 23" 05.3' at an elevation of approximately 4 650 ft above mean sea level (AMSL).						
Meteorological Information	Temperature- 30°C: Visibility- 10 km: Wind direction-SW @05 knots: Cloud base-±8000 ft: Cloud cover-Scattered cumulus.

AIRCRAFT ACCIDENT REPORT

Name of Owner/Operator : Beltimar (Pty) Ltd
Manufacturer : Eurocopter Helicopters
Model : EC-130 B4
Nationality : South African
Registration Marks : ZS-RZL
Place : On a maize fiel

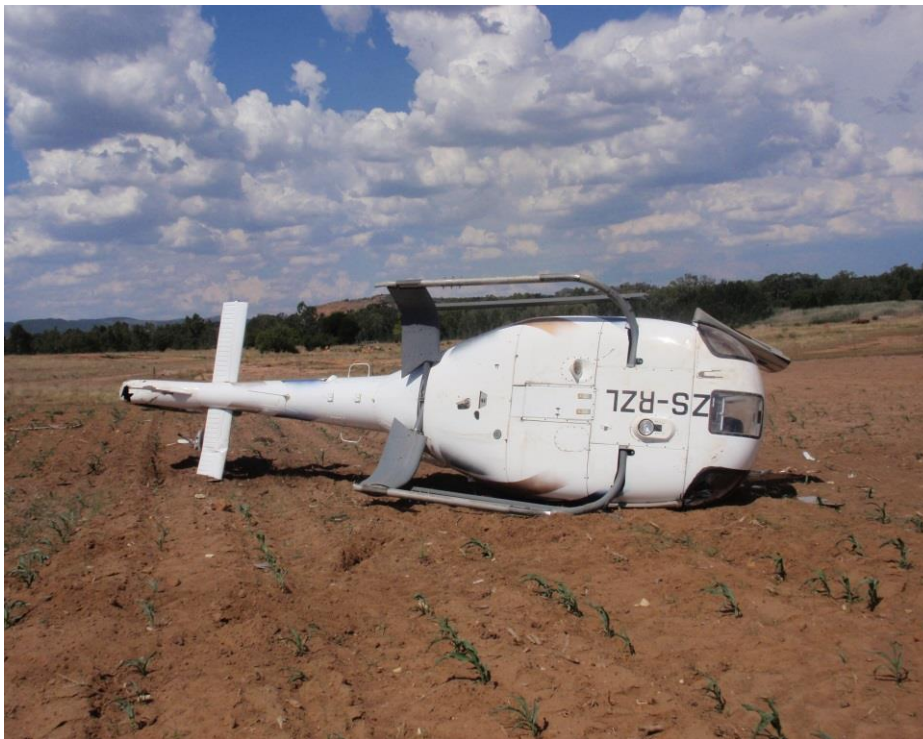
1.3.1 The helicopter was substantially damaged during the accident.

Figure 2: The helicopter as found at the accident site

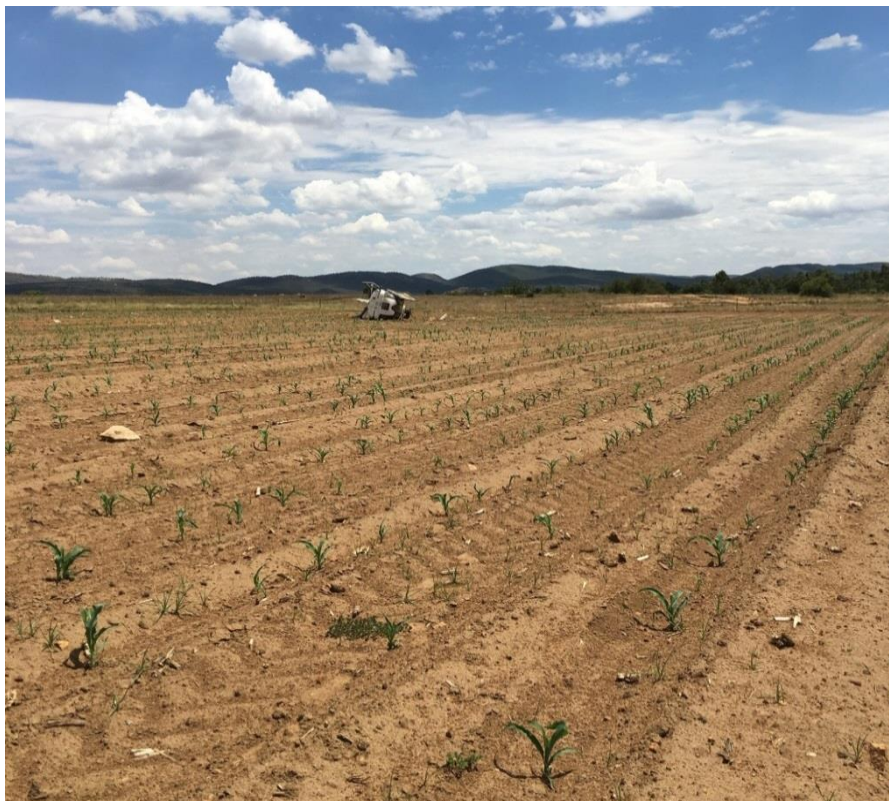
1.12.1 Examination of the helicopter wreckage at the site revealed that it was confined around its final resting position. There was no in-flight disintegration of any part of the helicopter. During examination of the helicopter at the accident site by engineers from Turbomeca, it was observed that the helicopter was resting on the ground facing west with the fuel shut-off lever in the closed position. Rotor strike marks were observed. All three main rotor blades were within the vicinity of the wreckage area. Each main rotor blade broke into multiple pieces, suggesting that the rotor system was powered at the time of the accident. The Perspex windshield shattered during the accident sequence. All the doors were able to move or latch without resistance. Both skids were undamaged; however substantial damage was limited to the helicopter. The tail boom displayed damage consistent with impact damage.

Figure 6: The helicopter as found at the accident site on the maize field

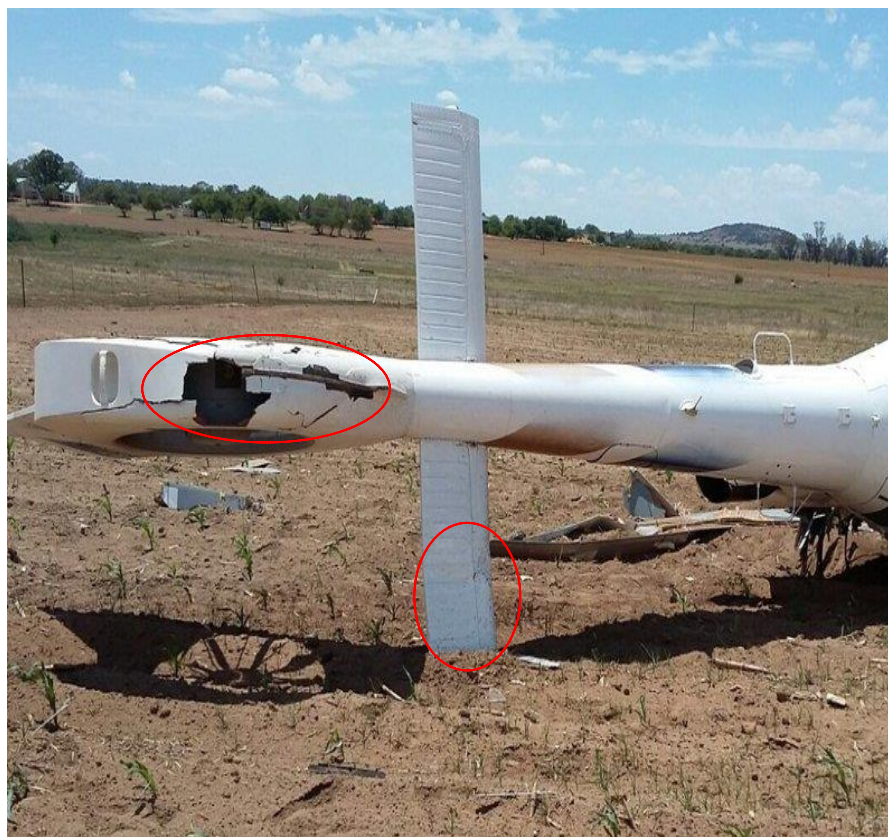
1.12.2 The condition of the left horizontal stabilizer/fin was consistent with impact damage. Flight control continuity was confirmed from the cockpit through the tail rotor system and from the cockpit cyclic and collective controls to the point where the controls are connected to the actuators mounted to the main transmission. Control tubes connecting the swash plate to the hub exhibited fractures consistent with an overload condition from impact. The transmission deck, mounting points, and mounting struts were damaged. Visual inspection on the engine mounting points showed that the engine had moved from its original mounted position. The engine gas producer and power turbine rotated freely. Engine magnetic plugs were removed, and no metallic particles were found. The engine chip detector was also free of metallic particles. The fuel and oil filters were removed and inspected and no debris was found. The air intake duct remained attached to the engine and showed no evidence of cracks or fractures. The drain hole in the air intake duct showed no evidence of blockages. The engine's fuel, oil, and electrical connections remained intact. The presence of fuel in the engine's hydro mechanical unit (HMU) was confirmed. A sample of Jet A1 fuel tested negative for the presence of water. The seats did not show signs of being weakened from impact forces during the accident sequence. The anti-torque pedals showed no signs of damage or stiffness. The damage sustained by the helicopter was all post impact.

Figure 8: Damage sustained by the helicopter's tail section

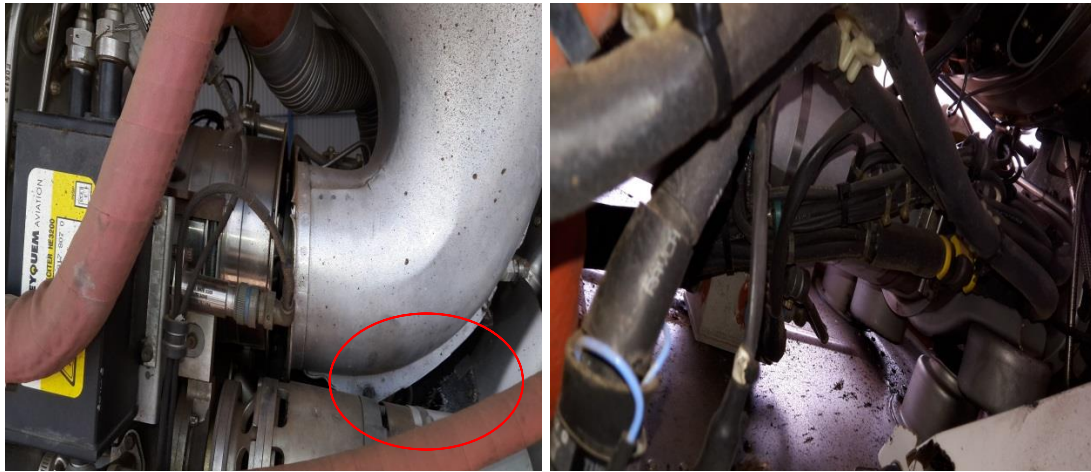
Figure 9: Engine moved from its mounting point with the exhaust muffler separated

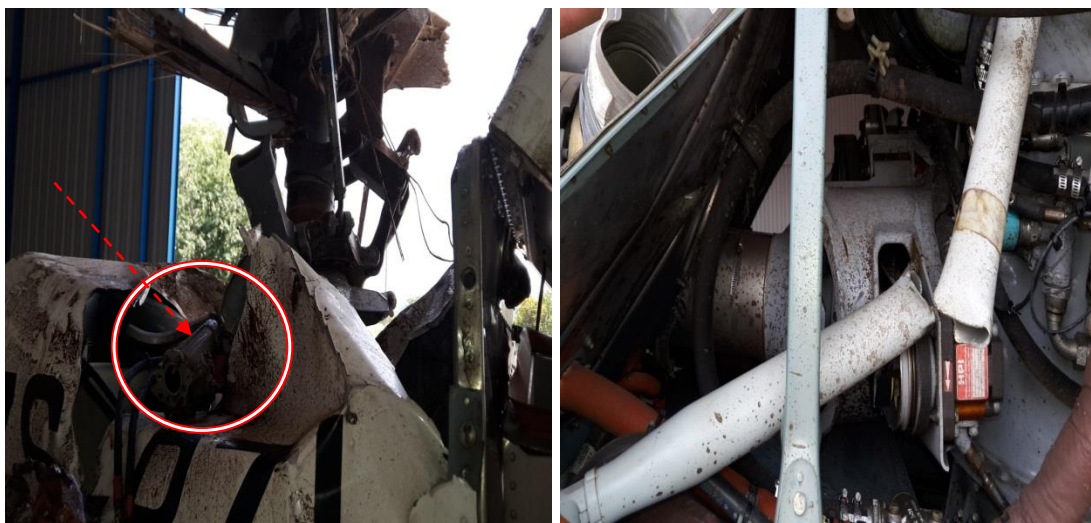
Figure 10: A photograph showing a detached hydraulic actuators and a damaged engine support bar

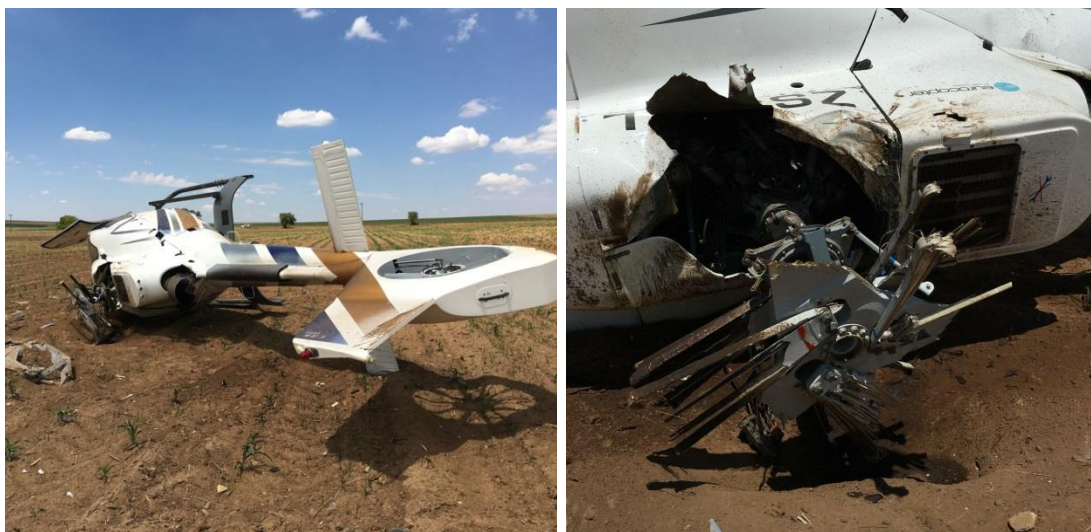
Figure 11: Photographs showing the final position of the rotor head

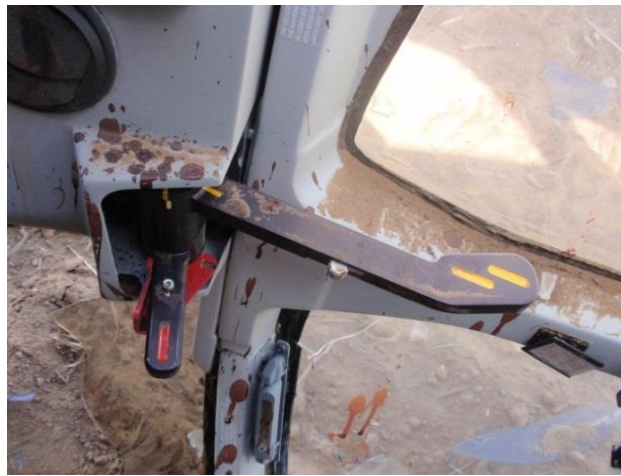
Figure 12: The position of the fuel shut-off lever
