DUTCH
SAFETY BOARD

Misaligned take-off from Runway 24, Amsterdam Airport Schiphol

The Hague, November 2018

Identification number:	2016004
Classification:	Serious incident
Date, time of occurrence:	18 January 2016, 17.25 hours ¹
Location of occurrence:	Amsterdam Airport Schiphol
Registration:	EC-JBD
Aircraft type:	Embraer EMB-120ER
Aircraft category:	Commercial – fixed wing
Type of flight:	Scheduled cargo flight
Phase of operation:	Take-off
Damage to aircraft:	Severe damage to the right-hand propeller, multiple fuselage skin puncture marks and damage to nose wheel
Flight crew:	Two
Passengers:	None
Injuries:	None
Other damage:	Runway edge lights
Light conditions:	Night-time

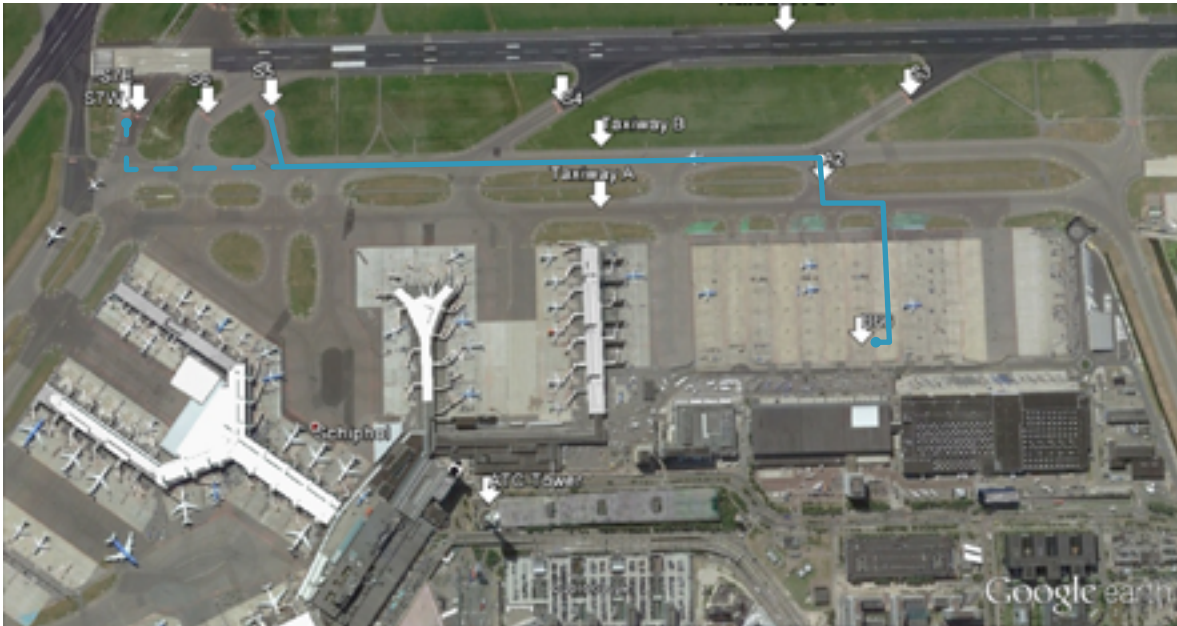
Figure 1: Overview of the relevant part of Amsterdam Airport Schiphol with the parking stand, taxiways and Runway 24 together with a rough representation of the intended (blue dashed) and actual taxiing track (blue). (Photo: Google Earth)

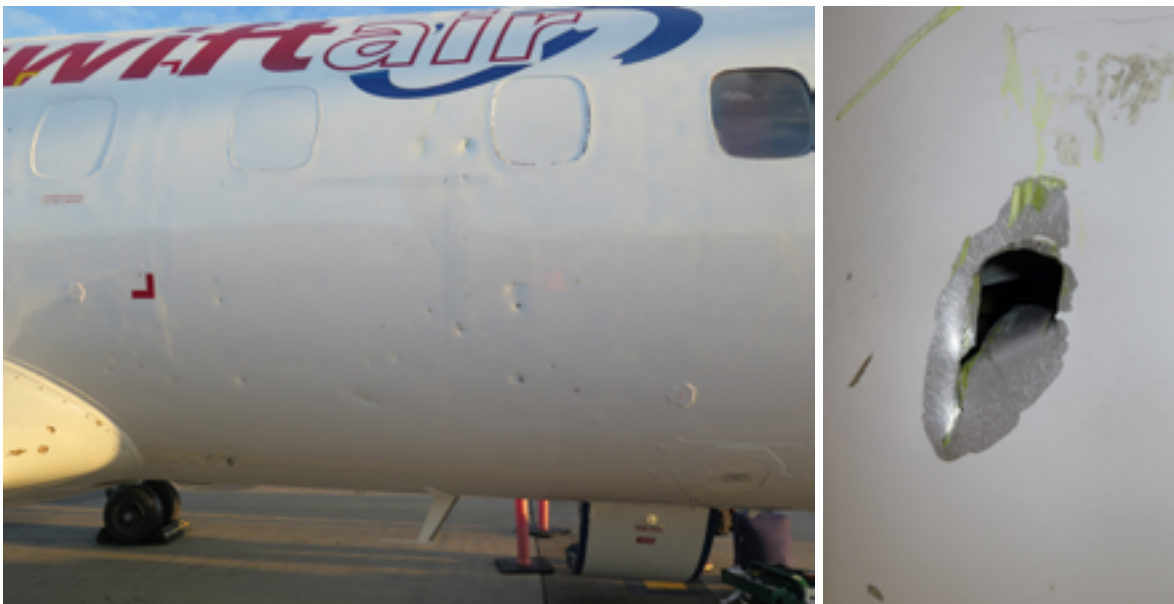
In contrast to the left-hand side, puncture marks were found at several locations on the right-hand side of the fuselage (see Figure 2 left). Around these locations, yellow paint deposits were visible on the white coloured fuselage skin. On one location, near the right-hand wing and body fairing, the fuselage skin was punctured (see Figure 2 right). This punctured hole also exhibited yellow paint marks around it.

Figure 2: Fuselage on the right-hand side of the aeroplane with the hole pattern (left) and a detailed view of the punctured fuselage with visible yellow paint deposits (right). (Photo: AAIB)

In order to explain the damage of the propeller and fuselage the following scenario was considered. After the lights were run over by the nose wheel of the aeroplane, parts of the runway edge lights were ejected to the right-hand side. Subsequently, some parts of the disintegrated lights hit the right-hand propeller. The latter is indicated by the yellow paint deposits that were found on the propeller blades. While being hit by the propeller blades, some parts of the edge lights were catapulted towards the fuselage due to the propeller's rotational velocity, leading to penetration of the fuselage skin. This explains the impact marks and punctured holes as found on the right-hand side of the fuselage skin. The yellow residue around the puncture marks on the fuselage matches the colour of the runway edge lights.

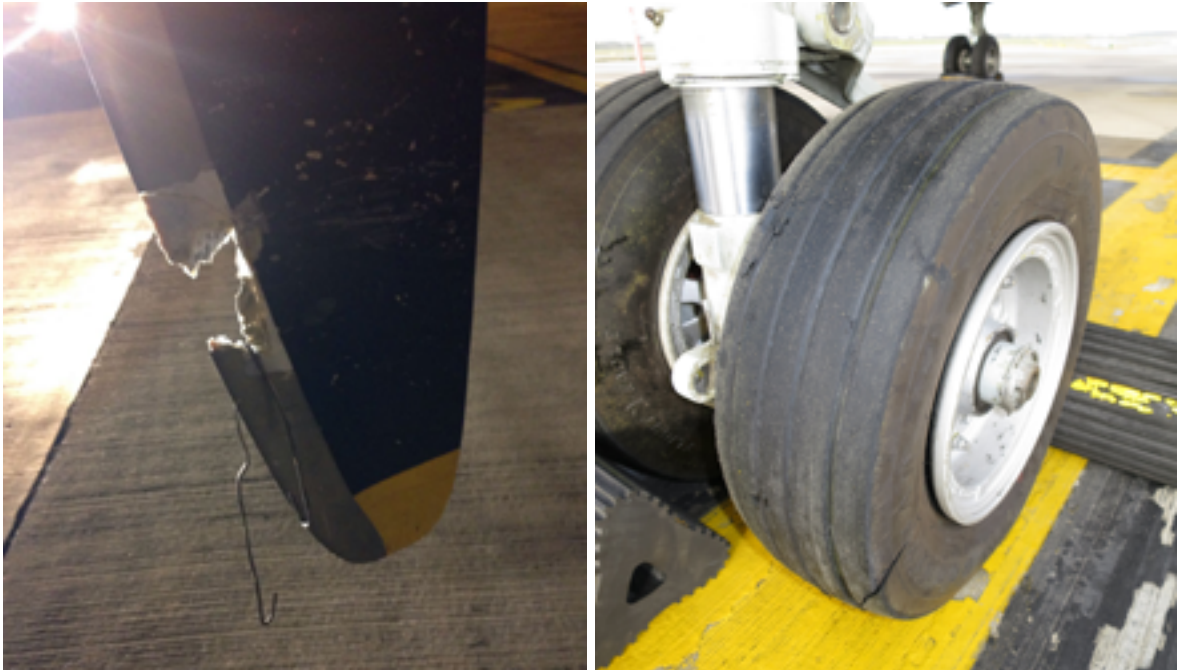
In addition to the damage on the aeroplane's fuselage, damage was found on the right-hand side propeller. This damage varied; one blade had a dent and a second blade was damaged on the leading edge with yellow paint scuff marks and a cut in the trailing edge. A third propeller blade was damaged more severely with a large cut in the leading edge with a piece of wire embedded in it (see Figure 3 left).

Figure 3: Right-hand engine propeller with wire embedded on arrival at Stansted airport (left image). Aeroplane nose wheel, as seen from the front side of the aeroplane, with port wheel damaged (right image). (Photo: AAIB)

The left-hand nose wheel (as seen from the front side of the aeroplane in Figure 3 right) exhibited yellow scuff marks and the tyre was cut just on the outside of the wheel extending to approximately halfway of the tyre's circumference. The tyre was found partially deflated and decoupled from its rim. The starboard nose wheel showed damage to the sidewall. In addition, yellow paint deposits were found on the rim and the outside of the tyre.

The port nose wheel sustained damage and yellow paint residue was found during visual inspection of the damage caused to the aeroplane. Again, this confirms that the runway edge lights were hit by the aeroplane; more specifically, the edge lights were hit by the nose gear.

In addition to the statements presented above, the hypothesis can be supported by the fact that a metal wire, originating from one of the runway edge lights, was found embedded in the leading edge of one of the propeller blades. Despite the embedded wire and other damage to the propeller blades, the propeller imbalance parameter extracted from the FDR, did not show any deviation from its nominal value.

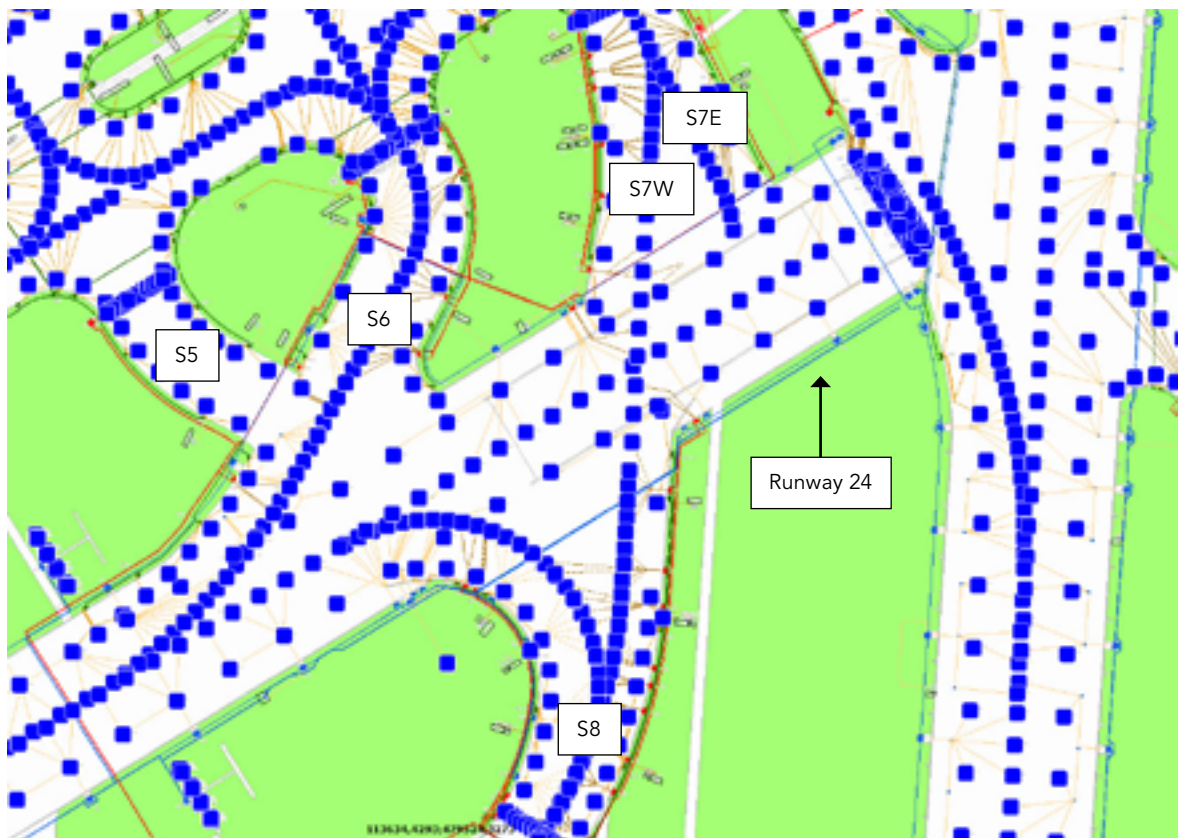
Figure 6: Location of the installed lights (both centre line and edge) on taxiway B and Runway 24 with Exit S5 to S8.

Contrary to the other taxiways leading to runway 06/24, taxiway S5 is equipped with blue edge lights and no green centre line lights are present. Other taxiways serving runway 06/24 are equipped with taxiway centre line lights.

Examination of CS ADR-DSN Certification *Specification and Guidance Material for Aerodromes Design* has indicated that, according to CS ADR-DSN.M.710 (b2), taxiway centre line lights should be provided on a taxiway intended for use at night in runway visual range conditions of 350 metres or greater, and particularly on complex taxiway intersections and exit taxiways. However, the same document also states that these guidance lights do not need to be provided on exit taxiways where the traffic density is light and taxiway edge lights and centre line marking provide adequate guidance.

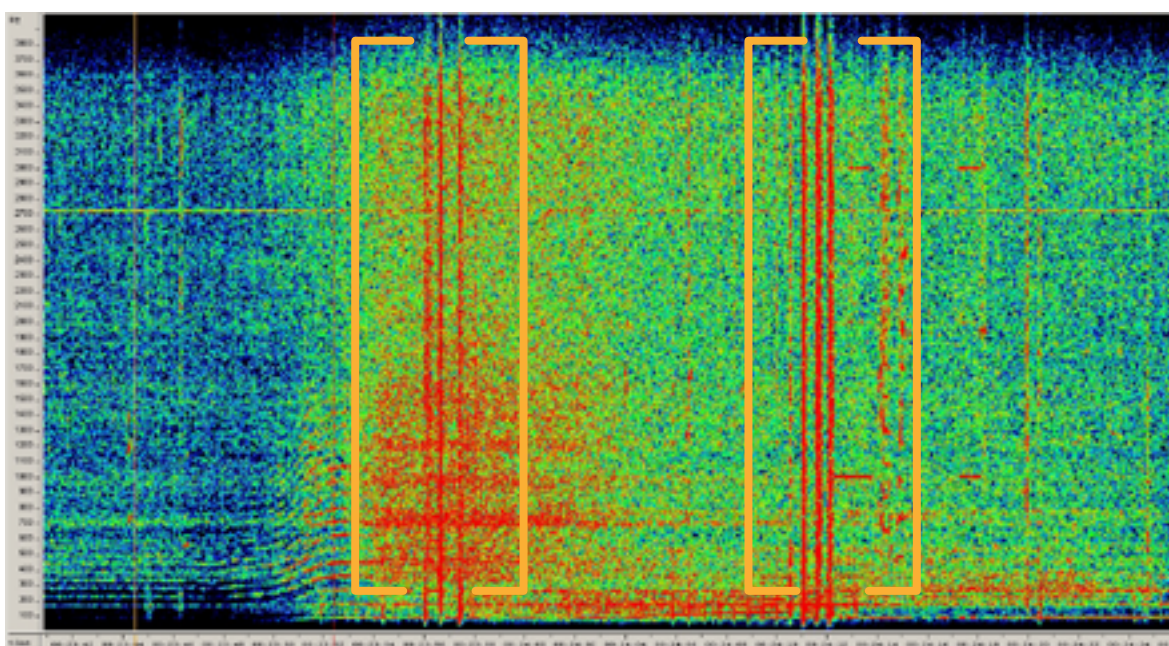
Figure 9: Spectral analysis of the audio track extracted from the CVR for the duration of the take-off. The impact sounds are emphasized by the yellow brackets.

CVR analysis revealed that several impact sounds were recorded by the cockpit area microphone during the take-off run. Following the first impact, it can be heard that the flight crew did discuss hearing a sound but attributed this to a falling pilot briefcase. During the interviews the flight crew acknowledged that some bumps were felt during the take-off run. At the time, the crew was not sure if this was coming from either the nose wheel or the main wheels. However, experiencing such sounds was not unusual for the flight crew because of its resemblance with the sound caused by the front gear running over the runway centre line lights. Hence, the flight crew did not have any indication for the severity of the incident.

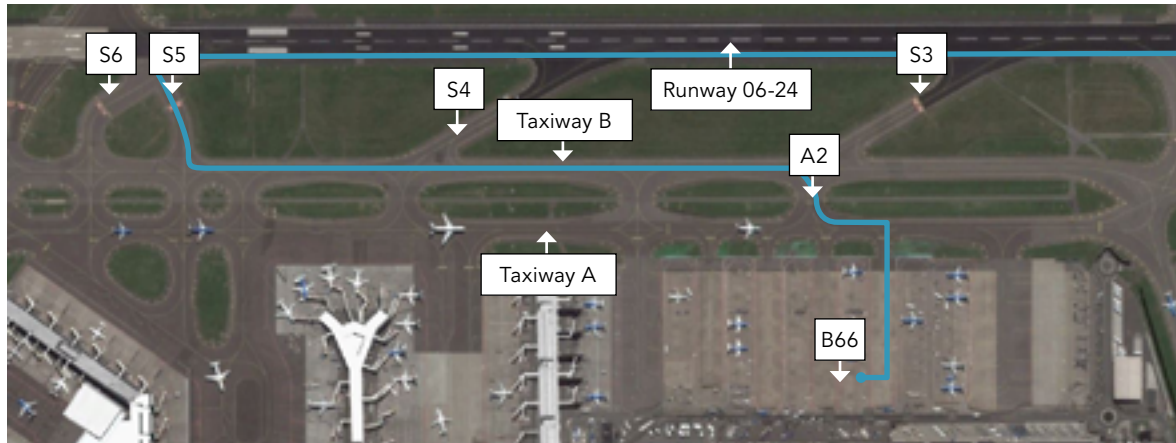
For the investigation, the ground radar data was requested in order to establish the ground track of the aeroplane. Analysis of the radar data confirms earlier findings; the aeroplane left its parking stand B66 and, after taxiing via taxiway A2 and B, a right-hand turn was made onto taxiway S5 (see Figure 10). Subsequently, the aircraft turned towards Runway 06/24. From the ground track it also becomes evident that the aeroplane, upon entering Runway 24, lined up on the right-hand side edge line. The aeroplane took off following the right-hand edge line. Comparison with radar data has confirmed that other aeroplanes, using intersections S5 and S7E, departing between 17.00 and 18.00 hours were correctly aligned with the runway centre line during take-off.

Figure 10: Aeroplane ground track derived from ground radar data. (Photo: Google earth)

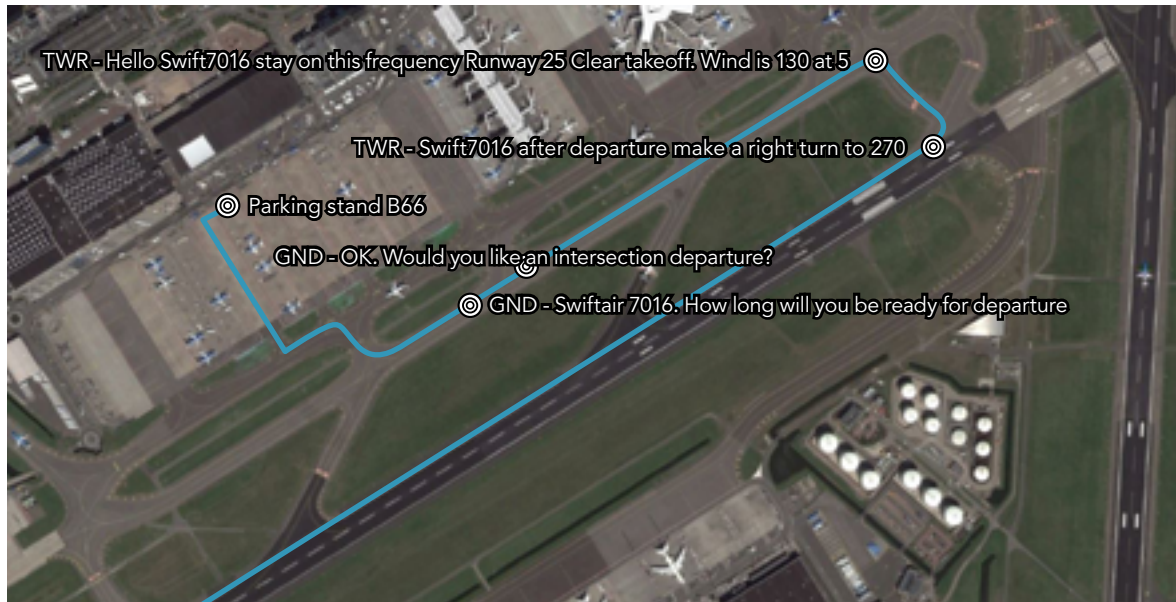
Figure 11: Actual taxi and take-off track of the aeroplane, reconstructed from radar data, together with a transcript of the relevant communication between ATC and the flight crew. (Photo: Google earth)

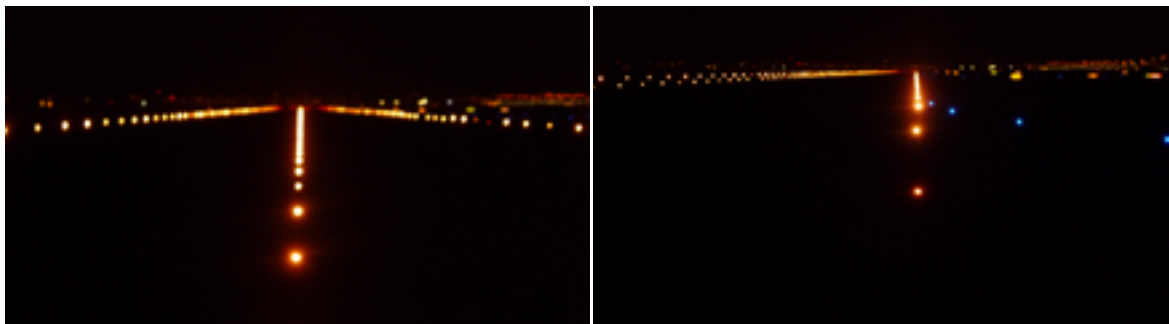
Although visual cues might be available, due to workload and/or other flight crew attention the determination if the aeroplane is lined up correctly might be difficult to make. A runway heading check is not sufficient to establish if the aeroplane is also laterally lined up correctly on the runway. It takes some time to observe and distinguish between the lights and (colour) patterns to establish the lateral position of the aeroplane.

Figure 12: View of Runway 24 from a position aligned with the centre line lights (left) and the runway edge lights (right).

As noted in the Biggin Hill report of the AAIB (AAIB, 2015), the dominant common factor between misaligned take-offs is that a visually compelling line of edge lights was visible to the crew. This edge line with lights was assumed to be the centre line by the crew. There is nothing inherent in an individual edge light that distinguishes it from a centre line light when viewed along the axis, as both have a white colour. It is the pattern of edge lights, and the relationship of this pattern with other lights and visual cues, which identifies them as edge lights. If this complex relationship becomes disrupted or misinterpreted, pilots can lose situational awareness.

It is recommended to initiate the process to develop, within Annex 14 Volume 1 'Aerodrome Design and Operations', a standard for runway edge lights that would allow pilots to identify them, specifically, without reference to other lights or other airfield features.

It is recommended to proactively take measures, in line with the above recommendation to ICAO, which prevent pilots from interpreting the runway edge lights as the runway centre line lights.
