**FINAL REPORT OF SERIOUS INCIDENT BETWEEN M/s JET AIRWAYS B737
AIRCRAFT VT-JBE AND M/s AIR INDIA A320 AIRCRAFT VT-EDD AT DELHI ON
30th JANUARY 2016.**

Ministry of Civil Aviation constituted a committee of inquiry to investigate the cause of the Serious Incident under Rule 11 (1) of Aircraft (Investigation of Accidents and Incidents),

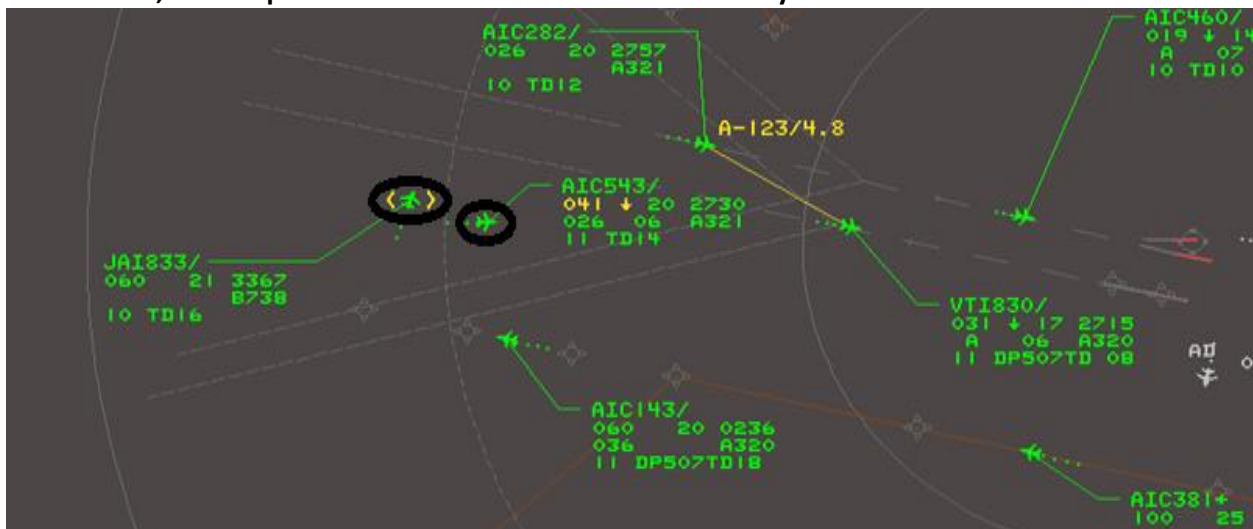
At time 0608, relative position of Air India AIC 543 and Jet Airways JAI833

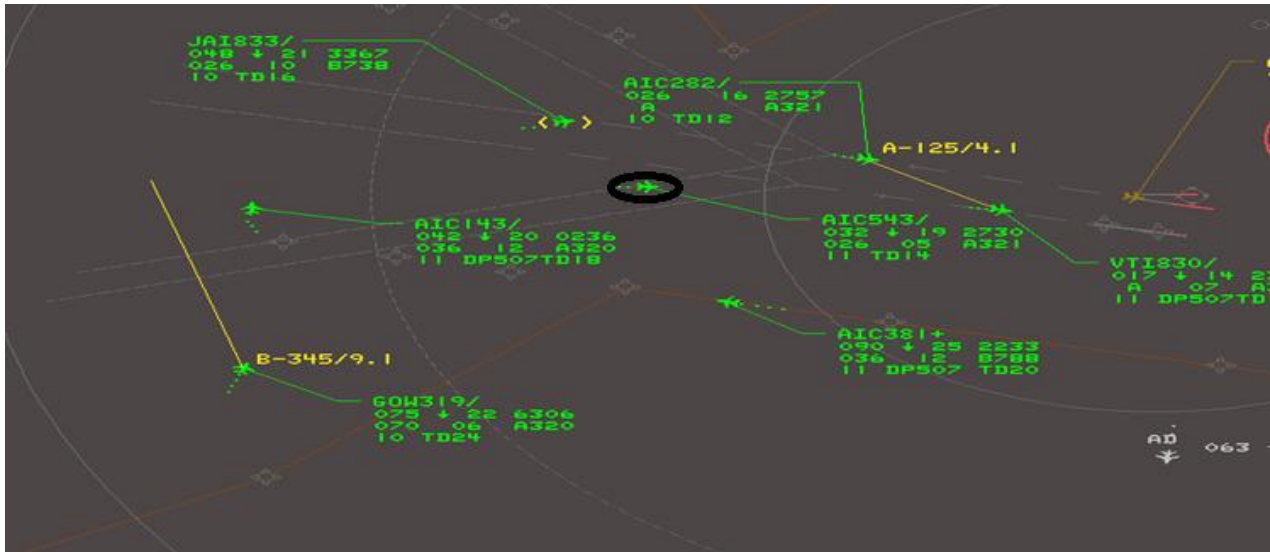
At time 0611, AIC 543 reported established on localizer Runway 11

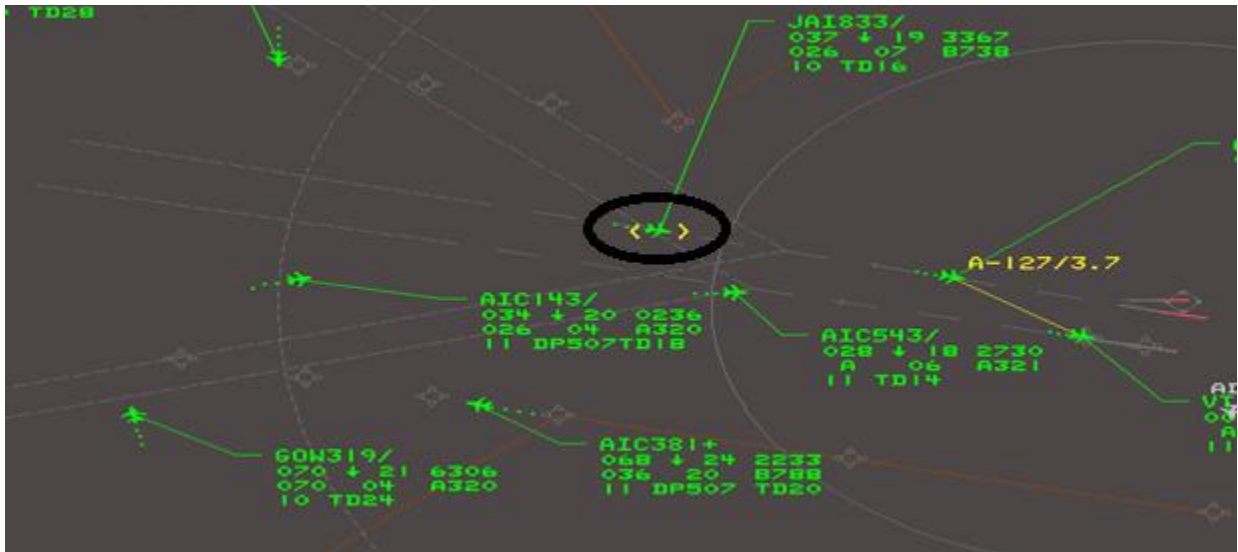
At time 0612, JAI 833 on localizer Runway 10

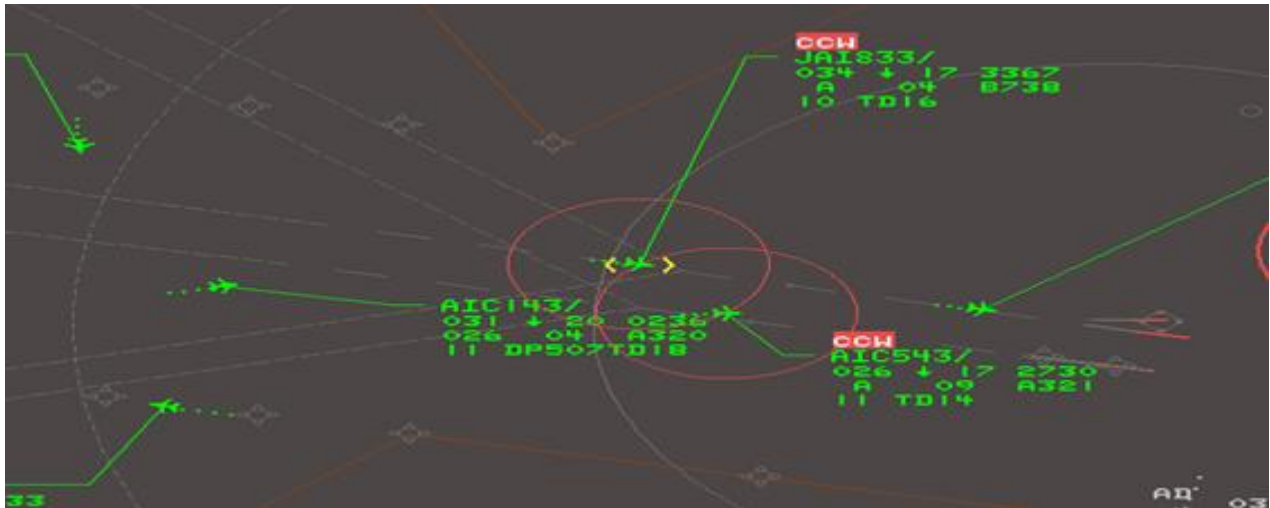
At time 0612, CCW warning generated

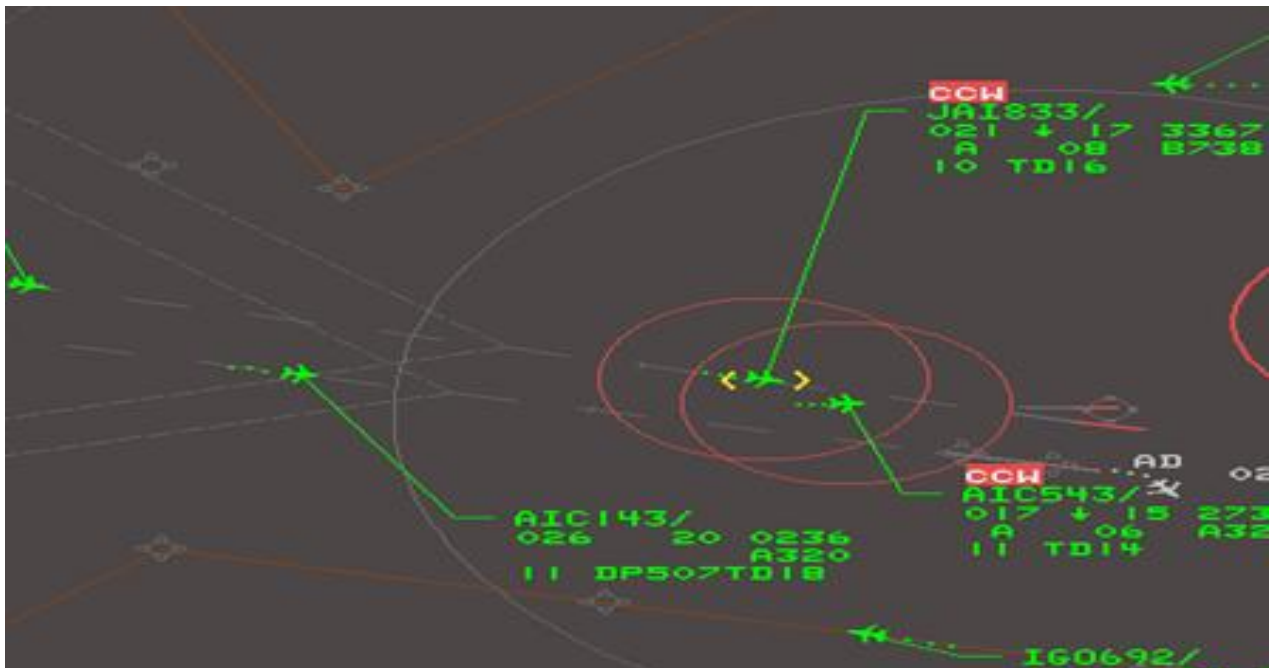
At time 0614, CCW warning still persisted and AIC543 aligned on runway 09

Aircraft was vectored by the ATC (Delhi) for runway ILS 11, the aircraft continued on the last assigned heading 075 provided by the ATC and intercepted the ILS for runway 09 due to wrong programming of the FMS.

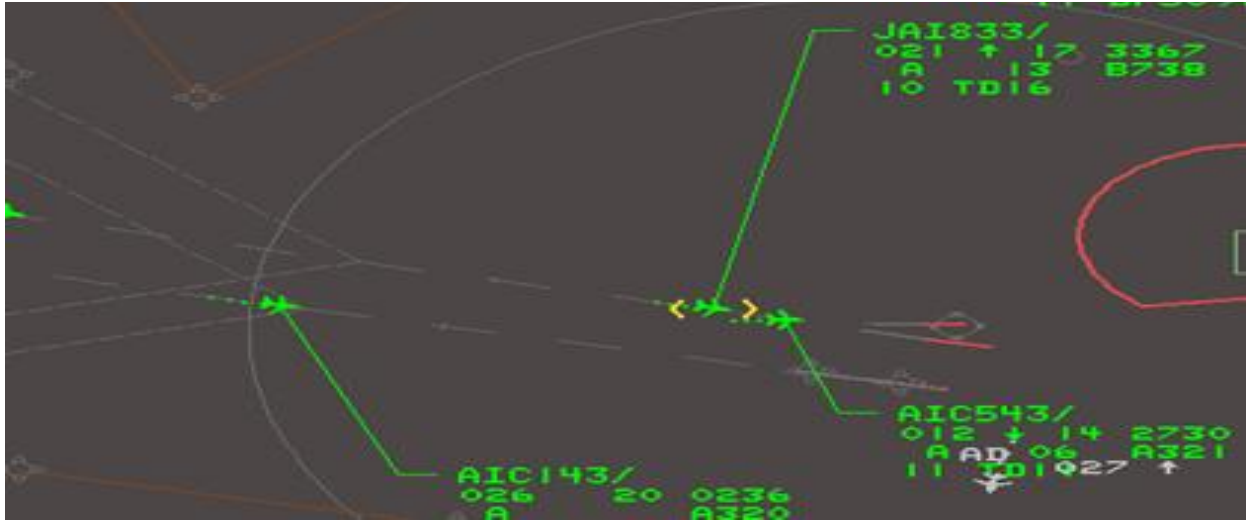
At Time 0615, AIC543 crossed the path of JAI833

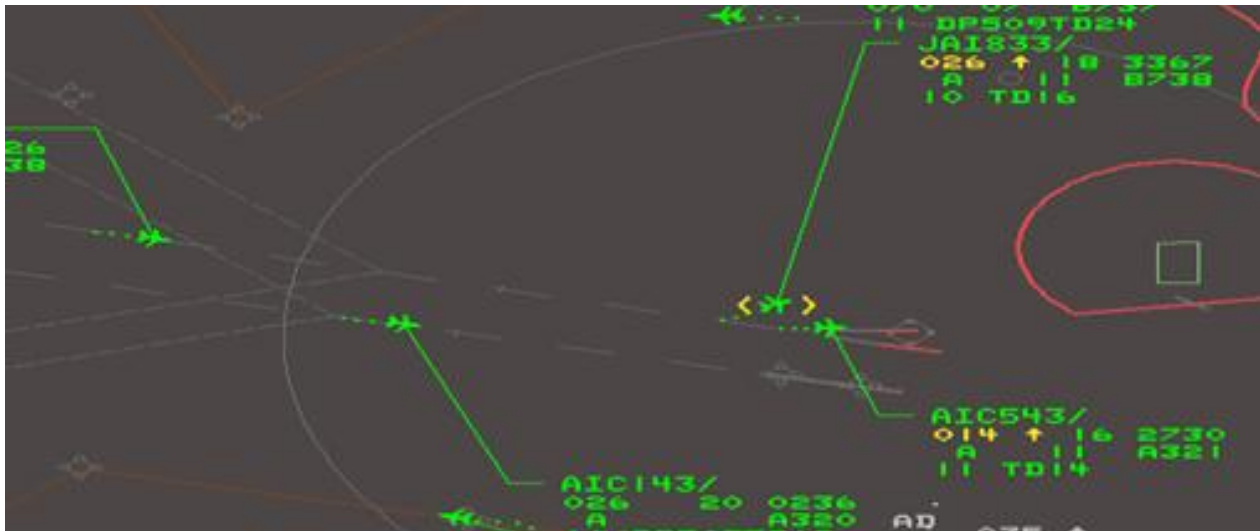
At Time 0615, AIC543 discontinue approach and JAI833 initiated Go around

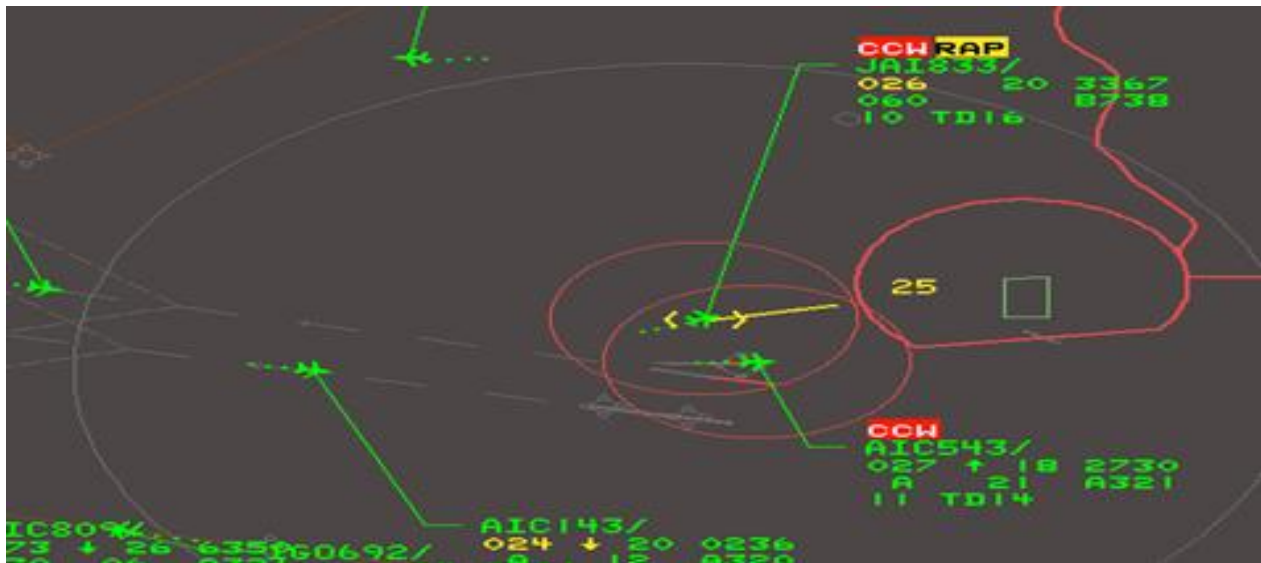
At time 0616, relative position of aircraft after Go around

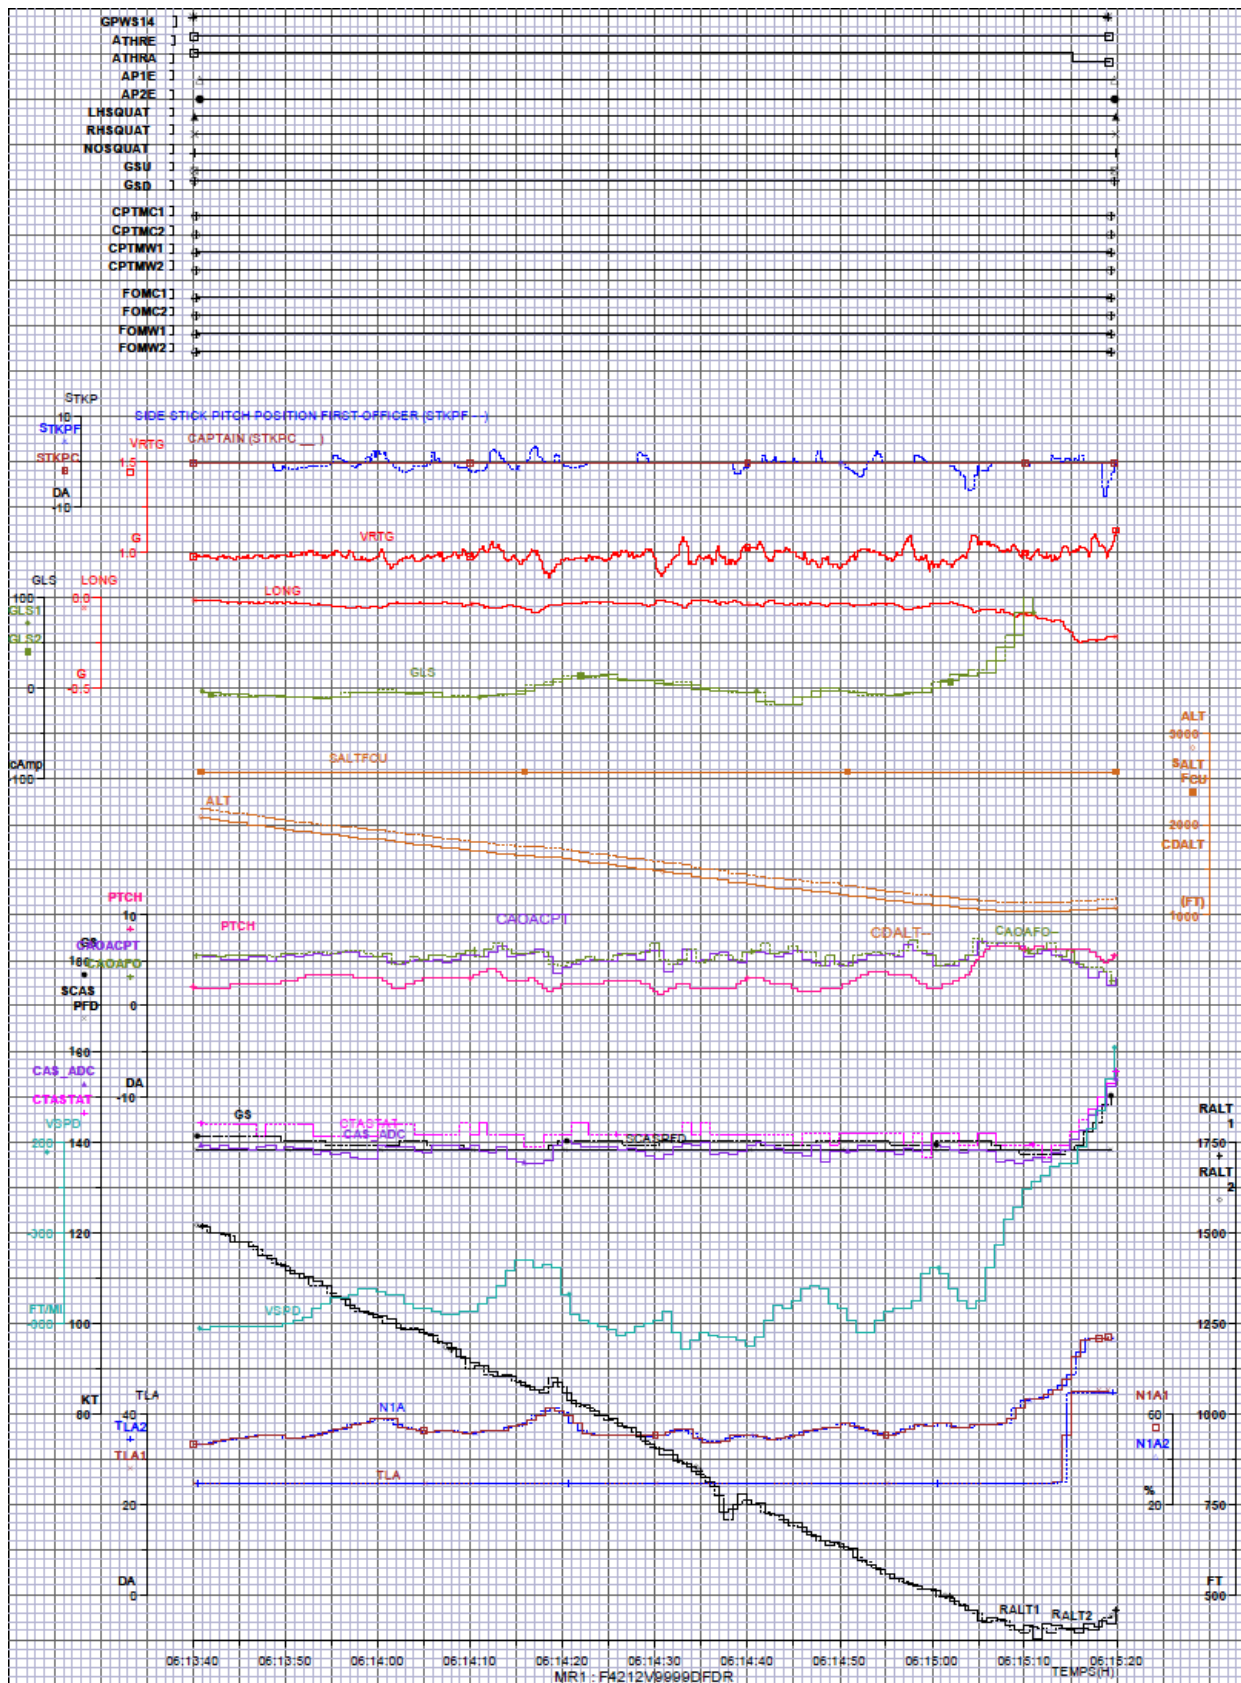
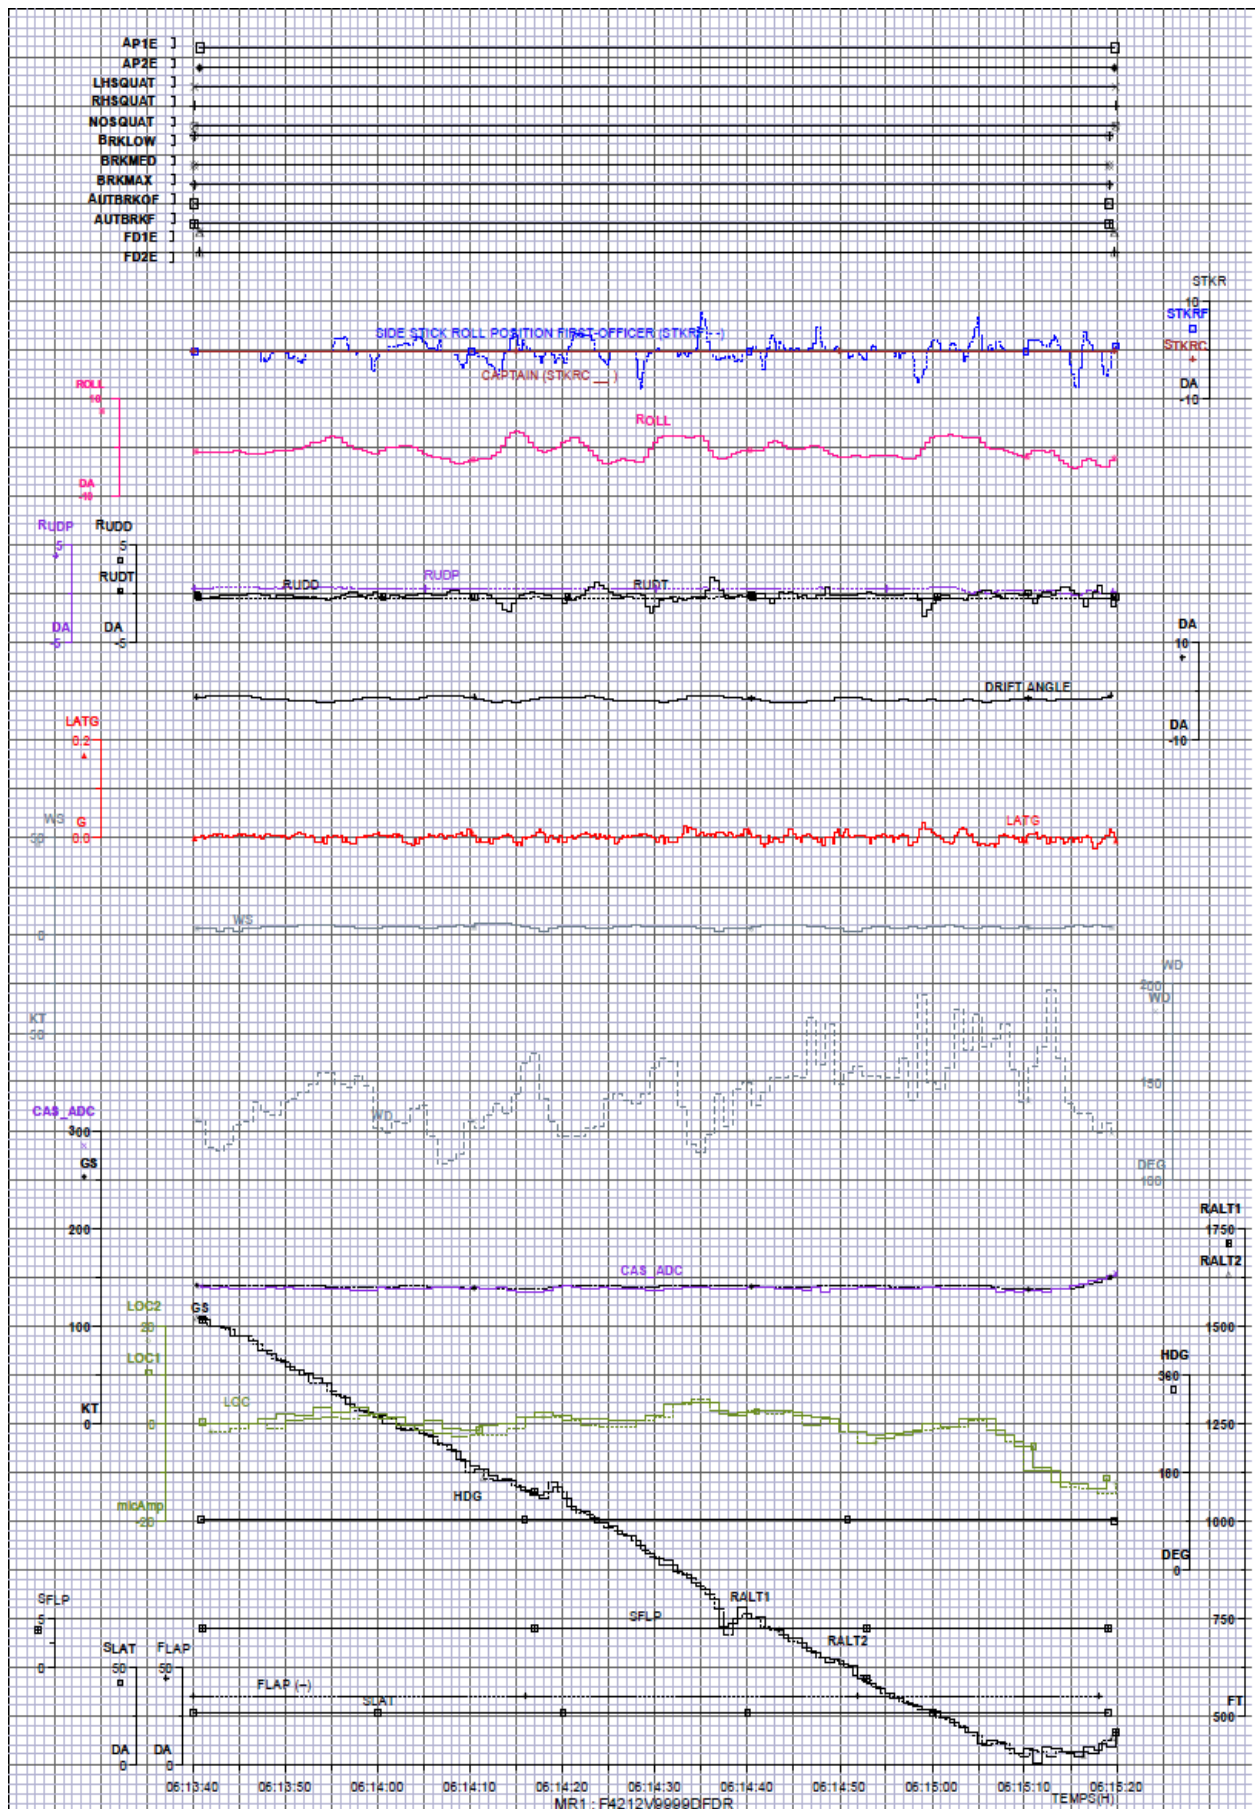
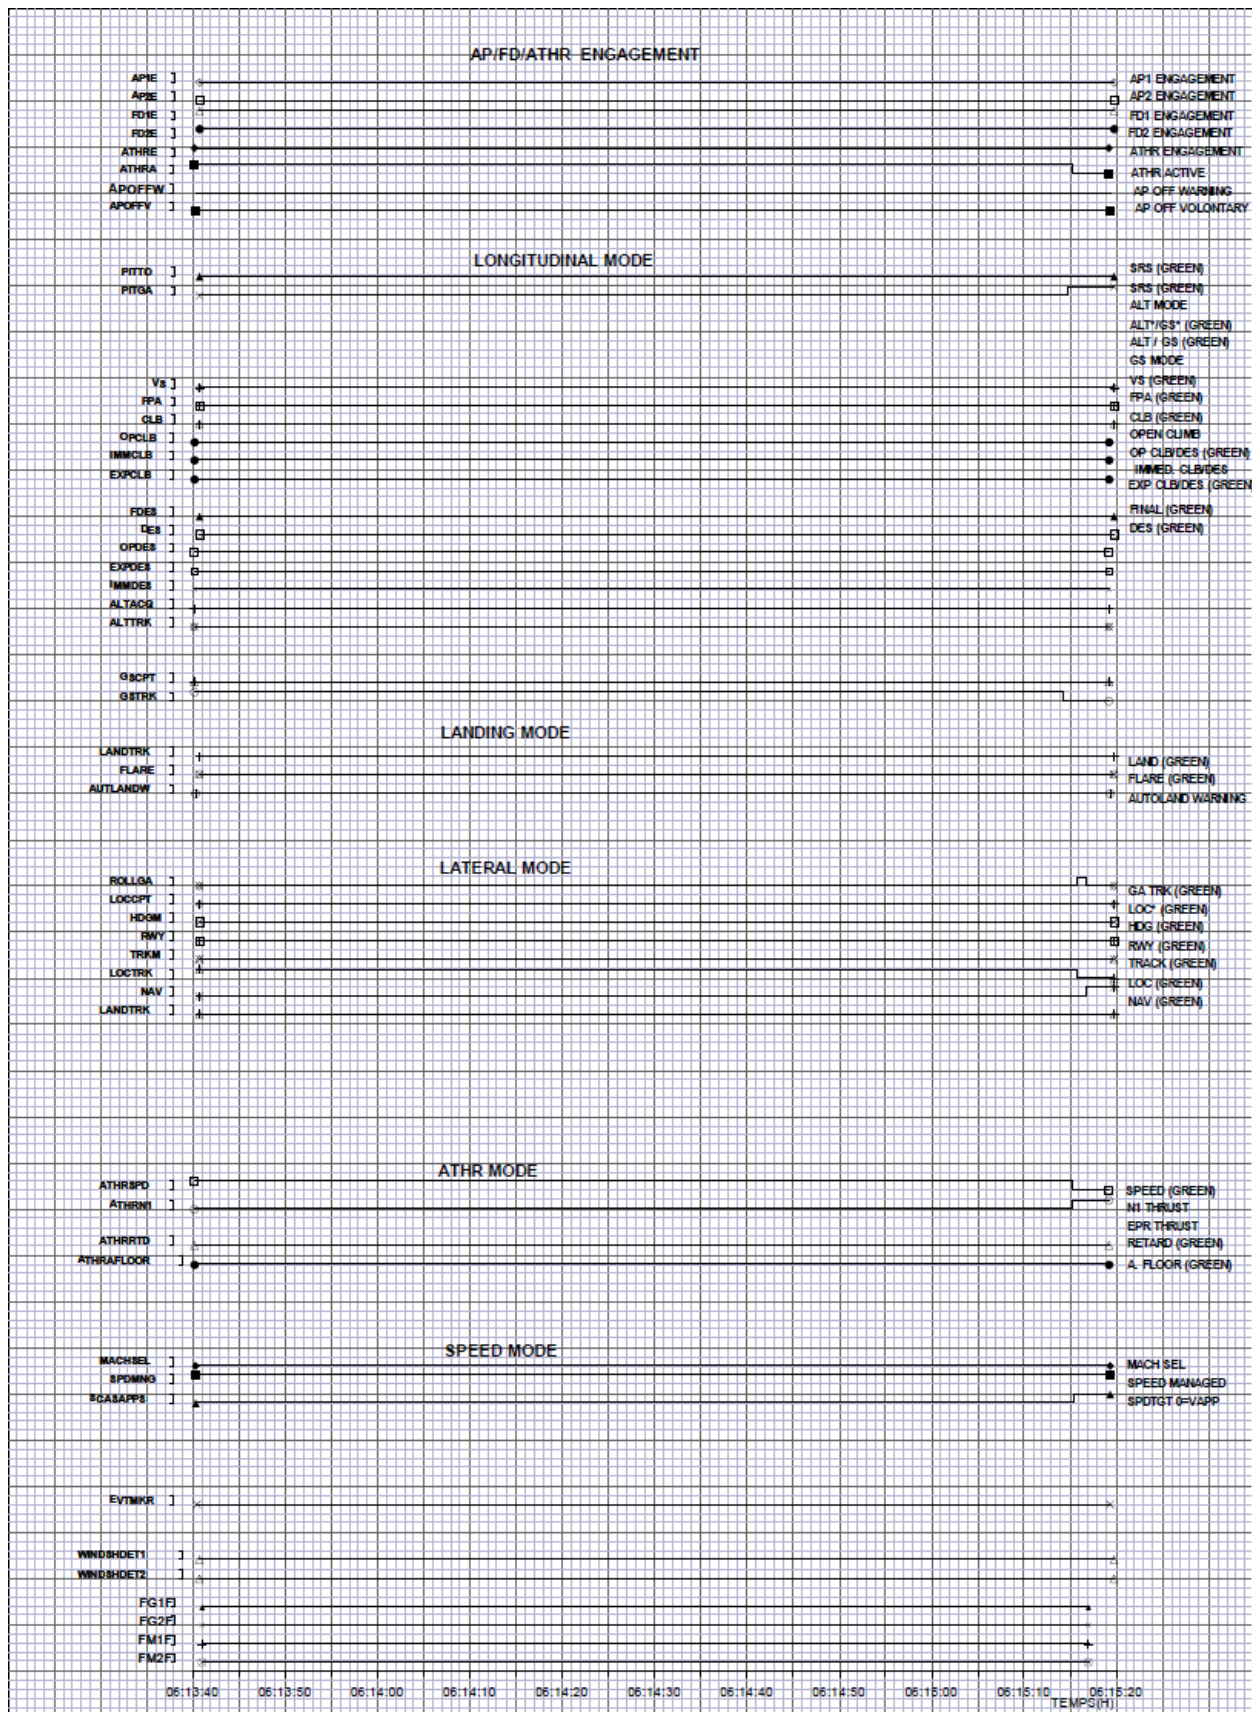
Post the flight data analysis by Airbus, it is now clear that the ILS frequency was 108.5 Mhz. i.e for ILS runway 09 at Delhi from 31800 feet till the aircraft carried out a go-around on runway 09 at Delhi. This would indicate that wrong runway was programmed in the “Flight Management System” (FMS) by “Pilot Flying” (PF) and same was not crossed checked by the “Pilot Monitoring” (PM). Hence the error remained undetected by either flight crew members. With the “Autopilots” engaged the aircraft would follow the FD commands which in turn were following the programming in the FMS.
