AIRCRAFT ACCIDENT REPORT AND EXECUTIVE SUMMARY

Reference:	CA18/2/3/9535	
Aircraft Registration	ZS-REW	Date of Accident	27 Feb 2016		Time of Accident	0402Z
Type of Aircraft	Robinson R22 Beta II		Type of Operation	Agriculture (Part 137)		
Pilot-in-command Licence Type	Commercial Pilot -Helicopter		Age	48	Licence Valid	Yes
Pilot-in-command Flying Experience	Total Flying Hours		1 559.9		Hours on Type	1 012.3
Last point of departure	Killer Krankie, Margate: KwaZulu-Natal					
Next point of intended landing	Killer Krankie, Margate: KwaZulu-Natal					
Location of the accident site with reference to easily defined geographical points (GPS readings if possible)						
Killer Krankie, Margate, KwaZulu-Natal. (GPS co-ordinates 29°25'59.36"S 30°42'30.64"E) elevation 3 166 feet (FT) AMSL.						
Meteorological Information	Wind: light and variable; Visibility: Good; Temperature: 12 °C; sky clear					
Number of people on board	1+0	No. of people injured	1	No. of people killed	0

AIRCRAFT ACCIDENT REPORT

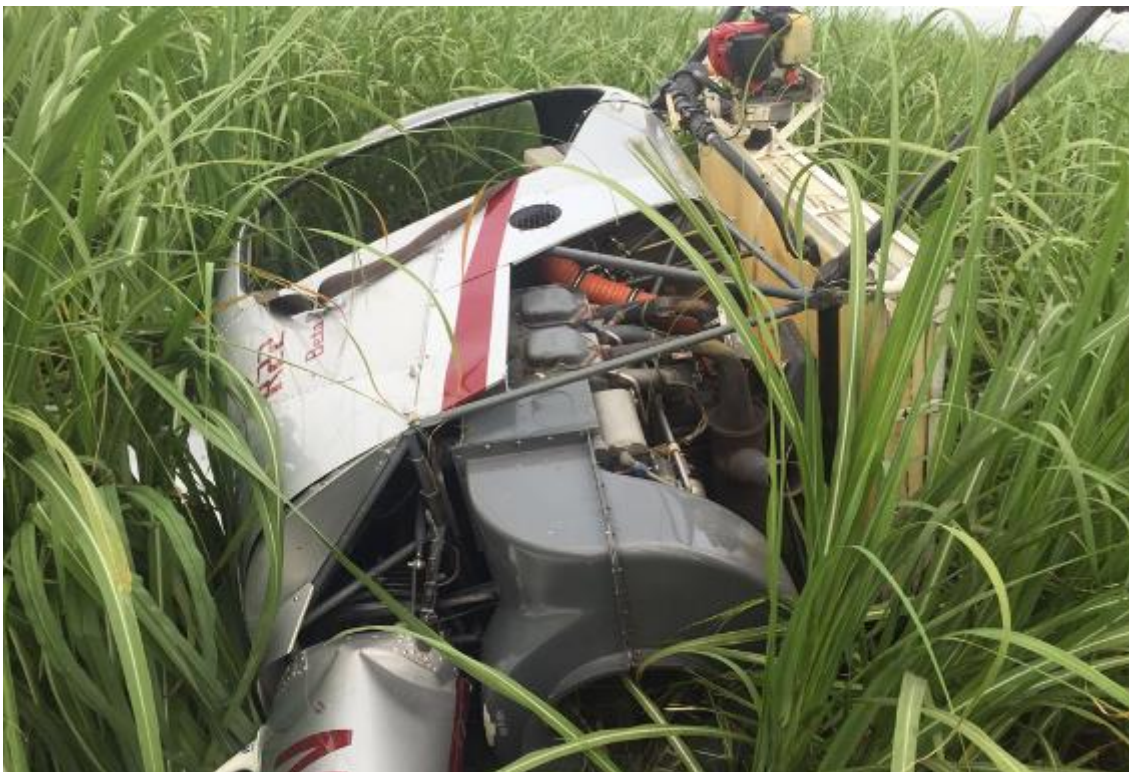
Figure 2: The helicopter after the accident

- 1.1.3 The pilot sustained minor injuries and the helicopter sustained damage to the main rotor blades, tail boom, mast and the left skid gear broke off.

1.3.1 The helicopter sustained substantial damage.

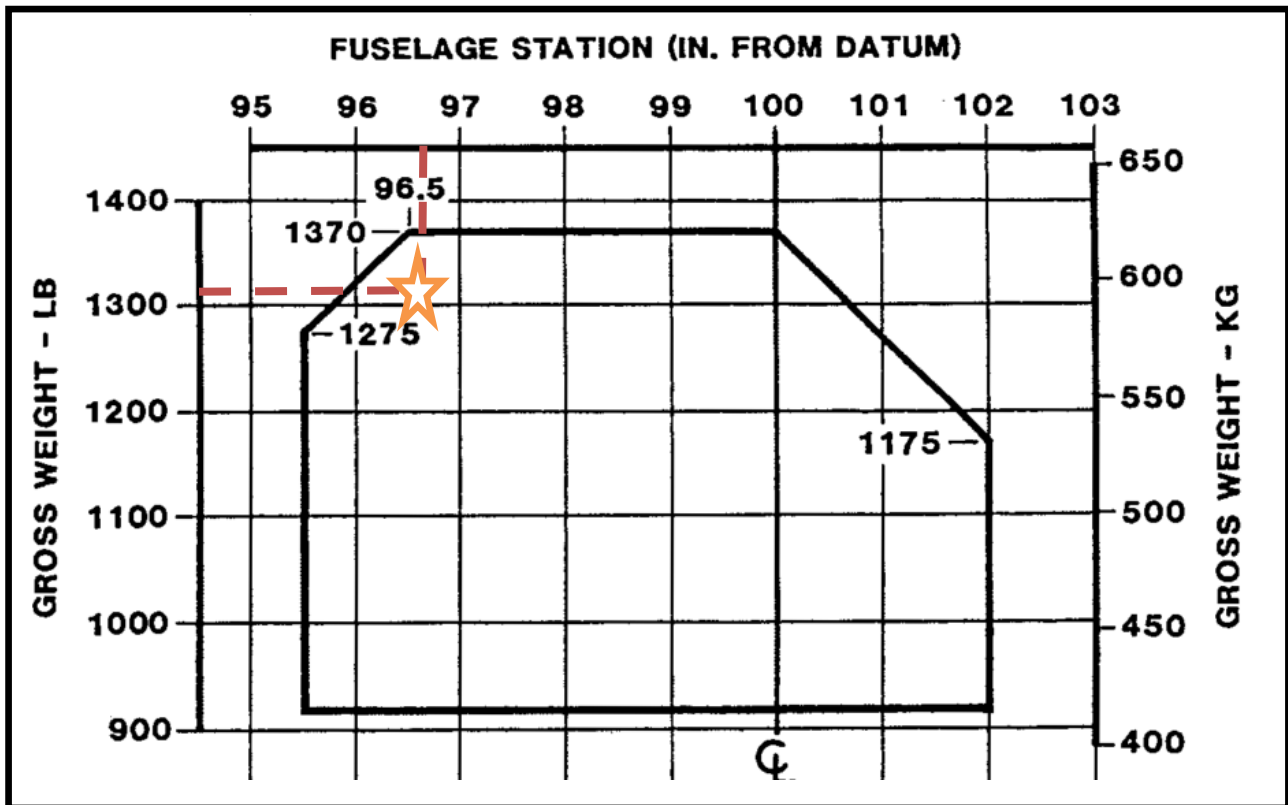
1.6.2 According to the pilot's operating handbook (POH), the maximum (certificated) take-off weight for the helicopter type in question was within allowed operating limits of 1370 pounds. The helicopter was being operated in close proximity to the forward CG limit as can be seen on the CG graph below.

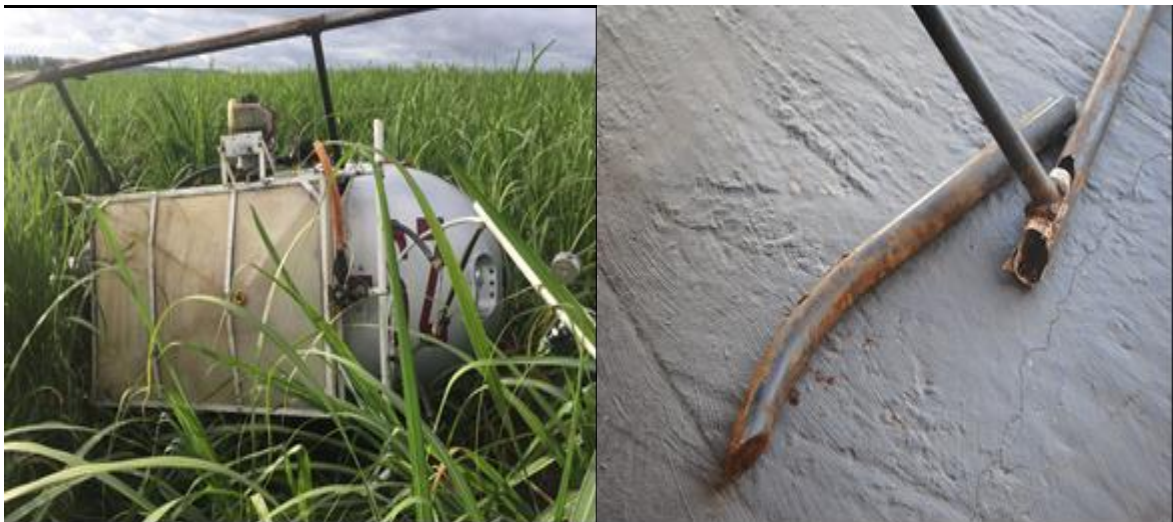
1.12.1 The helicopter's left skid was caught in a furrow and the helicopter entered a dynamic rollover before coming to rest on its left side. The left skid broke off at the front.

Figure 5: The position of the helicopter after the accident with broken skid

2.3 The pilot was unable to restore the rotor rpm because the helicopter was at a low altitude. The pilot attempted an emergency landing, but the ground ~~ground~~ was uneven and the helicopter skid got caught in the furrow. The helicopter entered a dynamic roll-over and came to rest on its left side.

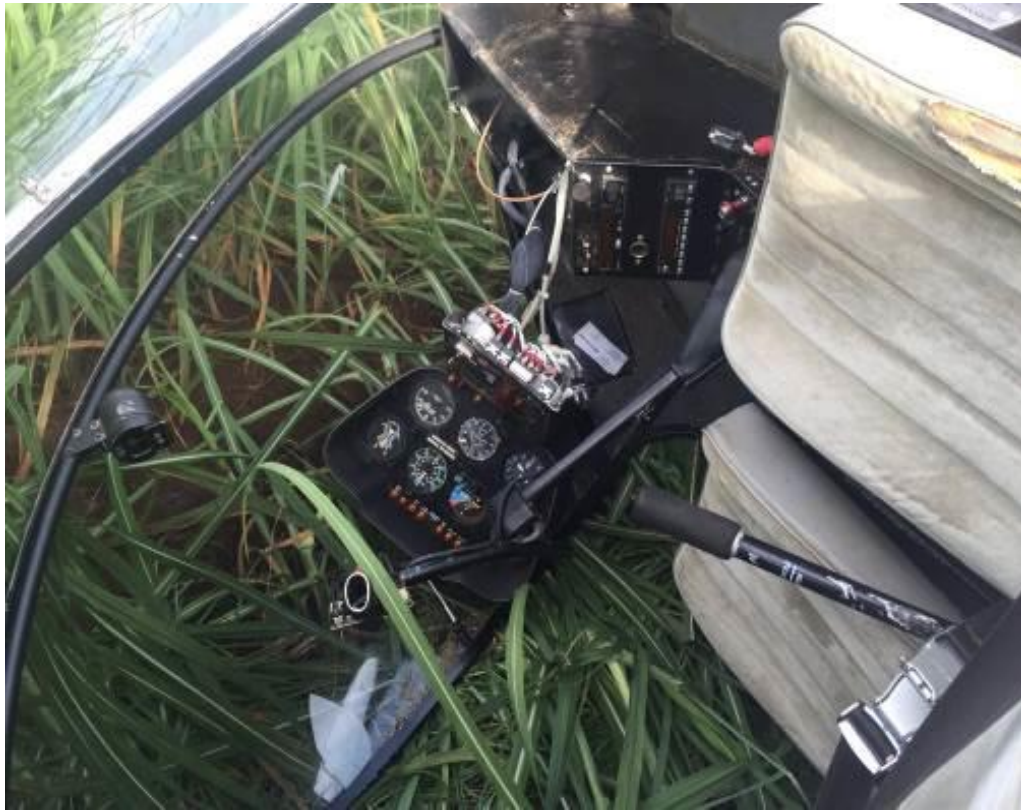
1.12.2 The engine indications instrument panel dislodged from the pedestal. The engine remained retained inside the engine-mounting support and displayed only minor impact damage to the surrounding engine cowlings.

Figure 6: Damage to instrument panel

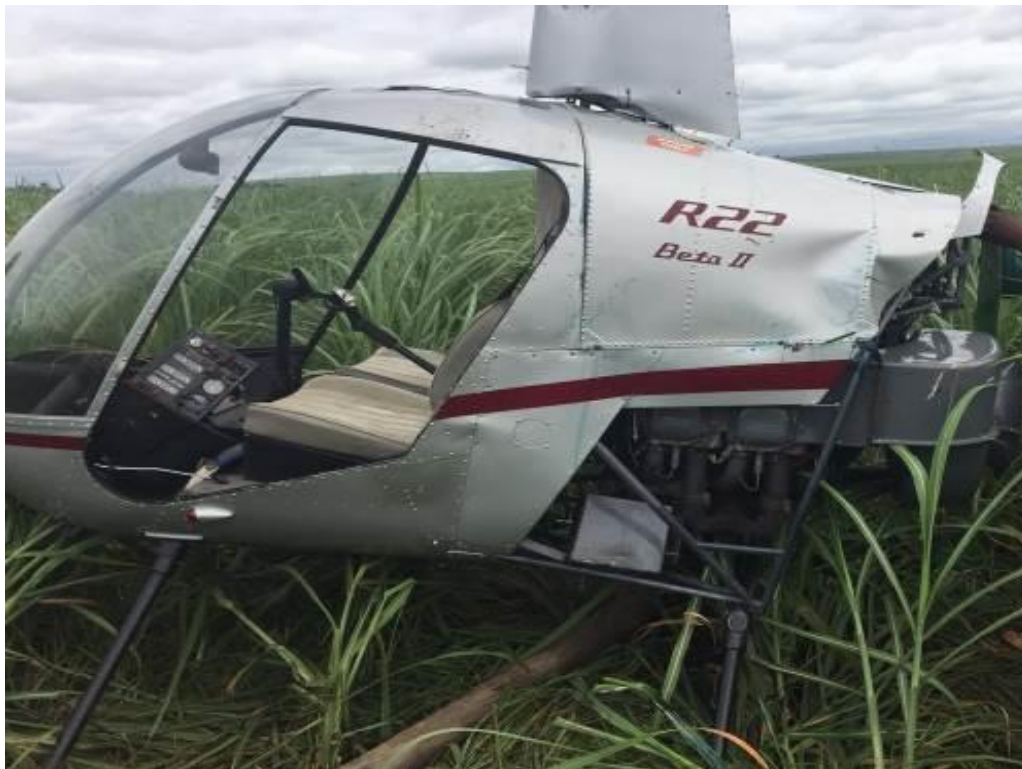
Figure 7: Condition of engine and cowlings

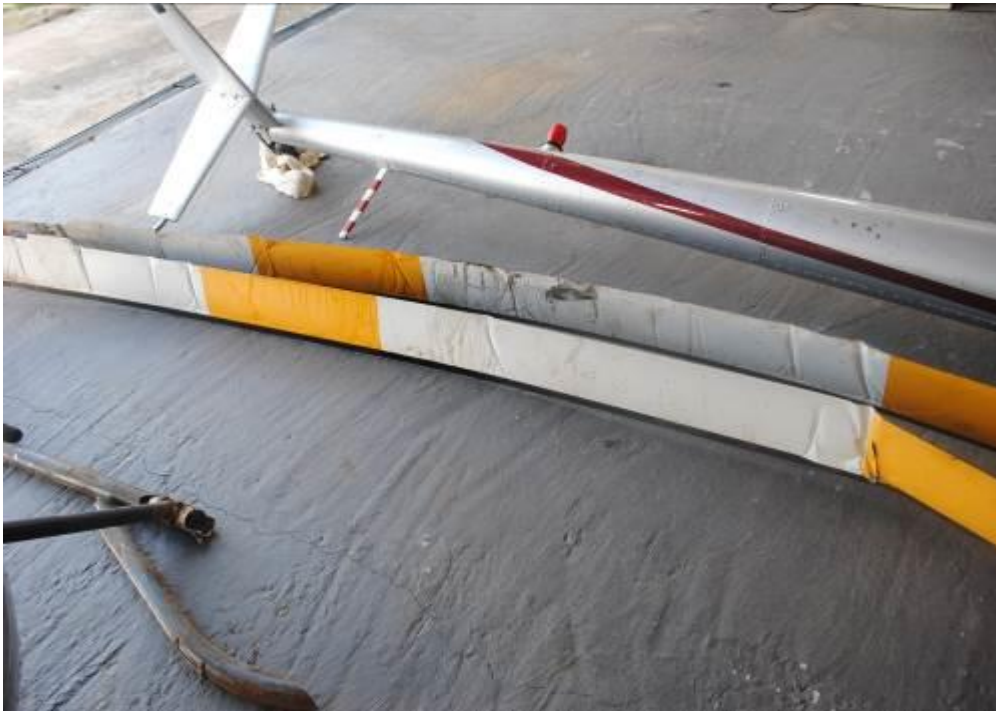
1.12.3 Both main rotor blades were destroyed after hitting the tail boom and the surrounding vegetation during the sequence of the accident. The rest of the tail boom remained attached to the fuselage of the helicopter, but was significantly crushed.

Figure 8: Damage to main rotor blades
