<b>AIRCRAFT ACCIDENT REPORT AND EXECUTIVE SUMMARY</b>
---

Reference:	CA/18/2/3/9524	
<b>Aircraft Registration</b>	<b>ZS-VOL</b>	<b>Date of Accident</b>	4 March 2016		<b>Time of Accident</b>	12:53
<b>Type of Aircraft</b>	Cirrus SR22		<b>Type of Operation</b>		Private - Part 24	
<b>Pilot-in-command Licence Type</b>		Private Pilot's Licence	<b>Age</b>	37	<b>Licence Valid</b>	Yes
<b>Pilot-in-command Flying Experience</b>		Total Flying Hours	186,2		Hours on Type	81,7
<b>Last point of departure</b>		Vredendal aerodrome (FAVR), Western Cape				
<b>Next point of intended landing</b>		Driefontein airfield, North West.				
<b>Location of the accident site with reference to easily defined geographical points (GPS readings if possible)</b>						
Next to a railway line close to Driefontein farm at Fochville						
<b>Meteorological Information</b>		Wind: 080°/5kt; Temperature: 26°C; Dew point: Unknown; Cloud: Clear skies; Visibility: >10km				
<b>Number of people on board</b>	1 + 3	<b>No. of people injured</b>	4	<b>No. of people killed</b>	0

## AIRCRAFT ACCIDENT REPORT

**Name of Owner** : K2014238670 (South Africa) Pty Ltd  
**Name of Operator** : K2014238670 (South Africa) Pty Ltd  
**Manufa

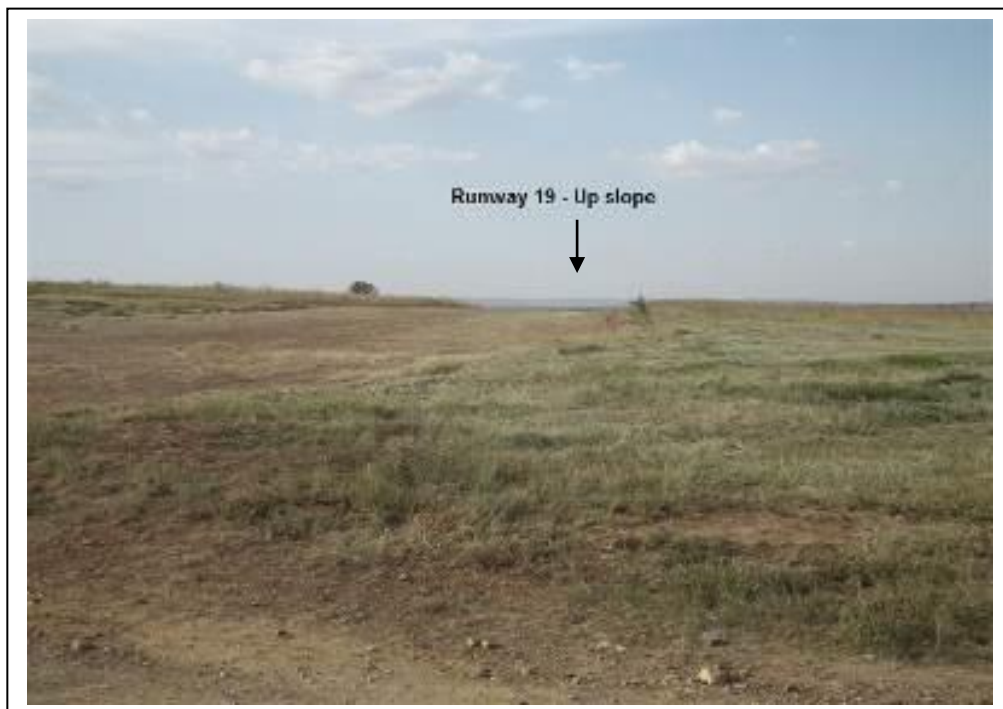
1.12.1 This was based on an explanation from the pilot. He stated that he had approached from a southerly direction to land on runway 21. The runway sloped upwards for a short distance towards the end.

**Figure 2:** The upslope of runway 21. The end of the runway is a short distance from the top of the slope

1.18.3 The pilot stated in his report that runway length was approximately 1 300m and that he landed the aircraft just after the sunflower field. This was about 580m down the runway. He indicated that after reaching the crest of the slope and the end of the runway, the aircraft was still not airborne. The end of the runway is about 160m from crest of the slope hill, and the upslope is about 4,6m in length.

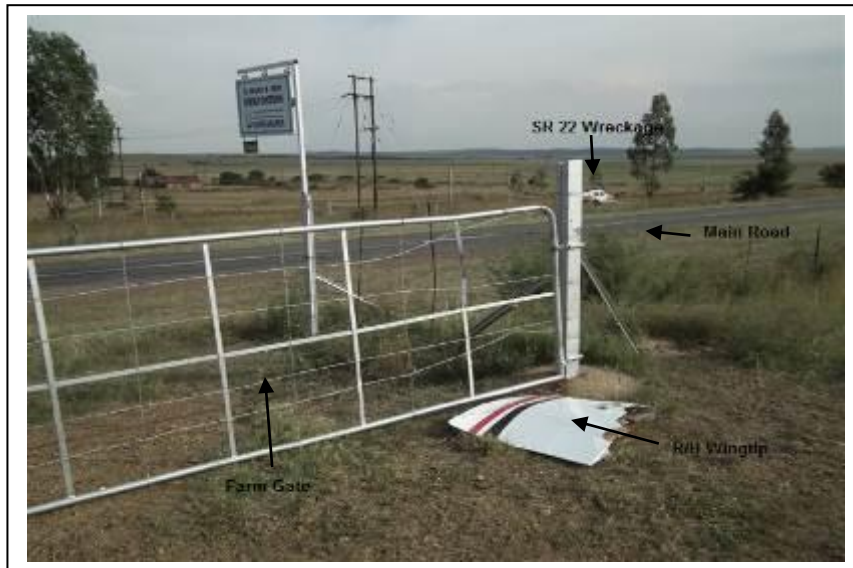
1.12.2 The pilot applied the brakes just after touchdown, realised that there was insufficient stopping distance before the end of the runway, and applied full power to execute a take-off and go-around. However, by the time the aircraft reached the end of the runway just beyond the crest of the slope, it was still not airborne. As the pilot was already committed to the take-off, there was no possibility of aborting it. The aircraft continued with the take-off run downslope, lifting about 1m off the ground. The left wing tip then struck the perimeter fence gate, which was about 1m high, and a substantial section of the wing tip was ripped off.

**Figure 3:** The left wing tip broke off after striking the gate.

- 3.1.13 By the time the aircraft reached the end of the runway, it was still not airborne. The pilot was already committed to the take-off and to abort it was not an option. The aircraft continued with the take-off run downslope, finally lifting about 1m off the ground. The left wing tip then struck the perimeter fence gate, which was about 1m high.

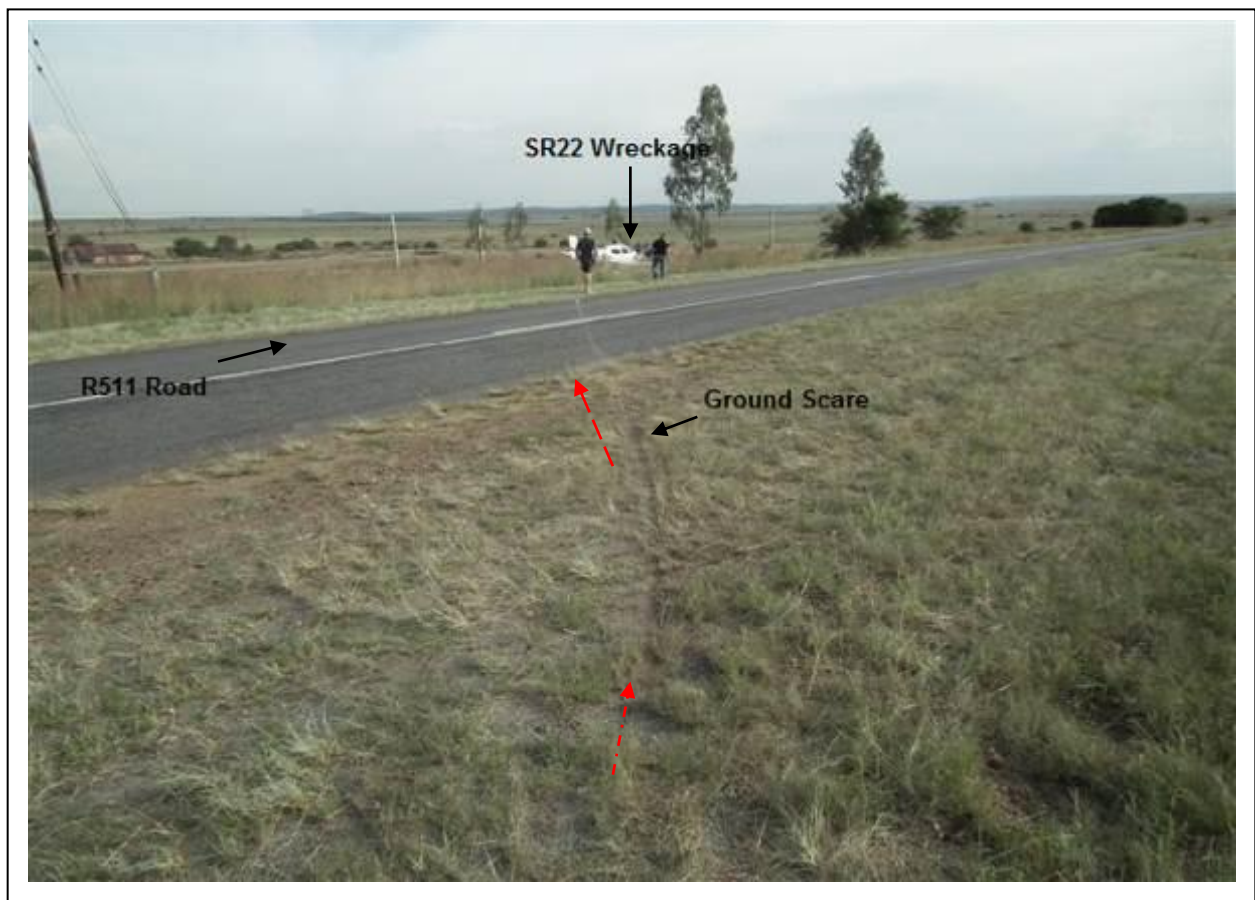
1.12.4 The disabled aeroplane skidded across the 8,5m-wide main road alongside the fence, slid across a small grassy patch, crashed through a railway line security fence, and came to a halt against a small tree at the top of an embankment next to the railway line. The aircraft sustained substantial structural damage.

**Figure 4:** The ground marks produced by ZS-VOL as it skidded to a halt.

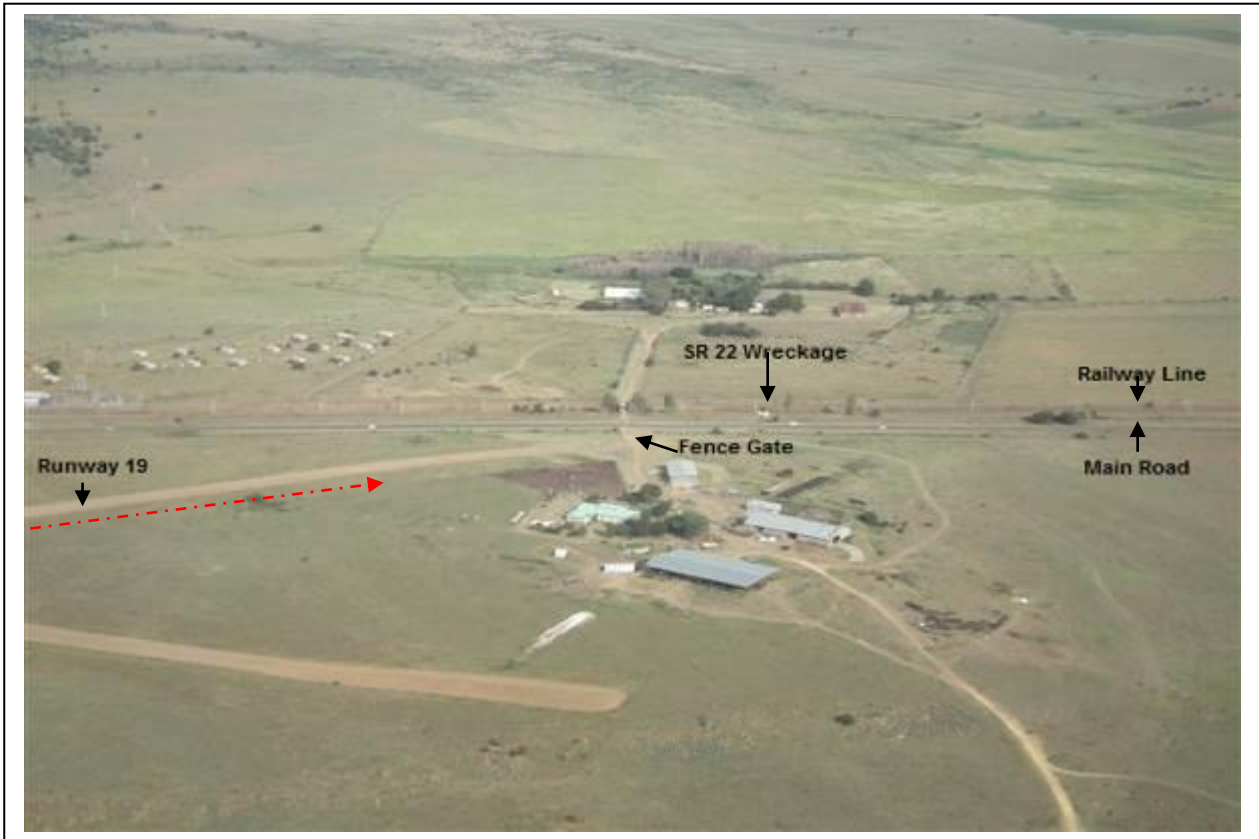
**Figure 5:** An aerial view of the accident scene.

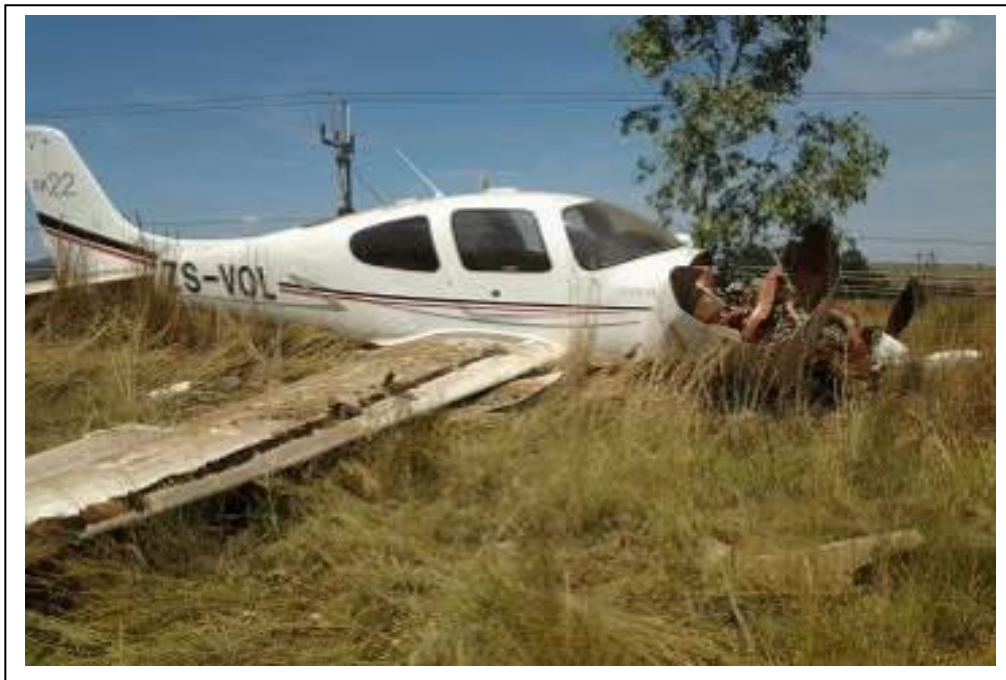
1.12.5 Extensive damage was caused to the nose section, engine compartment, landing gear, propeller and both wings.

**Figure 6:** The front of the aircraft and the wings were badly damaged.

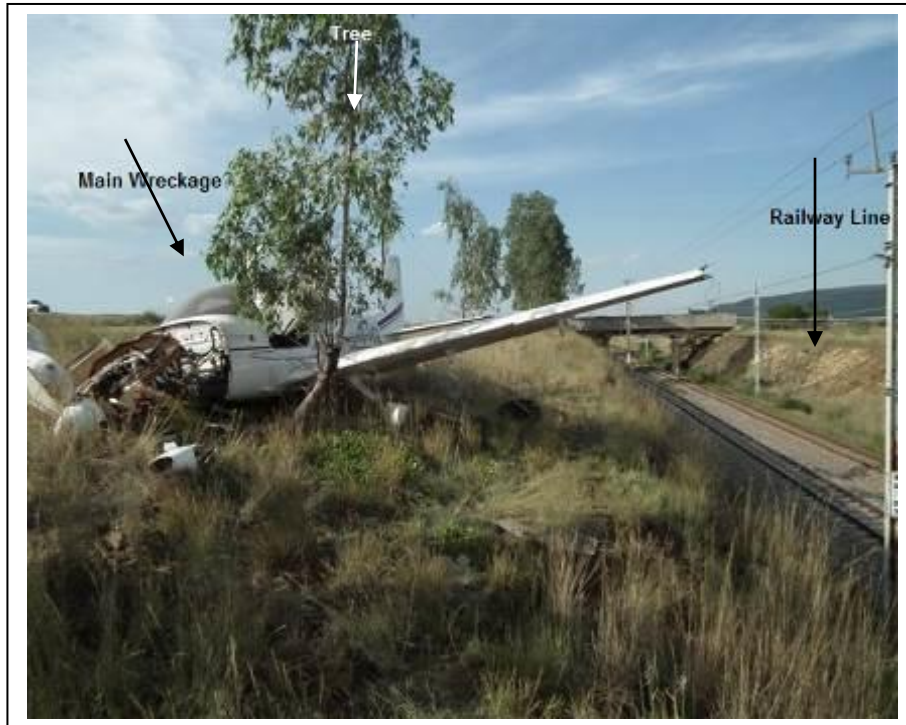
1.12.6 The aircraft came to a halt close to the Johannesburg-Potchefstroom railway line. Due to the obvious risks involved, the rail service provider installed a temporary repair to the security fence damaged by the aircraft.

Figure 7: The wreckage of the aeroplane, showing its proximity to the steep embankment alongside the Johannesburg-Potchefstroom railway line.

2.11 After the aircraft crashed through the perimeter fence, it skidding over a public tar road parallel to the fence, slid across a grassy area and finally came to rest against a small tree on top of a steep embankment alongside the Johannesburg-Potchefstroom railway line. The aeroplane ended up a few metres from the edge of the embankment and the occupants were fortunate that the aircraft did not fall over the edge.
