Havarikommissionen
Accident Investigation Board Denmark

FINAL REPORT

Serious incident

ATR42-500

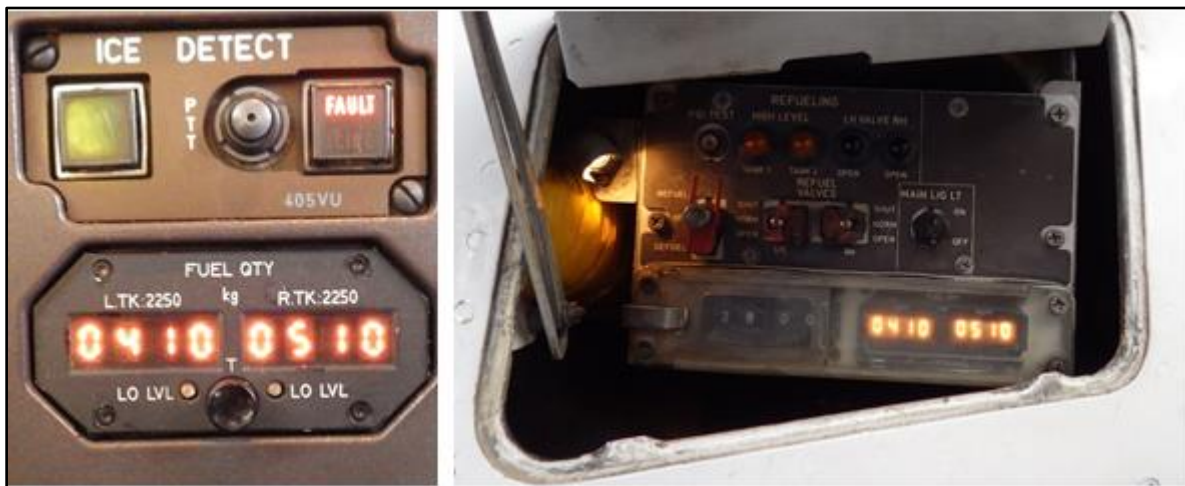
The initial investigation of the airframe fuel system revealed that:

1. The right fuel tank was physically empty.
2. The FQI in the cockpit and the refuel panel FQI repeater indicated:
 - a. Left fuel tank quantity 410 kg, which corresponded to the amount of fuel in the tank.
 - b. Right fuel tank quantity 510 kg, despite the fuel tank being empty.
 - c. Right fuel tank low level light (LO LVL) did not illuminate on the fuel quantity indicator, despite the physical fuel quantity being below 160 kg (the light will only illuminate when SB-ATR42-28-0033 has been incorporated).

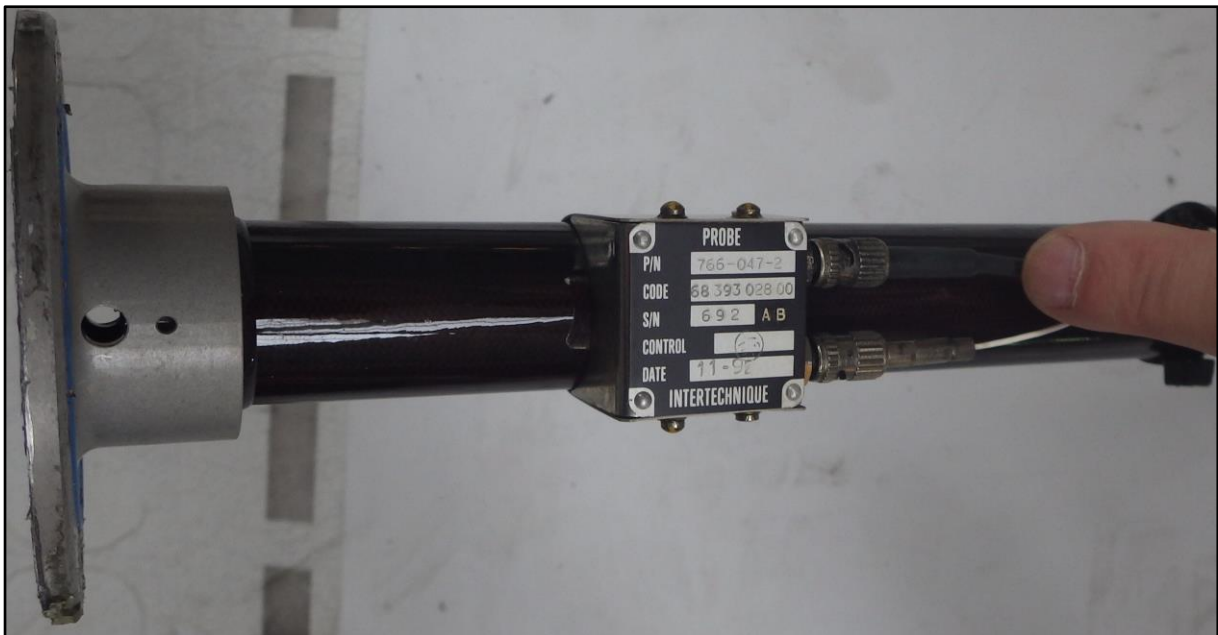
The right fuel tank probe no. 3 was uninstalled from the right fuel tank and placed on the aircraft wing. A capacitance test was performed with the aircraft harness connected to the probe.

The test revealed that the pF value fluctuated between 40.2 and 47.5 when the brown wire (covered by black heat-shrinkable tubing) was manipulated close to the connector and housing. See picture below.

After further manipulation of the wire, the capacitance value of the probe returned to 36.7 pF which was within the limitation of the JIC. It was not possible to replicate the fault, and the faulty connector was replaced.

7. A connector on the right tank capacitance probe no. 3 was found to be the cause of the incorrectly displayed fuel quantity from the right tank.
8. The defect on the capacitance probe connector was most likely introduced during removal and installation of the probe at the heavy maintenance check performed between 14-12-2015 and 09-02-2016.

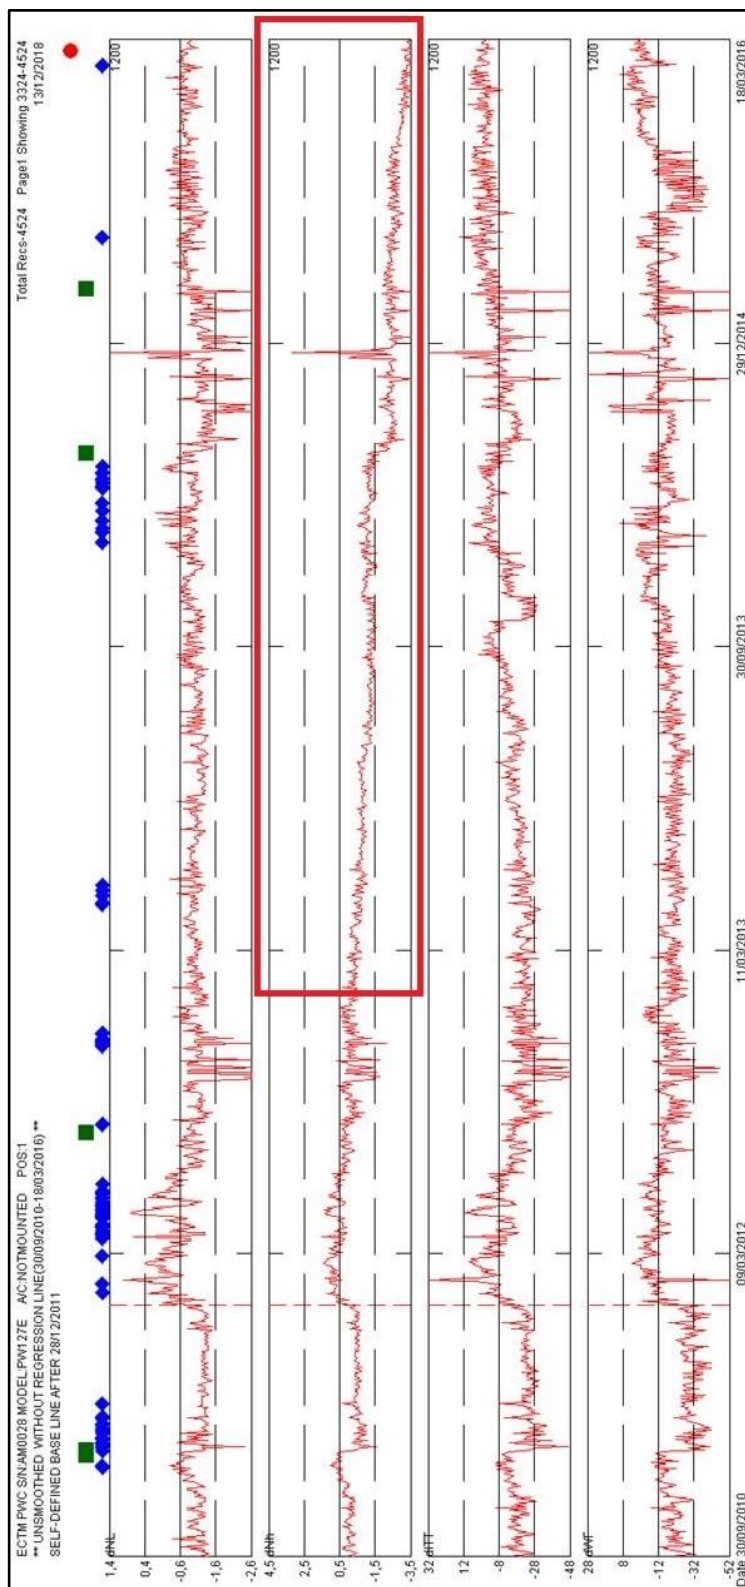
5.11 Left engine ECTM data

This was confirmed by a review of the ECTM data. The data showed that the NH had decreased by 3 % over a period of two years due to hot section deterioration. See [appendix 11](#).
