## SHORT ACCIDENT REPORT AND EXECUTIVE SUMMARY

Reference:	CA18/2/3/9531	
<b>Aircraft Registration</b>	ZS-HXS	<b>Date of Accident</b>	23 March 2016		<b>Time of Accident</b>	0600Z
<b>Type of Aircraft</b>	Robinson R22 Beta		<b>Type of Operation</b>	Private (Part 91)		
<b>Pilot-in-command Licence Type</b>	Private Pilot		<b>Age</b>	25	<b>Licence Valid</b>	Yes
<b>Pilot-in-command Flying Experience</b>	<b>Total Flying Hours</b>		154.7		<b>Hours on Type</b>	153.8
<b>Last point of departure</b>	Rand Airport (FAGM): Gauteng Province					
<b>Next point of intended landing</b>	New Castle Aerodrome (FANC): KwaZulu Natal					
<b>Location of the accident site with reference to easily defined geographical points (GPS readings if possible)</b>						
In front of the control tower at Rand airport (GPS position: 26°14'23.3" S 028°09'06.0" E, elevation 5482ft)						
<b>Meteorological Information</b>	Wind direction: 010°; Wind speed: 9kts; Temperature: 14°C; Visibility: 9000m; Dew point: 12°C; Cloud base: OVC at 800ft.

<b>AIRCRAFT ACCIDENT REPORT</b>
---------------------------------

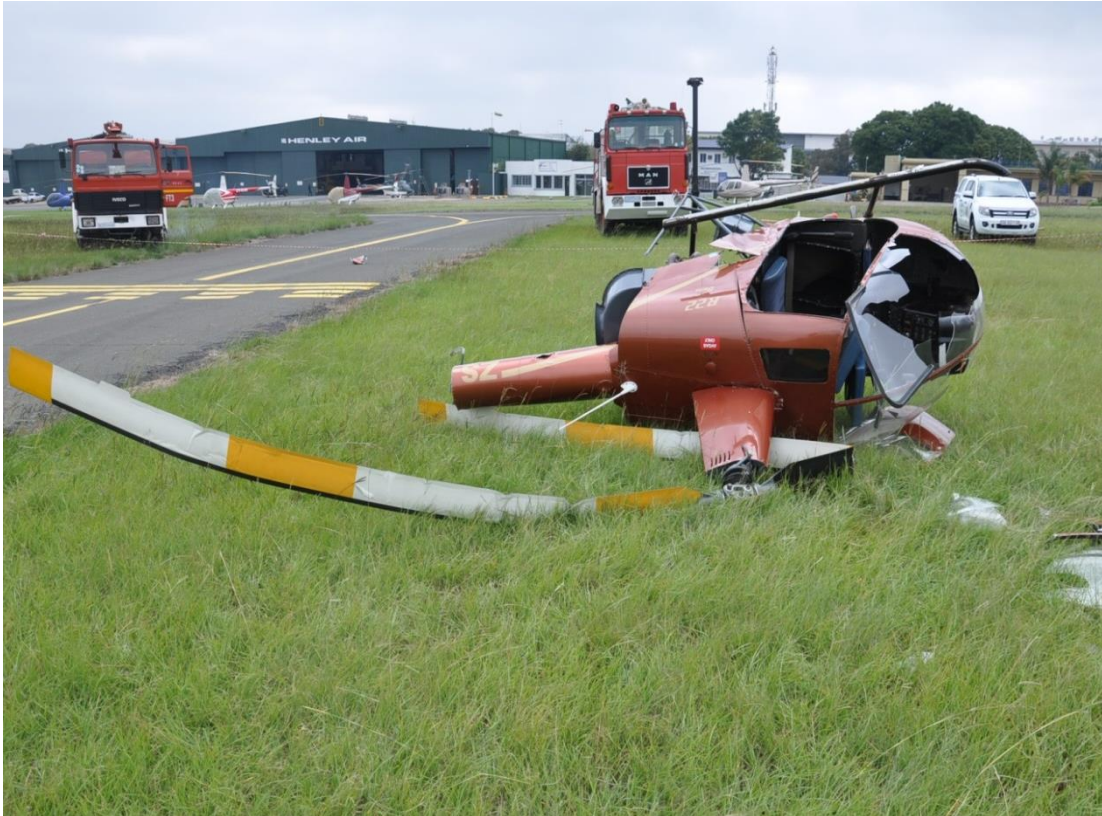
- 1.1.2 During take-off, the pilot observed the “Low RPM” warning light illuminating on the annunciator panel. He stated that he instantly rolled the throttle to increase power to the engine, pulled back slightly on the cyclic to gain height and then moved the cyclic forward to increase airspeed, but helicopter kept losing height. The helicopter impacted the ground very hard on its skids before rolling over to the right. During the process, the main rotor blades severed the tail boom into pieces. The pilot and the passenger were not injured. The helicopter sustained substantial damage.

- 1.2.1 The pilot was properly licensed and rated to perform the flight. The aircraft had a total of 5113.2 hours. The last Mandatory Periodic Inspection (MPI) on the aircraft was carried out on 14 March 2016 at 5109.8 hours, and the aircraft had flown 3.4 hours since the last inspection.
- 1.2.2 The pilot climbed out too early and did not continually monitor the rotor RPM and a few seconds later it decayed. The pilot used an incorrect procedure to restore RPM. Horn and caution light are disabled when collective is fully down. The pilot should have immediately rolled throttle on, lowered collective and then applied aft cyclic.

## 1.3 Damage to the helicopter

**Figure 3:** The helicopter wreckage at accident site.

- The helicopter experienced low main rotor RPM after lift-off. The pilot took an incorrect action to restore the rpm.
