AIRCRAFT ACCIDENT REPORT AND EXECUTIVE SUMMARY

Reference:		CA18/2/3/9541	
Aircraft Registration	ZS-OBJ	Date of Accident	15 April 2016		Time of Accident 1105Z
Type of Aircraft	Robinson R22 Beta II (Helicopter)		Type of Operation	Part 127	
Pilot-in-command Licence Type		Commercial (CPL)	Age	28	Licence Valid Yes
Pilot-in-command Flying Experience		Total Flying Hours	803.6		Hours on Type 385.6
Last point of departure		Rand aerodrome (FAGM): Gauteng province			
Next point of intended landing		Private farm located west of Lanseria airport (FALA): Gauteng province			
Location of the accident site with reference to easily defined geographical points (GPS readings if possible)					
Privately owned farm located west of Lanseria (FALA) airport, Krugersdorp area at GPS co-ordinates determined to be S25° 56. 291" E027° 46. 543" at an elevation determined to be 5 032 feet AMSL.					
Meteorological Information		Temperature, 25°C: Visibility, 10 km: Wind direction, North Easterly: Wind speed, 5 knots.

AIRCRAFT ACCIDENT REPORT

Name of Owner/Operator : T M Crane & Transportation Projects CC
Manufacturer : Robinson Helicopter Company
Model : Robinson R22 Beta II
Nationality : South African
Registr

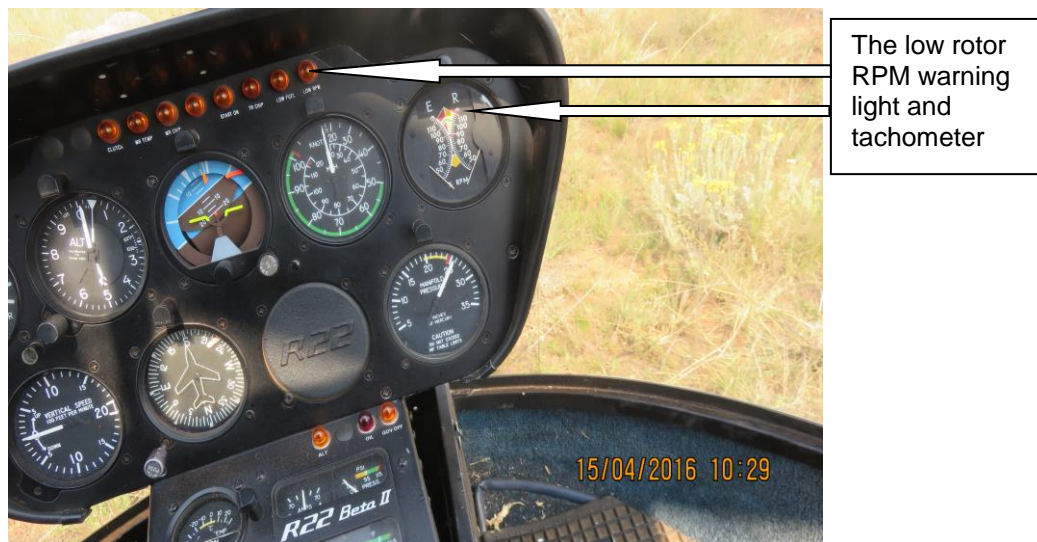
1.1.2 On approach to the farm, he began a descent while turning towards the farm and maintained a descent rate of about 300 feet per minute (fpm). At about 30 feet AGL, he began to flare the helicopter by moving the cyclic aft, before initiating a turn to the right into wind facing south westerly in preparation for animals “springboks” darting. After about 4 to 5 seconds at about 10 feet AGL, the low rotor RPM annunciator horn sounded and the low rotor RPM amber red warning light illuminated. At a look at the RPM gauge, the pilot recalled seeing the main rotor RPM needle at about 88%, which was unexpectedly low. Attached below is the photograph showing the helicopter’s instrument panel, with the red low rotor warning light and the tachometer visible.

Figure 1: The helicopter’s low rotor RPM/blade stall warning light and the tachometer

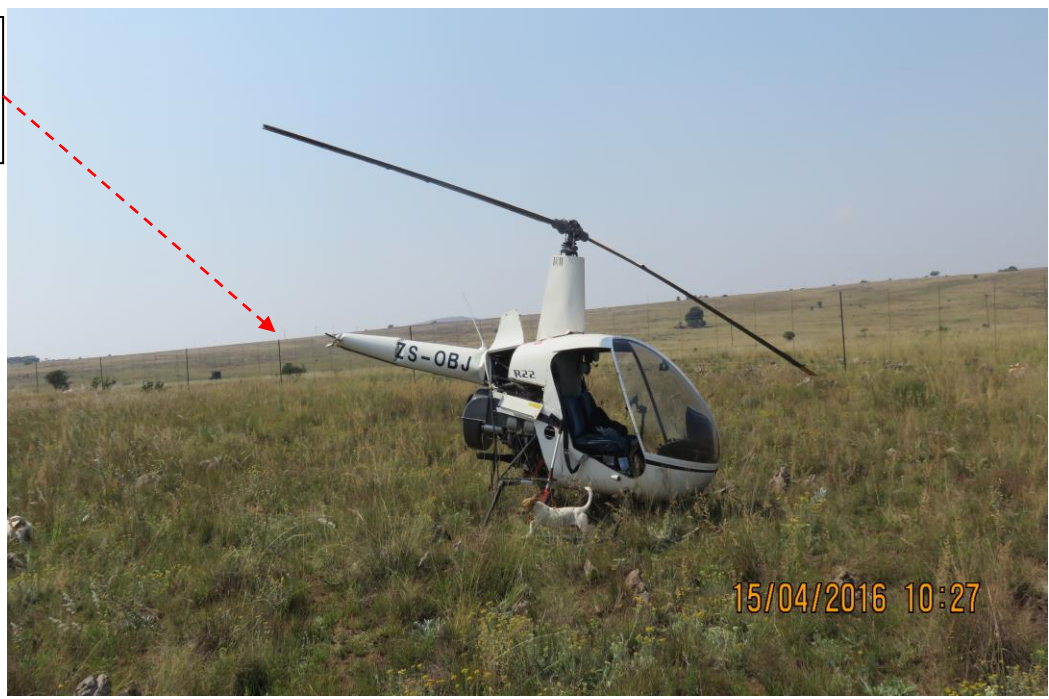
1.1.3 The pilot reported that, ahead of the helicopter was a farm perimeter fence, about three (3) meters high. According to the pilot’s written statement submitted to the investigator in charge (IIC), he avoided crashing the helicopter onto the fence by raising the collective and instantly opened the throttle intending to clear it and recover the helicopter from the condition, but things didn’t work out as per his plan. The pilot was able to clear the fence, but within seconds the helicopter entered an uncontrolled descent upon which it hit the ground heavily on the skids gear. The pilot sustained minor head injuries but the passenger was unharmed. The pilot instantly shut-down the electrics and informed his superiors before reporting the occurrence to accident and incident investigation division (AIID). The helicopter was substantially damaged during the accident sequence.

The fence on the helicopters flight path

Figure 3: The helicopter as found at the accident site with the farm fence visible

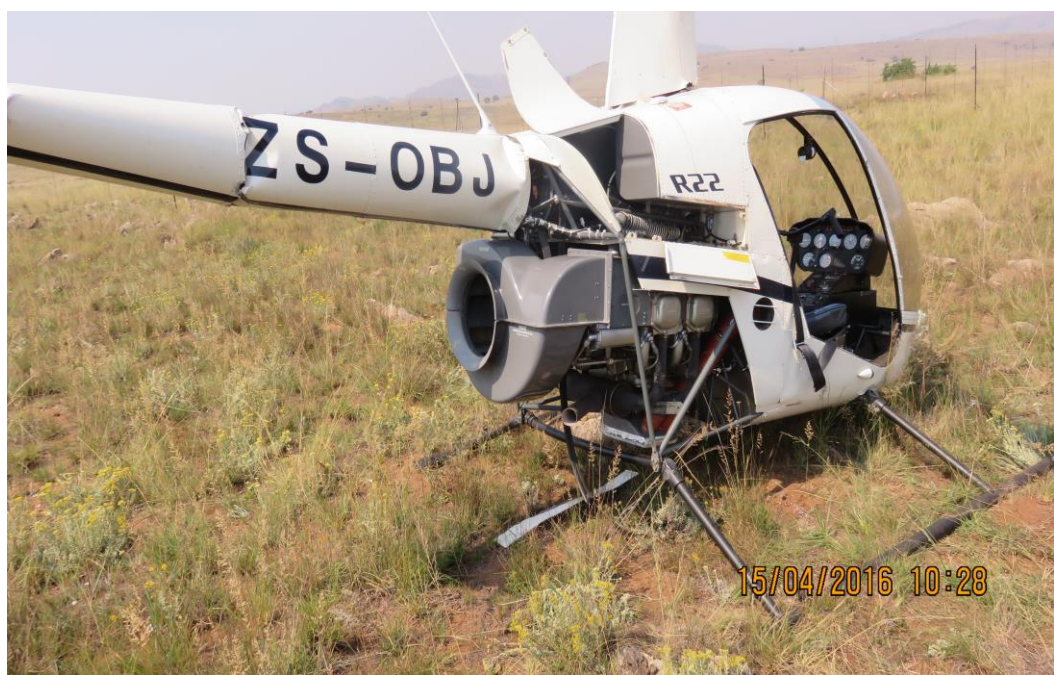
1.1.1 The helicopter sustained substantial damage to the instrument panel, the tail-boom, the tail-rotor, the main rotor blades and the skid gear.

Figure 4: Closer shot of the helicopter at the accident site

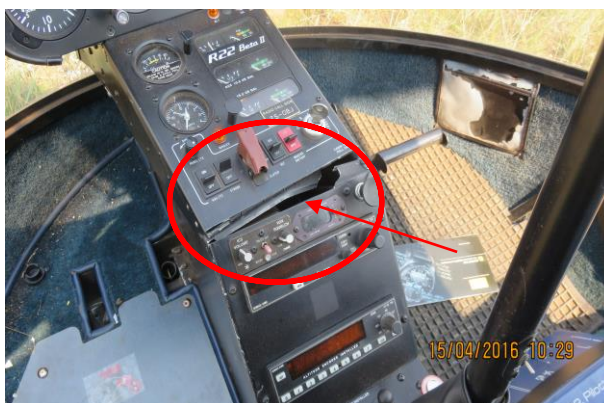
1.12.1 The accident happened on a farm west of FALA. The helicopter came to rest in an upright position with the instrument panel/centre console damaged and the skid gear deformed and bowed outwards. The wreckage, including pieces of the tail boom skin, tail rotor driveshaft and tail rotor, was dispersed over a distance of about 50 m radius. The tail boom, including the fin, tail rotor/blades and tail rotor gearbox were located to the east of the main wreckage. Attached below are the photographs.

Figure 7: A photograph of a severed instrument panel

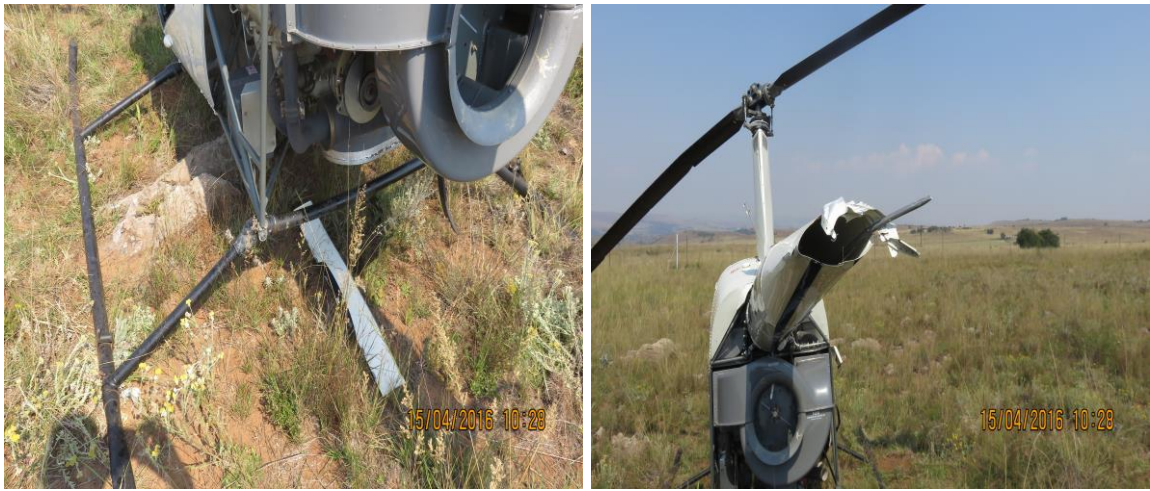
Figures 8: The skid gears as found (bowed out) and the severed tail boom

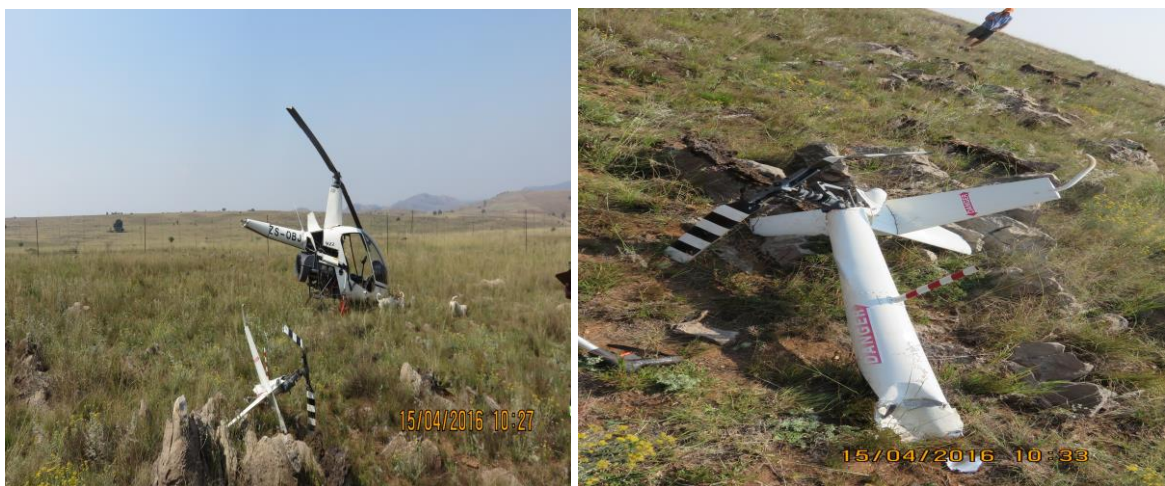
Figure 9: Photographs showing the wreckage lay-out and the closer shot of the tail rotor/fin

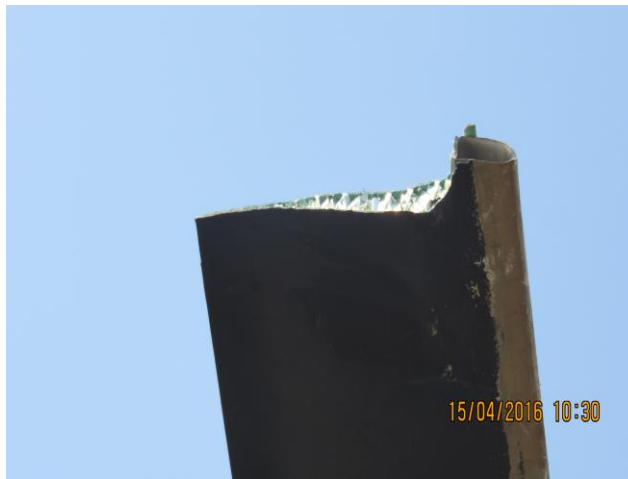
1.12.2 Examination of the wreckage at the accident scene showed the following: The helicopter had about 28.2 litres total fuel. One main rotor blade tip was severed. The engine drive V-belts were off their sheave grooves, but not broken. The engine was found still secured to its mounting points. Both sheaves were in good condition and the free running clutch within the upper sheave responded appropriately to manual rotation in both directions. Both pitch change links exhibited slight bending overload failures. In the cockpit, the clutch was still selected to engage and the clutch circuit breaker was in the normal (un-pulled) position. The clutch caution light and actuator overload fuse were both intact. The flex plate was intact/no cracks observed on the bolt holes. MIL-H5606 hydraulic fluid leak was observed on the main rotor hub and assembly. The distribution of the wreckage around the helicopter was consistent with the main rotor blade No 1 striking the tail boom. Attached below is the photograph showing a severed rotor blade.

Figure 10: A photograph displaying of a severed rotor blade
