# 飛航安全調查委員會

## 航空器飛航事故 調查報告

中華航空公司 CI025 班機

報告編號：ASC-AOR-17-06-001

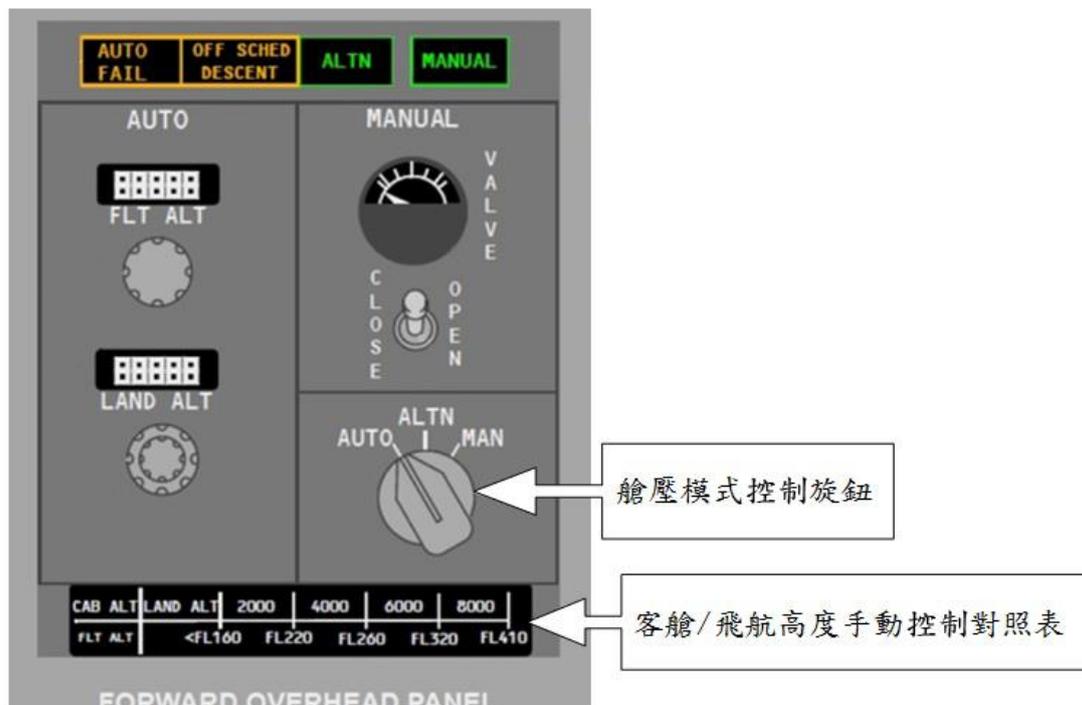
圖 1.1-1 艙壓控制模組面板

1421:37 時，該機爬升通過 27,434 呎高度，駕駛艙主警示<sup>3</sup>作動，伴隨艙壓控制模組（cabin pressure control module, CPCM）面板（詳圖 1.1-1）之「AUTO FAIL」（自動失效）及「ALTN」（替代備用）燈

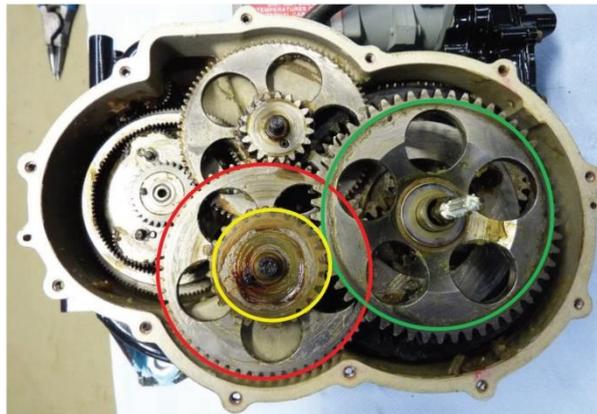
Picture 1 Gear Train

事故後該機之 OFV、CPCM 及 2 具 CPC 被拆下送至位於德國之 NORD-MICRO 原廠授權修理廠執行檢查及測試，1 號艙壓控制器壓力測試值未達測試標準但與本事故肇因無關；2 號艙壓控制器及艙壓控制模組檢查結果均正常；OFV 拆檢後發現，馬達傳動至閥門之兩只齒輪插銷斷裂，導致駕駛員無法以「AUTO」、「ALTN」及「MAN」模式控制 OFV 閥門開合。

After the Gearbox has been opened, it could be easily noticed that the **green** marked gear was decoupled from the **red** marked gear, which normally drives the green marked gear via the **yellow** one.

序號。SB 20209-21-001 說明上述齒輪組之空心插銷可能於操作時斷裂，導致艙壓控制器及手動控制模式無法作動，修改方式為將齒輪組兩只空心之齒輪插銷更換為實心插銷。
