<b>AIRCRAFT ACCIDENT REPORT AND EXECUTIVE SUMMARY</b>
---

Reference:	CA18/2/3/9553	
<b>Aircraft Registration</b>	ZU-SES	<b>Date of Accident</b>	12 May 2016		<b>Time of Accident</b>	0545Z
<b>Type of Aircraft</b>	Jabiru SP		<b>Type of Operation</b>		Private (Part 91)	
<b>Pilot-in-command Licence Type</b>		Private Pilot	<b>Age</b>	64	<b>Licence Valid</b>	Yes
<b>Pilot-in-command Flying Experience</b>		Total Flying Hours	2498.0		Hours on Type	892.4
<b>Last point of departure</b>		Kitty Hawk Aerodrome, Gauteng province				
<b>Next point of intended landing</b>		Mooketsi, Limpopo province				
<b>Location of the accident site with reference to easily defined geographical points (GPS readings if possible)</b>						
Plot 15, Boschkop at GPS position S 25°50'56.4" E 028°27'4.5"						
<b>Meteorological Information</b>		Surface wind: 060°/2 Kts, Visibility: 10000m, Temperature: 15.9°C, Dew point: 9.1°C, Cloud cover: 2 Octas, Cloud base: 2000m.				
<b>Number of people on board</b>	1+1	<b>No. of people injured</b>	1	<b>No. of people killed</b>	1

## AIRCRAFT ACCIDENT REPORT

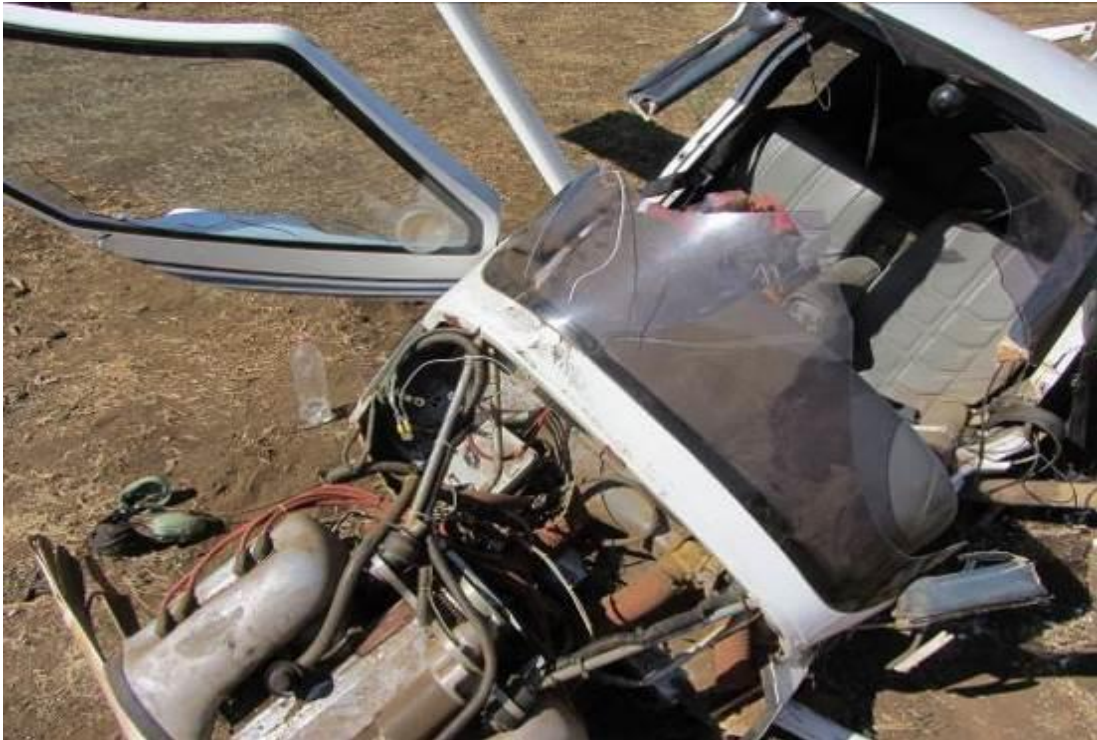
1.3.1 The aircraft was destroyed during the sequence of the accident.

**Figure 2** Damage caused to the aircraft during the accident

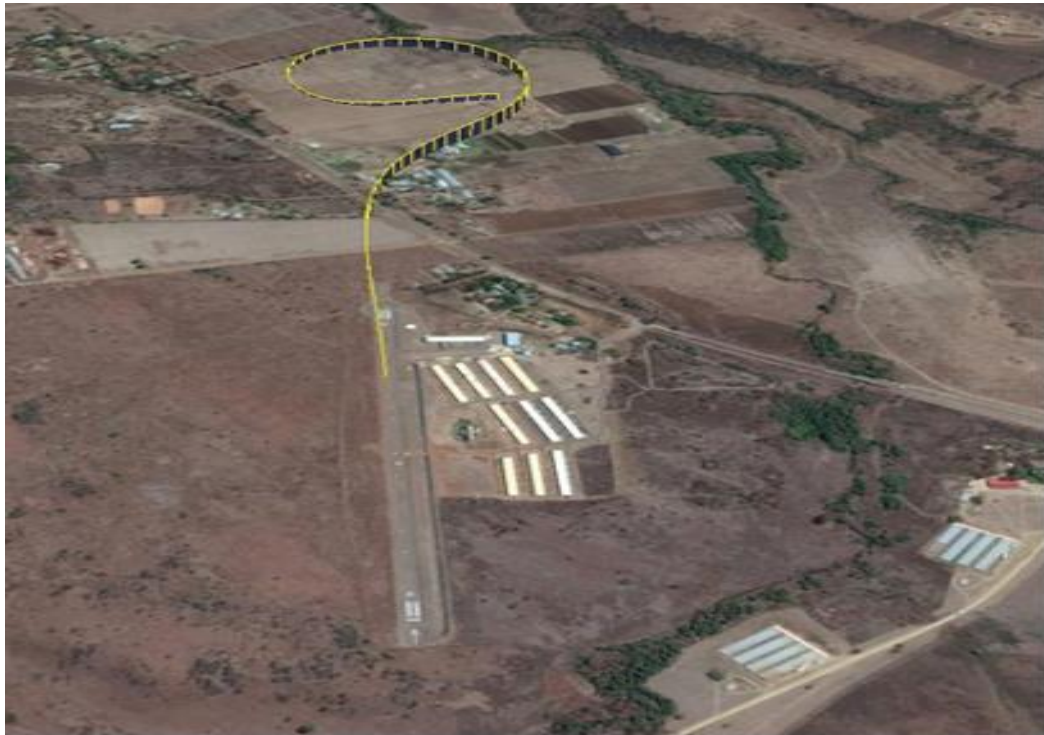
1.12.1 The total flight time from the moment the EFIS system start recording the aircraft speed till the time of impact was 93 seconds and the flight path is illustrated in the figure below.

**Figure 3** The flight path from take off

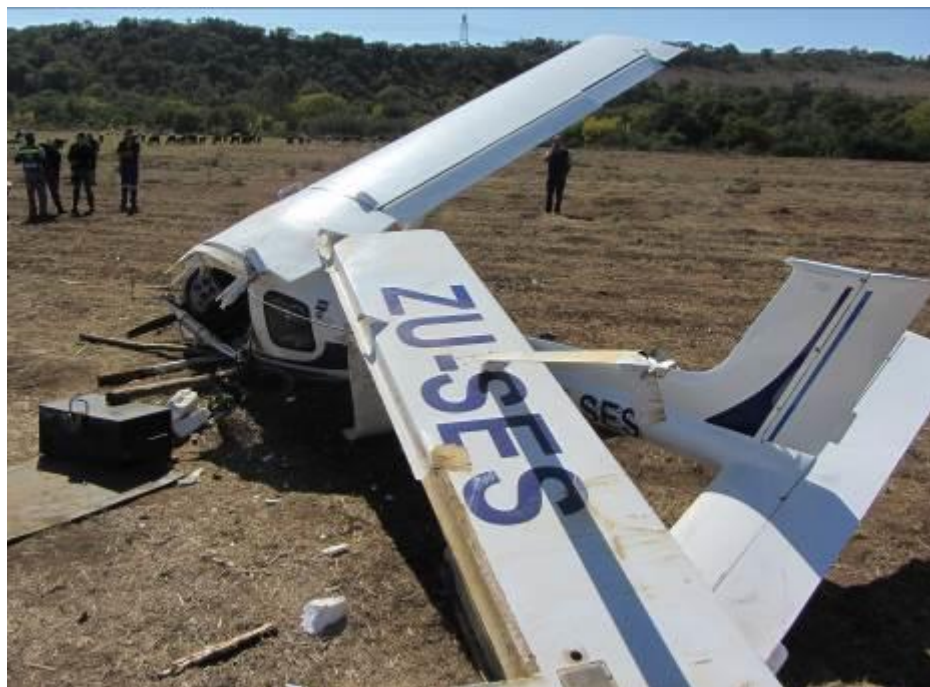
**Figure 4** Damage to the left wing

- 1.12.5 The right wing sustained minimum damage while the left wing was separated from the fuselage at the point where it attached to the fuselage. Orientation of the traces of impact of the left wing on the ground showed that the general flight direction of the aircraft at impact was 080° magnetic. The aircraft came to rest facing 312° magnetic.

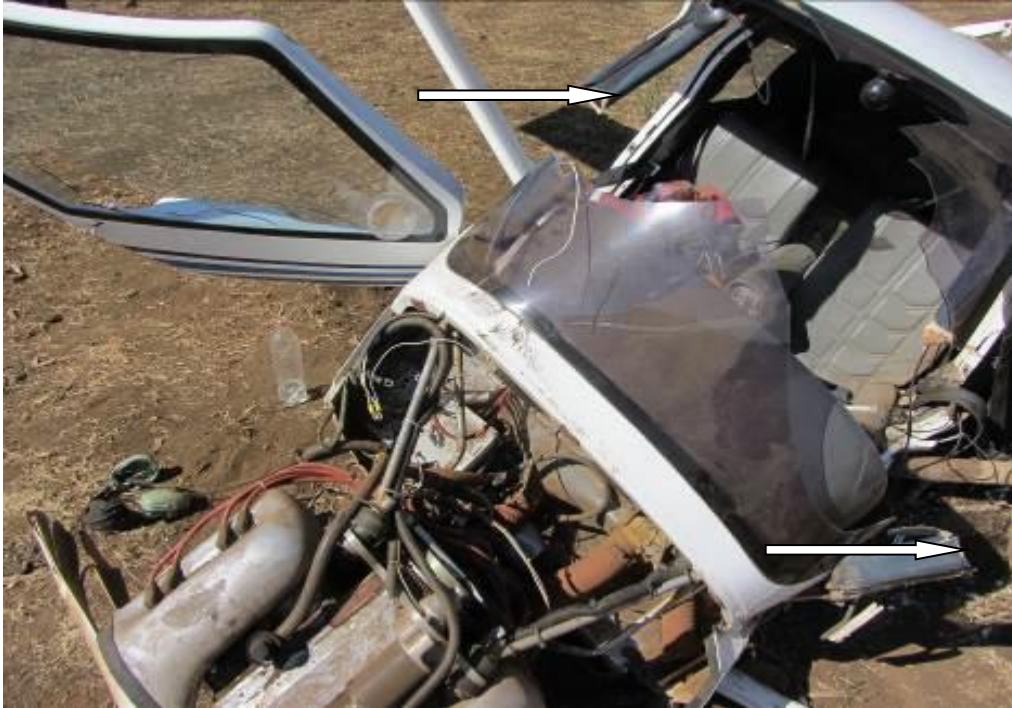
1.12.2 The front section of the cockpit was significantly damaged. Both the left- and right-hand window posts broke off completely and the cockpit floor was impaired. The left wing was broken at the point where it attached to the cockpit of the aircraft.

**Figure 5** Broken window posts

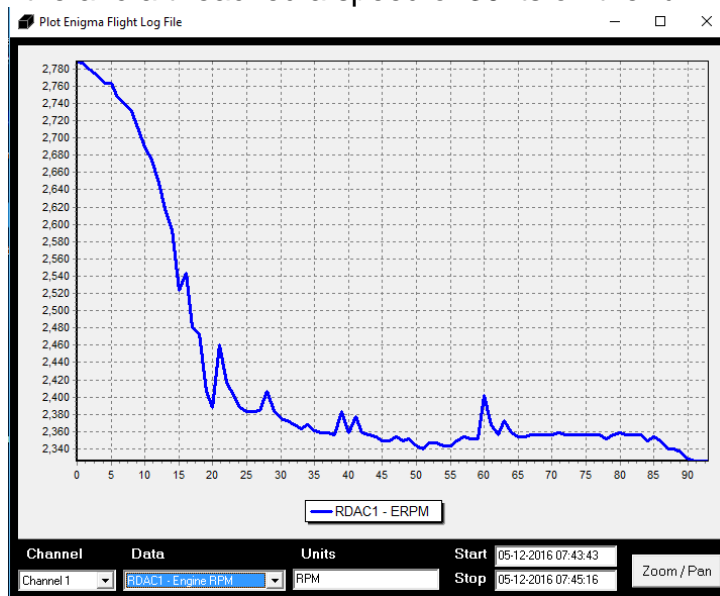
It was evident between 15 and 20 seconds after the aircraft had reached a speed of 30 knots that something had happened within the engine which caused a significant drop in engine revolutions per minute (RPM) from approximately 2780 RPM to approximately 2390 RPM. The RPM continued to drop till the end of the recording, when it dropped to approximately 2300 RPM.

**Figure 6** Engine RPM during the entire flight

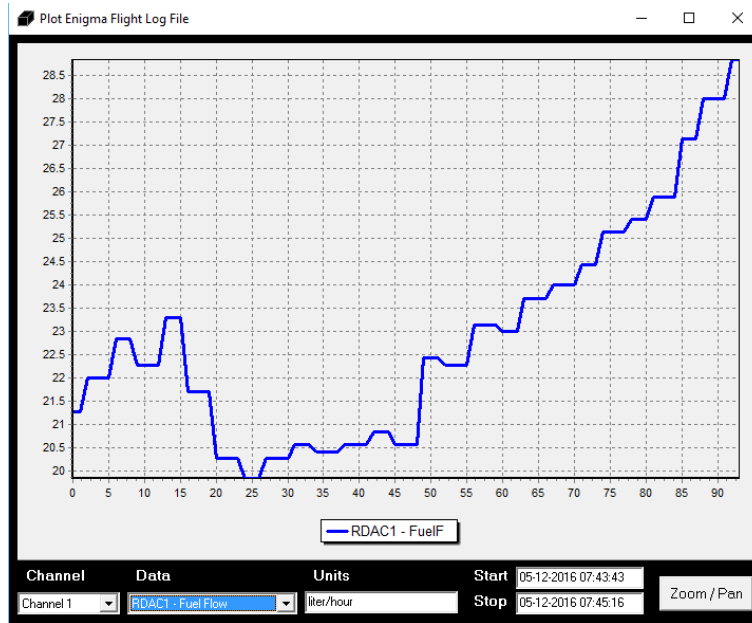
At approximately the same time interval, the fuel flow increased.

**Figure 7** Indication of an increase of fuel flow

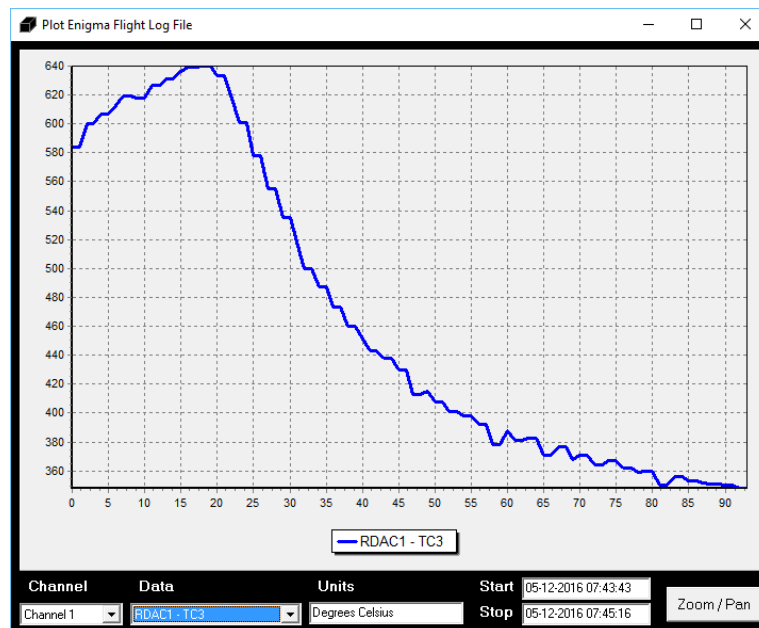
At approximately the same time, a loss in exhaust gas temperature (EGT) and a loss in cylinder head temperature (CHT) were experienced on cylinder number three, whereas the rest of the cylinders operated normally.

**Figure 8** Indication of a drop in EGT on number three cylinder

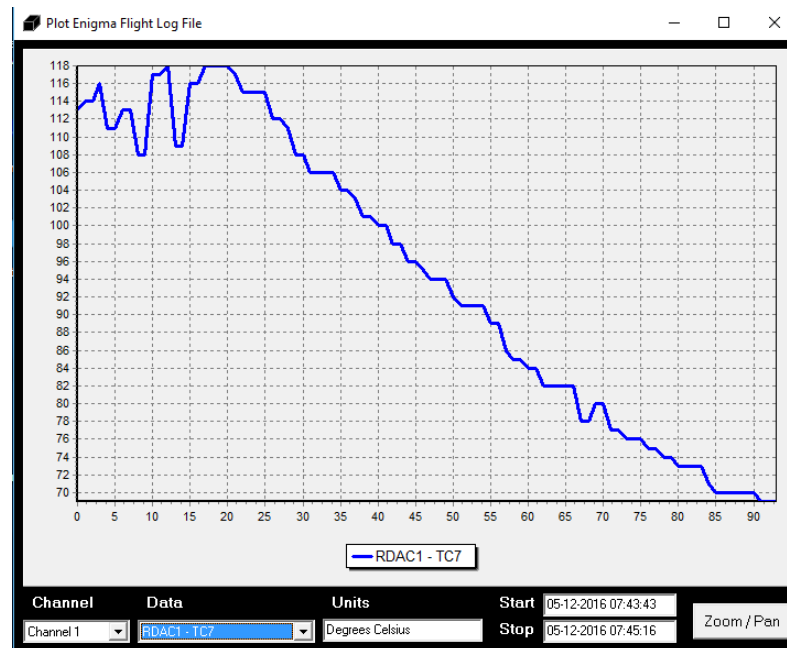
**Figure 9** Indication of a drop in CHT on number three cylinder

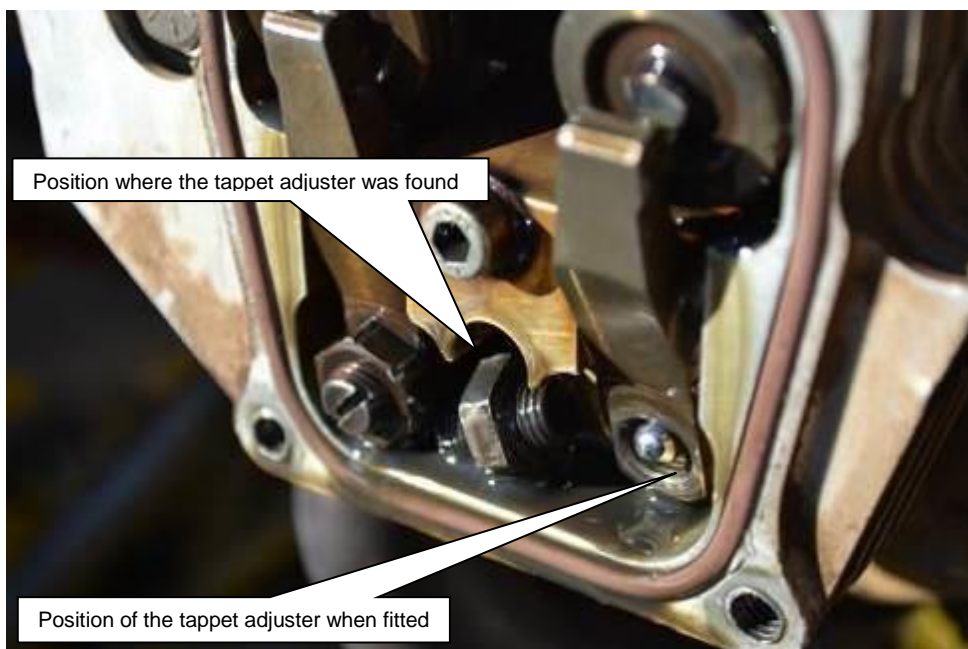
The number three-cylinder rocker cover was then removed and it was observed that the intake tappet adjuster was lying at the bottom of the rocker chamber and not fitted to the rocker arm as it was supposed to be.

**Figure 10** The tappet adjuster at the bottom of the rocker chamber

During a teardown inspection of the number three cylinder, a tappet adjuster of the inlet valve was found at the bottom of the rocker chamber. The loose tappet adjuster renders the valve operation inoperative, which caused the cylinder not to function and resulted in the engine providing power on only three cylinders.

- 3.1.7 The tappet adjuster on the number three-cylinder inlet valve was found to be not locked in position but on the bottom of the rocker chamber. The most likely reason for the out-of-position tappet adjuster was improper locking or no locking of the tappet adjuster during maintenance. The out of position tappet adjusted caused a partial power loss of the engine during take-off.

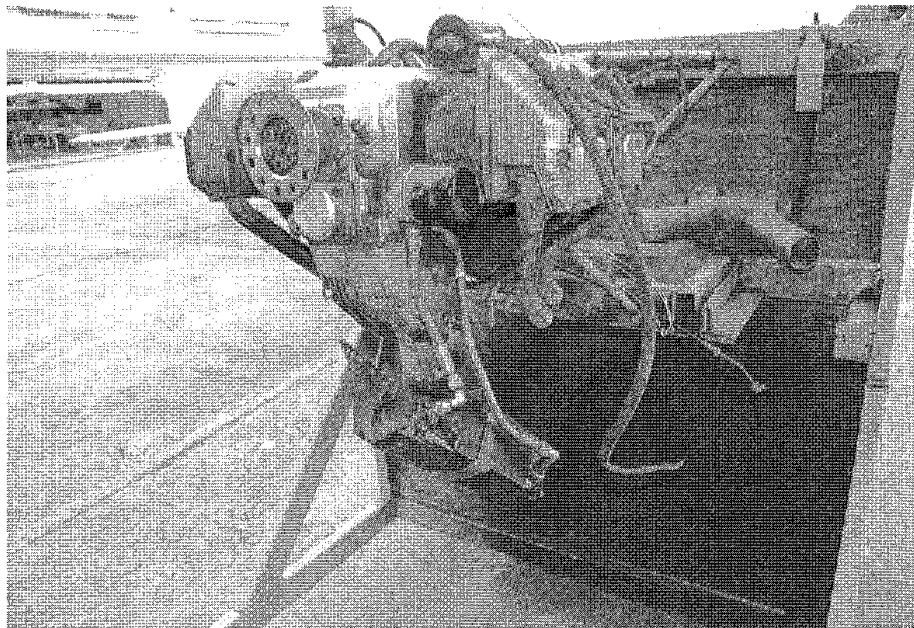
First observation was that the oil cooler was damage from impact. The oil cooler was then removed and a bypass manifold was fitted with the original oil filter.

*Above picture of Damaged oil cooler before removal*

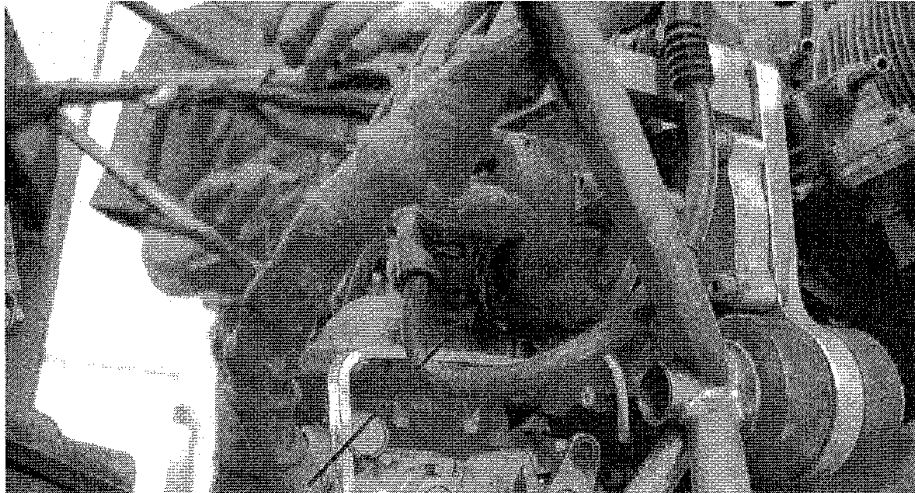
Other minor observation that were noted was that the right hand distributor cap was cracked it was left as is for the test.

*Above picture of Distributor cap with crack*

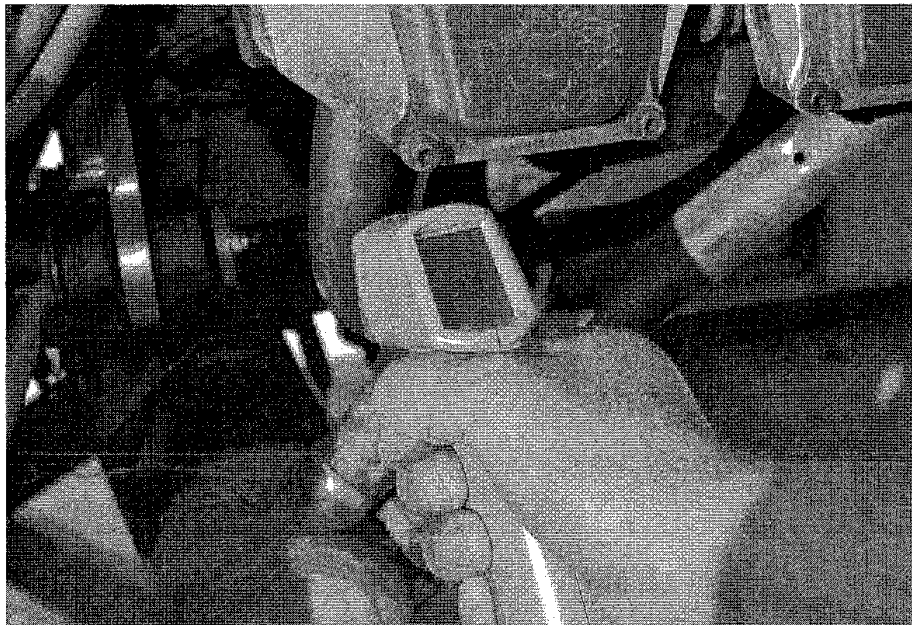
The engine was then shut down. After taking the temperature readings of the exhaust manifolds, it was noted that **no 3 cylinder** was notably cooler than the rest.

*Above picture of the No3 Cylinder showing temperature*

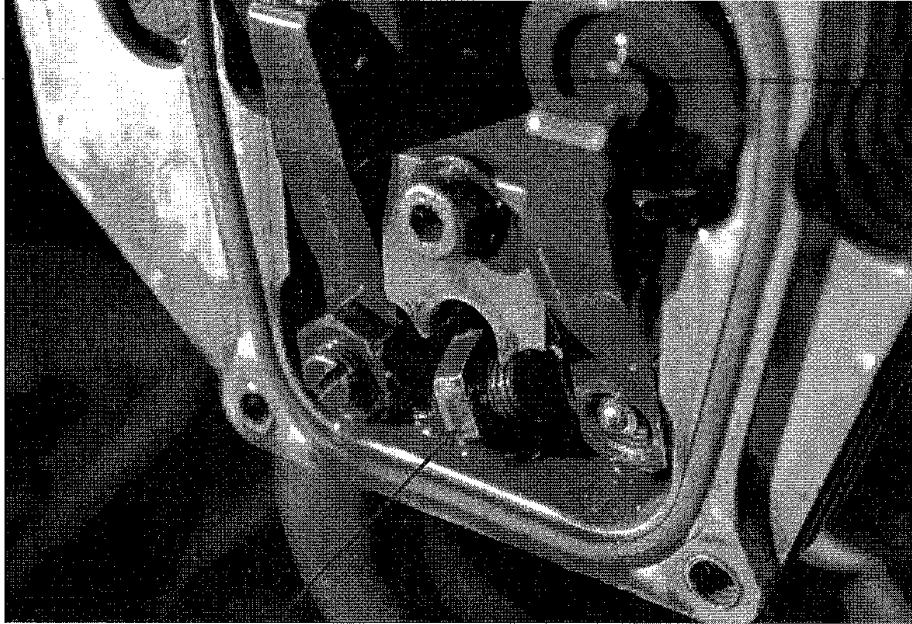
After removing no 3 cylinder rocker cover, it was observed that the intake tappet adjuster was lying at the bottom of the rocker chamber. This caused intake valve not to function causing the engine to run on 3 cylinders, thus the engine could not achieve full power.

*Above picture of the tappet adjuster lying at the bottom of the Rocker Chamber*

**The cause of the loss of power would be that the rocker adjusting screw had not been locked in place with the locking nut, allowing it to loosen up and fall out of the rocker arm.**

These valve adjusters are to be checked every 50 hours of flight and the necessary adjustments to be made to keep the correct clearance. ( See **appendix A** extract from Jabiru Engine Maintenance Manual JEM0002-6 dated 1<sup>st</sup> October 2015 to see how this is carried out and described for Maintenance personnel)

The procedure of setting the valve is to have that cylinder in the “Rocking” position. The locknut on the adjusting screw is loosened there after using a screwdriver the correct clearance is set with a feeler gauge.

While holding the adjustment screw with a screwdriver the locknut is tightened with a spanner. Failing to lock the adjustment screw with the locknut will allow the adjusting screw to loosen and eventually fall out.
